UNDERWATER BRIDGE INSPECTION REPORT

STRUCTURE NO. 31509

MISSISSIPPI RIVER

OCTOBER 1, 2012

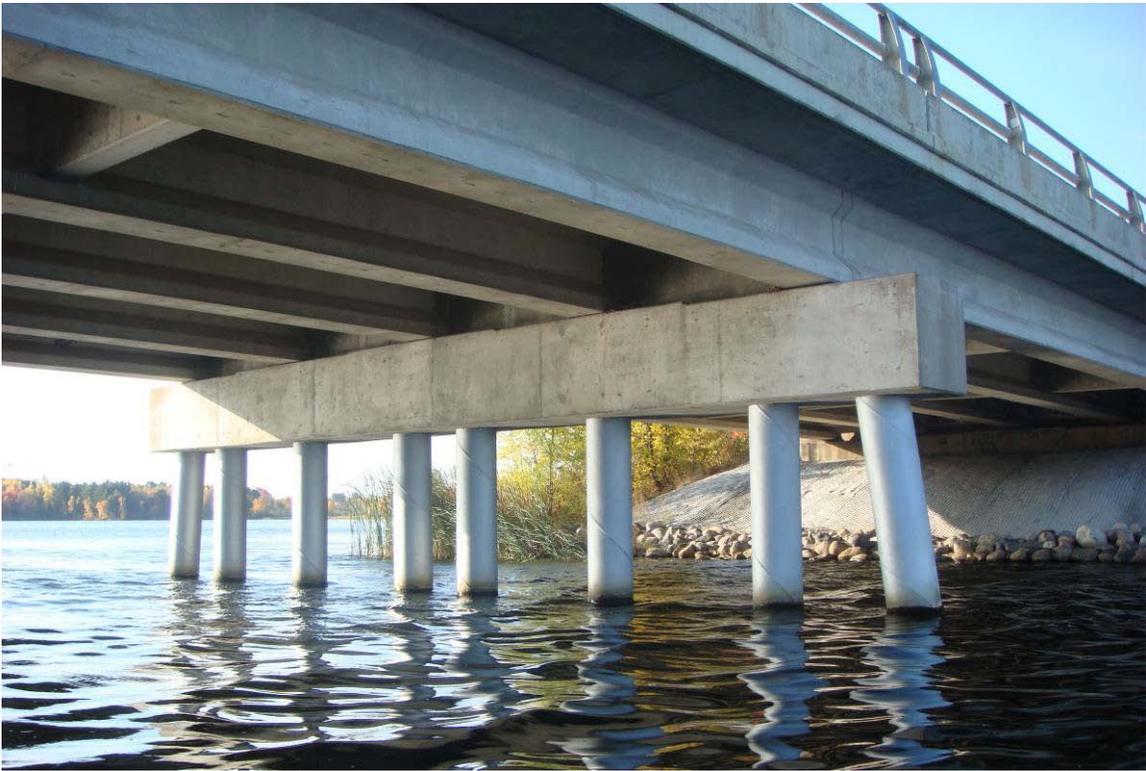
Photograph 2. View of Pier 1, Looking South.

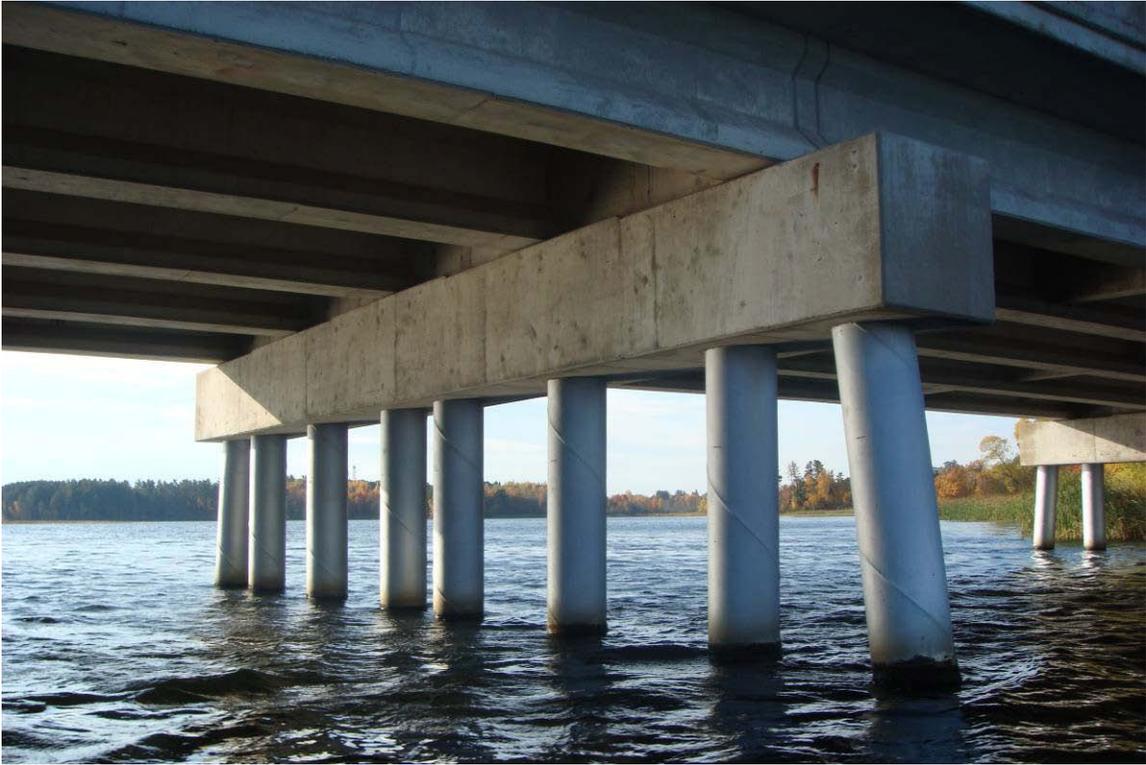
Photograph 3. View of Pier 2, Looking South.

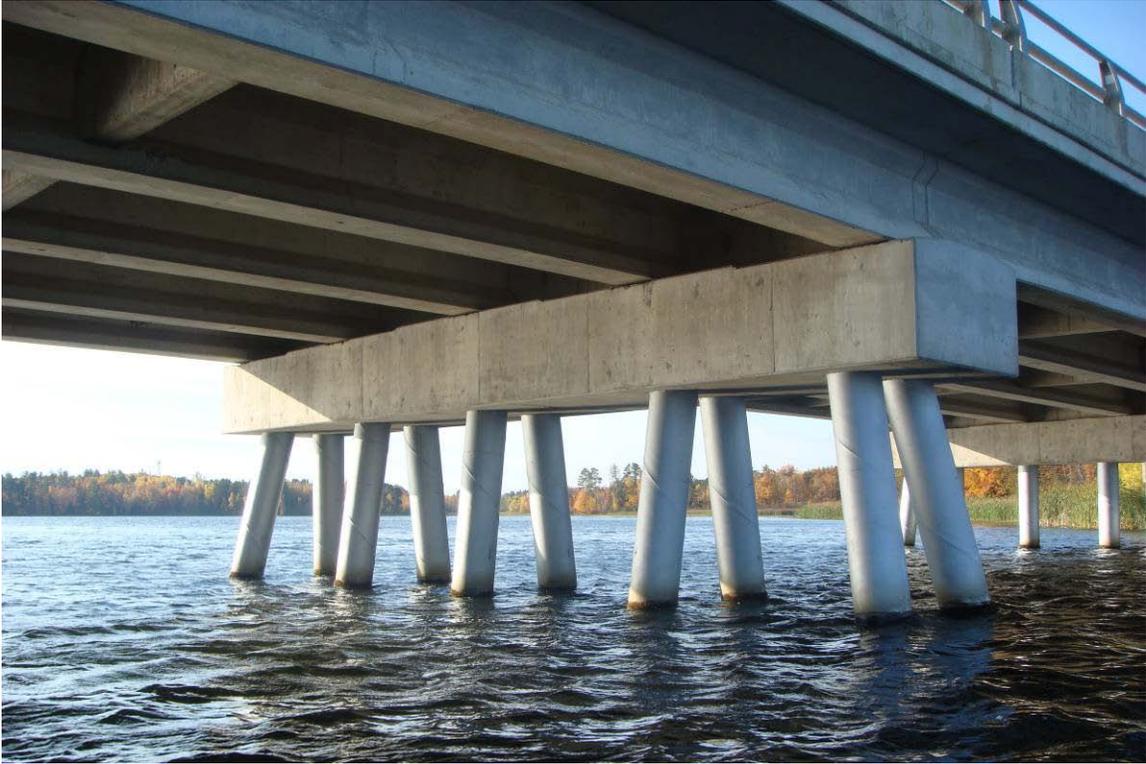
Photograph 4. View of Pier 3, Looking Southeast.

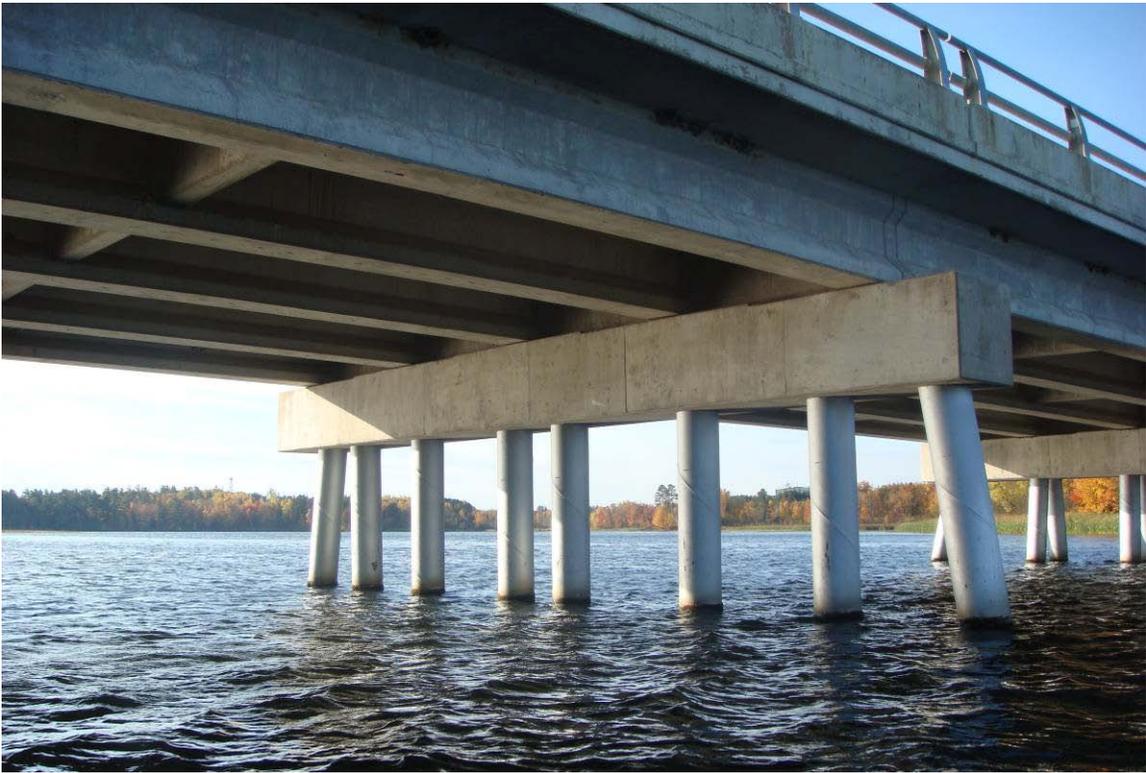
Photograph 5. View of Pier 4, Looking South.

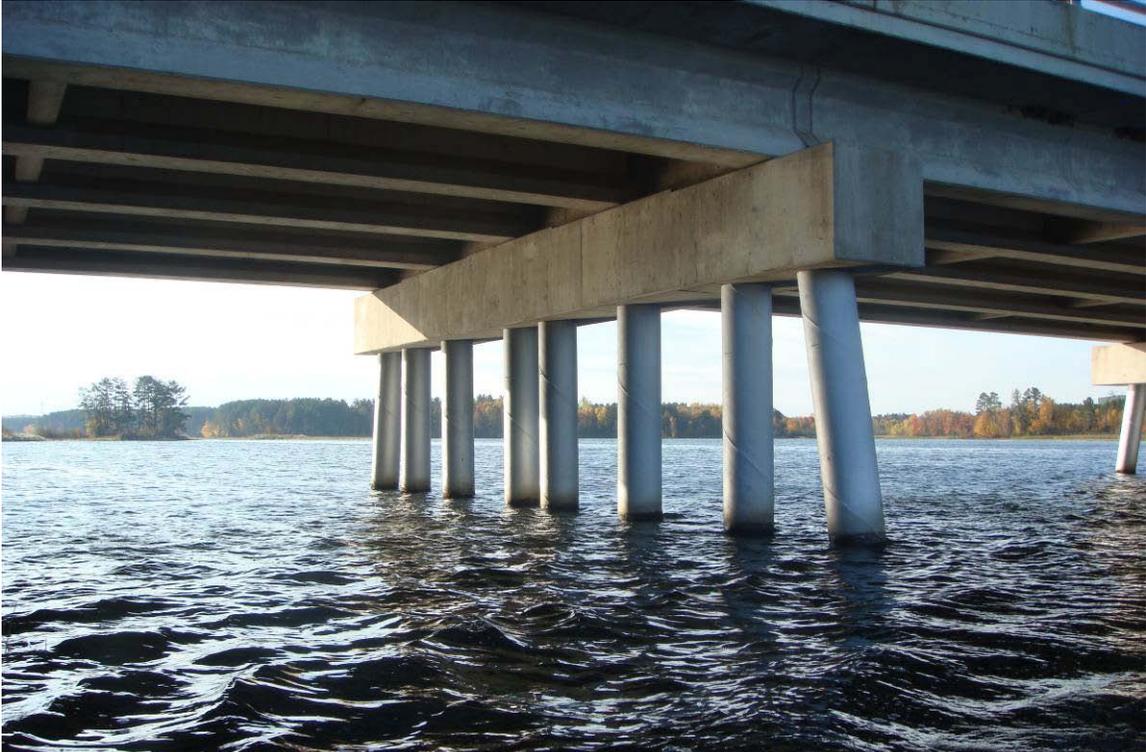
Photograph 6. View of Pier 5, Looking South.

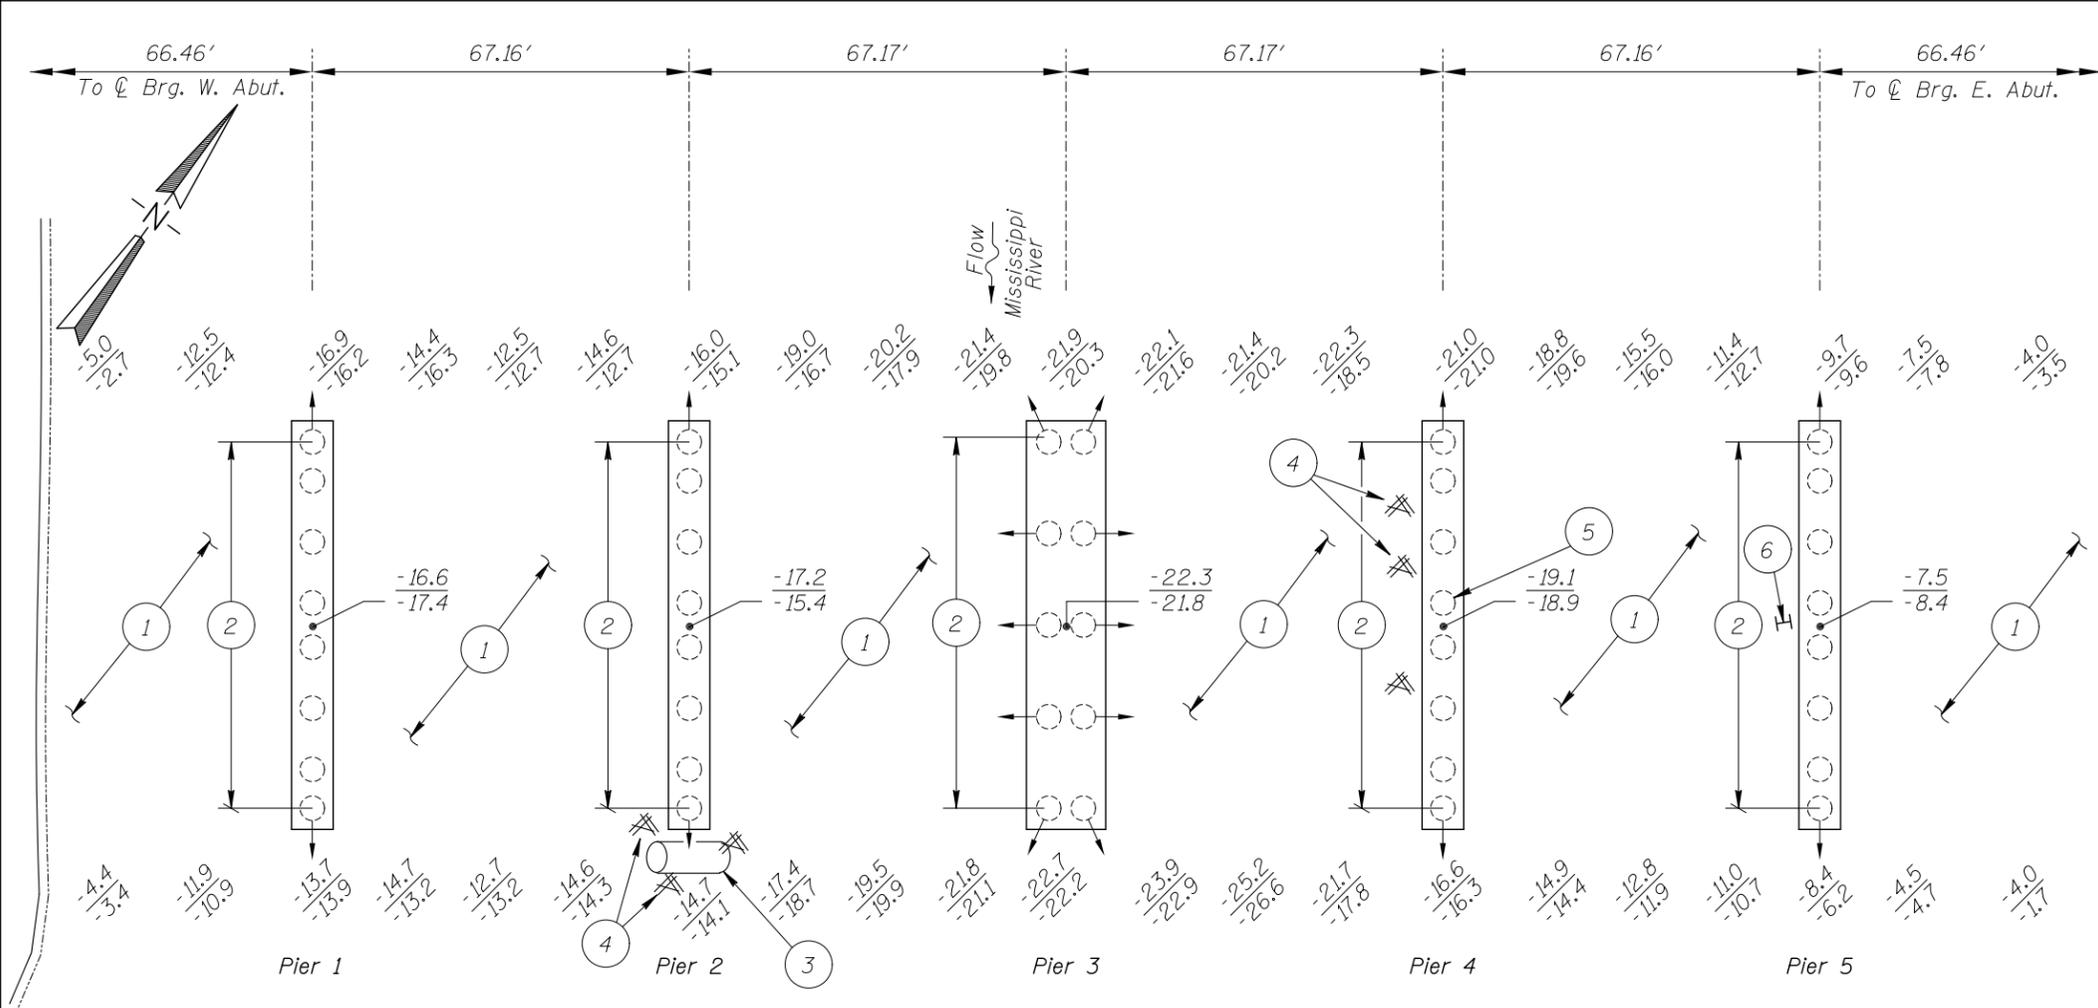
**SOUNDING PLAN**

- INSPECTION NOTES:**
- 1 Channel bottom consists of soft silty sand with gravel and cobbles, allowing up to 6 inches of probe rod penetration.
  - 2 Coating failure, corrosion, and rust nodules, were observed from 6 inches above the waterline to the channel bottom on approximately 80 to 100 percent of the surface area of all piles. Typical pitting penetrations of the rust nodules were 1/32 inch, with infrequent instances of 1/16 inch and 1/8 inch penetrations observed on the steel shell piles.

- 3 A large steel 5 feet diameter by 10 feet long corrugated metal pipe piece of debris was observed with random 6 inch diameter timber debris and 8 inch diameter posts in and around the pipe.

- 4 Timber drift consisting of scattered 6 to 8 inch diameter and smaller timber debris was observed at the mudline.
  - 5 3/4 inch diameter steel cables were observed to be wrapped around the pile.

- 6 A steel H-pile was sticking 10 feet out of the channel bottom and angled toward the downstream.
