UNDERWATER BRIDGE INSPECTION REPORT

STRUCTURE NO. 36514

RAPID RIVER

AUGUST 15, 2012

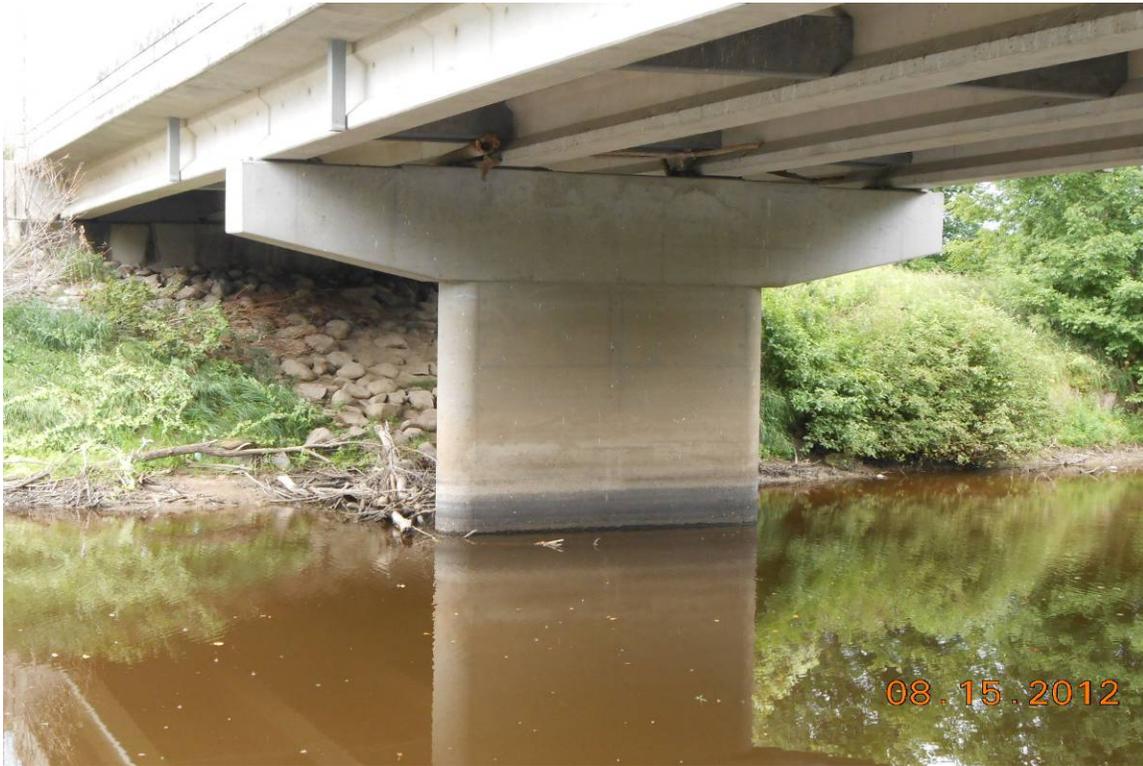
Photograph 1. View of Pier 1, Looking East.

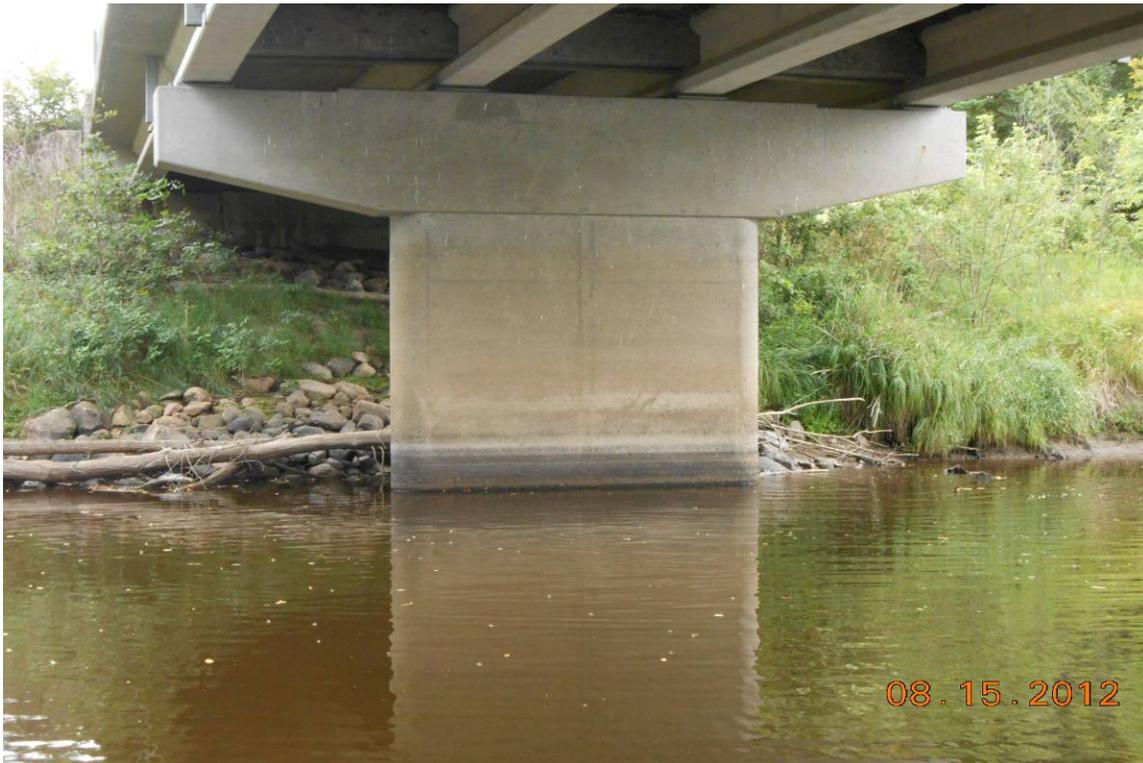
Photograph 2. View of Pier 2, Looking West.

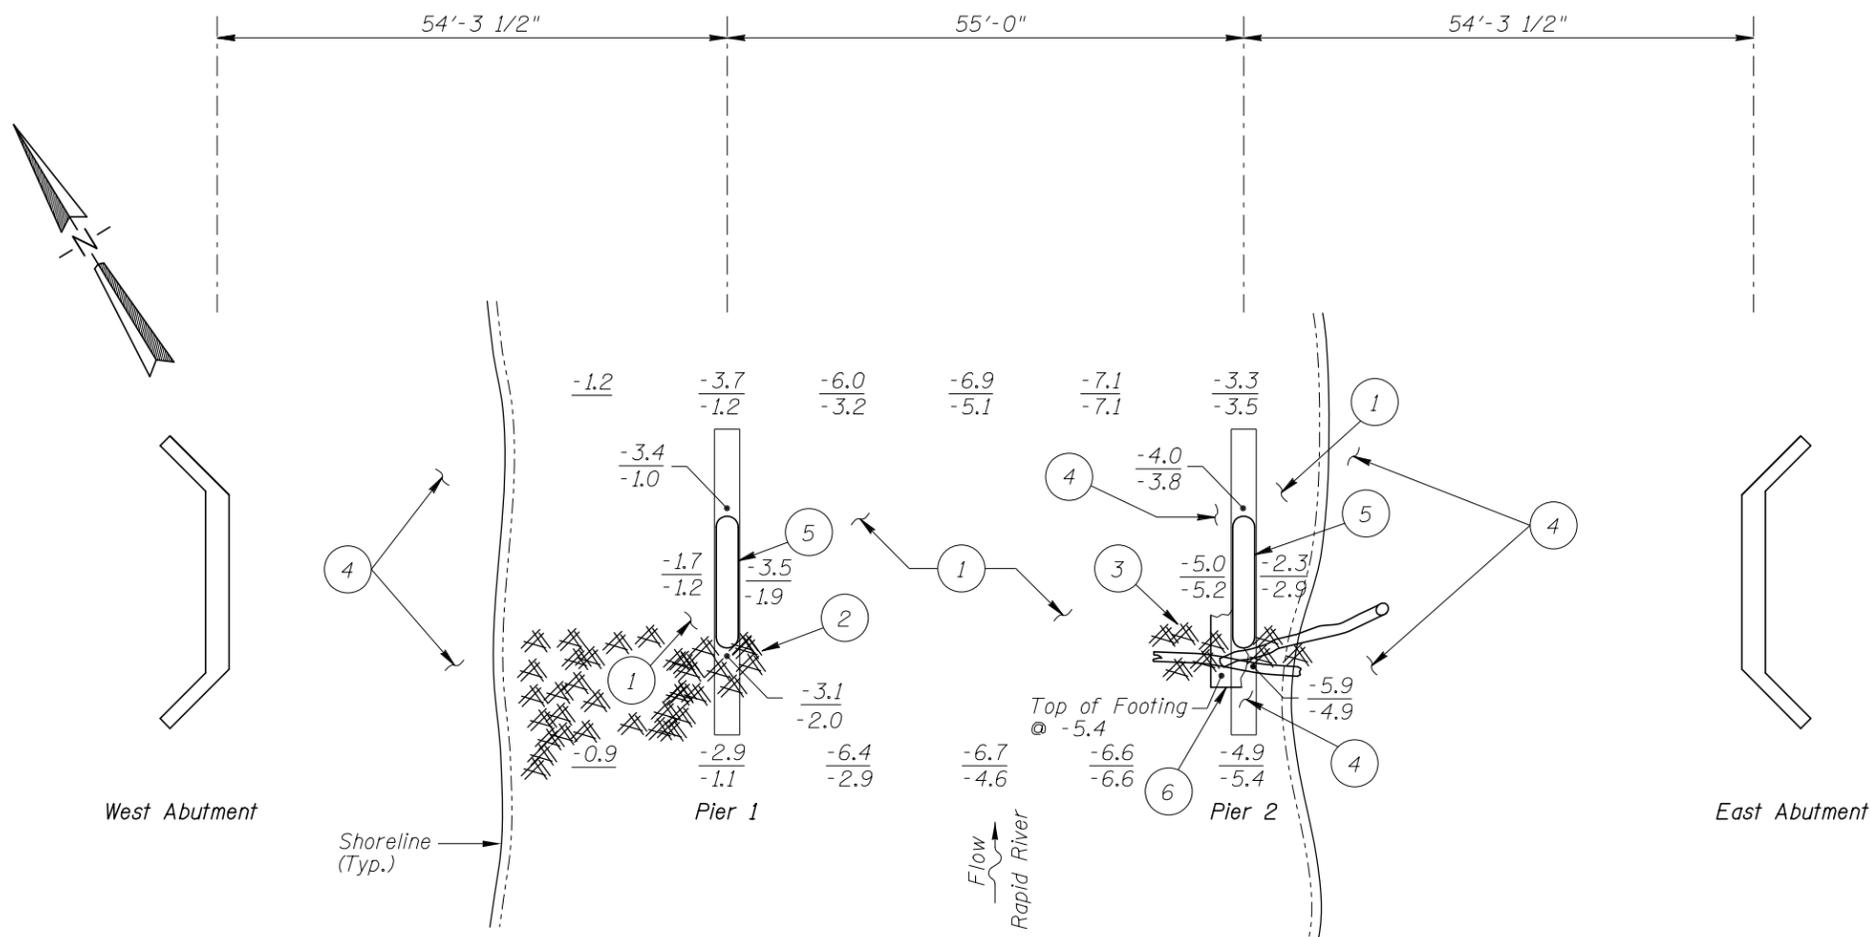
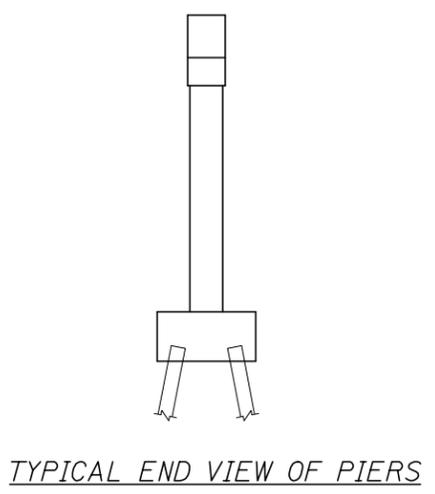
SOUNDING PLAN

- ① The channel material consisted of sand and gravel with some silt and up to 6 inches of probe rod penetration.
- ② A moderate accumulation of timber debris was observed at Pier 1, consisting of branches, each measuring up to 2 inches in diameter. The debris extended 1 foot up from channel bottom.

- ③ A moderate accumulation of timber debris was observed, consisting of numerous logs and tree trunks measuring up to 1 foot in diameter lying across the upstream nose and extending to the easterly shoreline. Debris extended from channel bottom to waterline at Pier 2.

- ④ The shoreline consisted of up to 2 feet diameter riprap, which was also present around the upstream and downstream noses of Pier 2.
- ⑤ Light scaling from 3 feet above the waterline to 2 feet below water level with 1/8 inch typical to 1/4 inch maximum penetrations was observed along the entire perimeter of Pier 1 and Pier 2.

- ⑥ The footing was partially exposed at the upstream end of Pier 2 on the channel side for a length of 4 feet with a maximum vertical face exposure of 6 inches.
