UNDERWATER BRIDGE INSPECTION REPORT

STRUCTURE NO. 69518

CSAH 4

ST. LOUIS RIVER

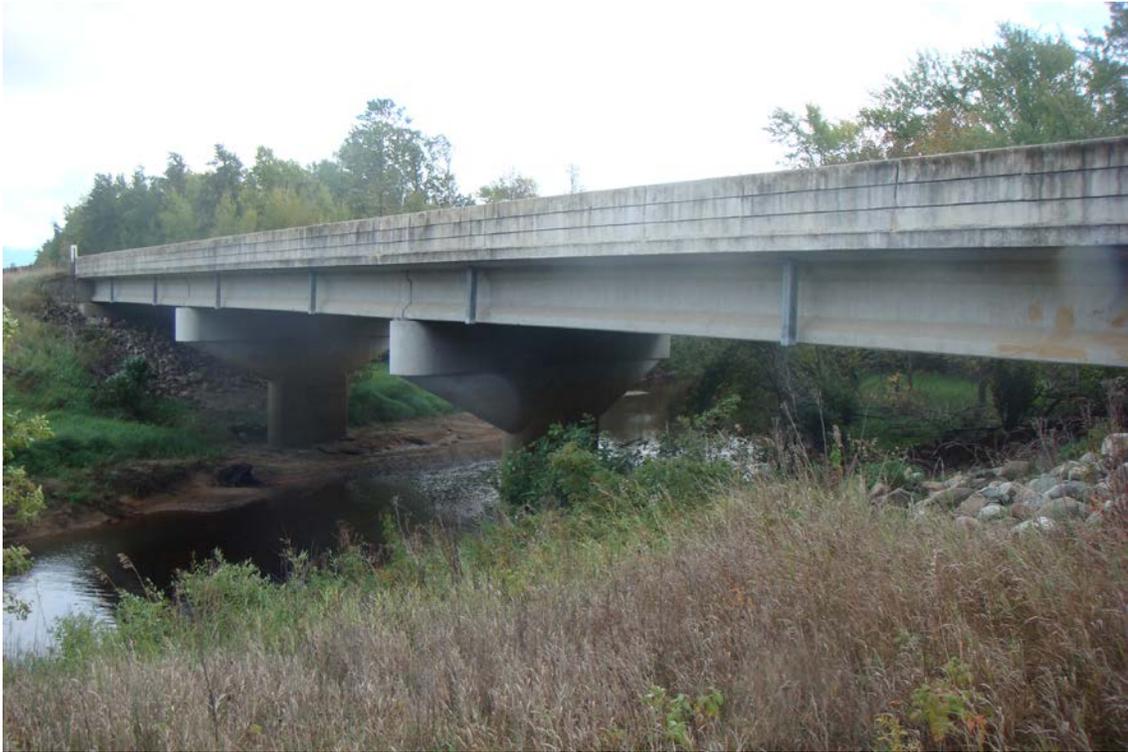
Photograph 1. Overall View, Looking Southwest.

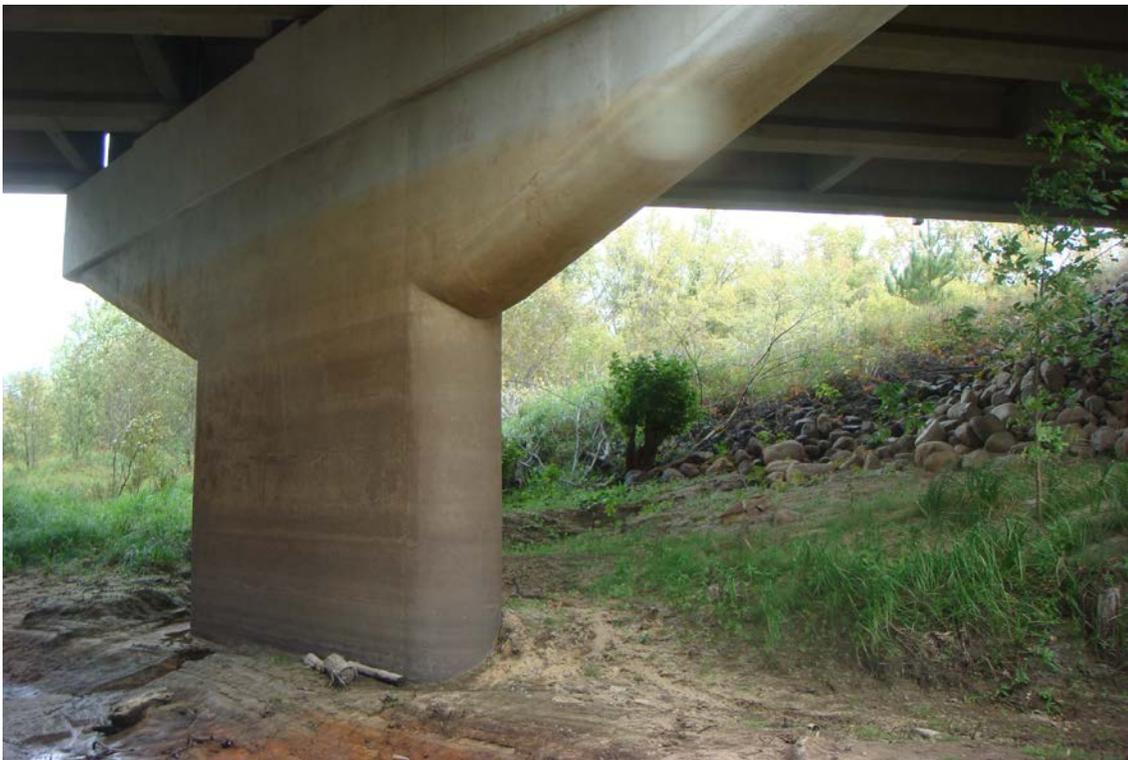
Photograph 2. Pier 1, Looking Southeast.

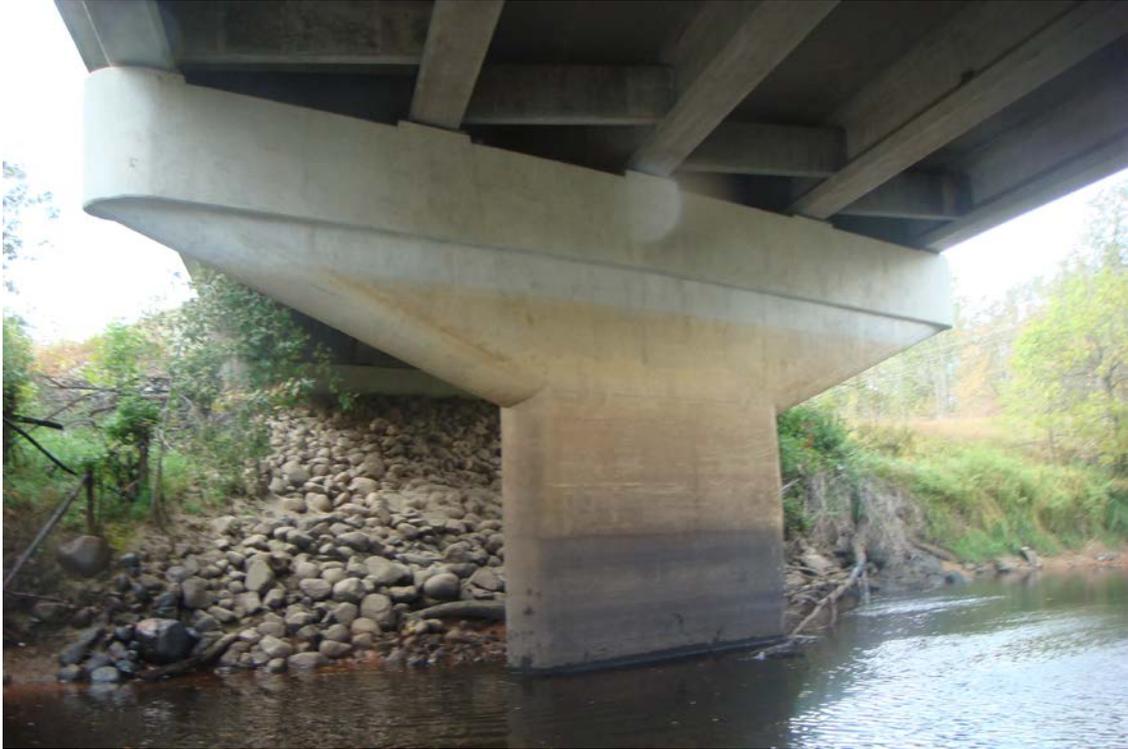
- (B) The channel bottom material to the south of Pier 2 consisted of firm sand and scattered cobbles with a typical probe rod penetration of 1 inch.
- (C) The concrete of the pier wall and footing was typically sound with a band of light scaling extending from the top of the footing to 2 feet above the waterline. The scaling had a typical penetration of 1/16 inch and a maximum of 1/8 inch.

Photograph 3. Pier 2, Looking Southeast.

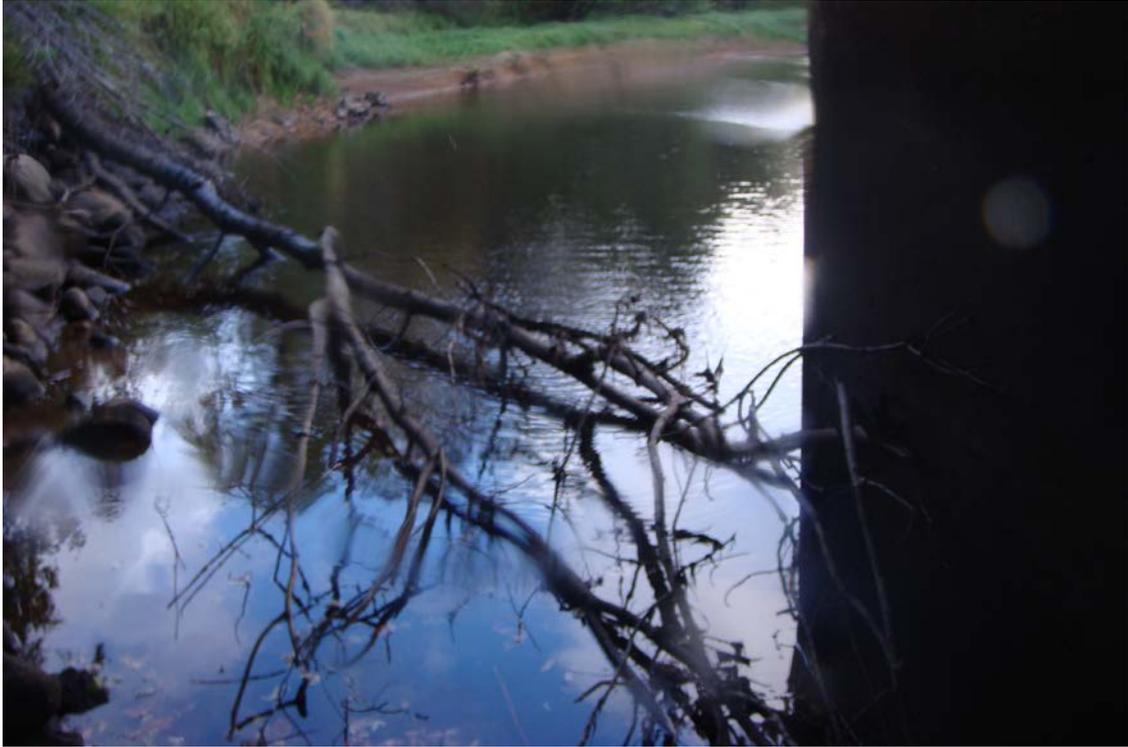
- (E) A 10 inch diameter tree was observed extending from the upstream nose of Pier 2 to the north shoreline.

Photograph 5. View of Tree Extending From Pier 2 to the Shoreline, Looking East.

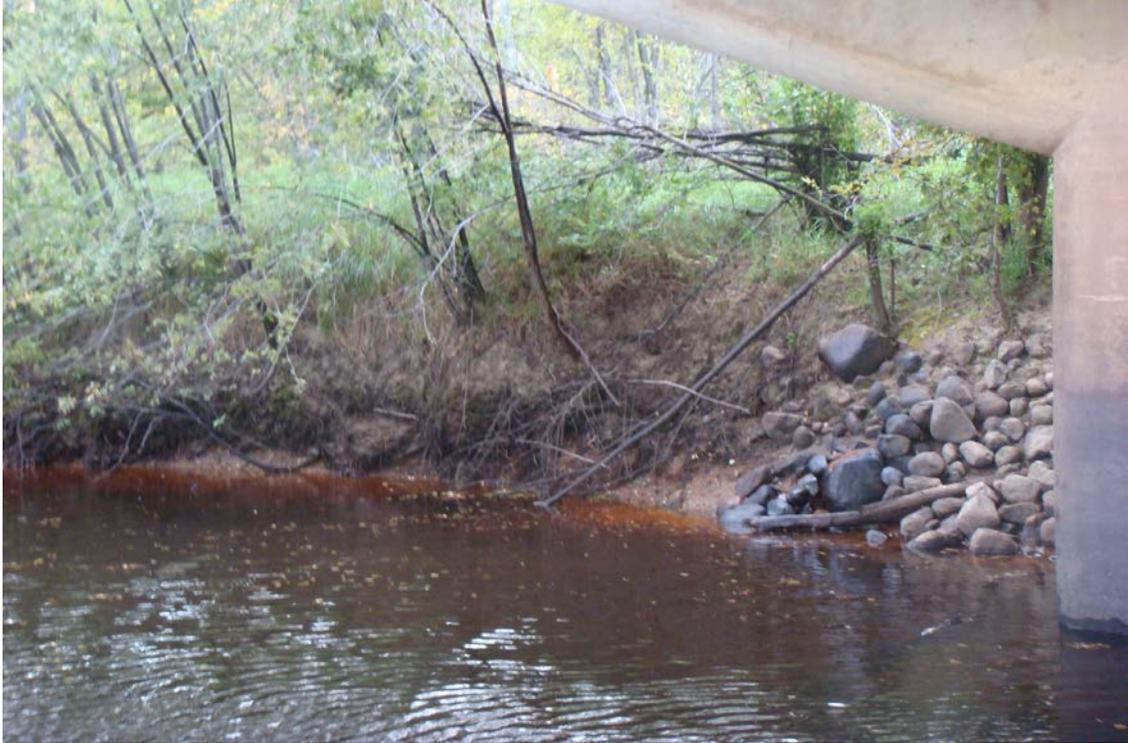
- (F) The upstream and downstream shorelines were heavily eroded with a maximum undercutting of 10 feet.

Photograph 6. View of Heavy Shoreline Erosion Downstream of Pier 2, Looking Southeast.

Monitor shoreline erosion during future inspections.

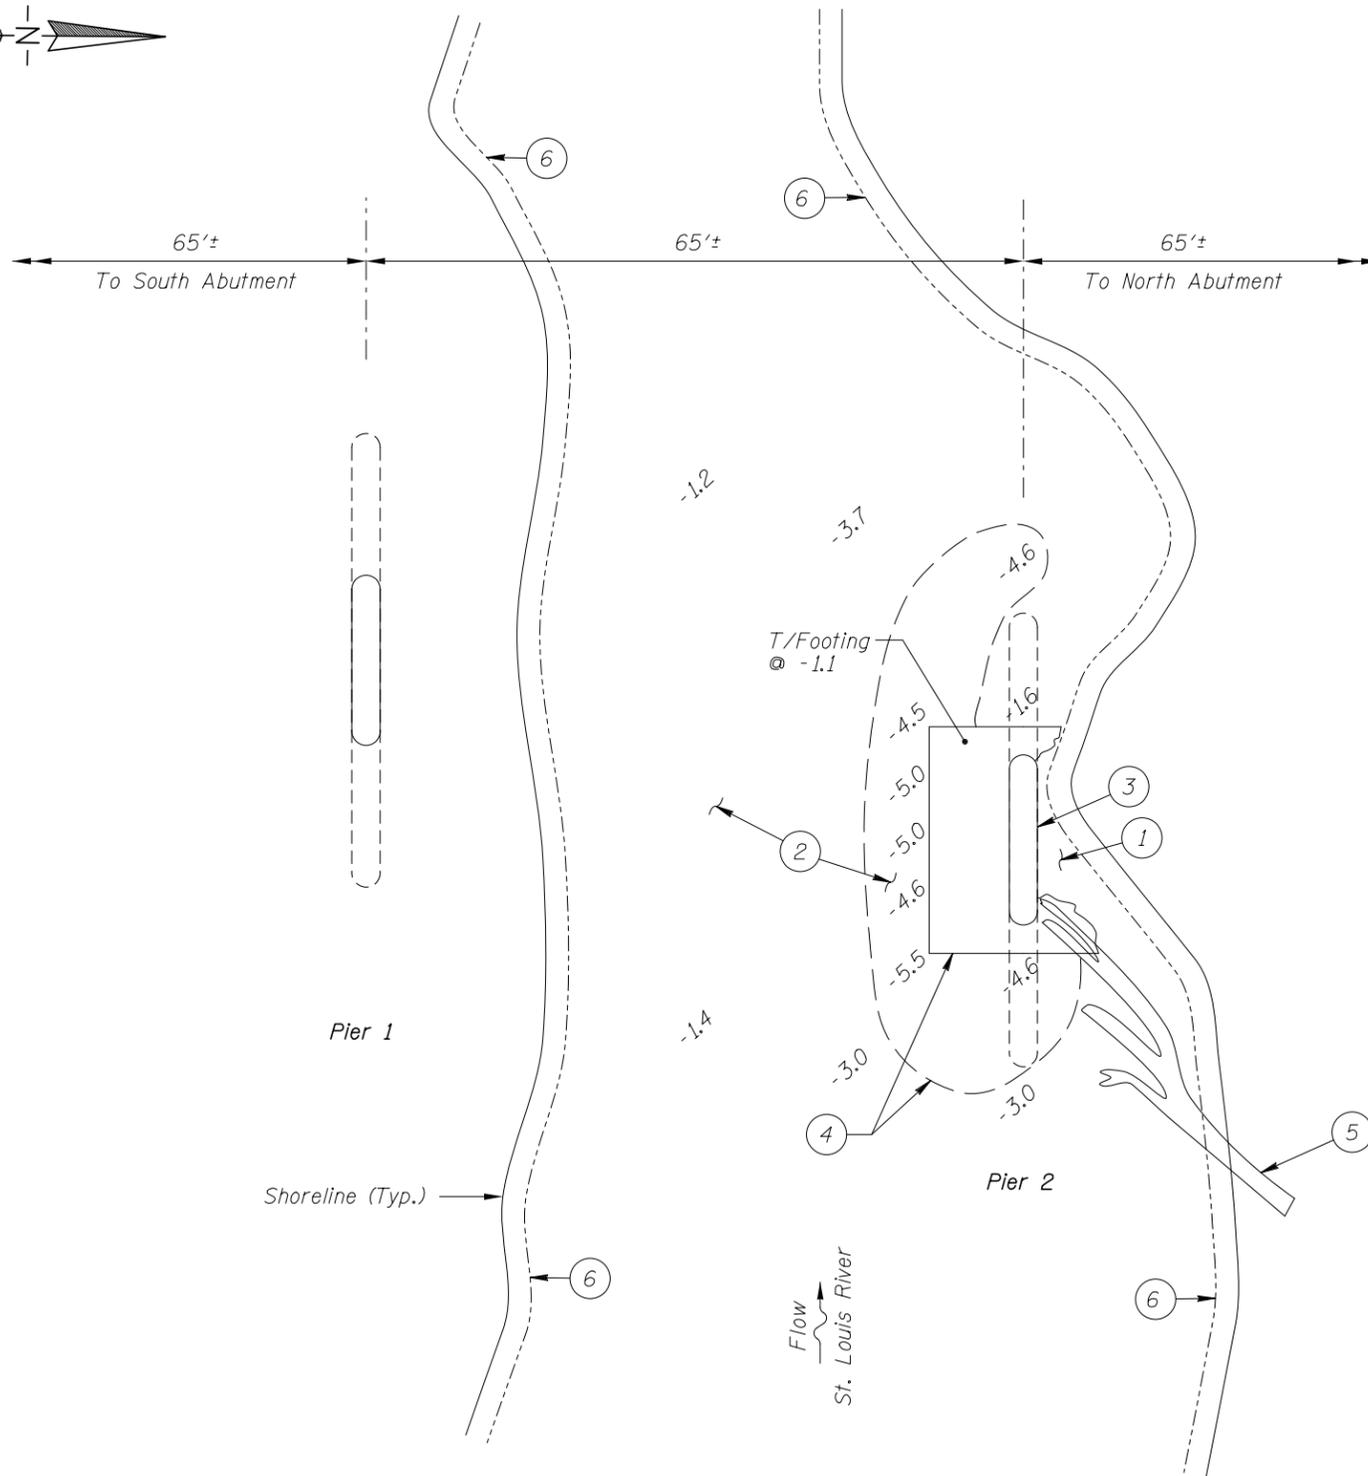
SOUNDING PLAN

- ① The channel bottom material consisted of stones and cobbles up to 2 feet in diameter with no appreciable probe rod penetration.
- ② The channel bottom material consisted of firm sand and scattered cobbles with a typical probe rod penetration of 1 inch.

- ③ The concrete of the pier wall and footing was typically sound with a band of light scaling extending from the top of the footing to 2 feet above the waterline. The scaling had a typical penetration of 1/6 inch and a maximum of 1/8 inch.

- ④ A 2 foot deep scour pocket was observed that extended 8 feet off the upstream and downstream nose and along the entire south face of Pier 2. Within the scour pocket the concrete footing of Pier 2 was exposed with a maximum vertical exposure of 4.4 feet at the upstream south corner.

- ⑤ A 10 inch diameter tree was observed extending from the upstream nose of Pier 2 to the north shoreline as shown.
- ⑥ The upstream and downstream shorelines were heavily eroded with a maximum undercutting of 10 feet.
