UNDERWATER BRIDGE INSPECTION REPORT

STRUCTURE NO. 69536
TWP NO. 415
OVER THE
CHANNEL AT LAKE VERMILLION
ST. LOUIS COUNTY

JUNE 21, 2012

BY
COLLINS ENGINEERS, INC.

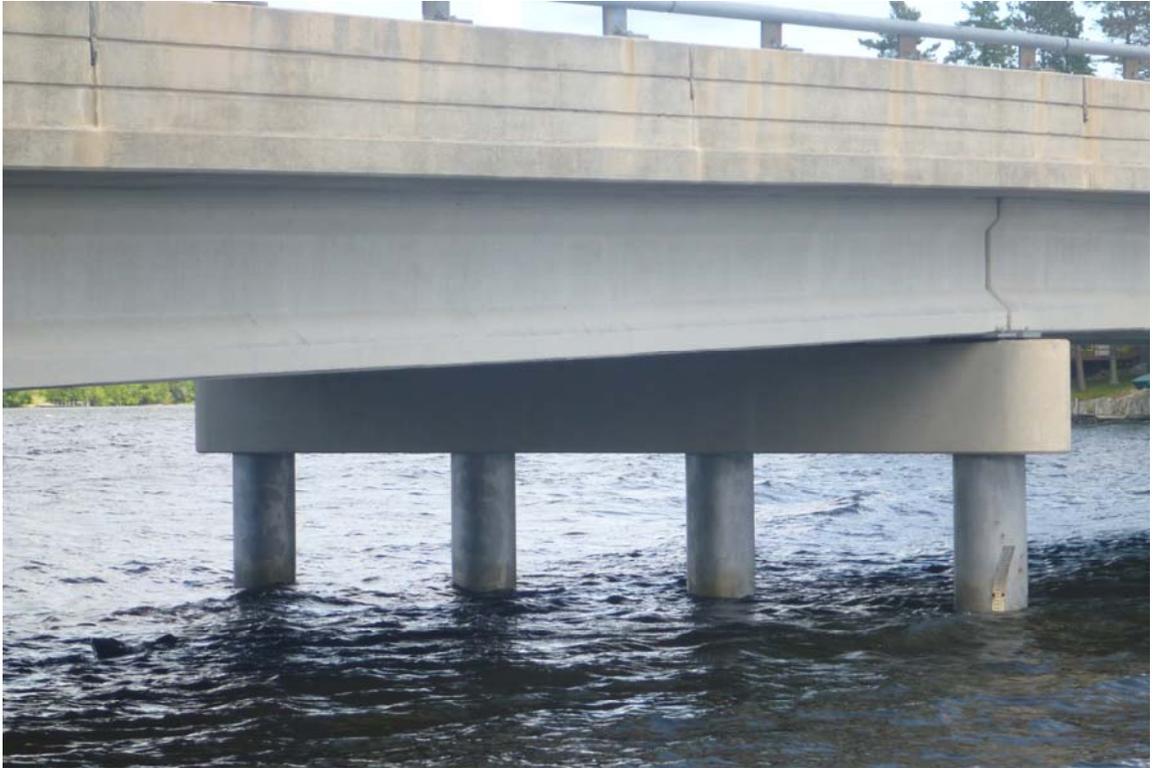
Photograph 3. View of Pier 1, Looking Northeast.

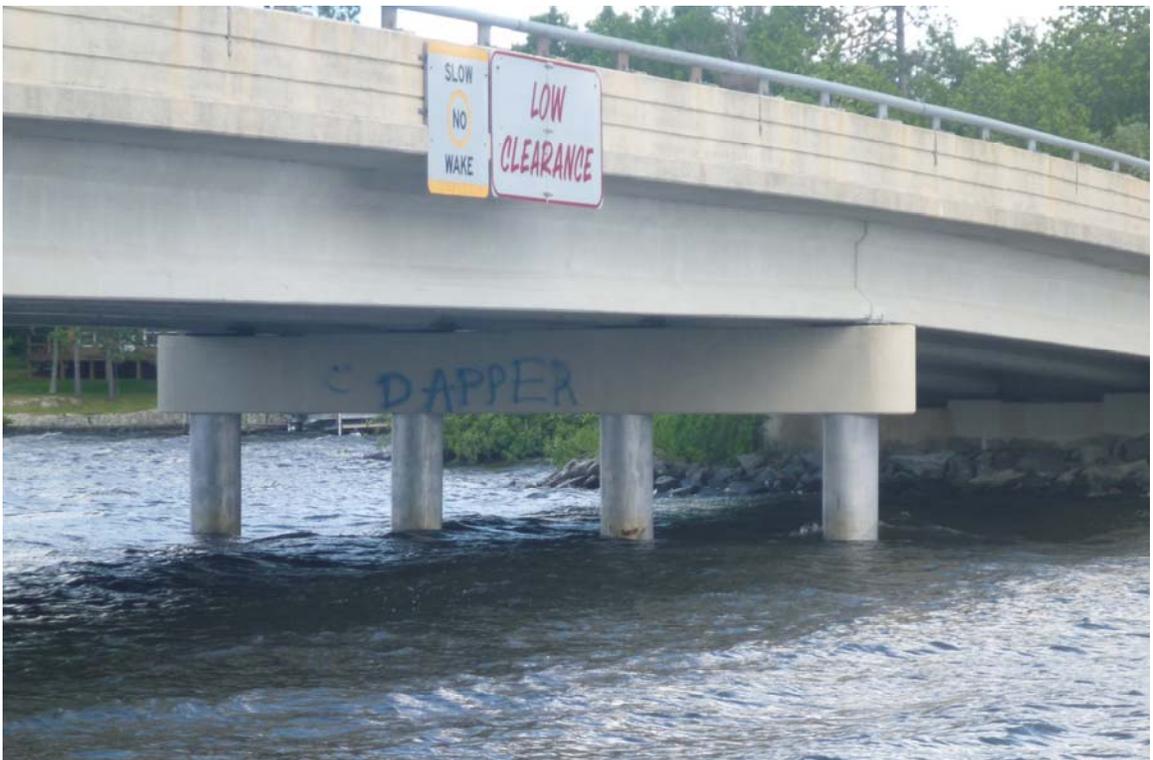
Photograph 4. View of Pier 2, Looking Northeast.

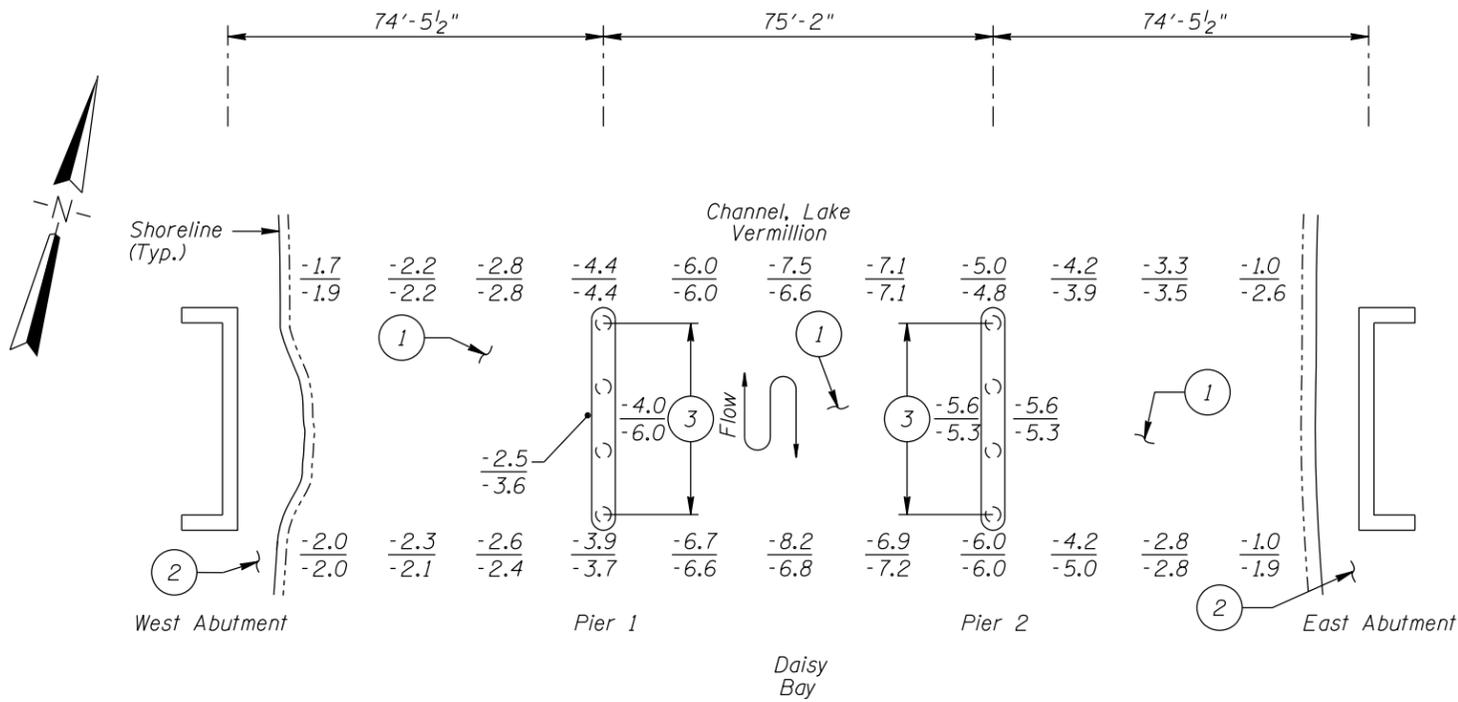
- ① The channel bottom material typically consisted of firm sand with scattered riprap up to 18 inches in diameter allowing a maximum probe rod penetration of 1 to 3 inches.
- ② Both shorelines were well protected with 12 inch to 3 foot diameter riprap material along the banks.
- ③ The steel pipe piles exhibited 50 to 75 percent coating loss from 2 feet below the waterline to the channel bottom with heavy nodular corrosion (50 percent coverage), ranging in size from 1 to 1.5 inches in diameter. Rust nodules exhibited typical pitting of 1/32 inch deep and a maximum of 1/16 inch deep.
- ④ Above water there were random small areas of coating failure with surface corrosion on the exposed steel. These areas had no measurable loss of section.
