UNDERWATER BRIDGE INSPECTION REPORT

STRUCTURE NO. 69592

WHITEFACE RIVER

MINNESOTA DEPARTMENT OF TRANSPORTATION
UNDERWATER BRIDGE INSPECTION

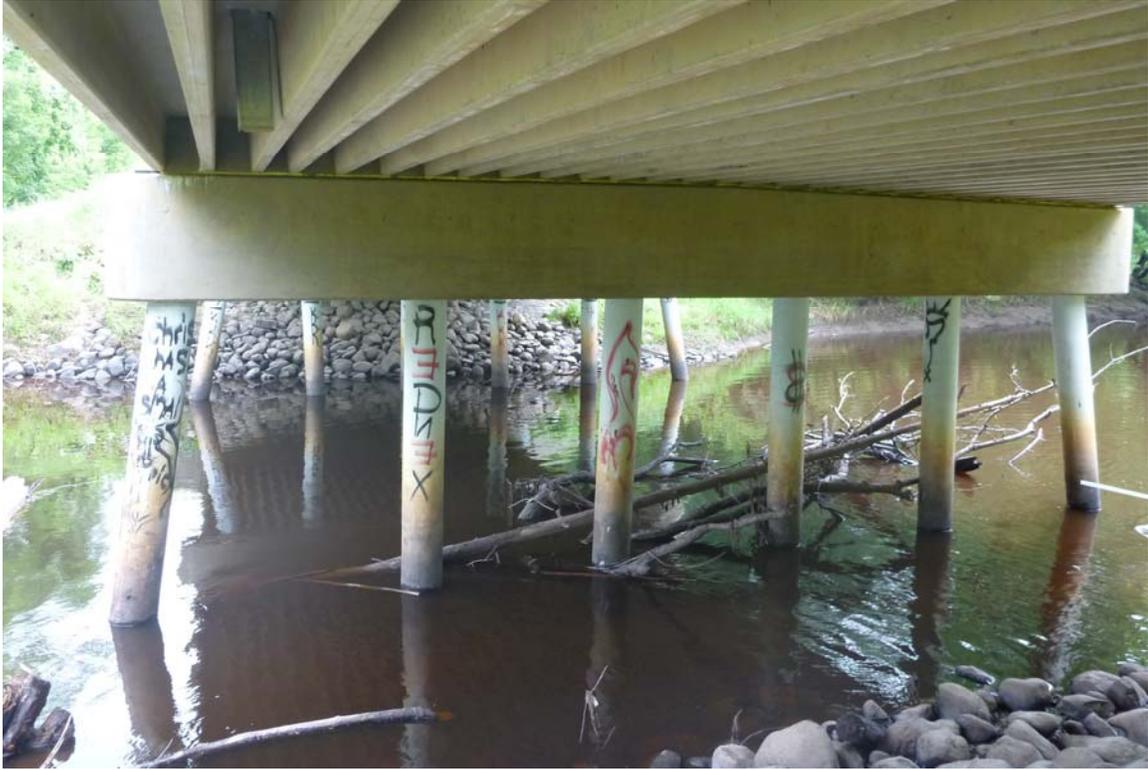
- (A) A moderate amount of timber debris was observed around Pier 1 consisting of logs and branches with up to 12 inch diameter. The debris extended from the shore out 20 feet to the upstream nose, and continued along the east face of the pier, extending from the channel bottom to 5 feet above the waterline.
- (B) The channel bottom material consisted of sand allowing 4 inches of probe rod penetration.
- (C) All steel pipe piles typically exhibited surface corrosion from 2 feet above the water line to the channel bottom, but no associated loss of section was observed.

Photograph 1. View of Pier 1, Looking East.

- (A) Monitor the extent of surface corrosion during future underwater inspections.
- (B) Monitor the timber debris accumulation at the piers, during future inspections, and if found to be increasing to a more detrimental extent, removal operations may become warranted at that time.
- (C) Reinspect the submerged substructure units at the normal maximum recommended (NBIS) interval of sixty (60) months.

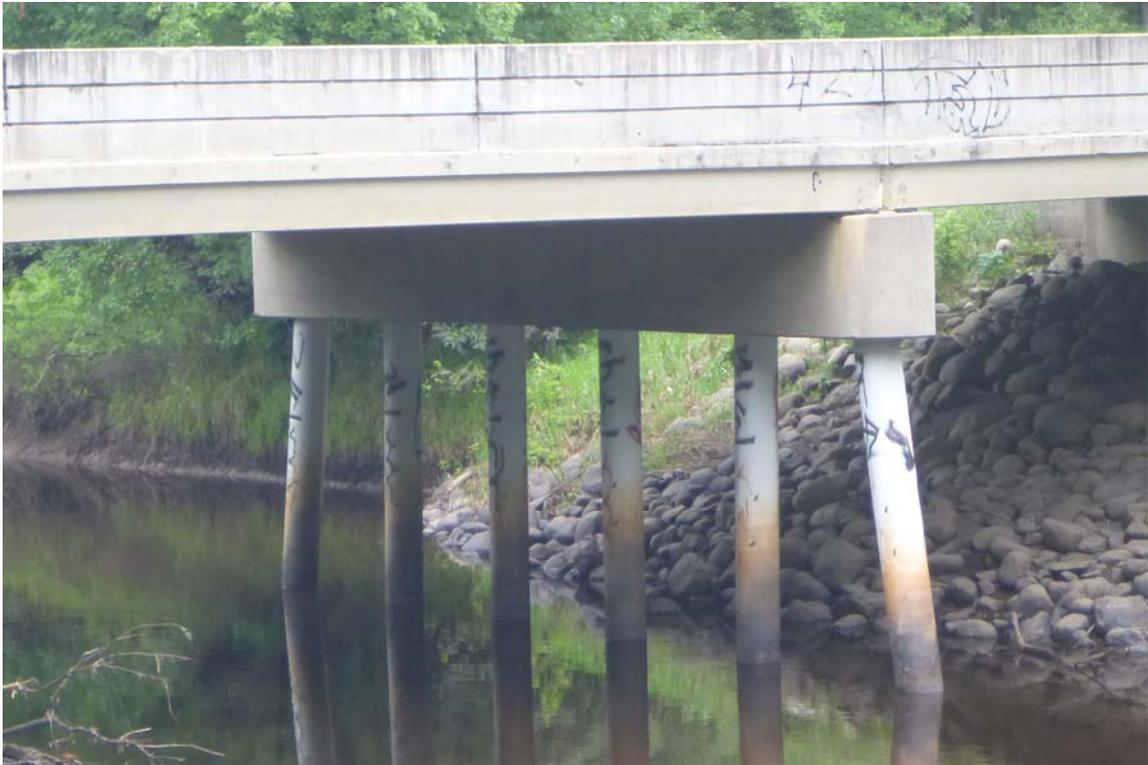
Photograph 2. View of Pier 2, Looking Northeast.

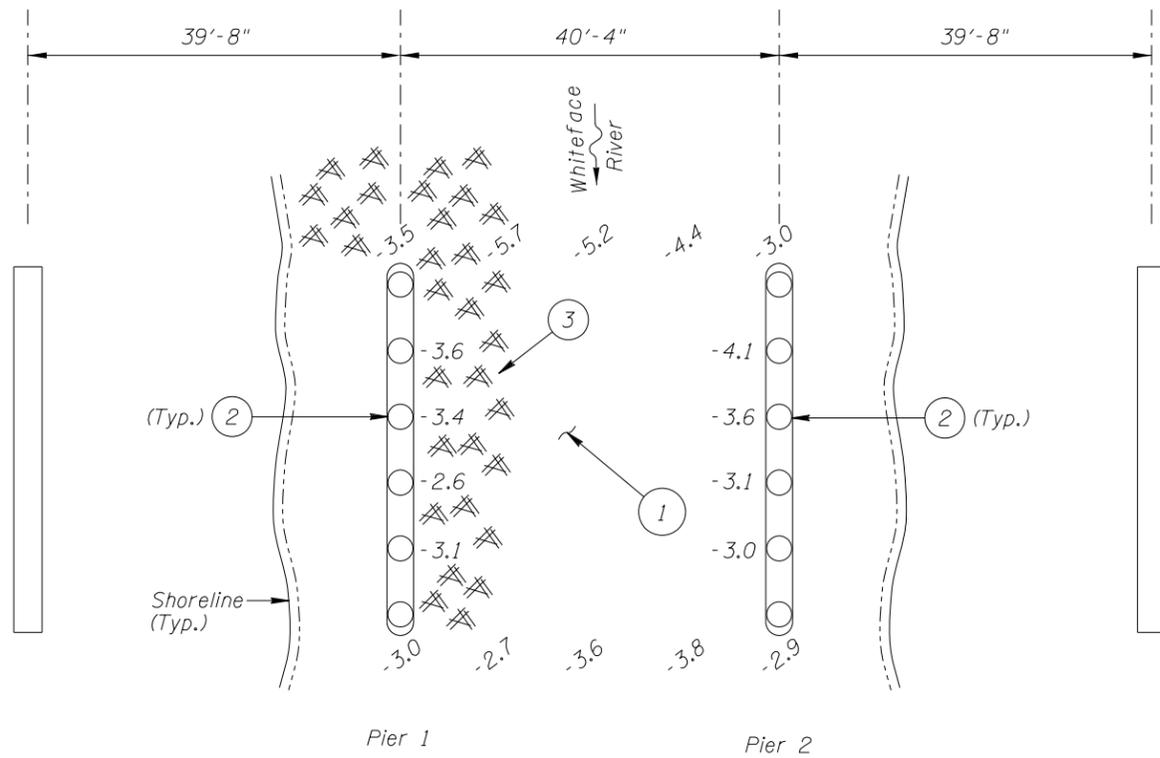
INSPECTION AND SOUNDING PLAN

- ① The channel bottom material consisted of sand allowing up to 4 inches of probe rod penetration.
- ② All steel pipe piles typically exhibited surface corrosion from 2 feet above the waterline to channel bottom, with no measurable section loss.
- ③ A moderate accumulation of timber debris, consisting of logs and branches 12 inch diameter and smaller, was observed from the shore out 20 feet to the upstream nose of Pier 1, and along the east face of the pier, extending off the face up to 10 feet. The debris extended from the channel bottom to 5 feet above the waterline.
