UNDERWATER BRIDGE INSPECTION REPORT

STRUCTURE NO. 69J13

RAILROAD STREET

MINNESOTA DEPARTMENT OF TRANSPORTATION
UNDERWATER BRIDGE INSPECTION

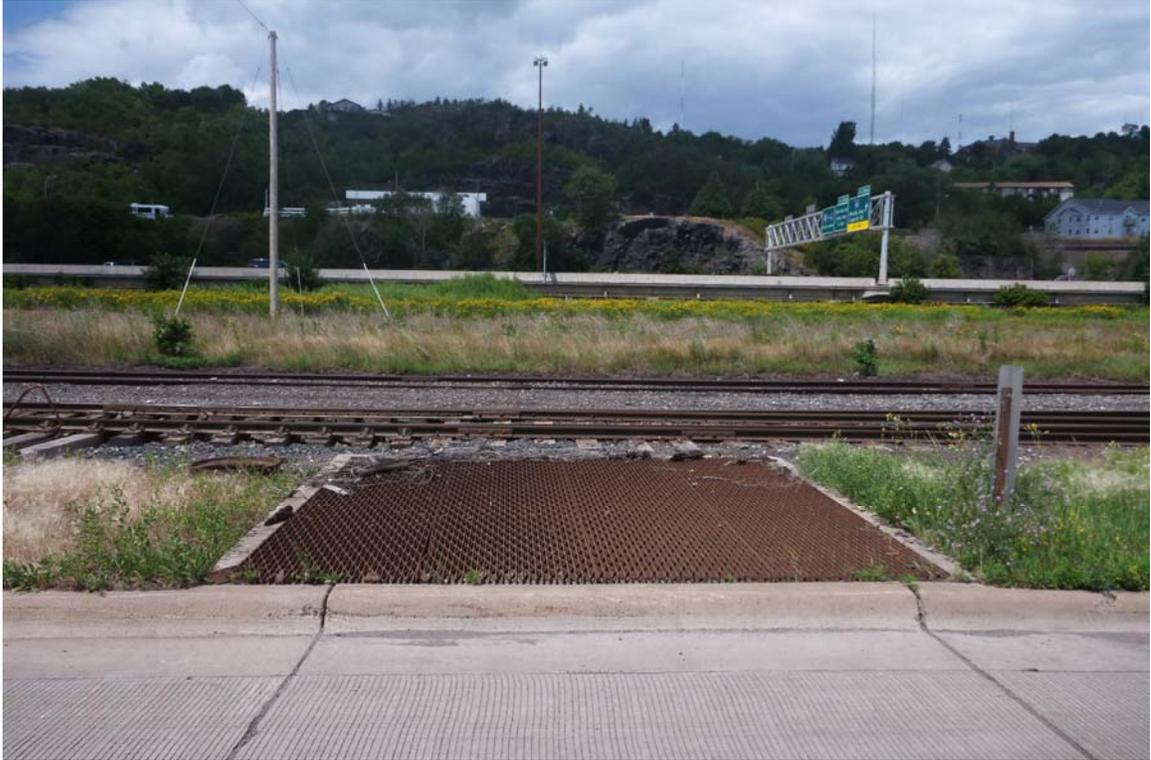
Photograph 1. View of Roadway Above Culvert and Grating Covering Culvert Opening, Looking East.

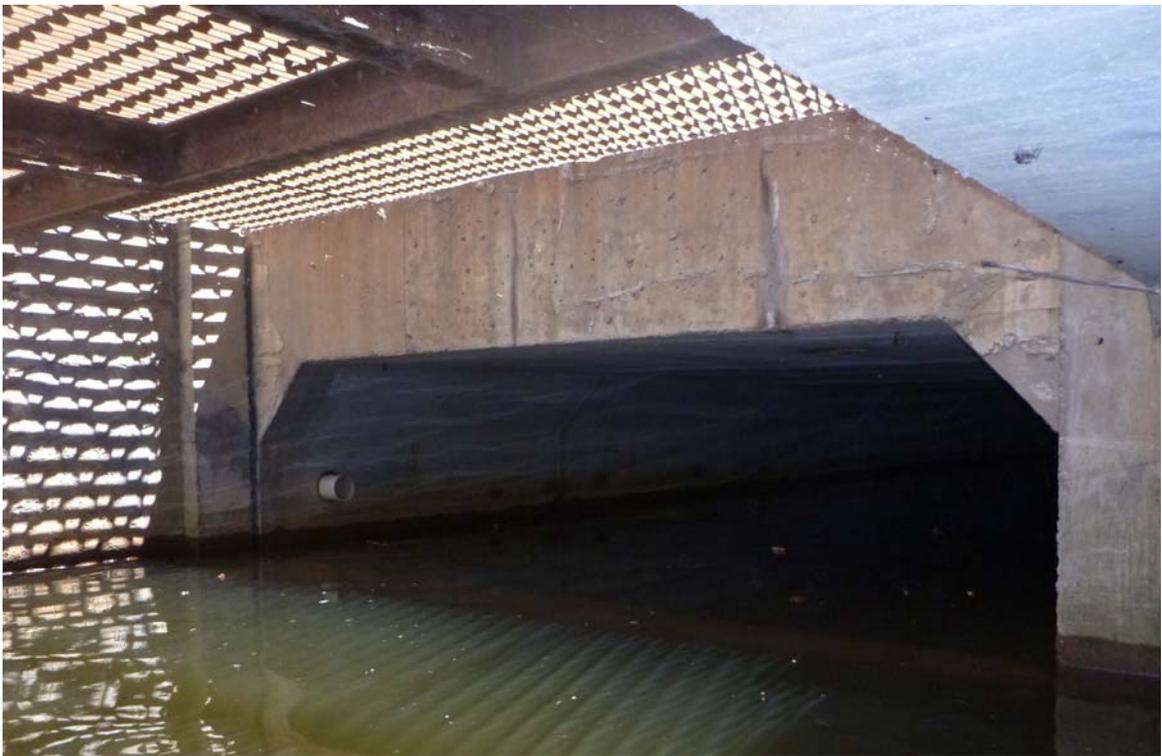
Photograph 2. View of Upstream End of Culvert, Looking Northeast.

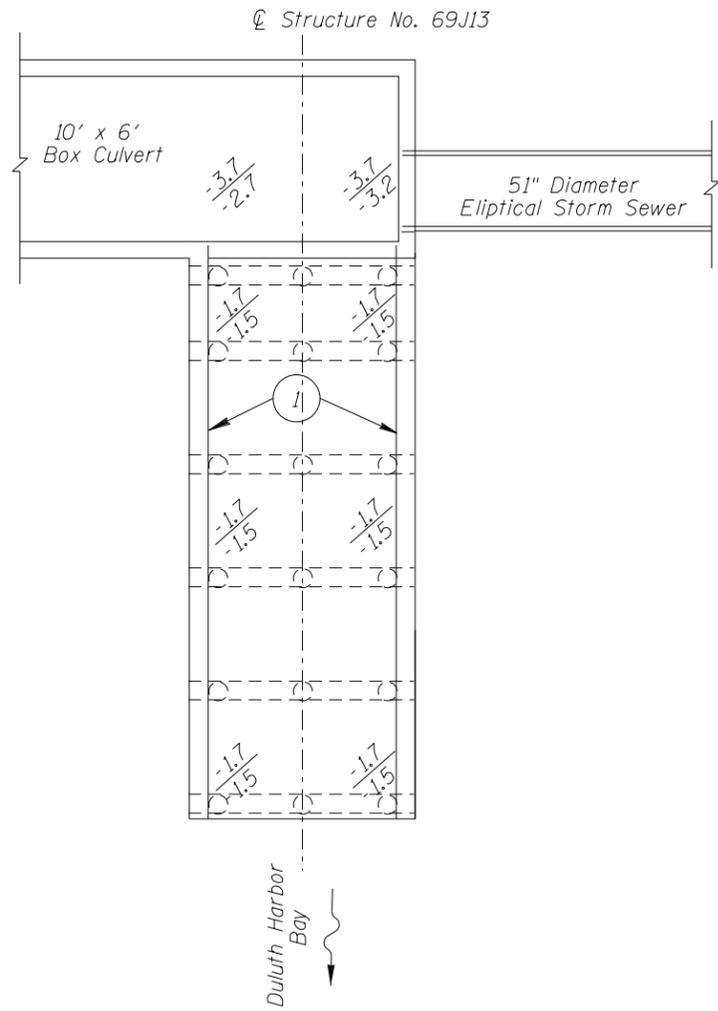
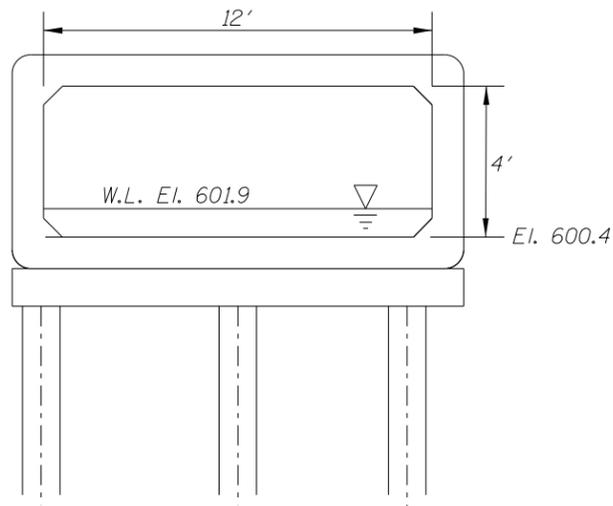
SOUNDING PLAN

- 1 The concrete was smooth and sound with no notable deterioration. The joints between culvert segments exhibited 1/4- to 1-inch-wide gaps (at tongue and groove arrangement with no complete separations of joints) and up to 1/2 inch differentials between faces across joints.
