UNDERWATER BRIDGE INSPECTION REPORT

STRUCTURE NO. 7695

CSAH 28

STONE RIVER

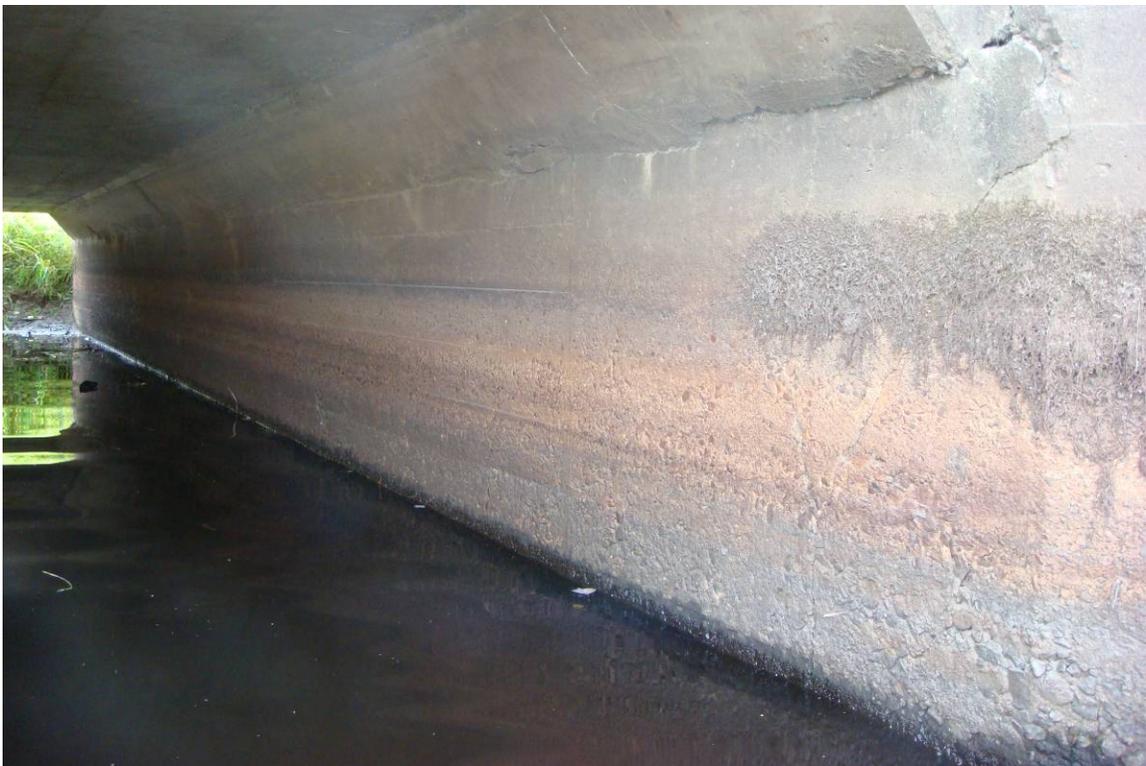
- (C) Light concrete scaling was observed extending from 2 feet above the waterline to the channel bottom on all walls and the floor of both boxes with a typical penetration of 1/8 inch.

Photograph 2. View of the West Wall of Box 1, Looking Southwest.

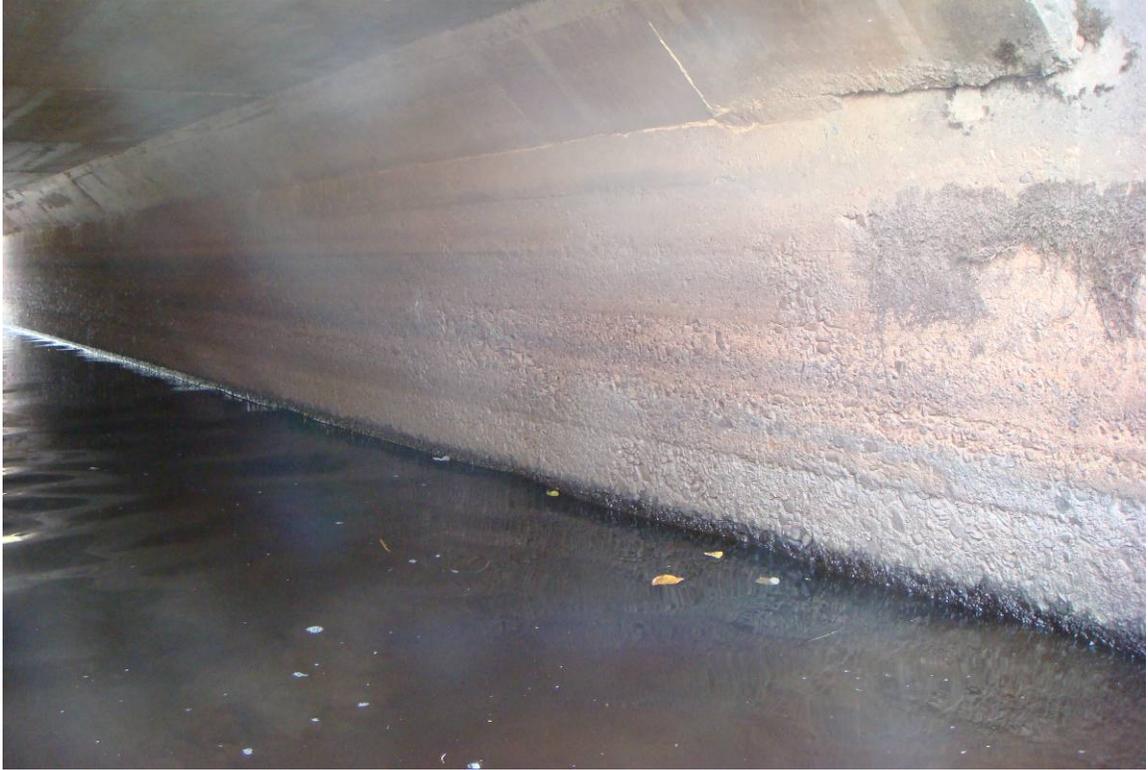
Photograph 3. View of the Center Wall, Looking Southwest.

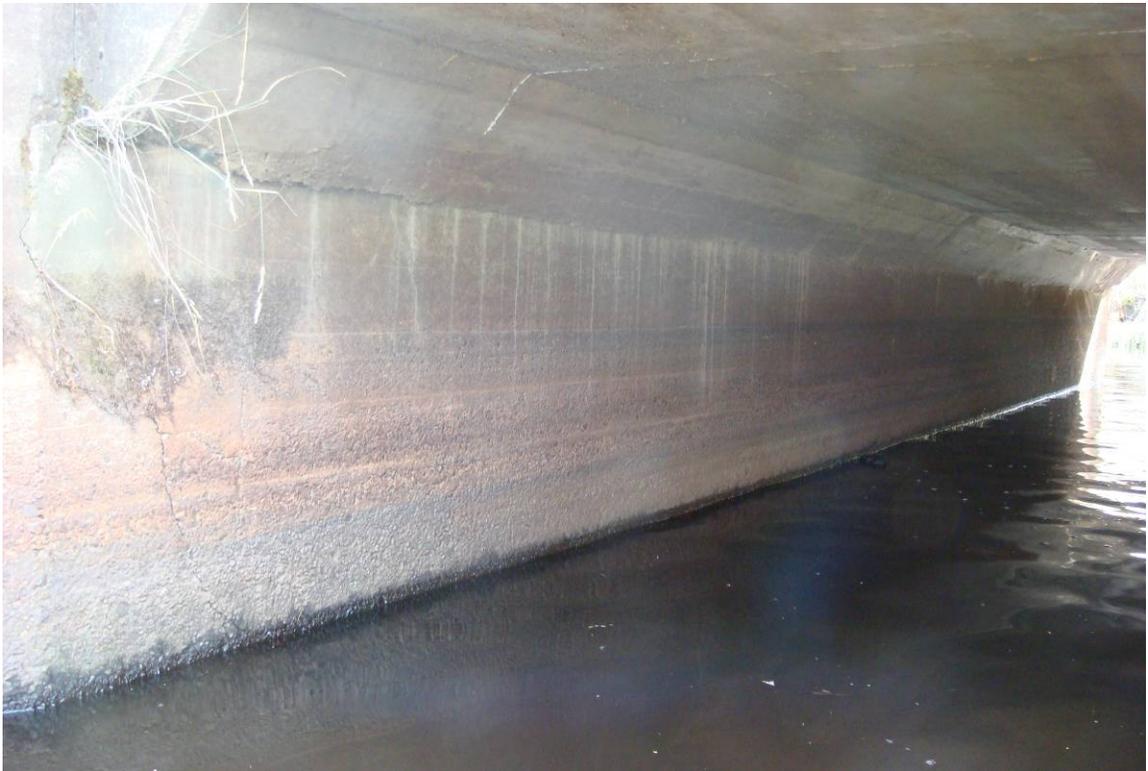
Photograph 4. View of the East Wall of Box 2, Looking Southeast.

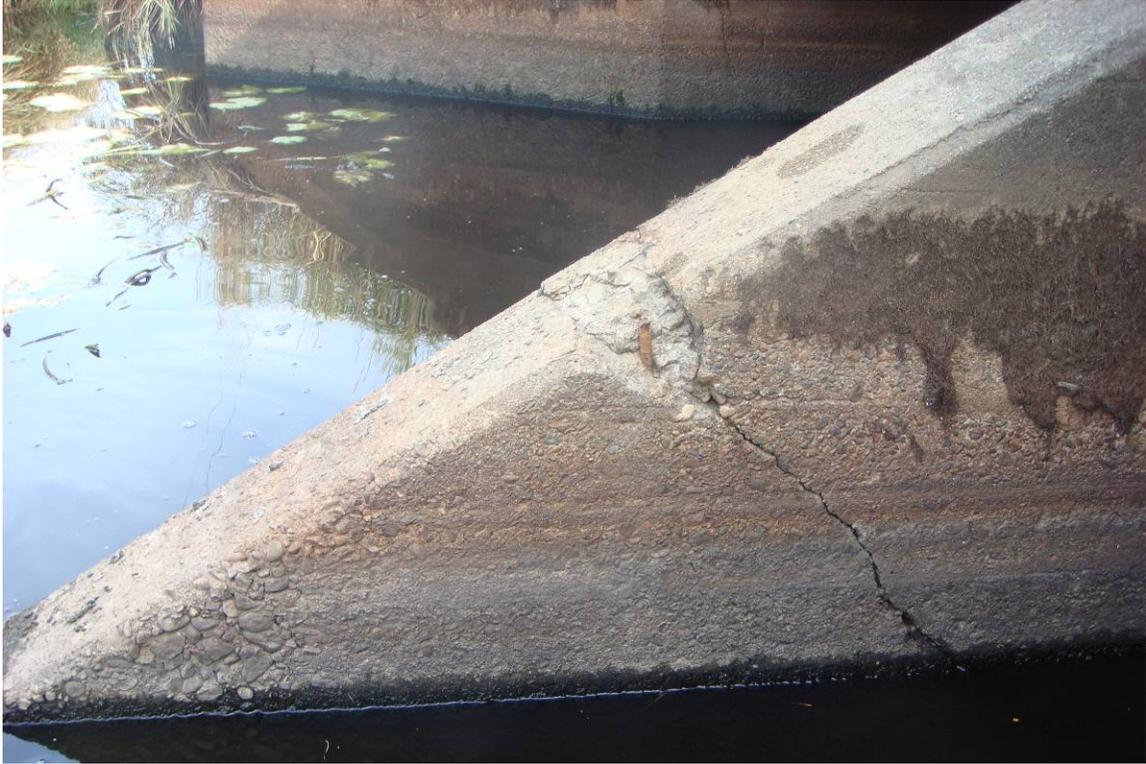
- (D) Diagonal cracks were observed on the upstream and downstream center wall extensions typically 1/8 inch wide with associated areas of concrete section loss. At the downstream extension, an area of section loss measured 6 inches wide by 6 inches long with a maximum penetration of 2 inches with one exposed reinforcing bar. At the upstream extension, an area of section loss measured 4 inches wide by 4 inches long with a maximum penetration of 1.5 inches.

Photograph 5. View of the Diagonal Crack and Associated Area of Concrete Section Loss with Exposed Reinforcing Steel at the Downstream Extension of the Center Wall, Looking West.

The area of concrete section loss at the downstream end of the center wall extension is not a structural concern at this time; however, it should be repaired to prevent further deterioration. The repair should include removal of concrete to a minimum of 1 inch behind the reinforcing steel, cleaning and replacing reinforcing steel as required, and placing concrete designed to provide high durability with low permeability.

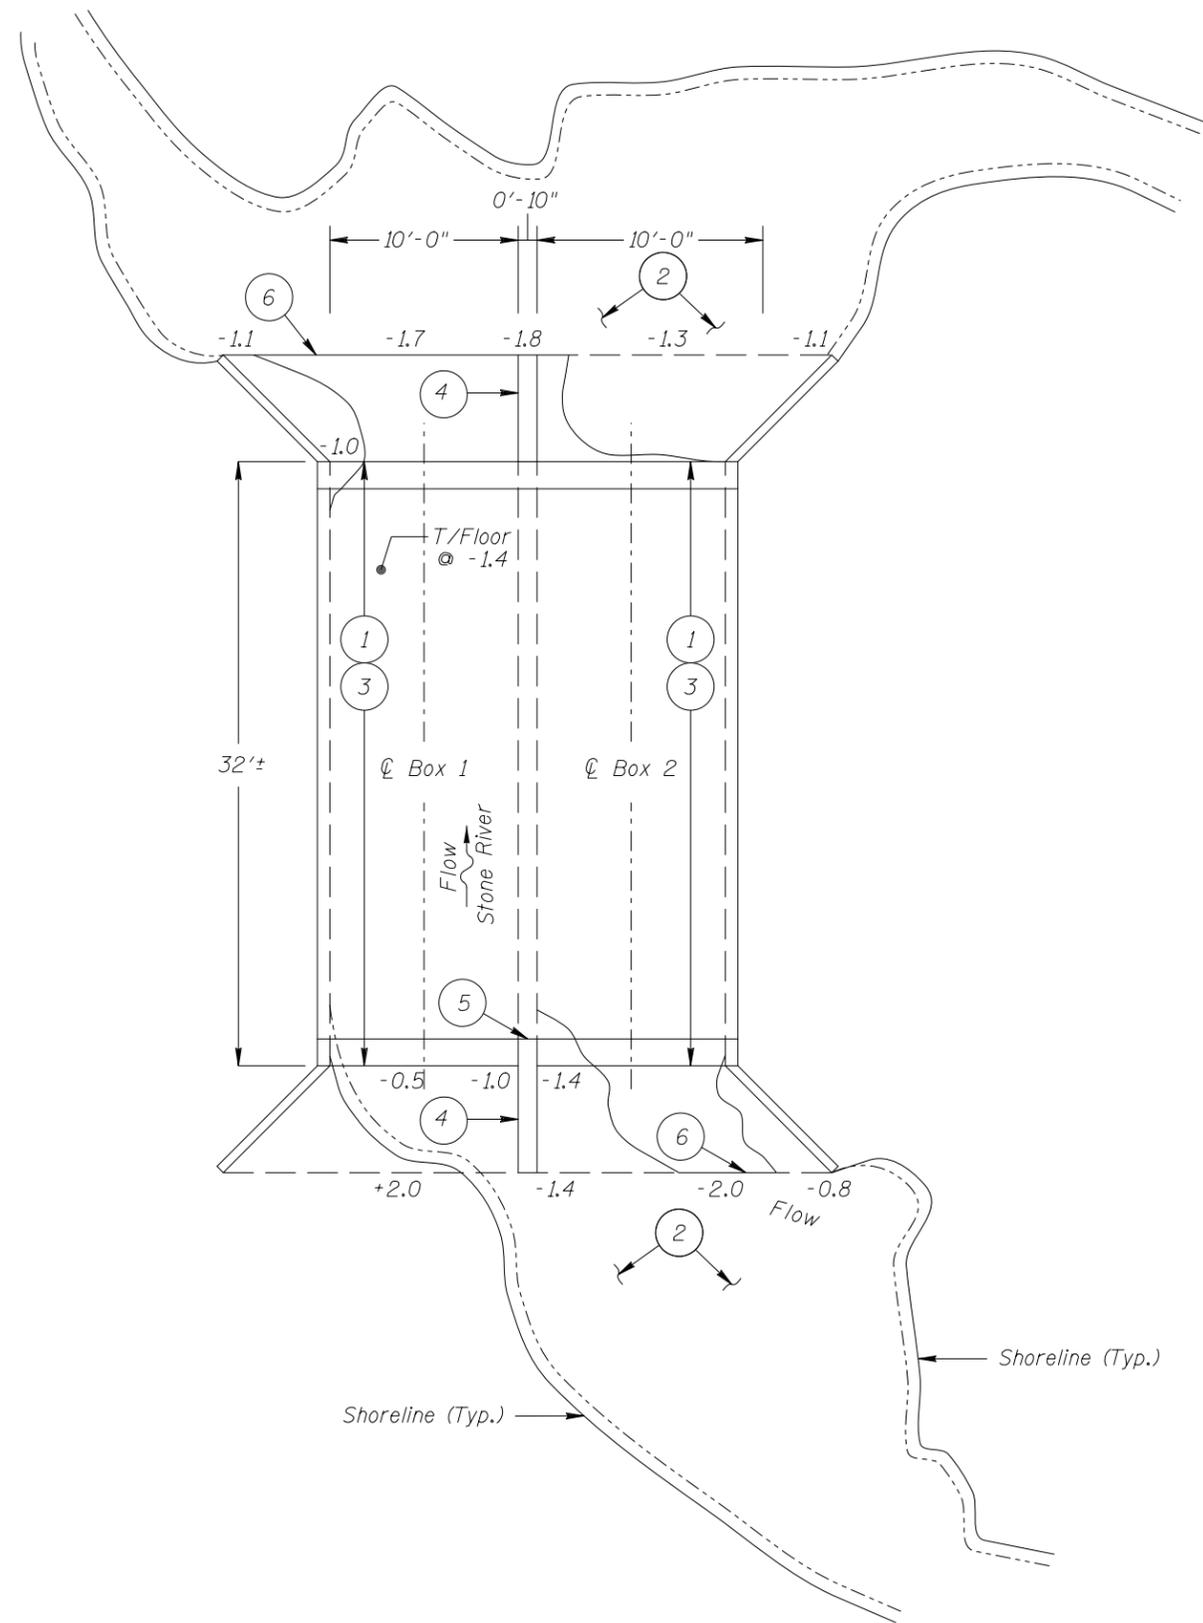
SOUNDING PLAN

- 1 The culvert floor throughout the length of both boxes was typically clear of any debris or silt build-up.
- 2 The channel bottom material upstream and downstream of the culvert apron consisted of silt and random stones approximately 4 inches in diameter allowing a maximum probe rod penetration of 1 foot.

- 3 Light concrete scaling was observed extending from 2 feet above the waterline to the channel bottom on all walls and the floor of both boxes with a typical penetration of 1/8 inch.

- 4 Diagonal cracks were observed on the upstream and downstream center wall extensions typically 1#8 inch wide with associated areas of concrete section loss. At the downstream extension, an area of section loss measured 6 inches wide by 6 inches long with a maximum penetration of 2 inches and one exposed reinforcing bar. At the upstream extension, an area of section loss measured 4 inches wide by 4 inches long with a maximum penetration of 1.5 inches.

- 5 A spall 1 foot wide by 8 inches high was observed on the upstream headwall above the center wall with a maximum penetration of 1.5 inches.
- 6 The concrete apron toe was exposed at the upstream end of Box 2 with a maximum vertical exposure of 0.3 feet and at the downstream end of Box 1 with a maximum vertical exposure of 0.6 feet. No undermining of the concrete apron was observed.
