UNDERWATER BRIDGE INSPECTION REPORT

STRUCTURE NO. 7766

CSAH 108

PALEFACE RIVER

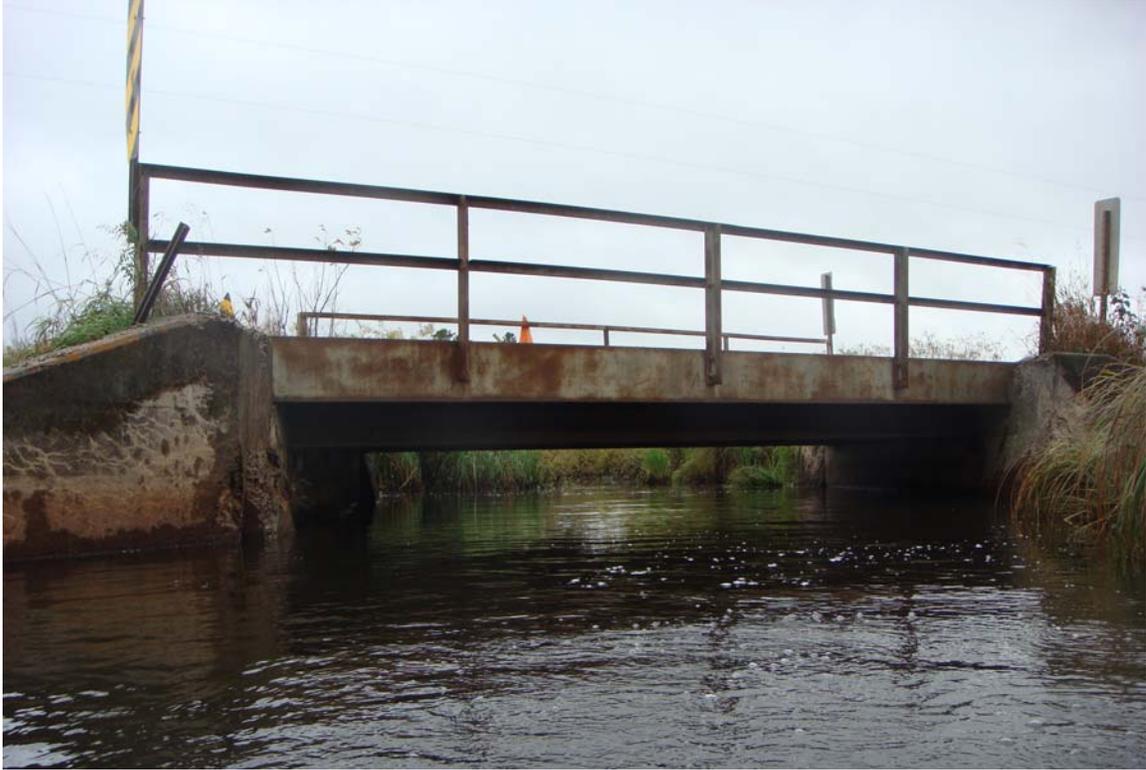
Photograph 1. Overall View of Structure, Looking South.

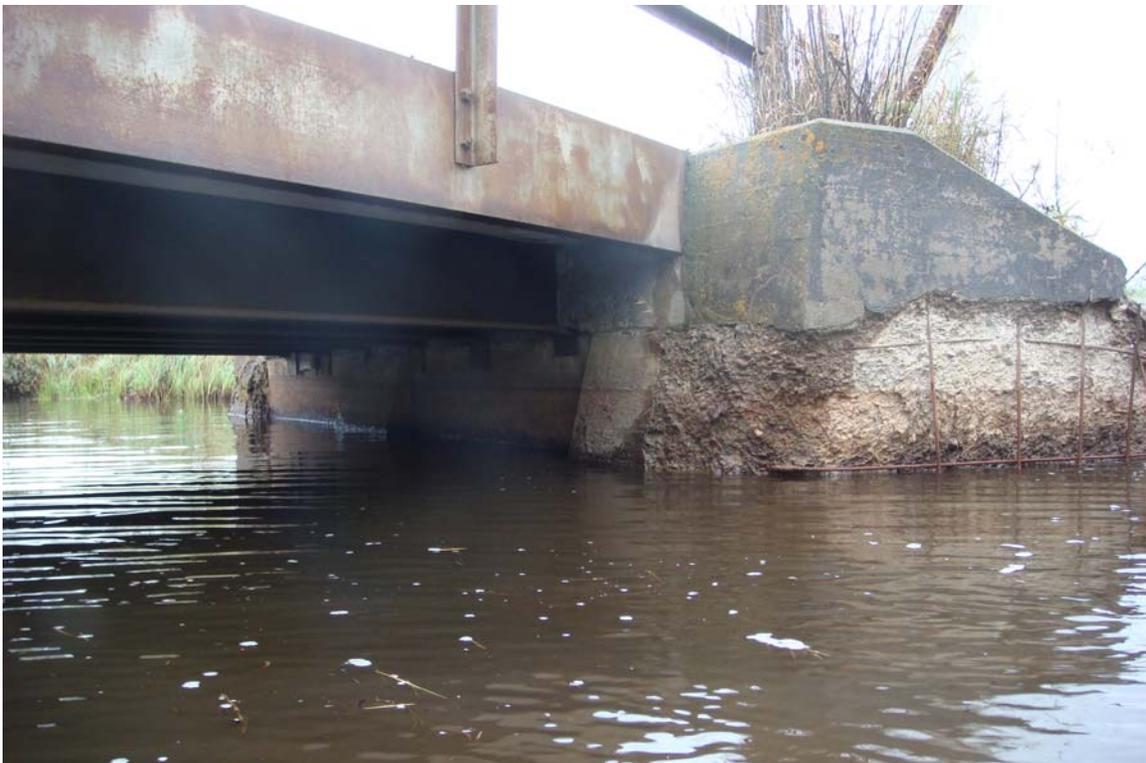
Photograph 2. View of the East Abutment, Looking Northeast.

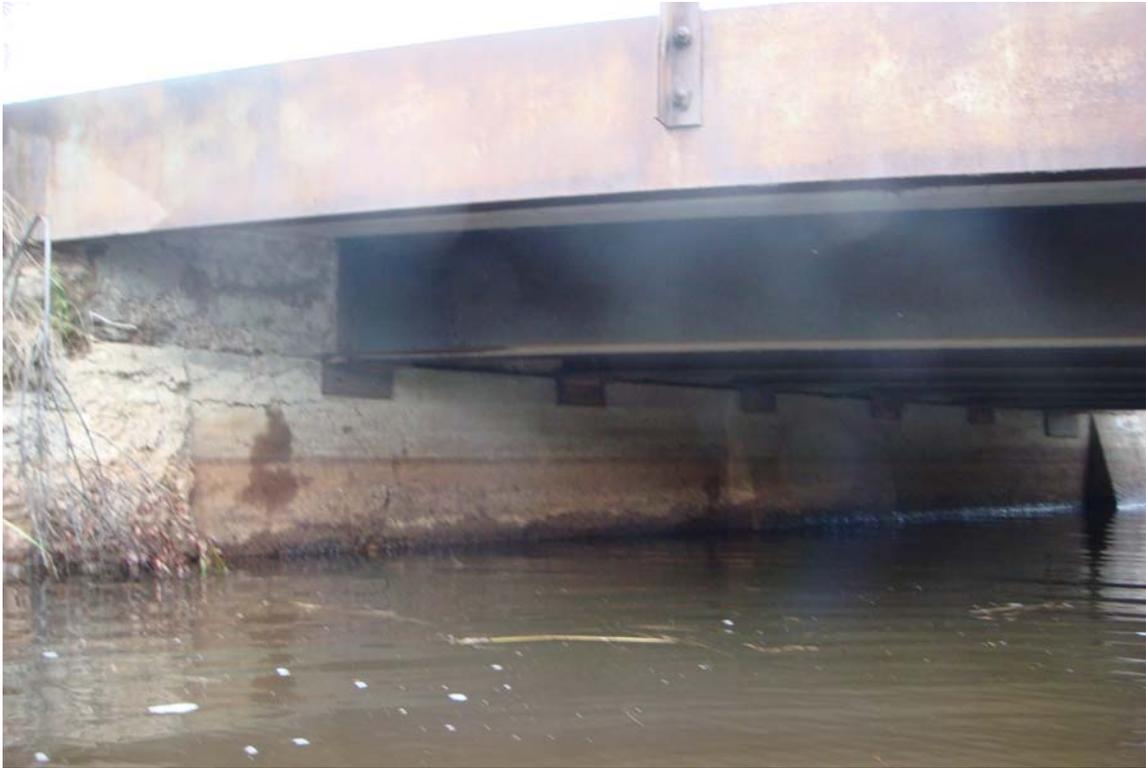
Photograph 3. View West Abutment, Looking Northwest.

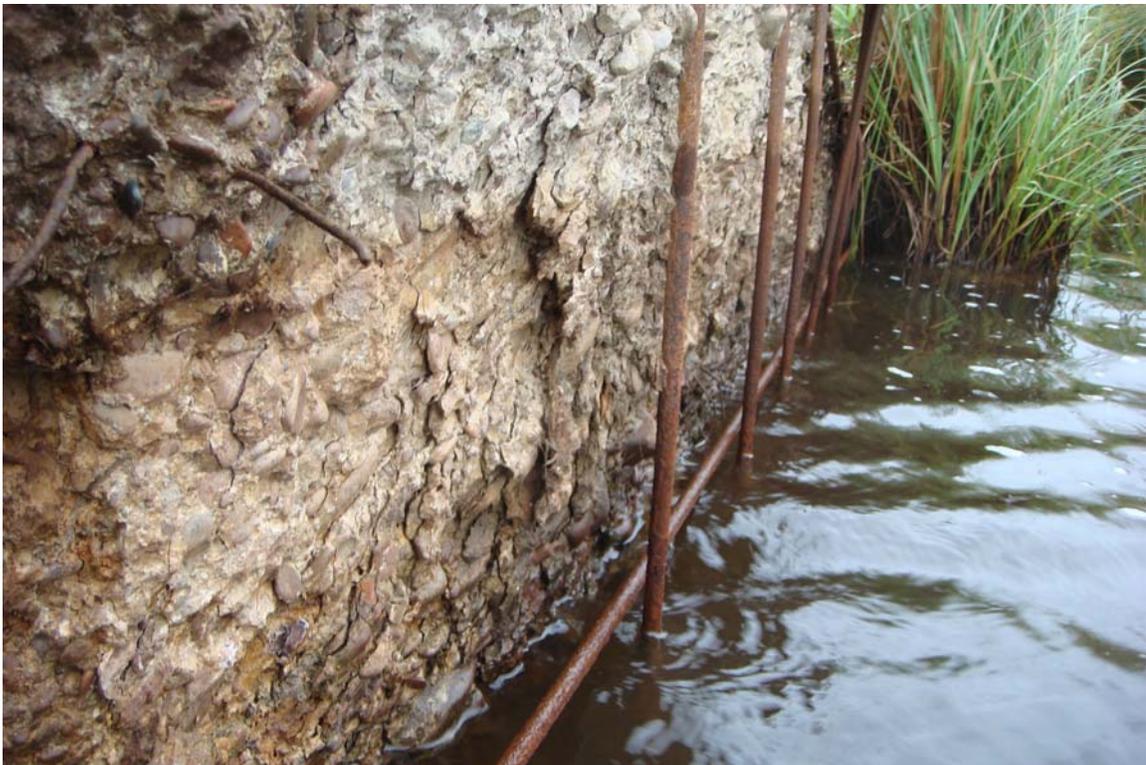
- (A) The channel bottom material typically consisted of gravel and silt with a maximum probe rod penetration of 1 foot.
- (B) The southwest and northeast wingwalls and the southwest and northeast concrete tapered columns exhibited heavy scaling with up to 4 inches of penetration. Reinforcing steel was exposed with a maximum loss of section of approximately 15 percent. The exposed concrete substrate was typically unsound and exhibited delaminations up to 1 inch thick.

Photograph 4. View of the Typical Wingwall Concrete Substrate and Exposed Reinforcing Steel, Looking East.

- (A) The heavy scaling, unsound concrete and associated concrete delaminations at all wingwalls are not significant structural concerns at this time, however, they should be repaired or replaced to prevent further, more detrimental deterioration. Prior to making any repairs, insitu concrete testing should be preformed to establish the suitability of repairs. If repaired, the repairs should include removal of concrete to a minimum of 1 inch behind the reinforcing steel, cleaning and replacing reinforcing steel as required, and placing concrete designed to provide high durability with low permeability.

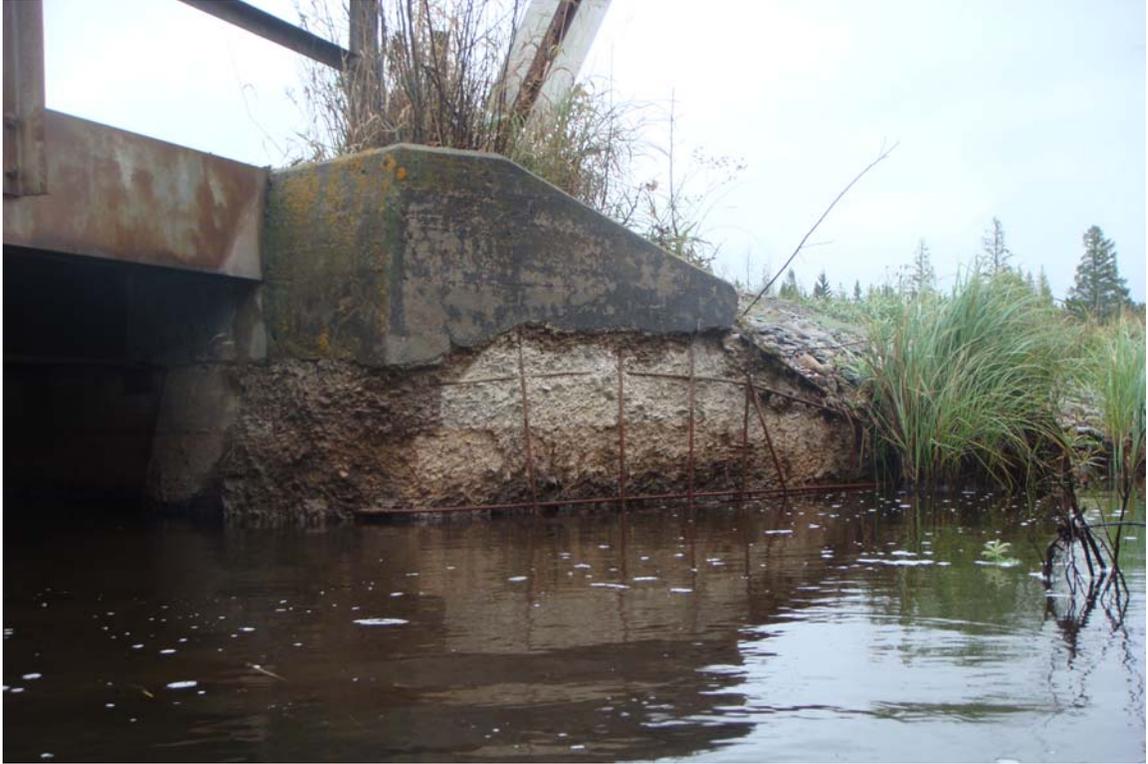
Photograph 5. View of the Southeast Wingwall, Looking Northeast.

- ⑦ The southeast wingwall and southeast concrete tapered column exhibited heavy scaling with up to 8 inches of penetration. Reinforcing steel was exposed with a maximum loss of section of approximately 15 percent. The exposed concrete substrate was typically unsound and exhibited delaminations up to 1 inch thick.

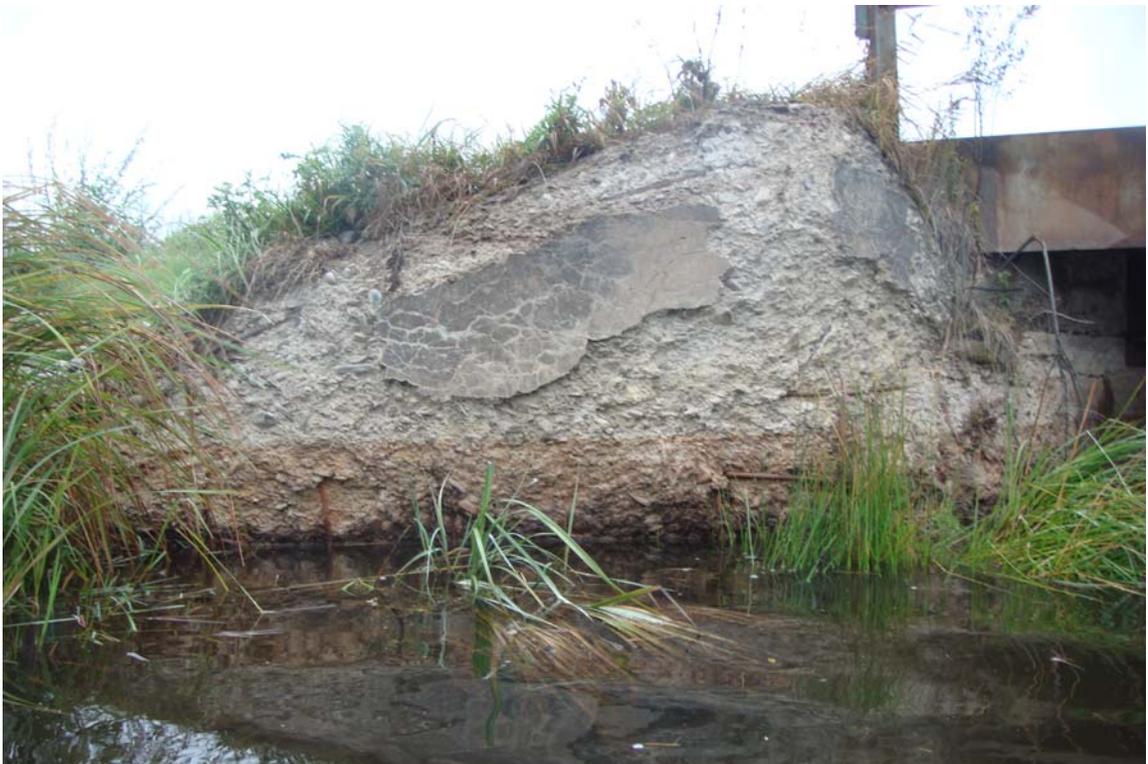
Photograph 6. View of the Southwest Wingwall, Looking Northwest.

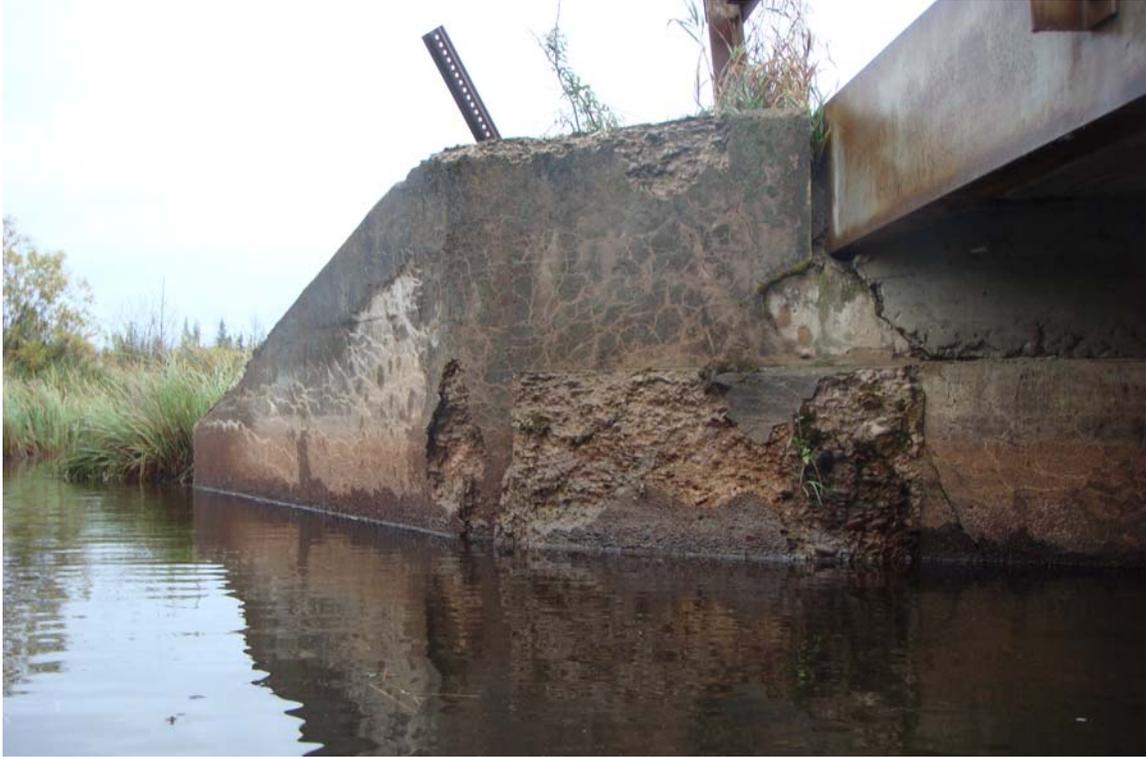
Photograph 7. View of the Northeast Wingwall, Looking East.

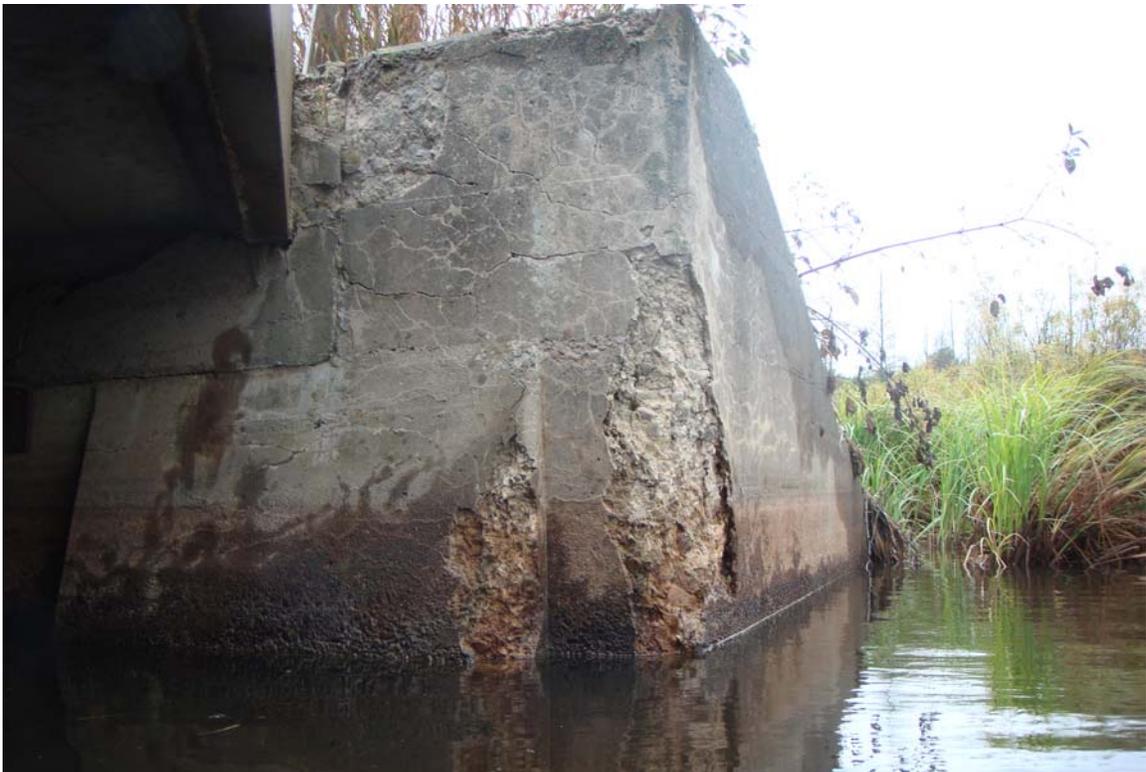
- (E) The northwest wingwall exhibited delaminations and unsound concrete over its entire surface area.

Photograph 8. View of the Northwest Wingwall, Looking West.

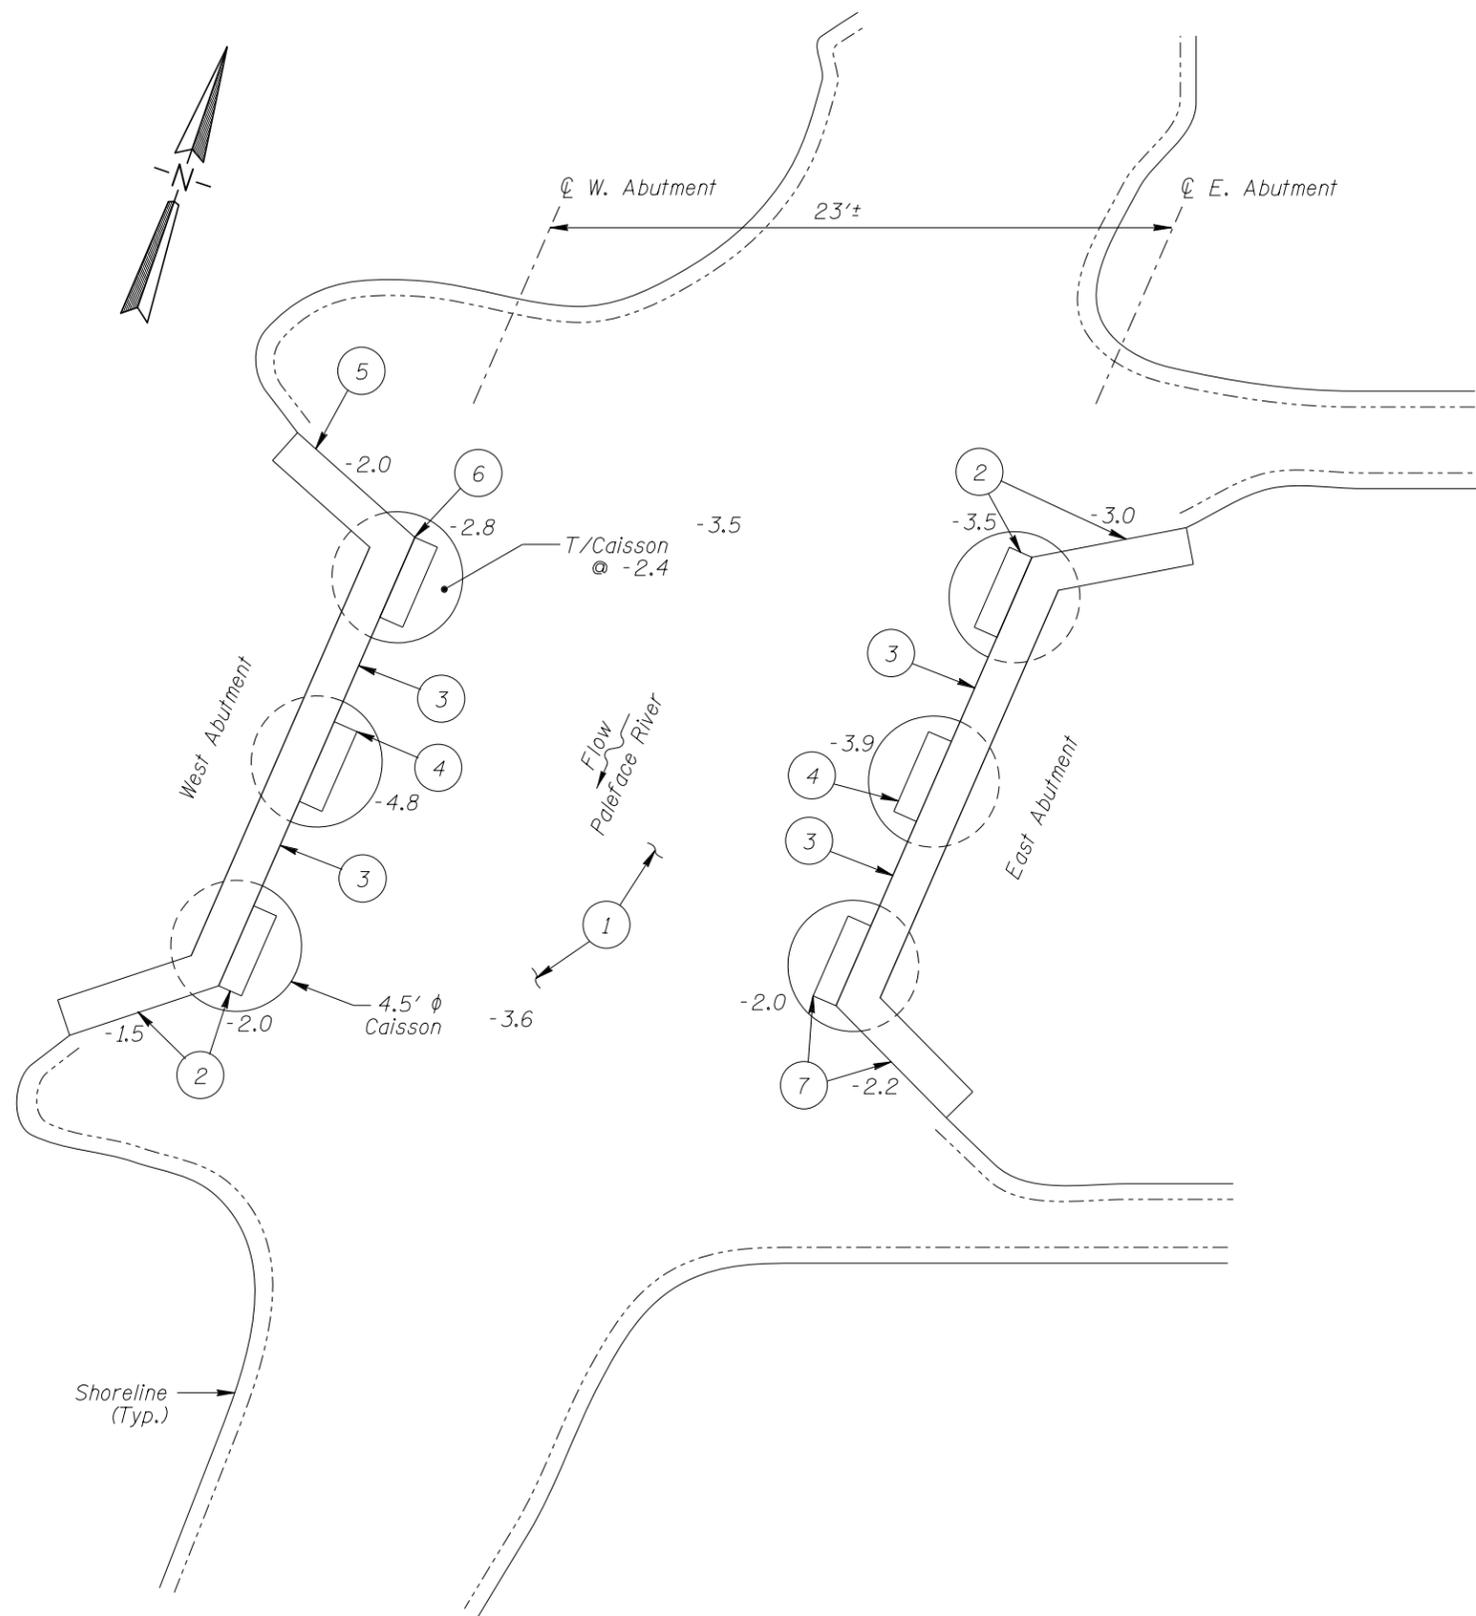
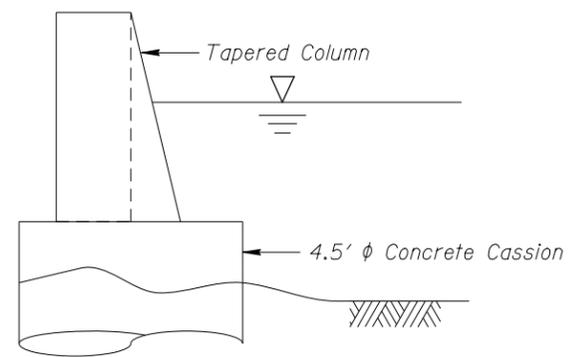
SOUNDING PLAN

- ① The channel bottom material typically consisted of gravel and silt with a maximum probe rod penetration of 1 foot.
- ② The southwest and northeast wingwalls and the southwest and northeast concrete tapered columns exhibited heavy scaling with up to 4 inches of penetration. Reinforcing steel was exposed with a maximum loss of section of approximately 15 percent. The exposed concrete substrate was typically unsound and exhibited delaminations up to 1 inch thick.

- ③ The concrete backwalls were generally sound with random vertical and horizontal cracks up to 1/8 inch wide and moderate scaling with up to 1/2 inch of penetration. The backwalls (between the caissons) were typically undermined a maximum of 1 foot horizontally and 1 foot vertically at the West Abutment and 1.5 feet horizontally and 1 foot vertically at the East Abutment.

- ④ The center tapered concrete column of the East and West Abutments was generally sound exhibiting scaling with up to 1/2 inch of penetration extending from the top of the column to the caisson.

- ⑤ The northwest wingwall exhibited delaminations and unsound concrete over its entire surface area.
- ⑥ A area of heavy scaling measuring 2 feet wide was observed on the northwest corner of the north tapered concrete column of the West Abutment extending from the channel bottom to 3 feet above the waterline with a maximum penetration of 3 inches. The concrete substrate is very unsound with cracking and typically 1 inch thick delaminations.
