UNDERWATER BRIDGE INSPECTION REPORT

STRUCTURE NO. 7821

CR 615

SPRING RIDGE CREEK

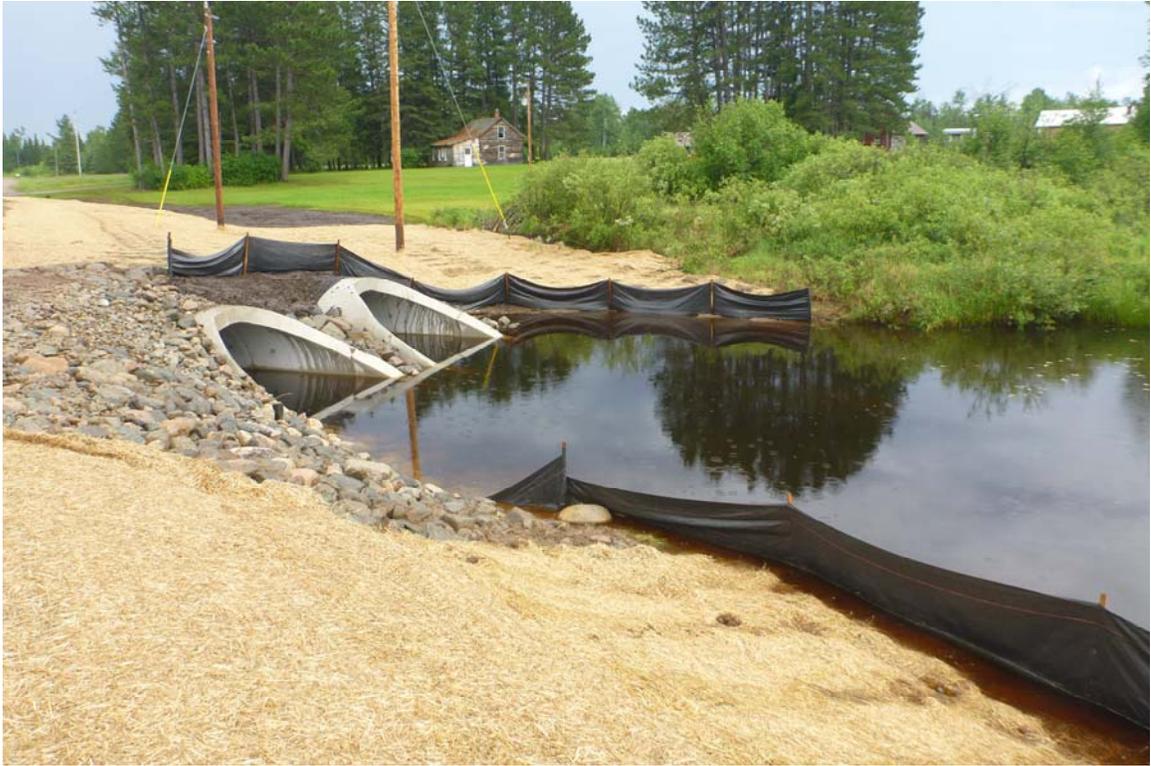
Photograph 1. View of Upstream Opening, Looking East.

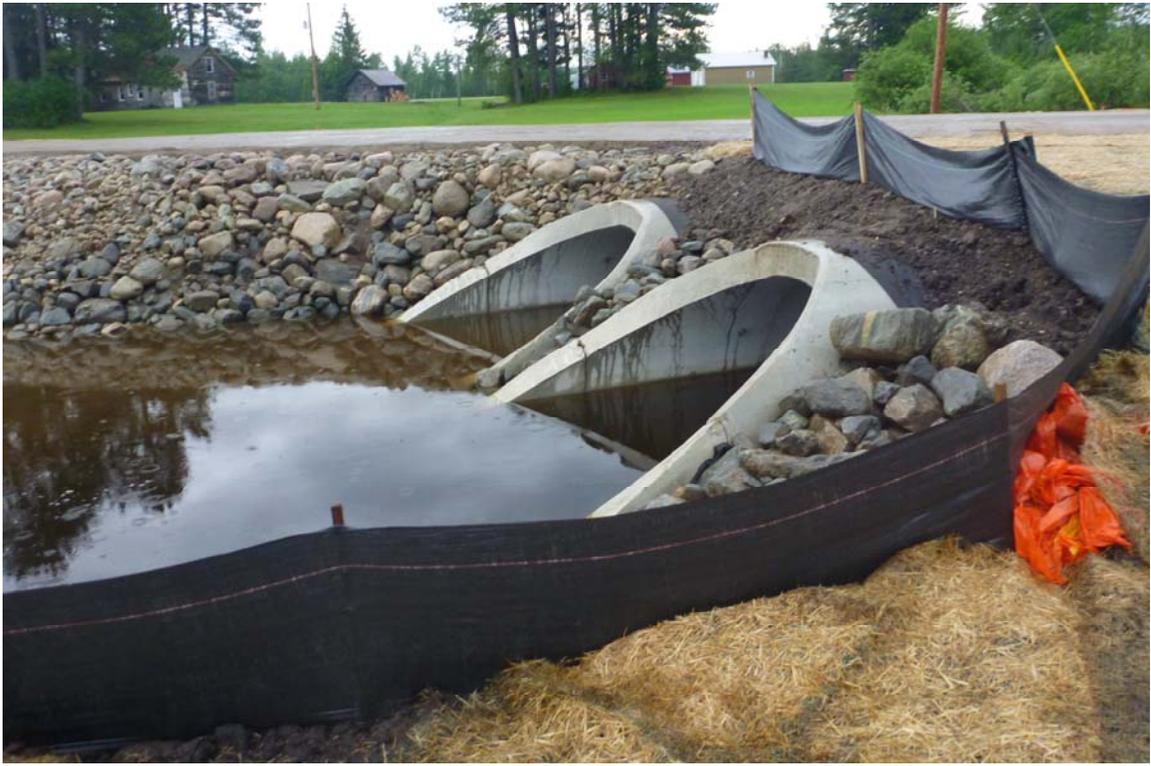
Photograph 2. View of Downstream Opening, Looking Southeast.

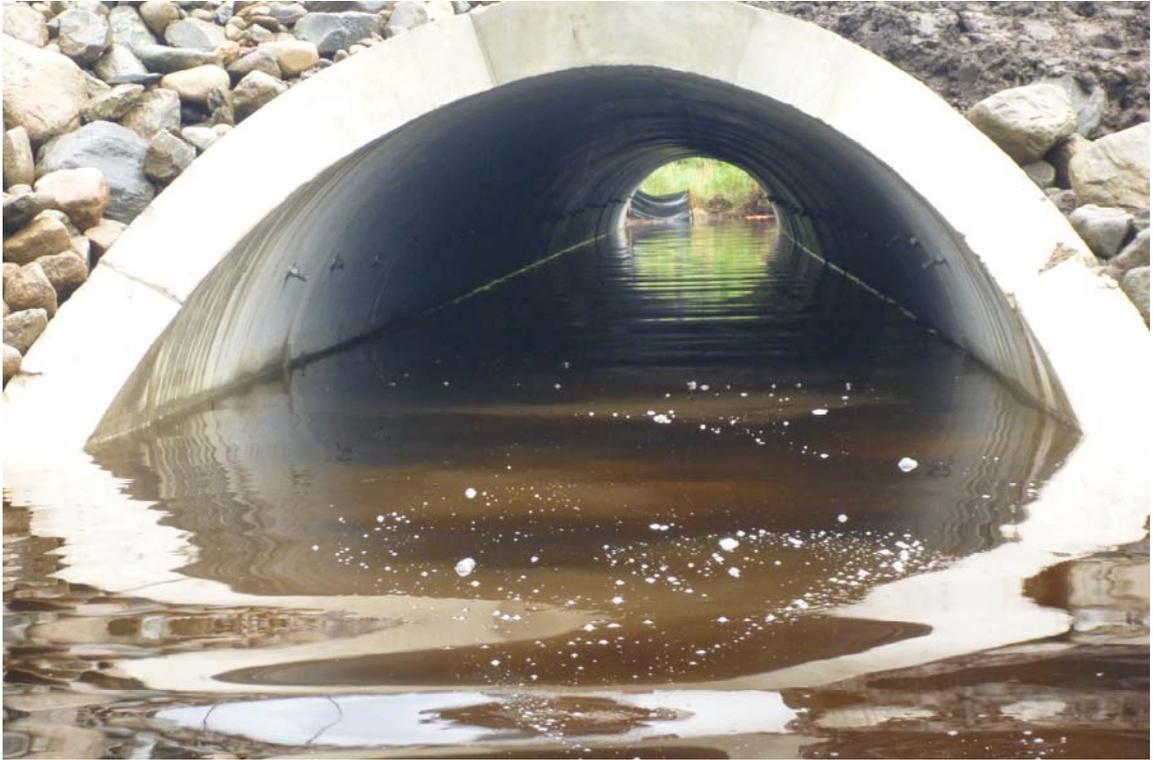
Photograph 3. Overall View of North Culvert, Looking Northeast.

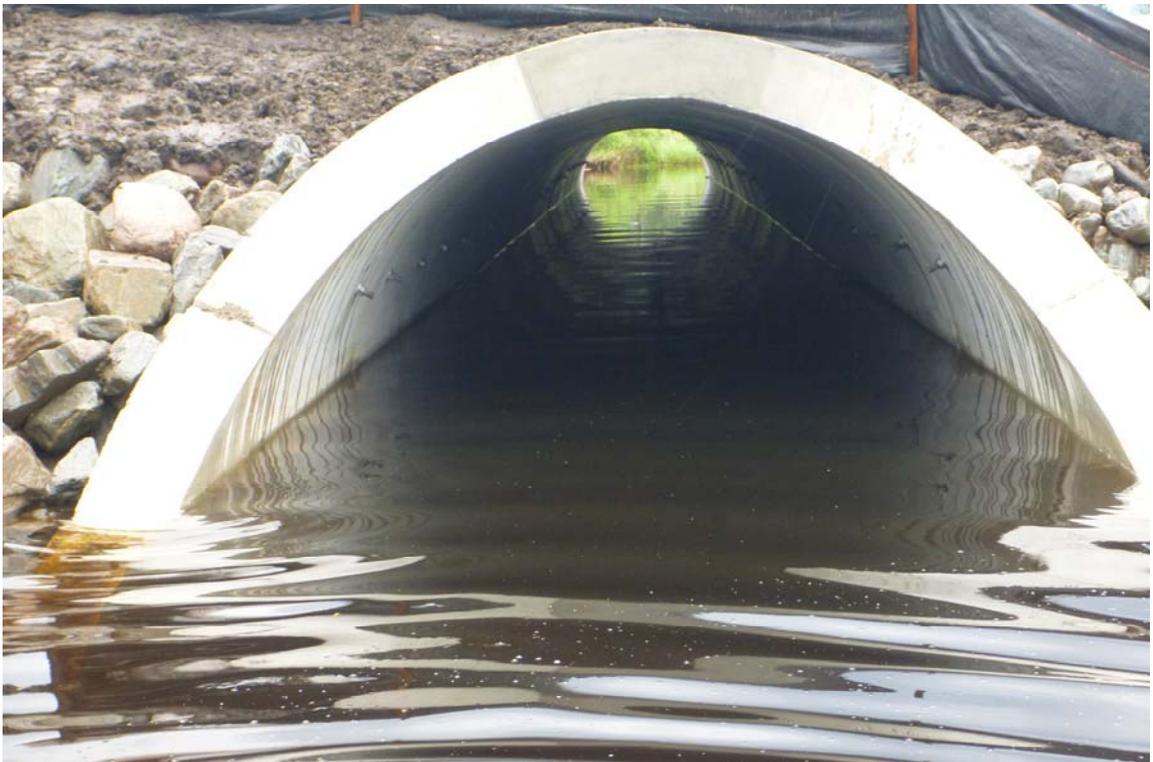
Photograph 4. Overall View of South Culvert, Looking Northeast.

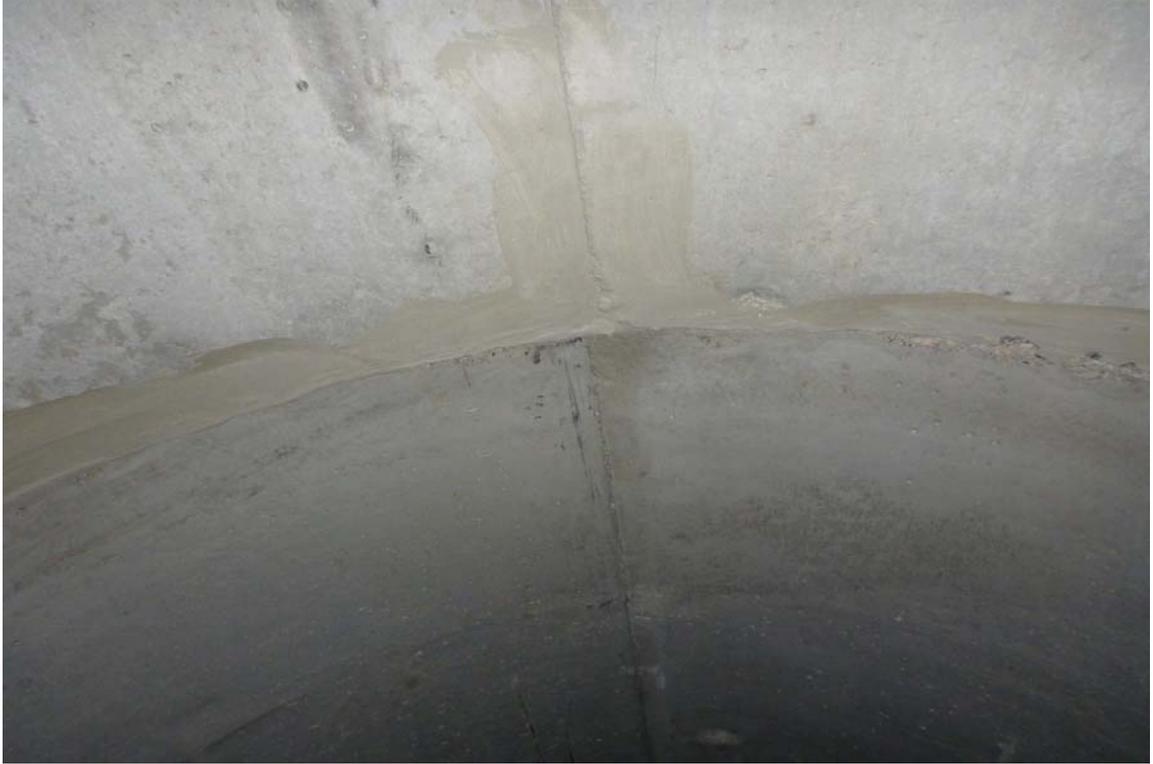
Photograph 5. View of Typical Concrete Condition in Culvert.

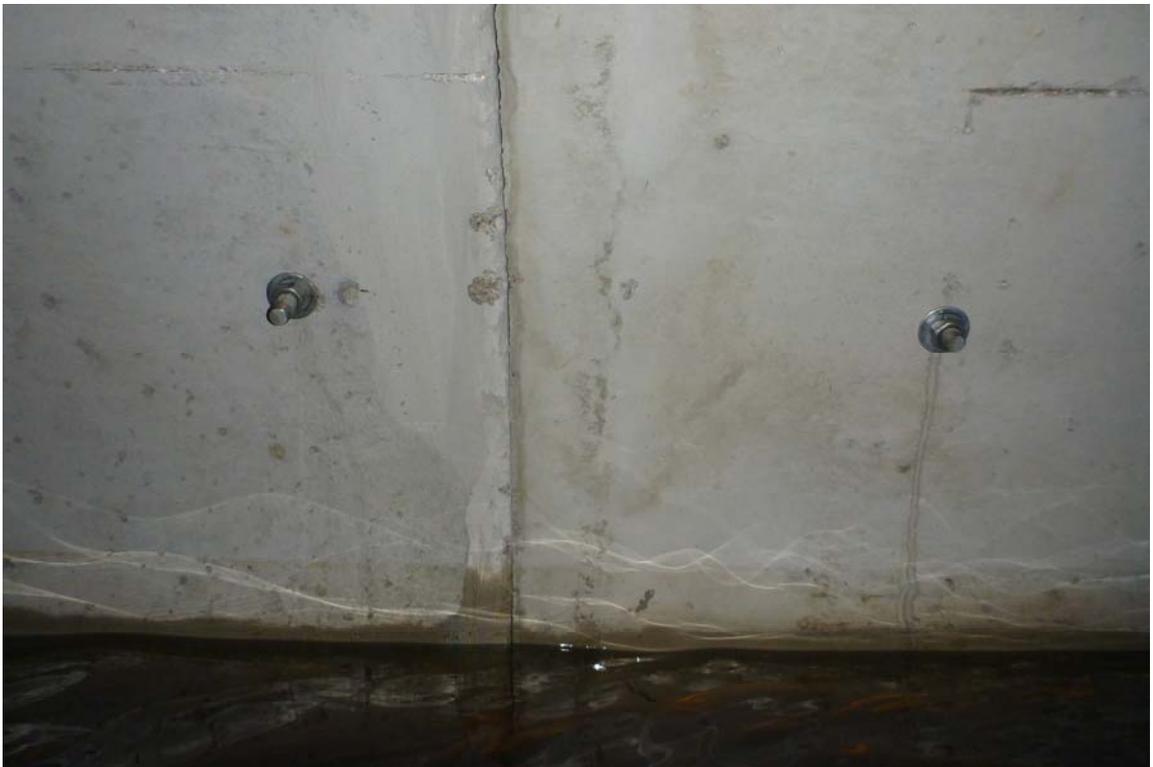
Photograph 6. View of Typical Joint in Culvert.

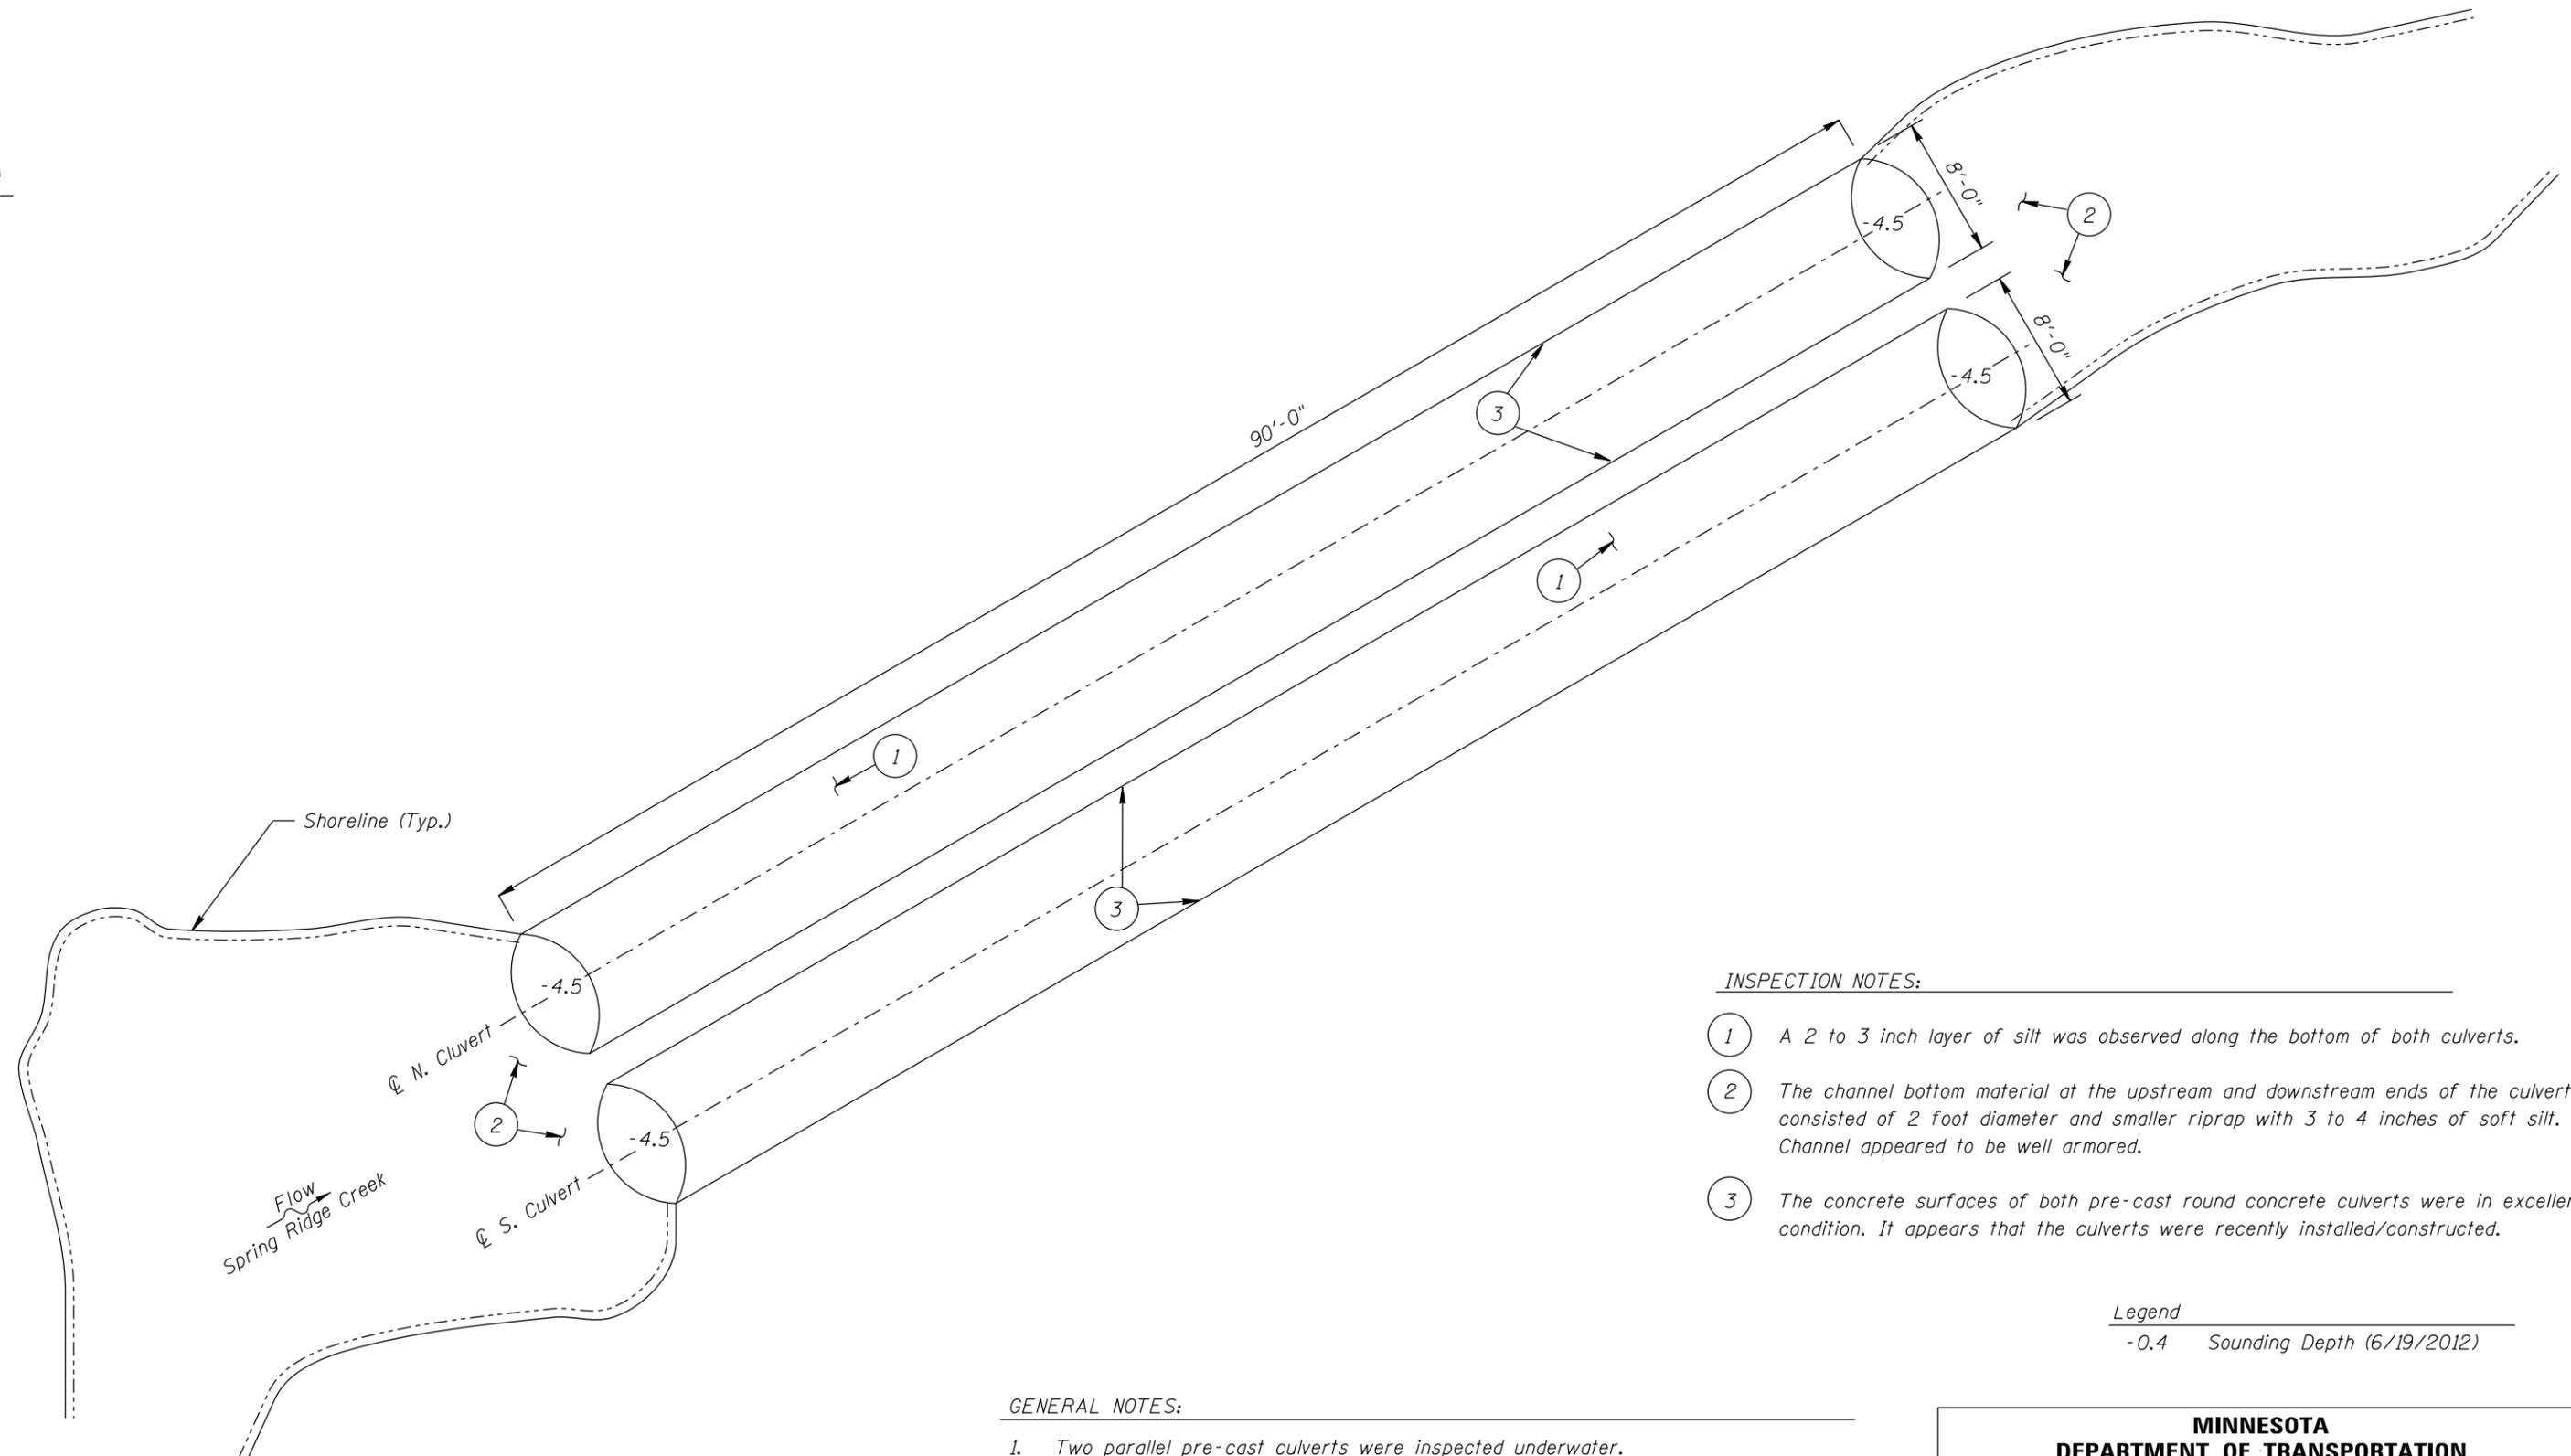
- ① A 2 to 3 inch layer of silt was observed along the bottom of both culverts.
- ② The channel bottom material at the upstream and downstream ends of the culverts consisted of 2 foot diameter and smaller riprap with 3 to 4 inches of soft silt. Channel appeared to be well armored.
- ③ The concrete surfaces of both pre-cast round concrete culverts were in excellent condition. It appears that the culverts were recently installed/constructed.
