UNDERWATER BRIDGE INSPECTION REPORT

STRUCTURE NO. 88699

CR 877

LESTER RIVER

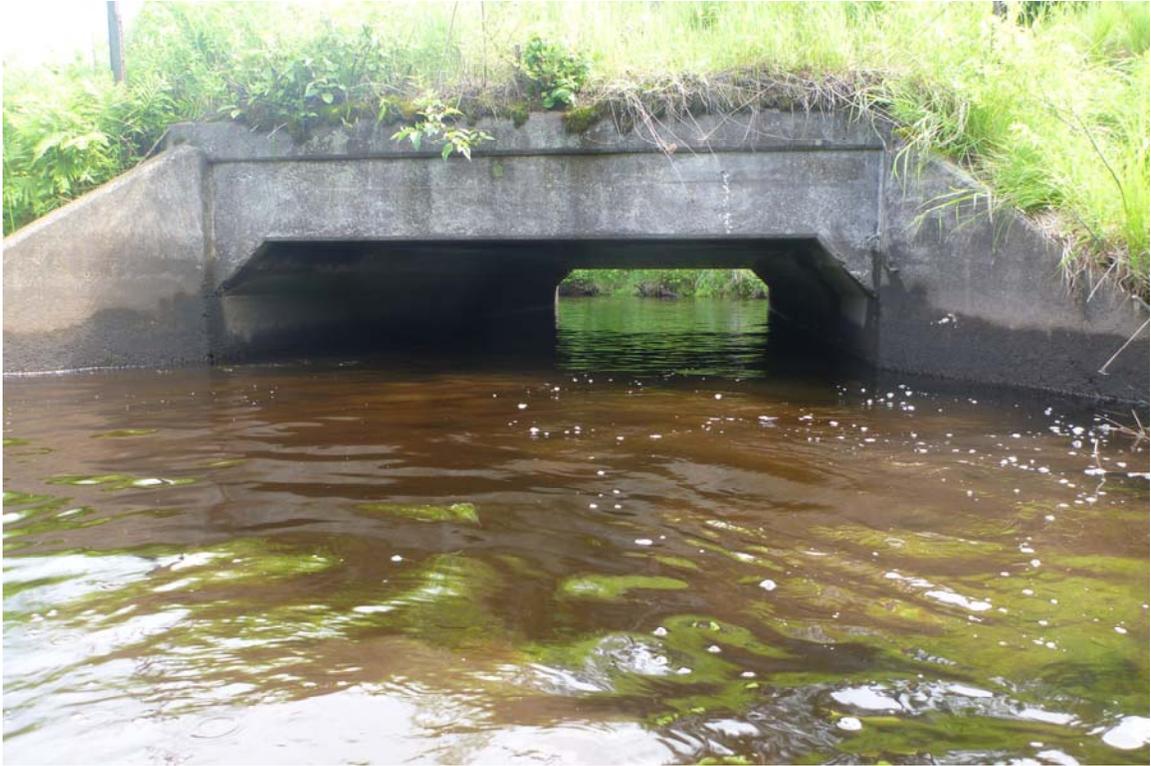
Photograph 1. View of the Upstream Opening of the Culvert, Looking East.

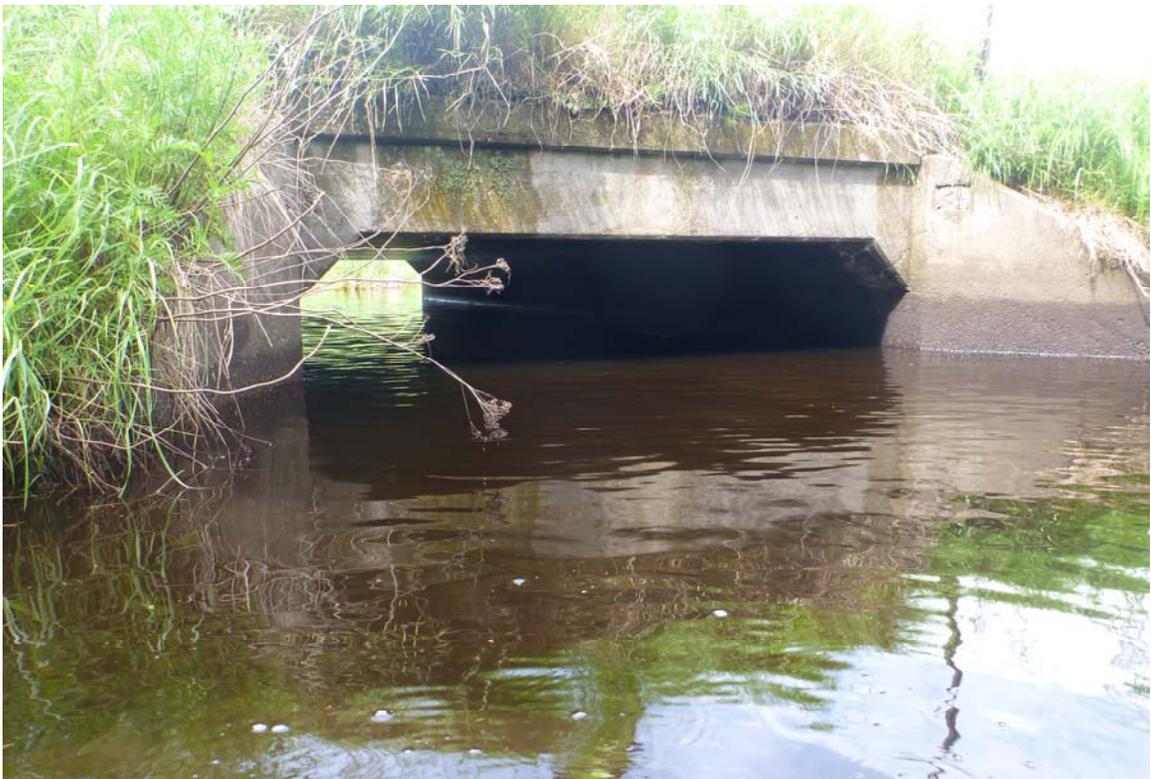
Photograph 2. View of the Downstream Opening of the Culvert, Looking Northwest.

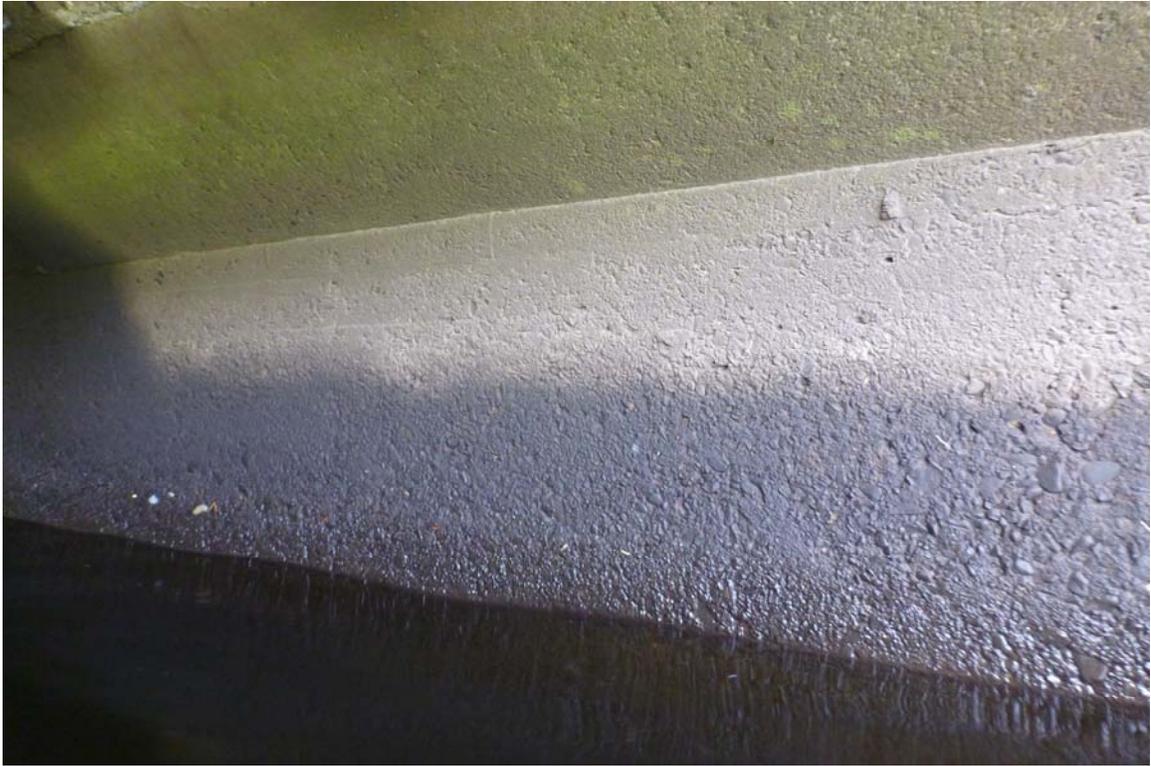
- (A) A band of light scaling was observed around the waterline along the length of the culvert with a typical penetration of 1/16 inch and a maximum penetration of 1/8 inch.
- (B) The concrete throughout the culvert ceiling was sound with no significant structural defects.
- (C) The top of the concrete apron at the upstream opening of the culvert was partially exposed. The channel bottom at the upstream opening of the culvert was approximately level with the top of the concrete apron with minimal vertical apron toe exposure present. The channel bottom material consisted of 1 to 2 inch diameter cobblestones and smaller gravel.
- (D) The flow of the waterway is directed towards the southerly side of the culvert resulting in more concrete apron exposure along the south half of the culvert opening and some minor erosion along the southern banks.

Photograph 3. View of the Typical Concrete Condition near the Waterline, Looking Southeast.

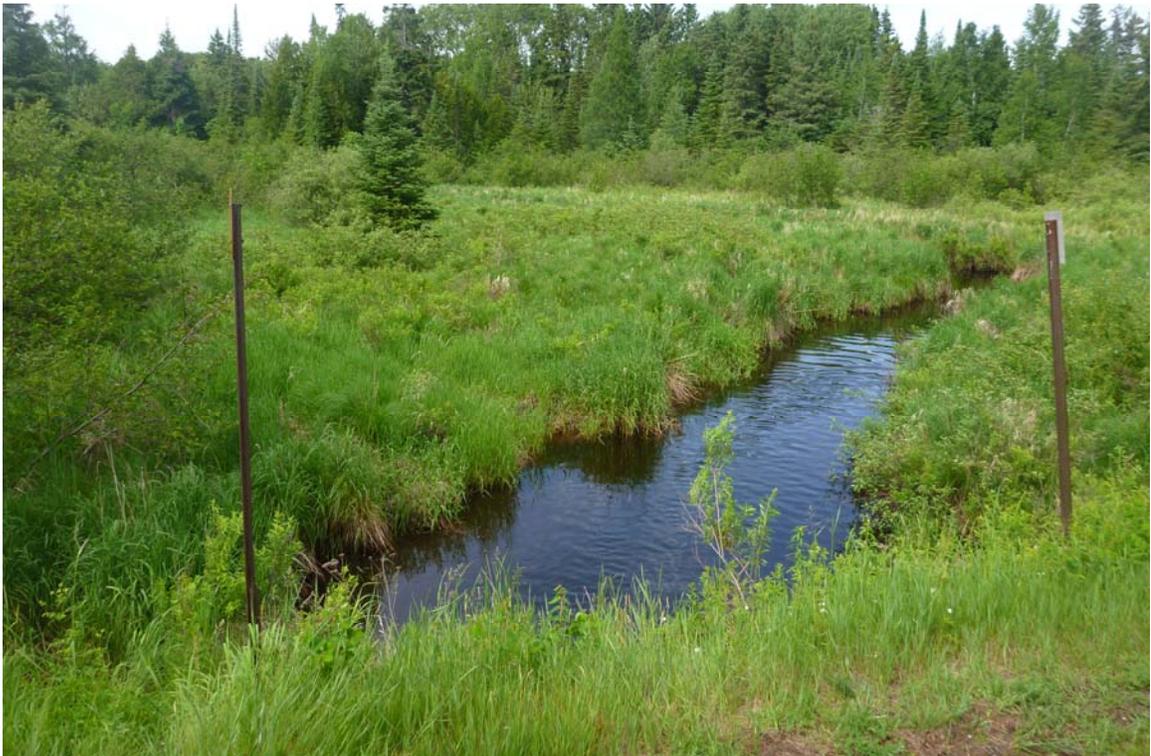
Photograph 4. View of the Upstream Channel, Looking West.

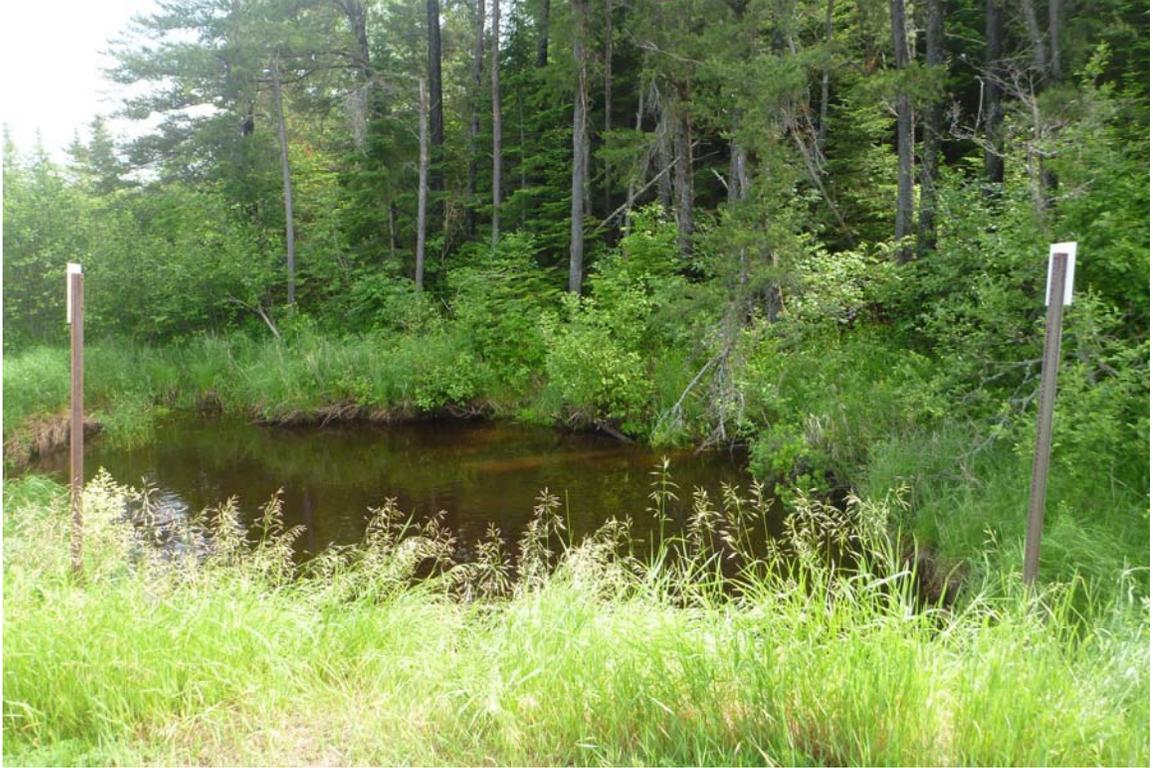
Photograph 5. View of the Downstream Channel, Looking East.

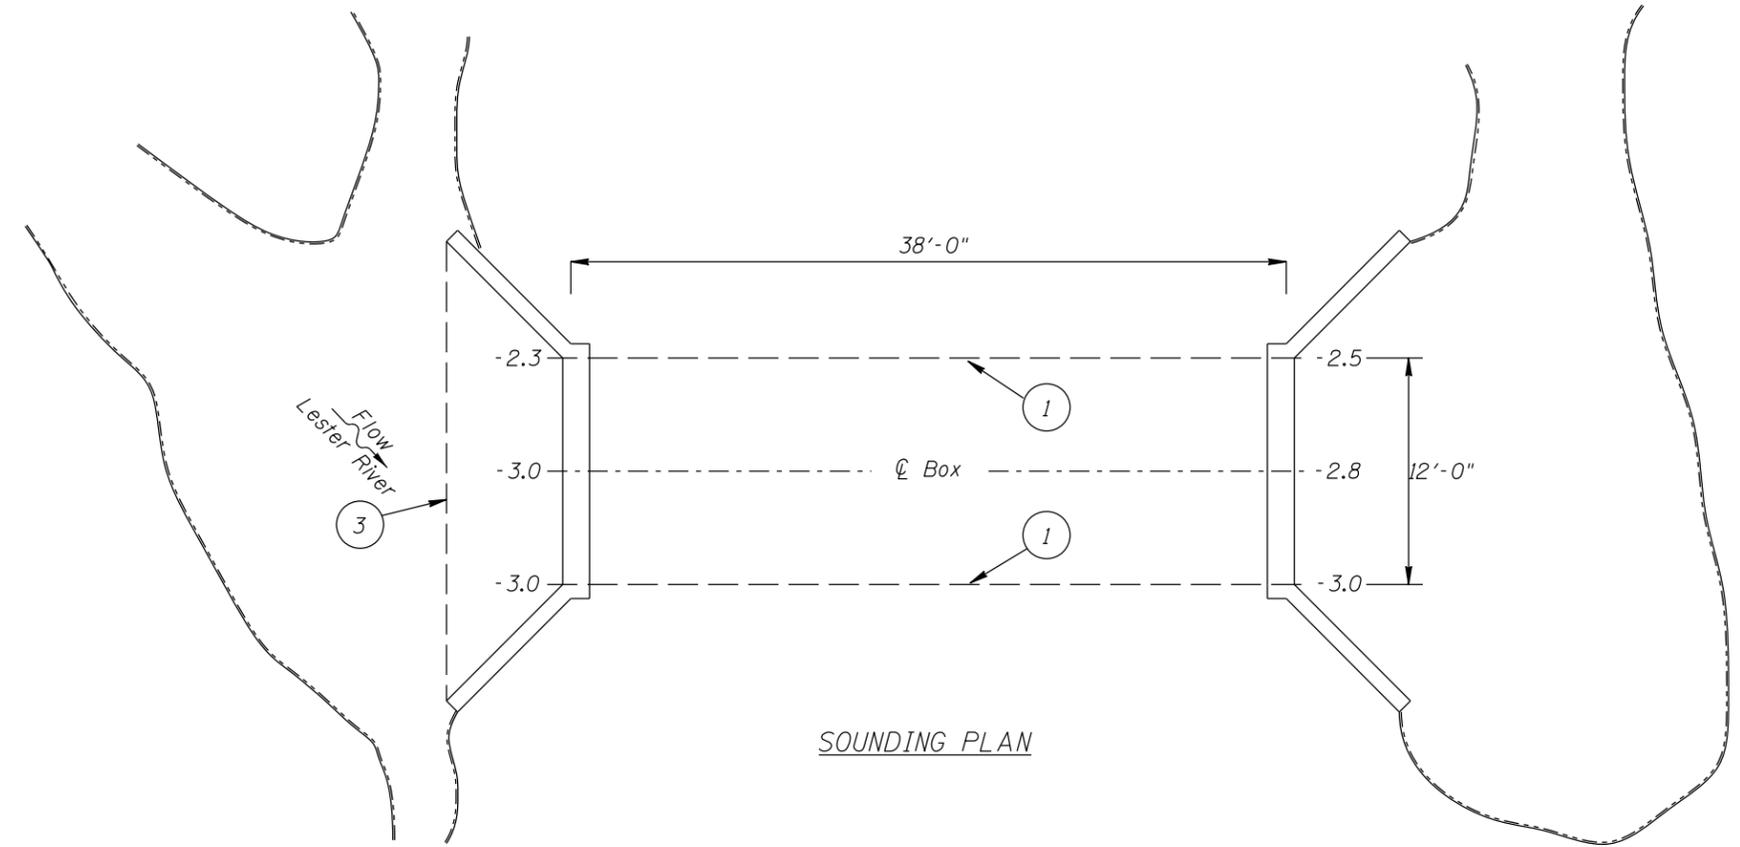
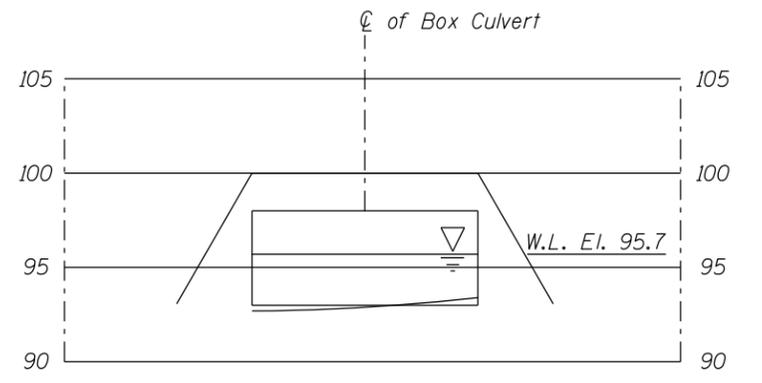
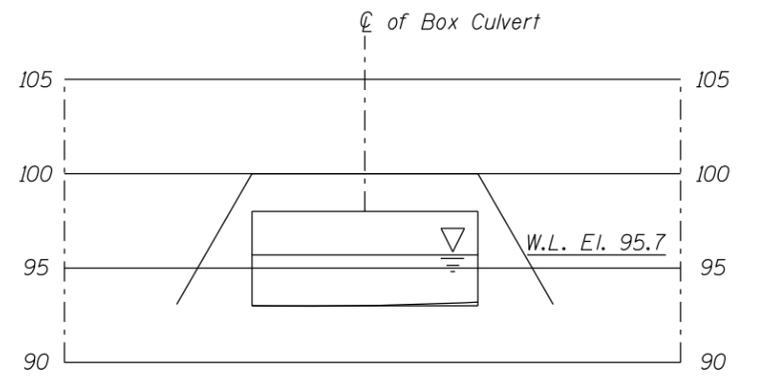
SOUNDING PLAN

- 1 A band of light scaling was observed around the waterline along the length of the culvert with a typical penetration of 1/16 inch and a maximum penetration of 1/8 inch.
- 2 The concrete throughout the culvert ceiling was sound with no significant structural defects.
- 3 The top of the concrete apron at the upstream opening of the culvert was partially exposed. The channel bottom at the upstream opening of the culvert was approximately level with the top of the concrete apron with minimal vertical apron toe exposure present. The channel bottom material consisted of 1 to 2 inch diameter cobblestones and smaller gravel.
- 4 The flow of the waterway is directed towards the southerly side of the culvert resulting in more concrete apron exposure along the south half of the culvert opening and some minor erosion along the southern banks.
