UNDERWATER BRIDGE INSPECTION REPORT

STRUCTURE NO. L4160

DEMPSEY CREEK

MINNESOTA DEPARTMENT OF TRANSPORTATION  
UNDERWATER BRIDGE INSPECTION

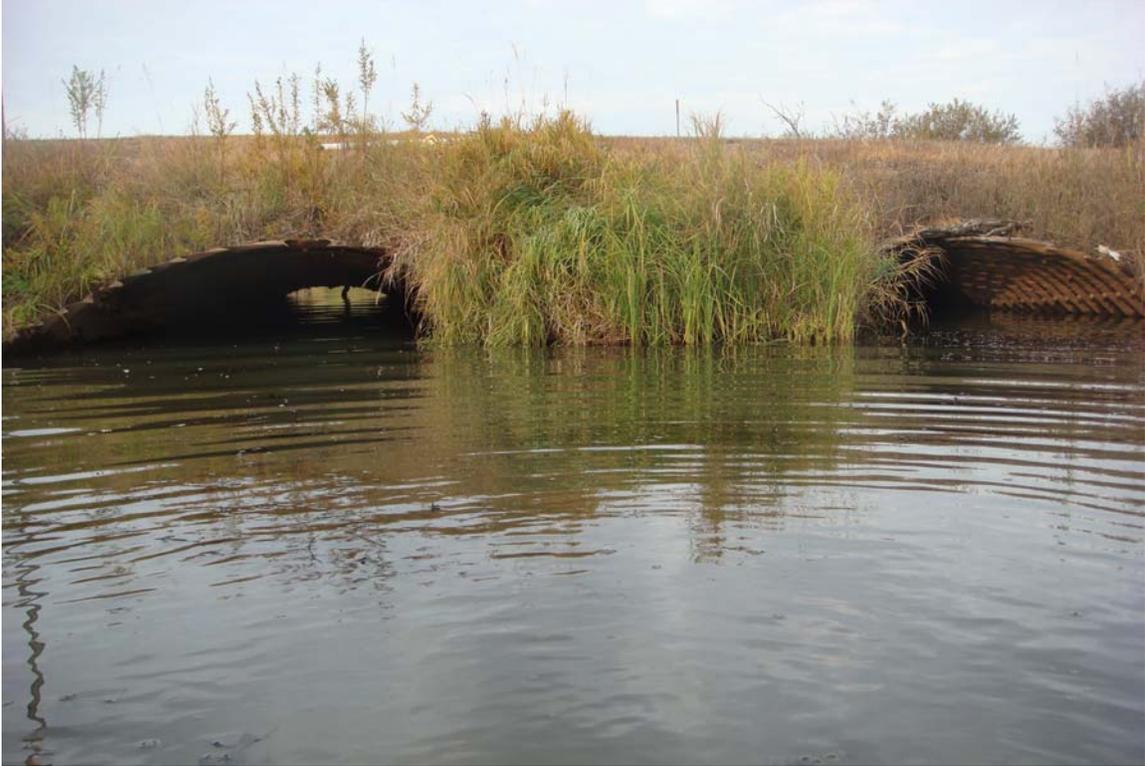
Photograph 1. View of the Upstream Openings of the Structure, Looking West.

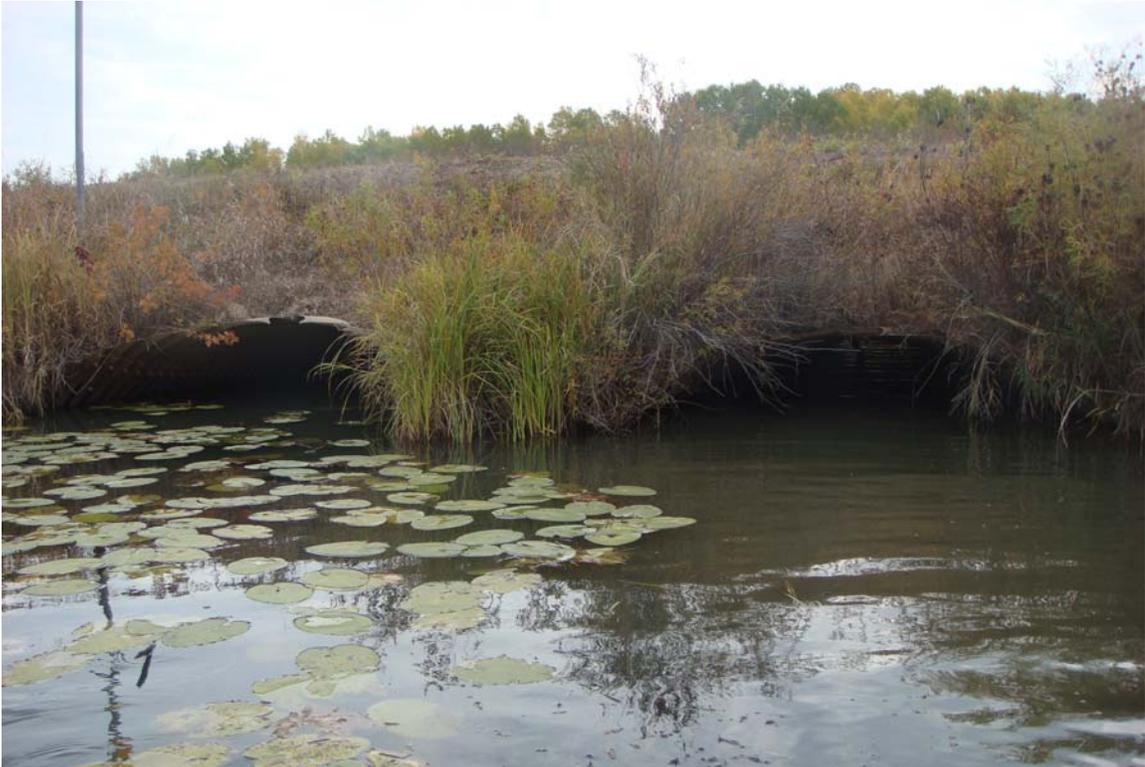
Photograph 2. View of the Downstream Openings of the Structure, Looking East.

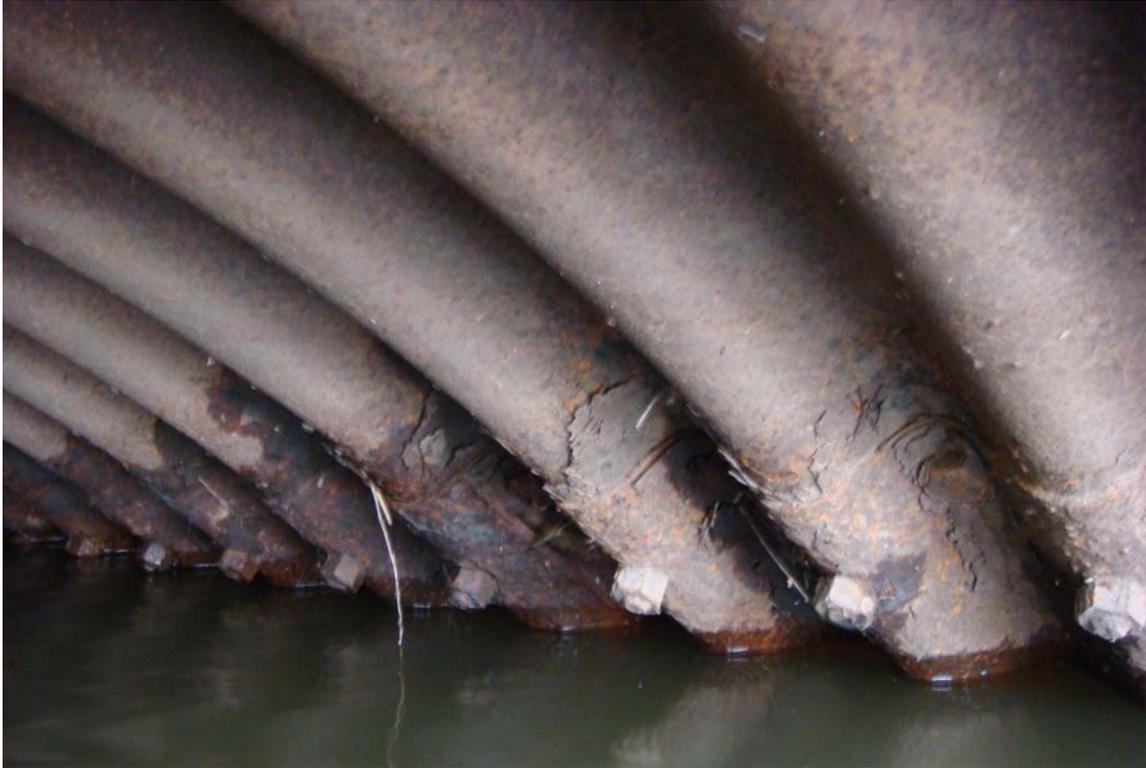
Photograph 3. View of the Typical Steel Condition Near the Waterline, Looking Southeast.

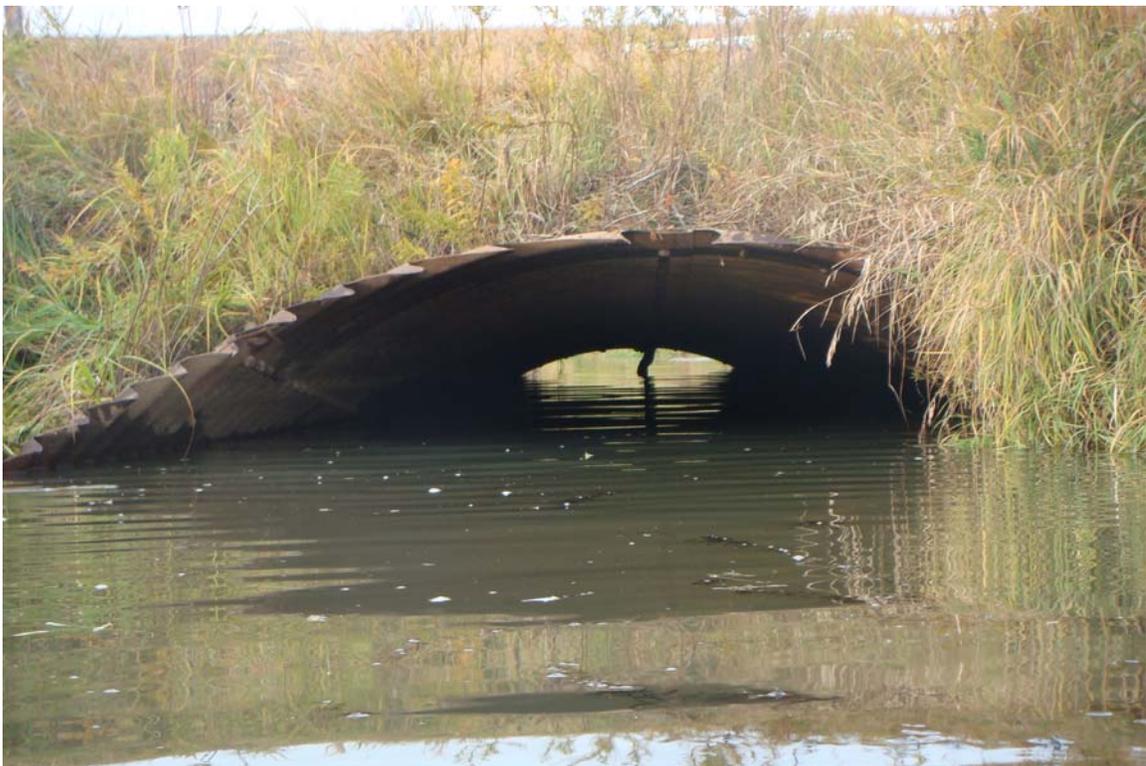
Photograph 4. View Through the South Barrel Showing 1 foot Sag in top (ceiling), Looking East.

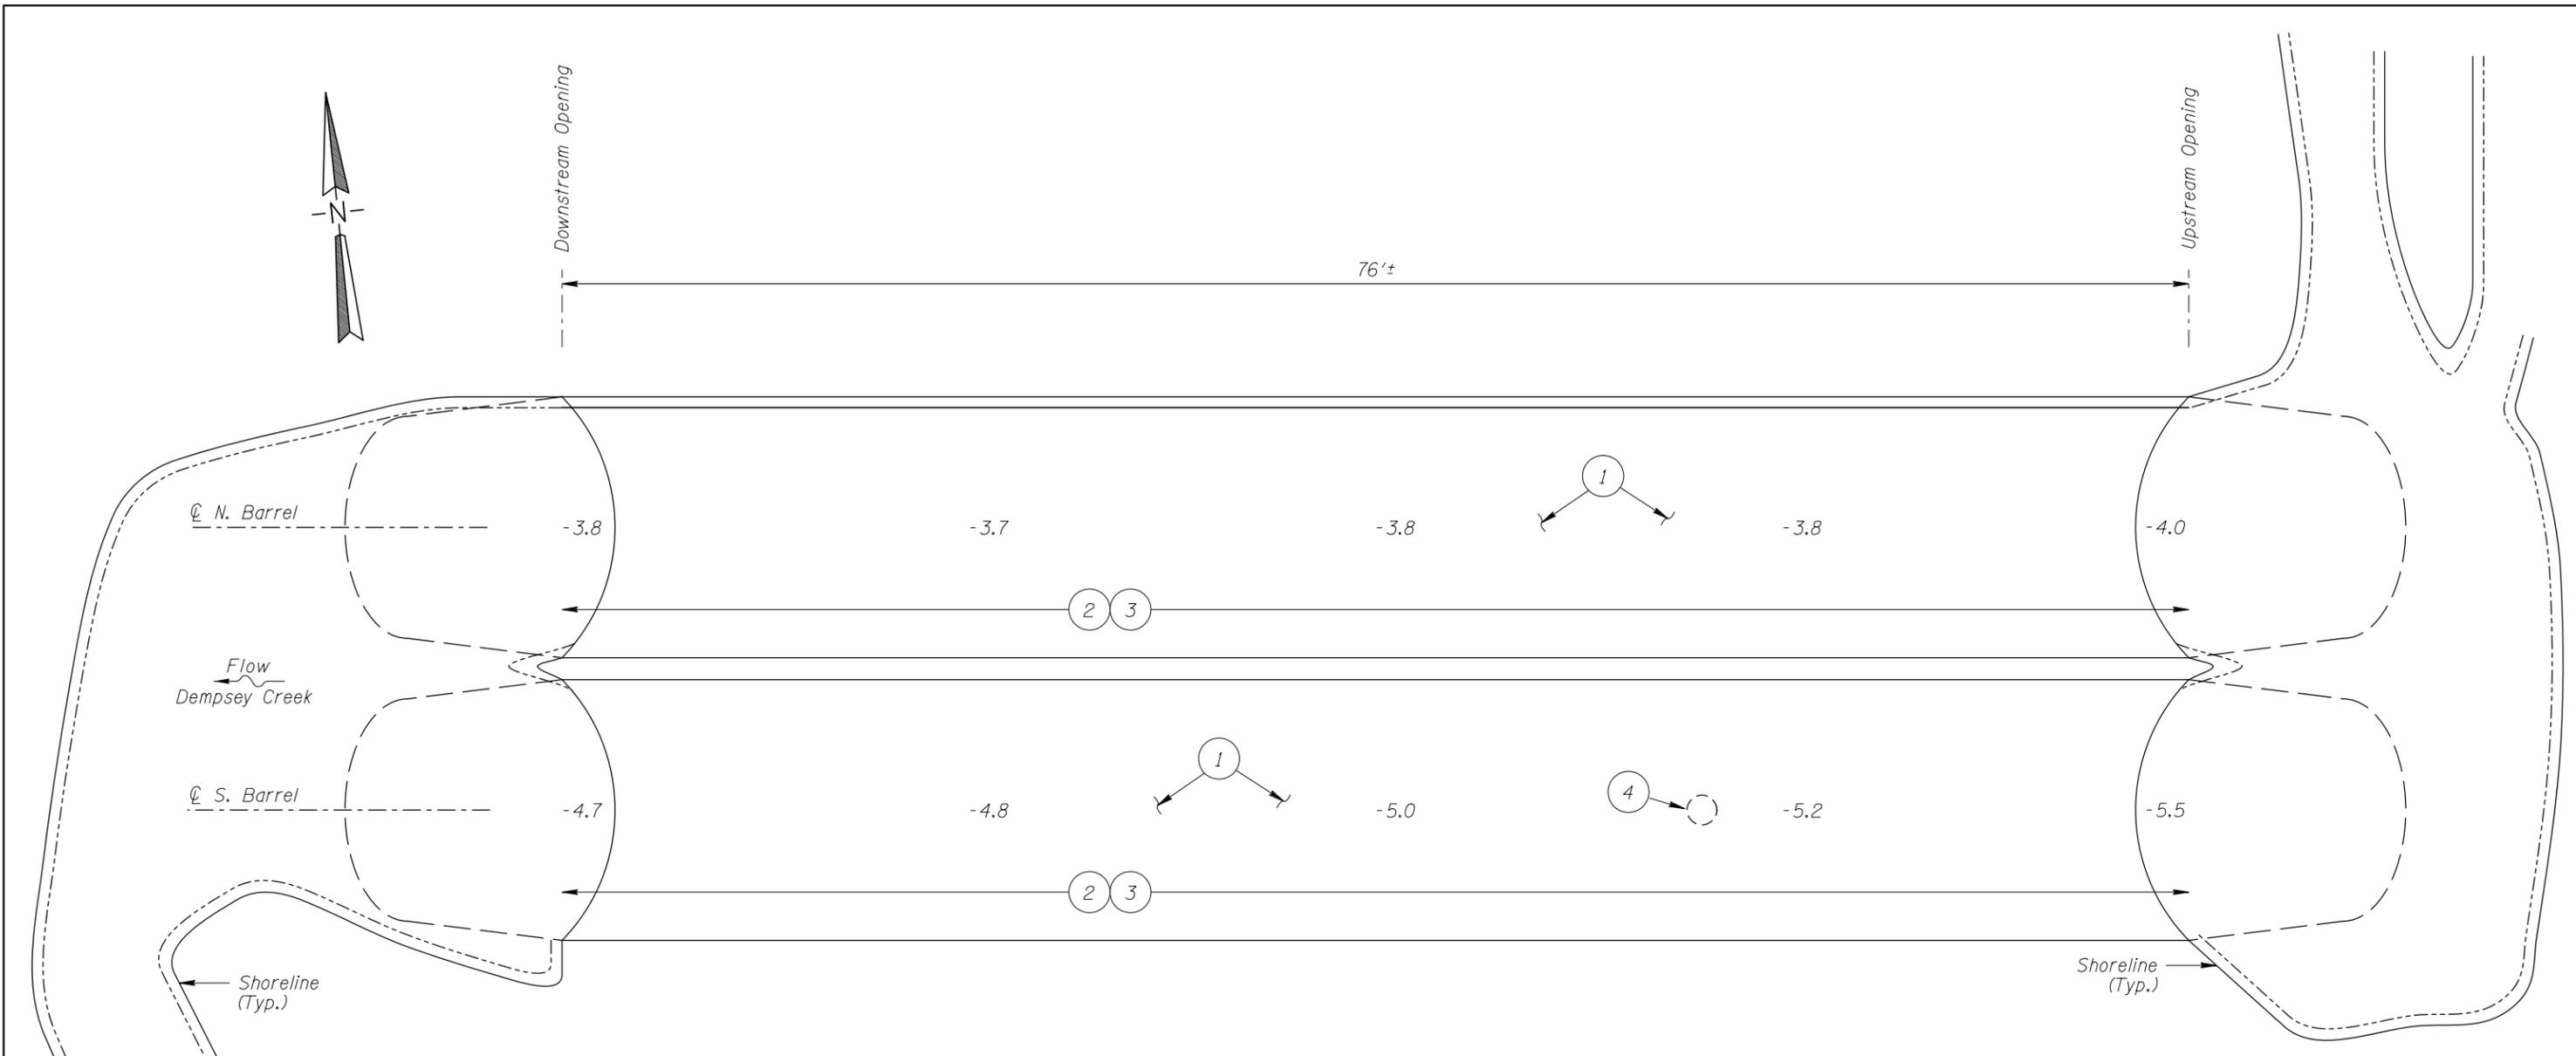
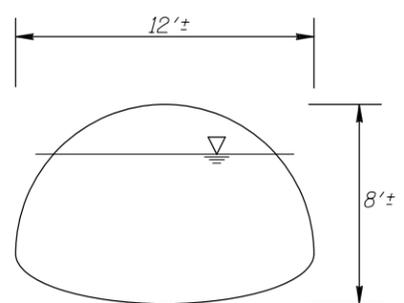
- ① The channel bottom material at the upstream and downstream openings and throughout the length of both barrels of the culvert typically consisted of sandy silt with a maximum probe rod penetration of 6 inches. The culvert floor was covered by a layer of sandy silt ranging from 0.5 to 2.5 feet thick.
- ② The steel of both barrels exhibited light corrosion with rust scaling up to 1/8 inch thick extending from 1 foot below to 1 foot above the waterline.
- ③ Both barrels exhibited a 1 foot sag at the top (ceiling) starting approximately 5 feet from each end. The sag was consistent throughout the length of the barrel.
- ④ A 5 inch diameter timber log was lodged vertically in the south barrel at 20 feet in from the upstream opening.
