UNDERWATER BRIDGE INSPECTION REPORT

STRUCTURE NO. L4198

CR 666

SECOND CREEK

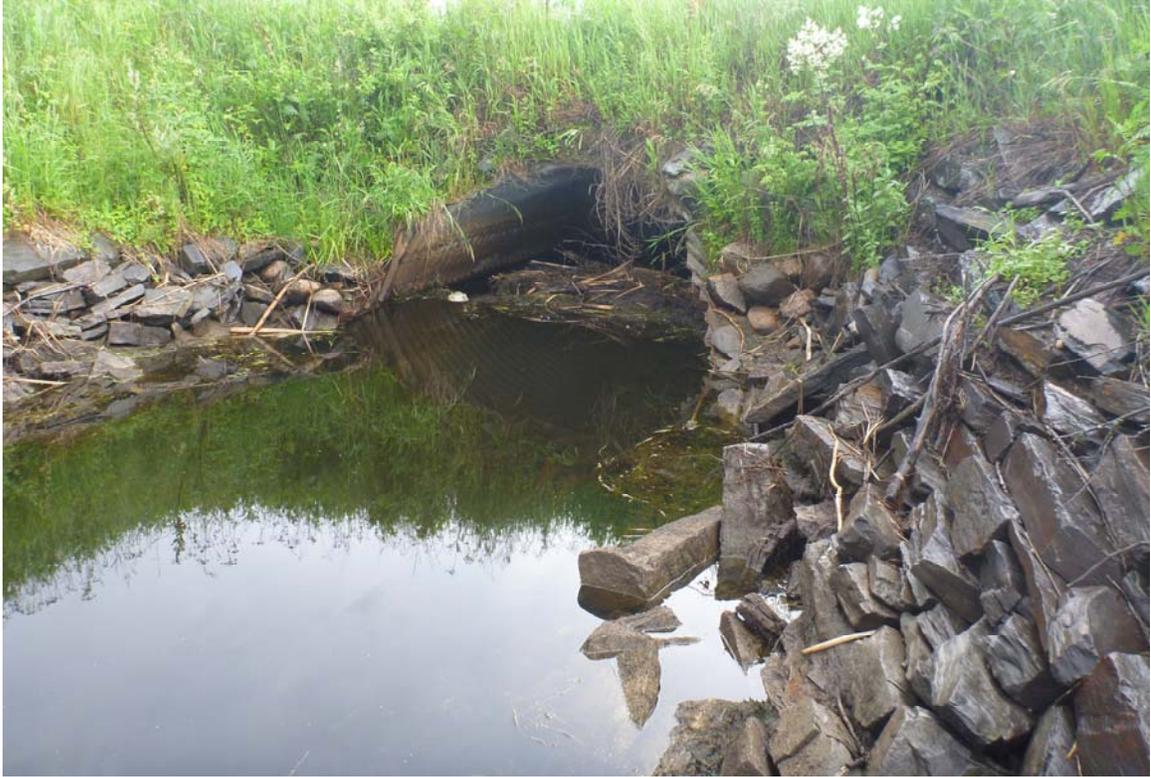
Photograph 1. View of the Upstream Opening Showing Timber Debris Accumulation, Looking Southeast.

- (A) Monitor the timber debris accumulation at both ends of the culvert and if found to be increasing in extent, removal operations may be warranted.

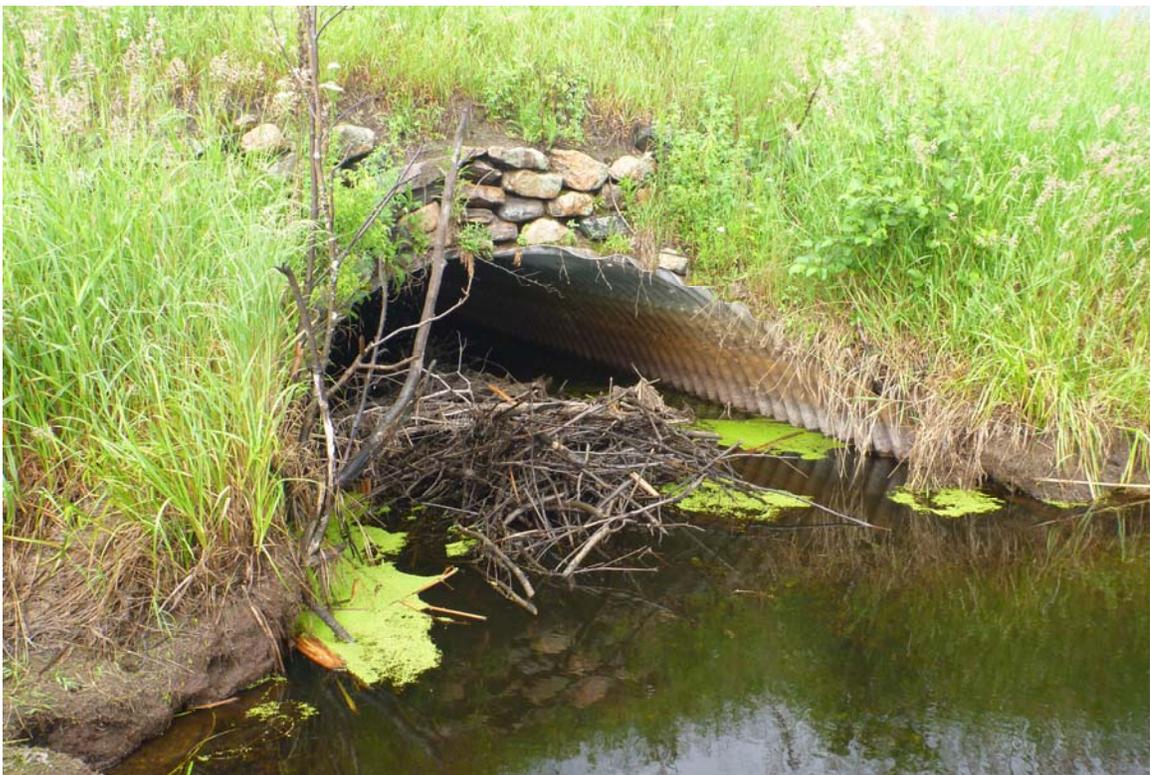
Photograph 2. View of Downstream Opening Showing Timber Debris Accumulation, Looking Northeast.

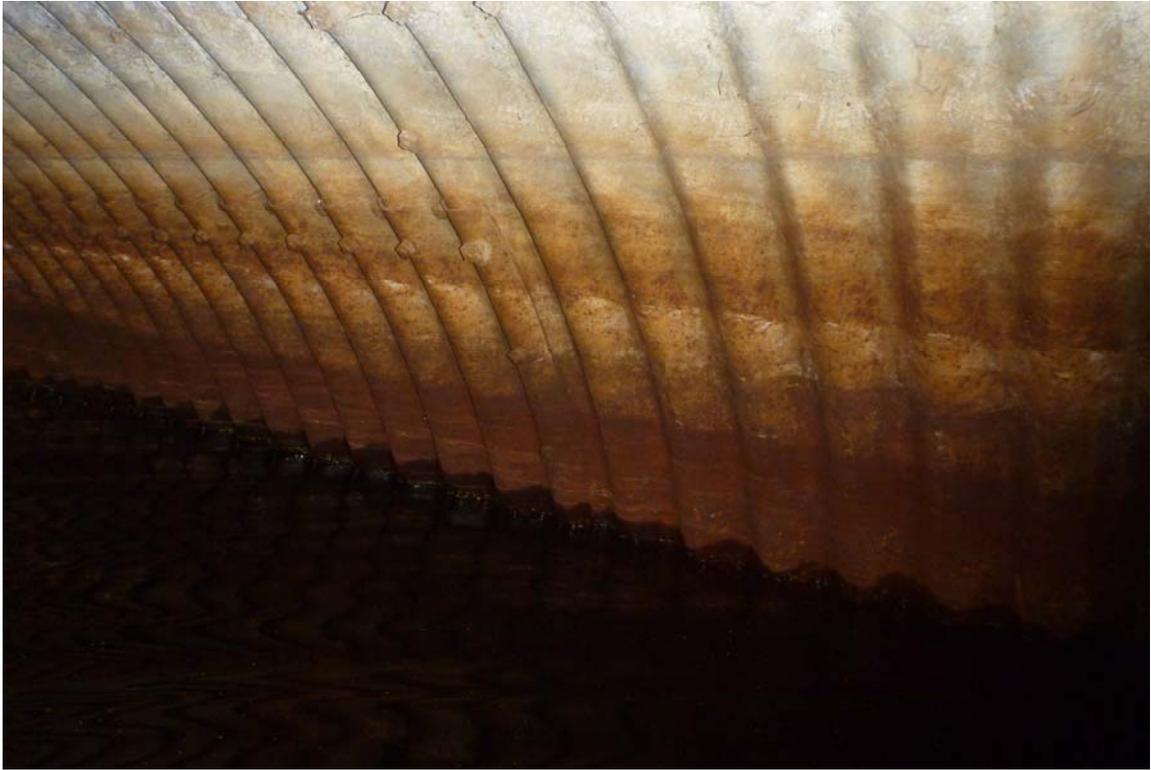
Photograph 3. Typical View of the Steel Condition at the Waterline, Looking South.

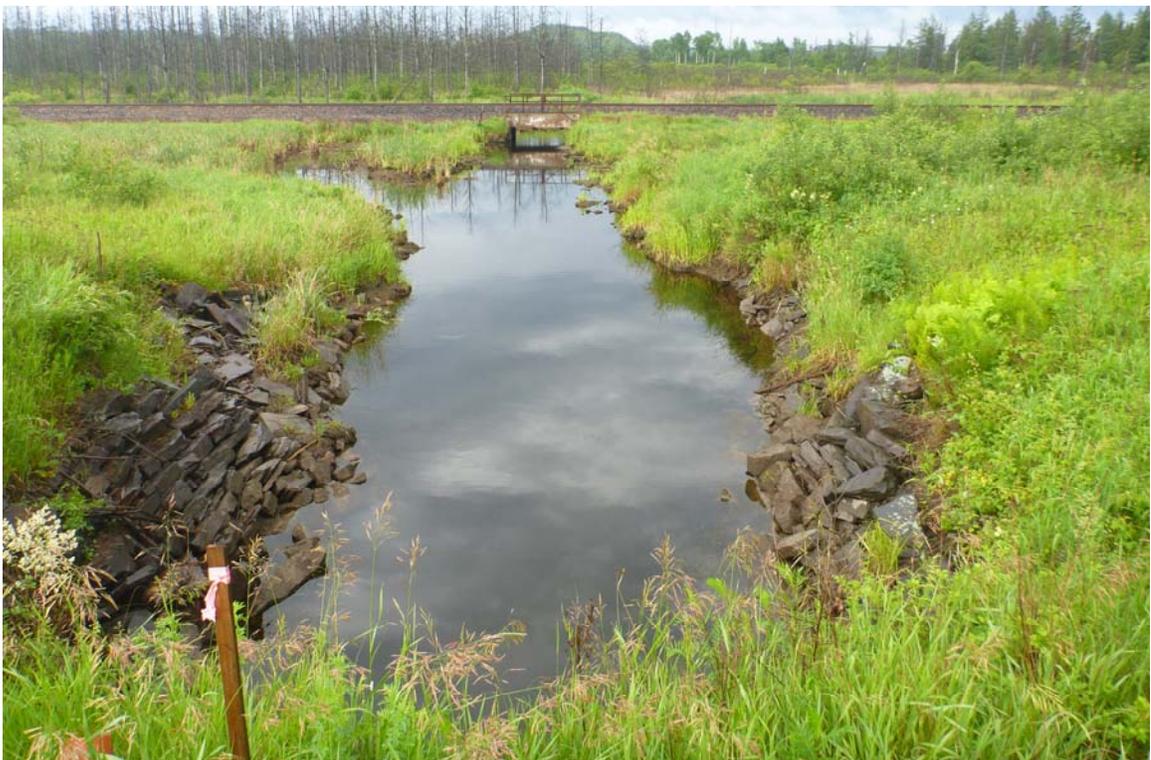
Photograph 4. View of the Upstream Channel, Looking North.

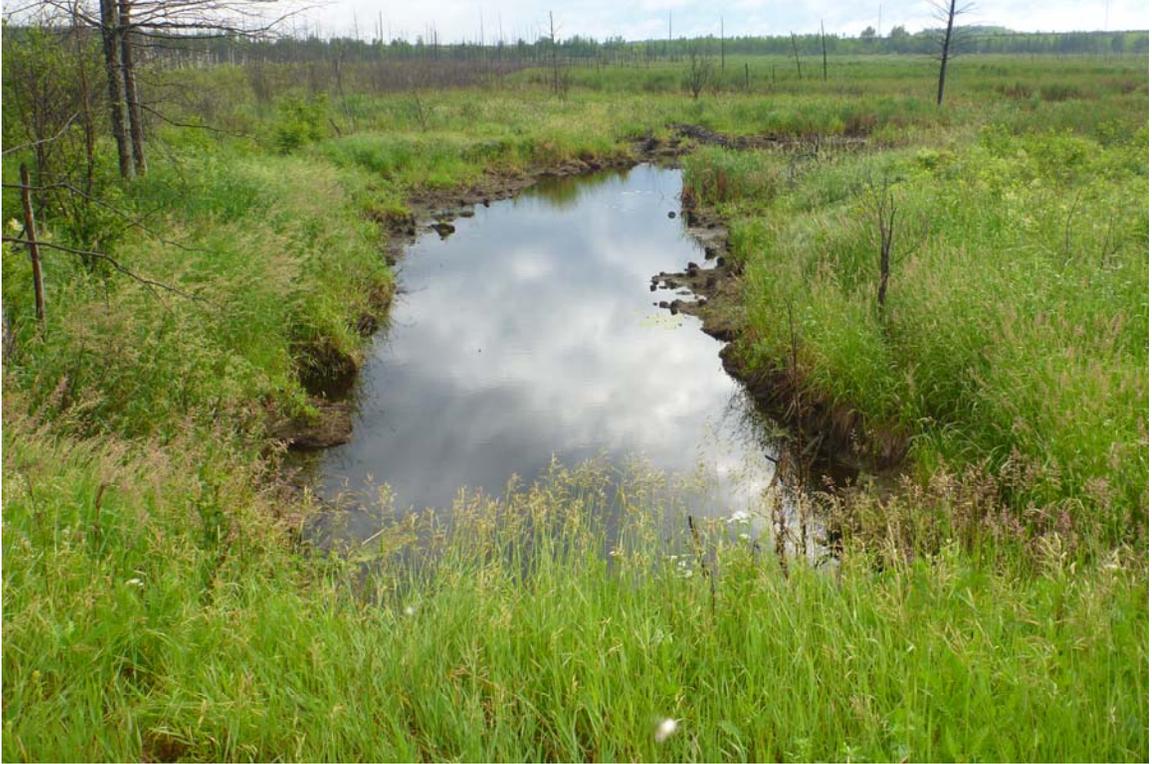
Photograph 5. View of the Downstream Channel, Looking South.

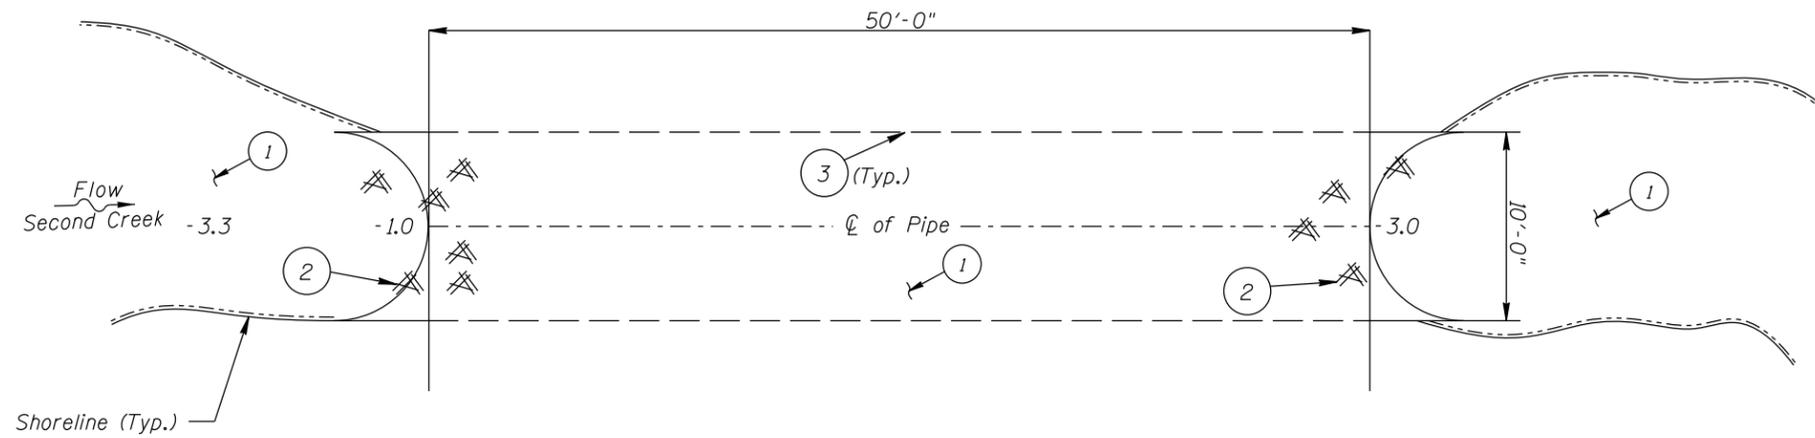
SOUNDING PLAN

- INSPECTION NOTES:
- ① The channel bottom material through the culvert consisted of a layer of silt, approximately 8 inches thick, over firm sand. At the openings the channel bottom material consisted of a layer of silt, approximately 12 to 18 inches thick, over scattered rocks.
  - ② A light to moderate timber debris accumulation was observed at both ends of the culvert and extended across the width of the opening resulting in a somewhat obstructed flow.
  - ③ The corrugated steel pipe exhibited light surface corrosion from 2 feet above to 2 feet below the waterline with no significant loss of section. The joints and alignment was satisfactory with no deflection or distortion.
