# 2016 UNDERWATER BRIDGE INSPECTION REPORT

## BRIDGE # 31556 CSAH 14 over BIG FORK RIVER

Date of Inspection: 06/04/2016

Contractor: Collins Engineers, Inc.

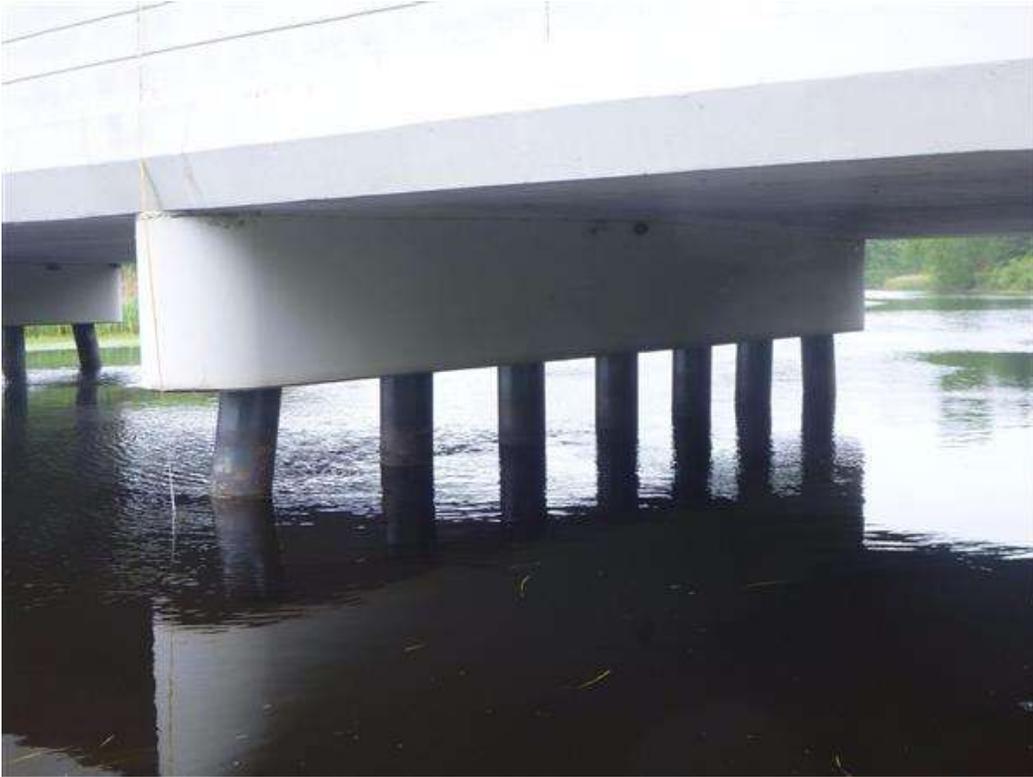
Photo 3 - Pier 1, Looking Northeast

(D) A light accumulation of timber debris with logs up to 12 inch diameter was present along the upstream piles of Pier 1.

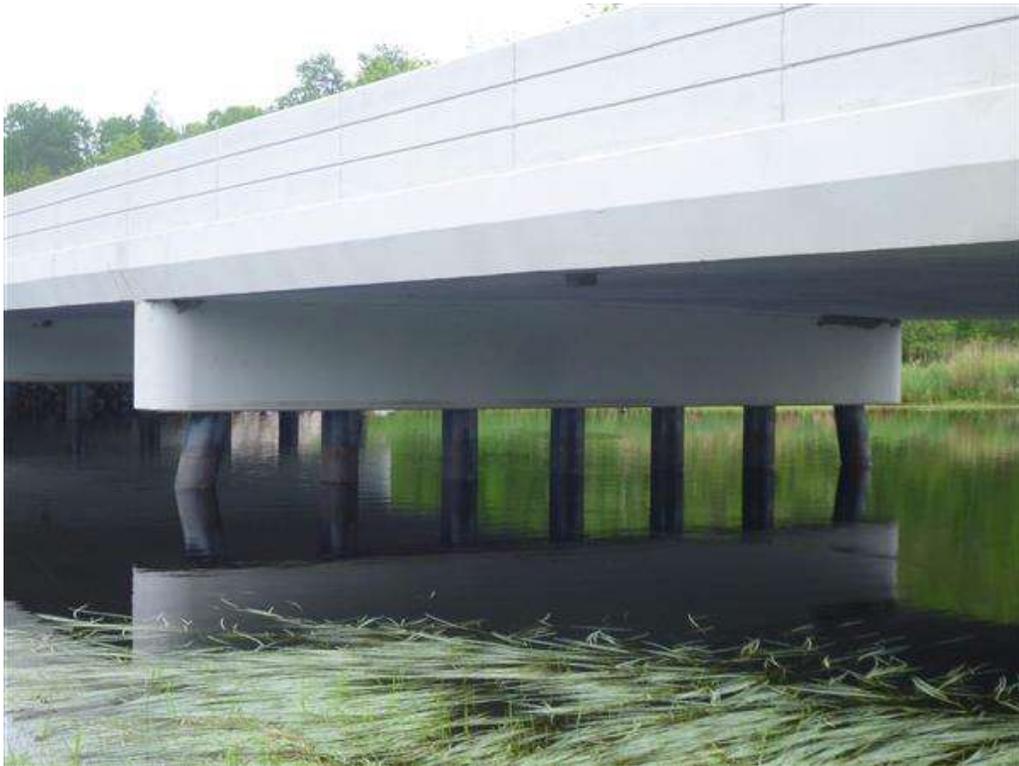
Photo 4 - Pier 2, Looking Southwest

(C) The channel bottom material at Piers 1 and 2 typically consisted of sandy gravel allowing up to 2 inches of probe rod penetration. Additionally a 12 inch diameter log was present along the north side of the upstream pile of Pier 2.

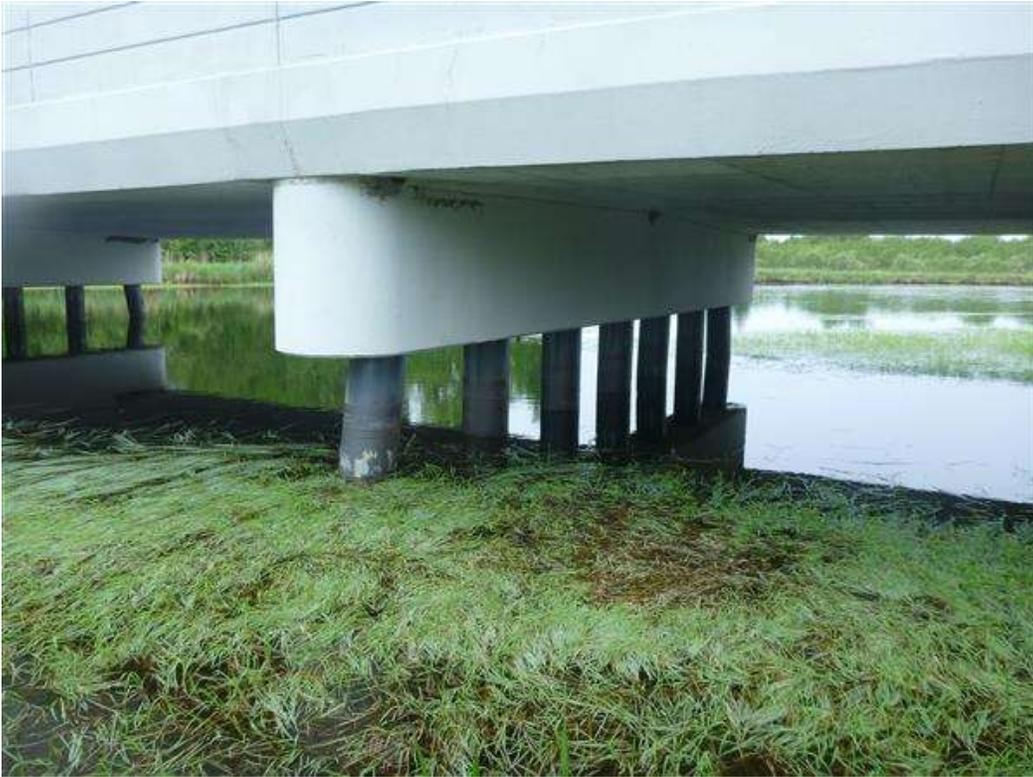
Photo 5 - Pier 3, Looking Southwest

(E) The channel bottom material around Pier 3 consisted of soft silt allowing up to 1.5 feet of probe rod penetration.

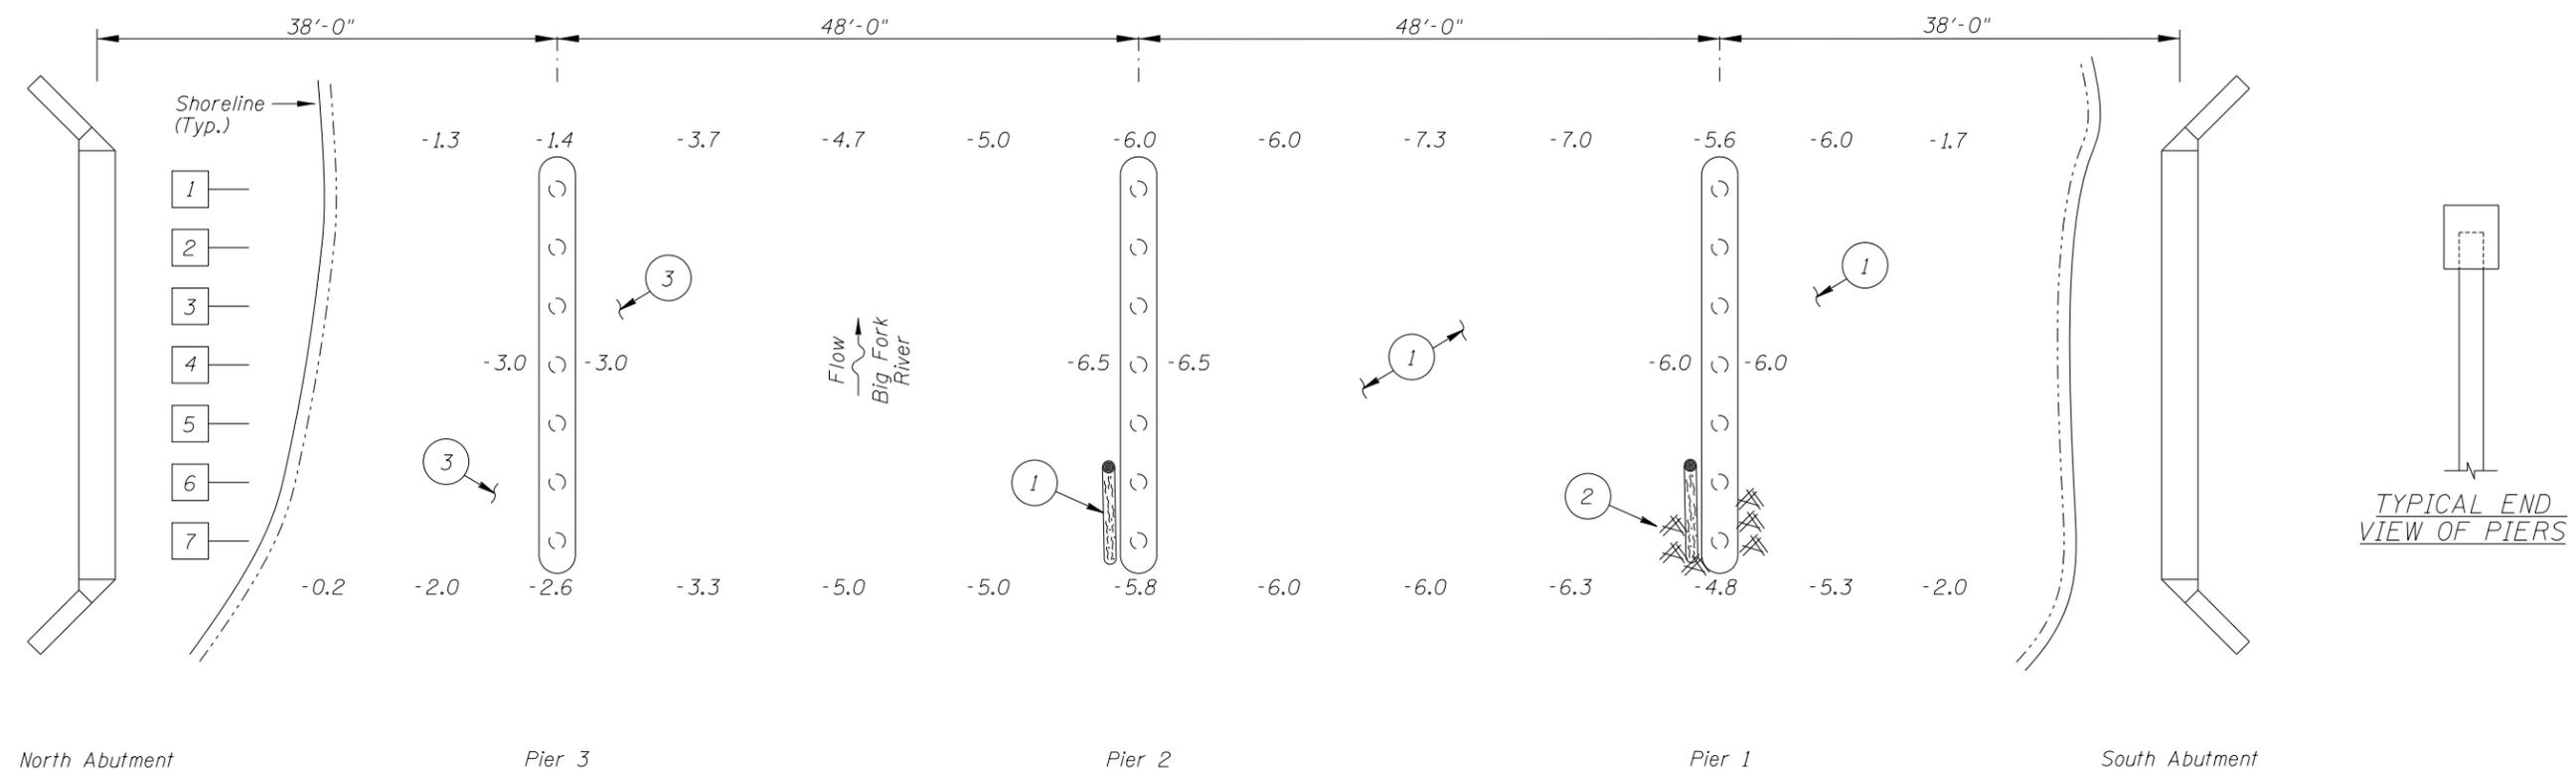
1. The channel bottom material at Piers 1 and 2 typically consisted of sandy gravel allowing up to 2 inches of probe rod penetration. Additionally, a 12 inch diameter log was present along the north side of the upstream pile at Pier 2.
2. A light accumulation of timber debris with logs up to 12 inch diameter was present along the upstream piles of Pier 1.
3. The channel bottom material around Pier 3 consisted of soft silt allowing up to 1.5 feet of probe rod penetration.
