2016 UNDERWATER BRIDGE INSPECTION REPORT

BRIDGE # 36508 CSAH 6 over STREAM

DISTRICT: District 1

COUNTY: Koochiching

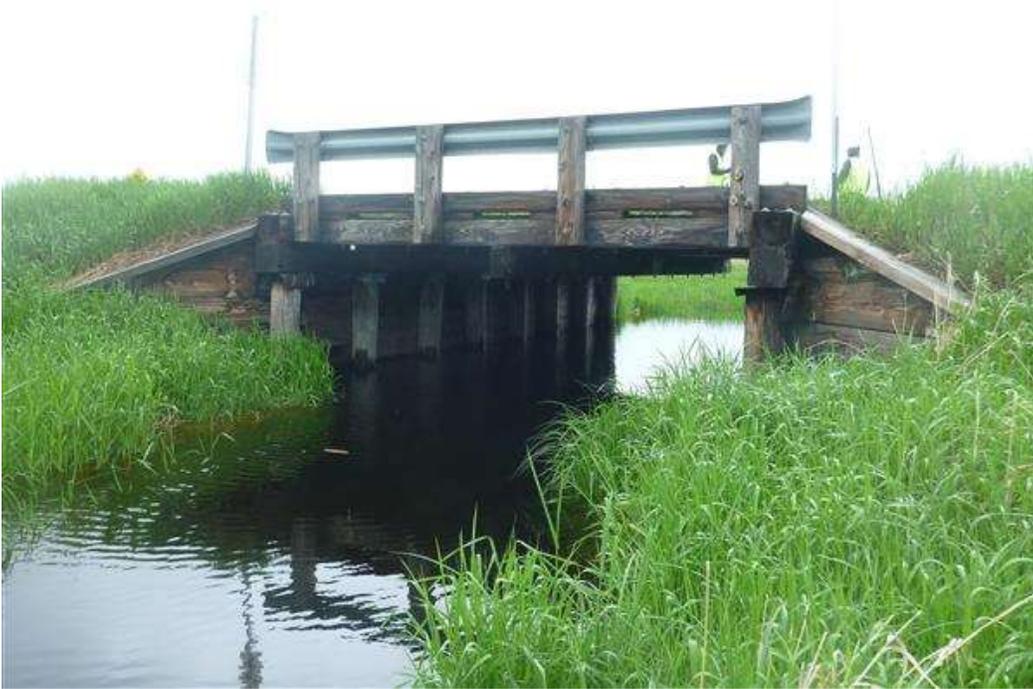
Photo 1 - Overall View of Structure, Looking Northwest

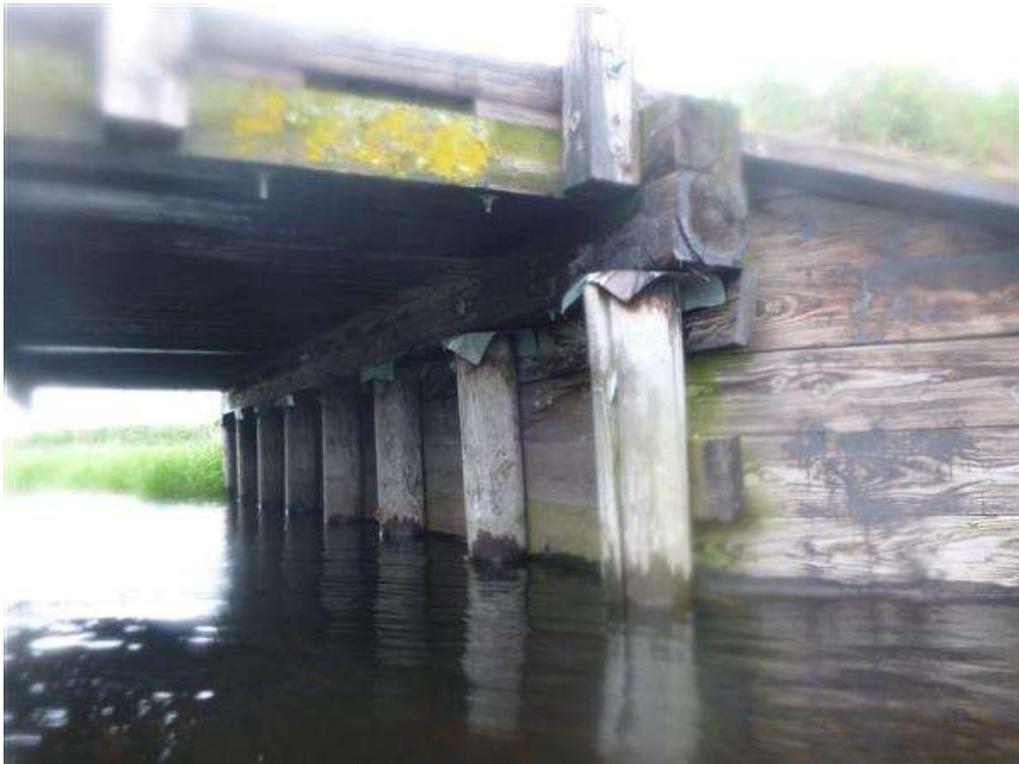
Photo 2 - Overall View of West Abutment, Looking Southwest

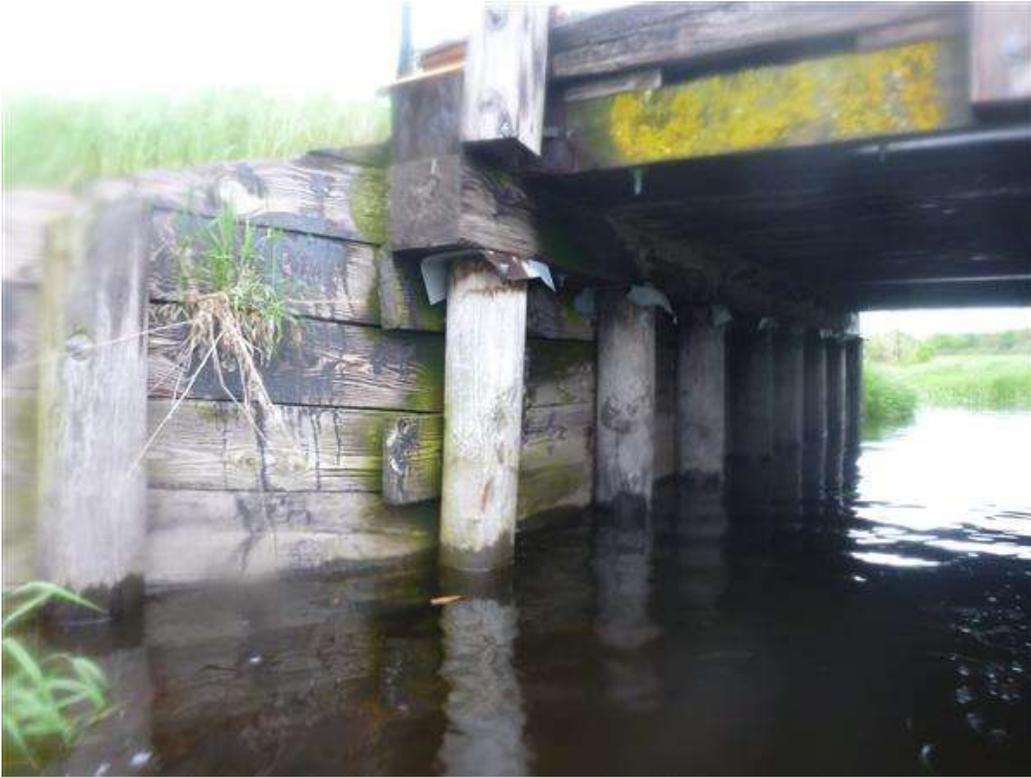
Photo 3 - Overall View of East Abutment, Looking Southeast

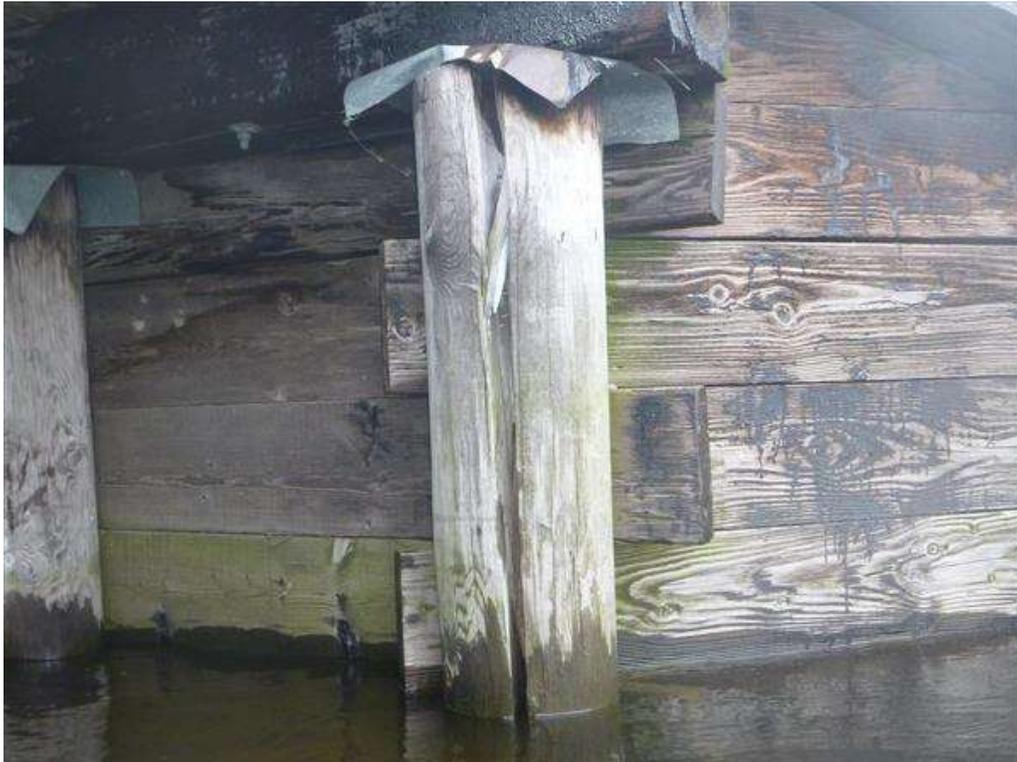
Photo 4 - Split in Upstream Pile of the West Abutment, Looking West

- Pile 1 at the West Abutment exhibited an up to 1.5 inch wide split with decay in several locations extending through to the middle of the pile.
- Pile 8 at the West Abutment exhibited a split up to a 1/2 inch wide on the south face extending from the top of the pile down 3 feet and allowing up to 3 inches of penetration.

(A) Ideally, the cracked and decayed pile at West Abutment should be replaced to restore full load carrying capacity of the structure. If pile is not replaced or assisted with a helper pile, the existing pile should be monitored during future inspections.

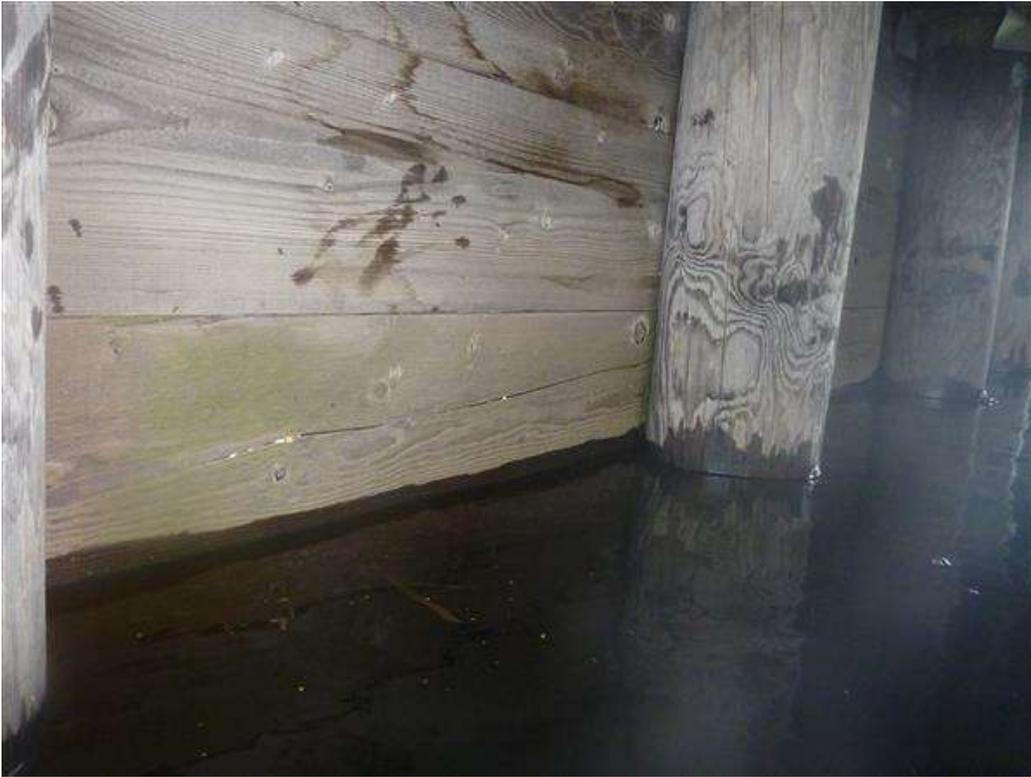
Photo 5 - Split in East Abutment Backwall, Looking Southeast

- The East Abutment backwall exhibited 1/4 inch wide gaps between the planks with minor movement of the planks detected, but with no loss of fill.
- A 1/4 inch wide split in the wall planking was observed 1 foot above the waterline and extended between Pile 1 and Pile 5 of the East Abutment.

- The second board from the top, at the East Abutment backwall, exhibited an outward rotation of 1 inch.

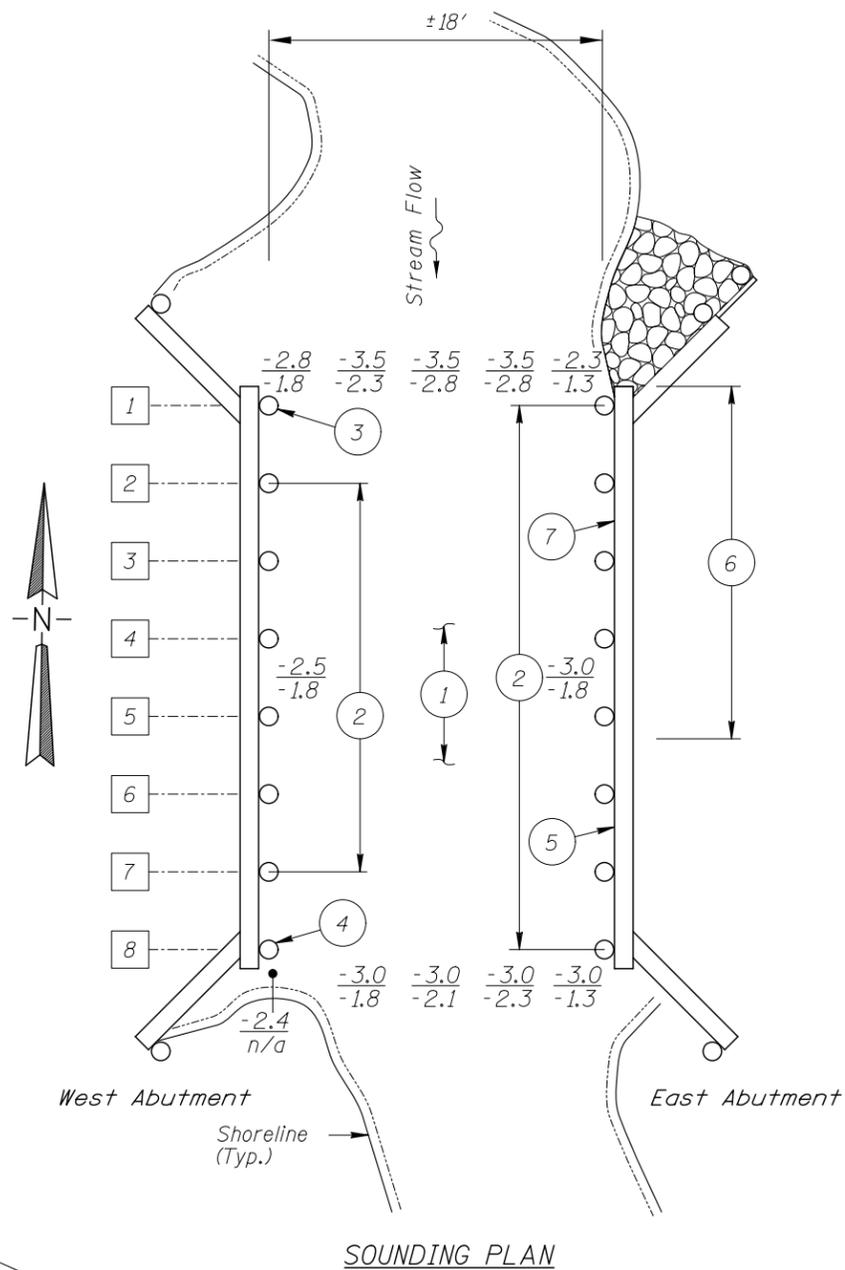
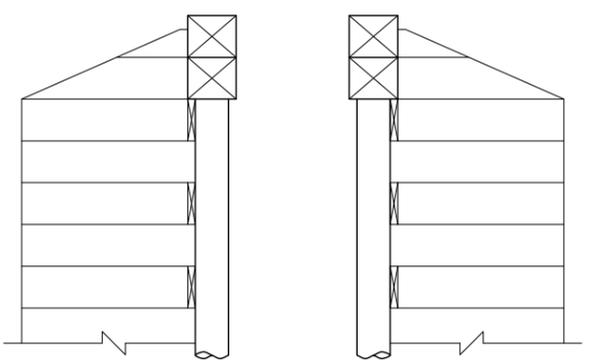
- The channel bottom consisted of 1 foot diameter cobbles and riprap allowing no probe rod penetration.
- The timber piles were mostly in satisfactory and sound condition with occasional checking up to 1/8 inch wide.
