2016 UNDERWATER BRIDGE INSPECTION REPORT

BRIDGE # 36511 CSAH 15 over BATTLE RIVER

DISTRICT: District 1 COUNTY: Koochiching CITY/TOWNSHIP: T - 151 R - 29
STATE: Minnesota

Date of Inspection: 06/04/2016

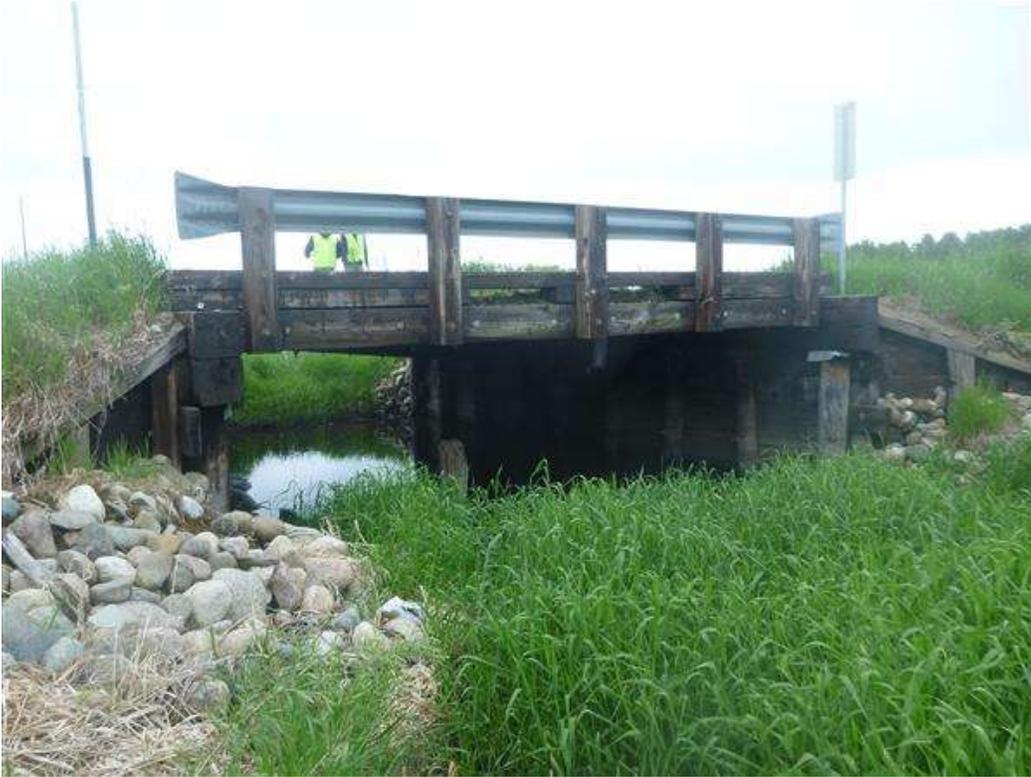
Photo 1 - Upstream Fascia, Looking Northwest

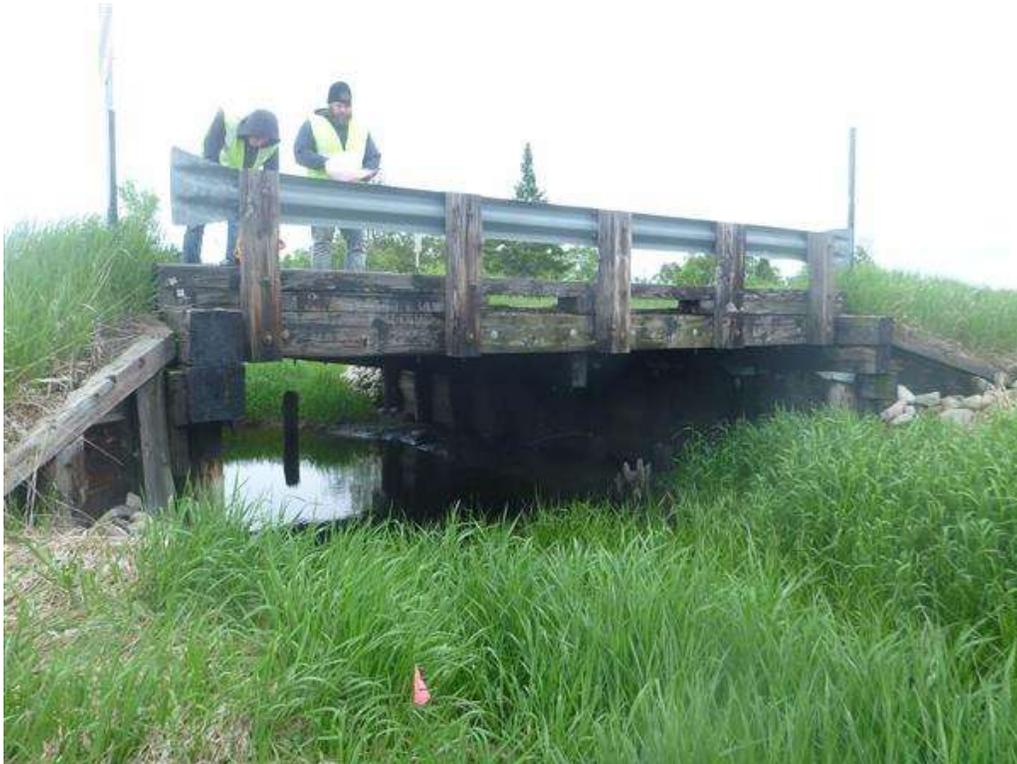
Photo 2 - Downstream Fascia, Looking Southeast

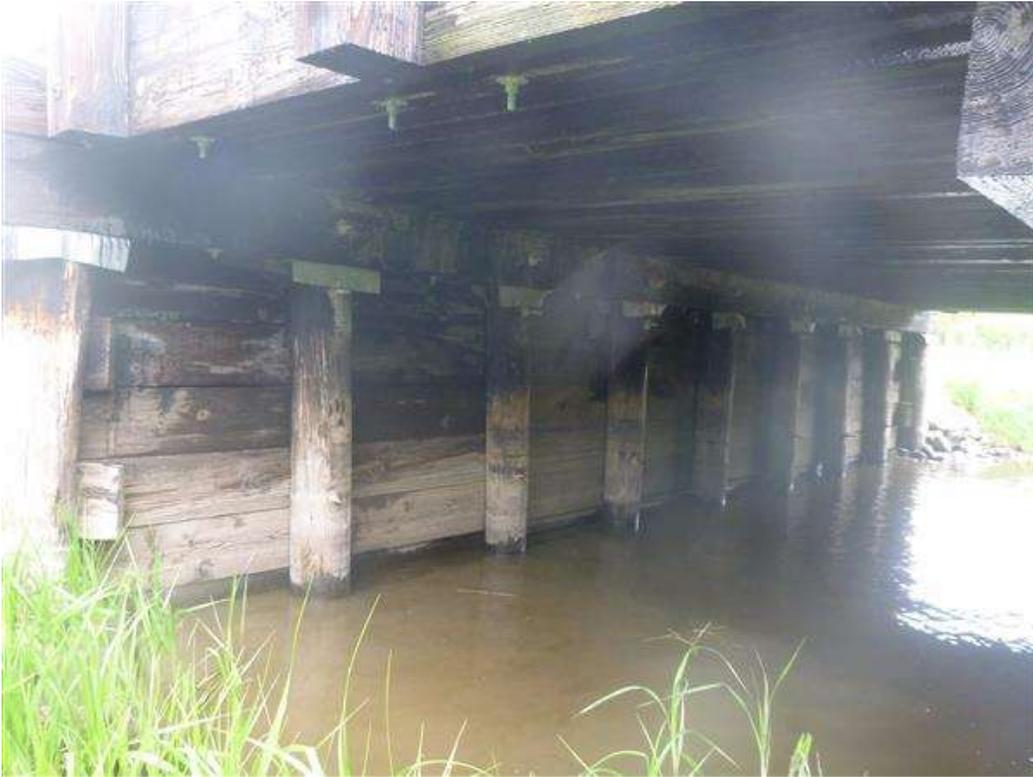
Photo 3 - North Abutment, Looking Northeast

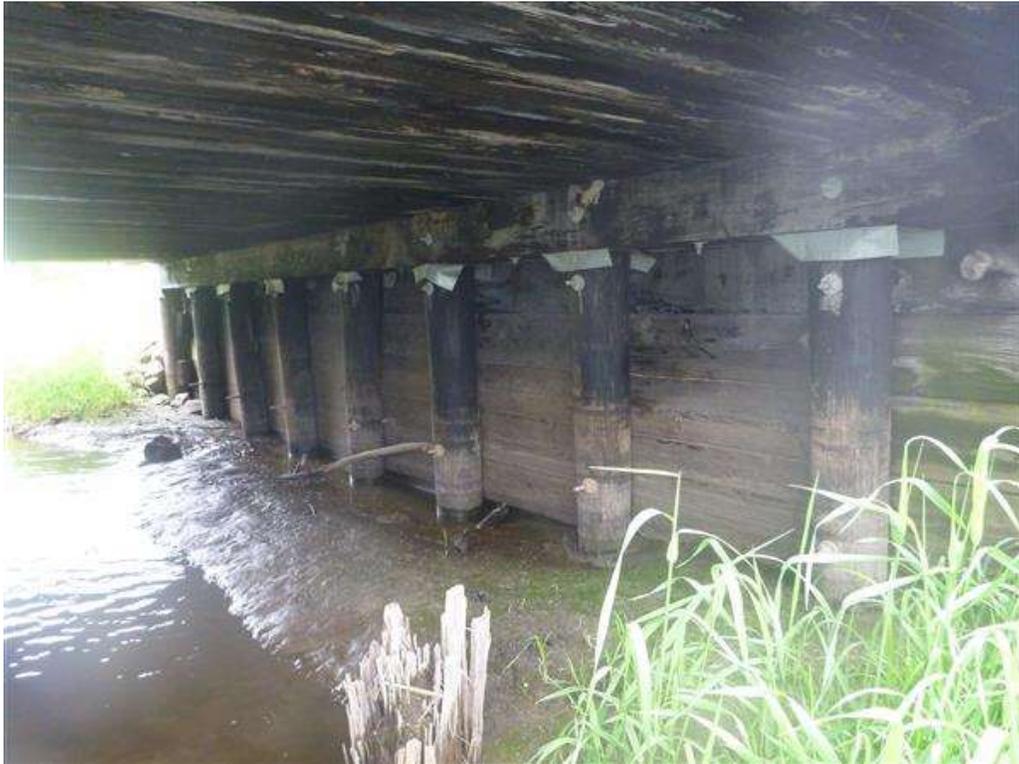
Photo 4 - South Abutment, Looking Southeast

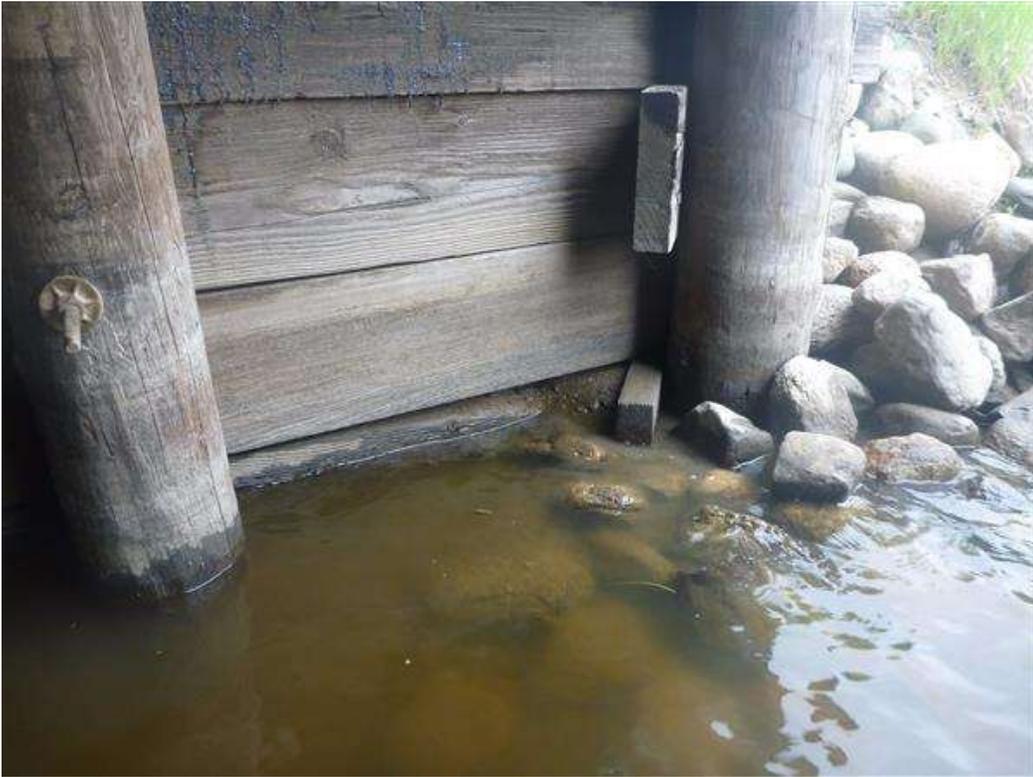
Photo 5 - Upstream End of North Abutment Backwall Gap, Looking Northeast

- 5 The bottom of the wall planking of the North Abutment was observed 1 foot below the waterline with undermining and 6 inches of probe rod penetration into the backfill.

(A) Monitor the areas of potential backfill loss at the North Abutment, and if it progresses repairs may be necessary. (B) Reinspect the submerged substructure units at the normal maximum recommended (NBIS) interval of sixty (60) months.

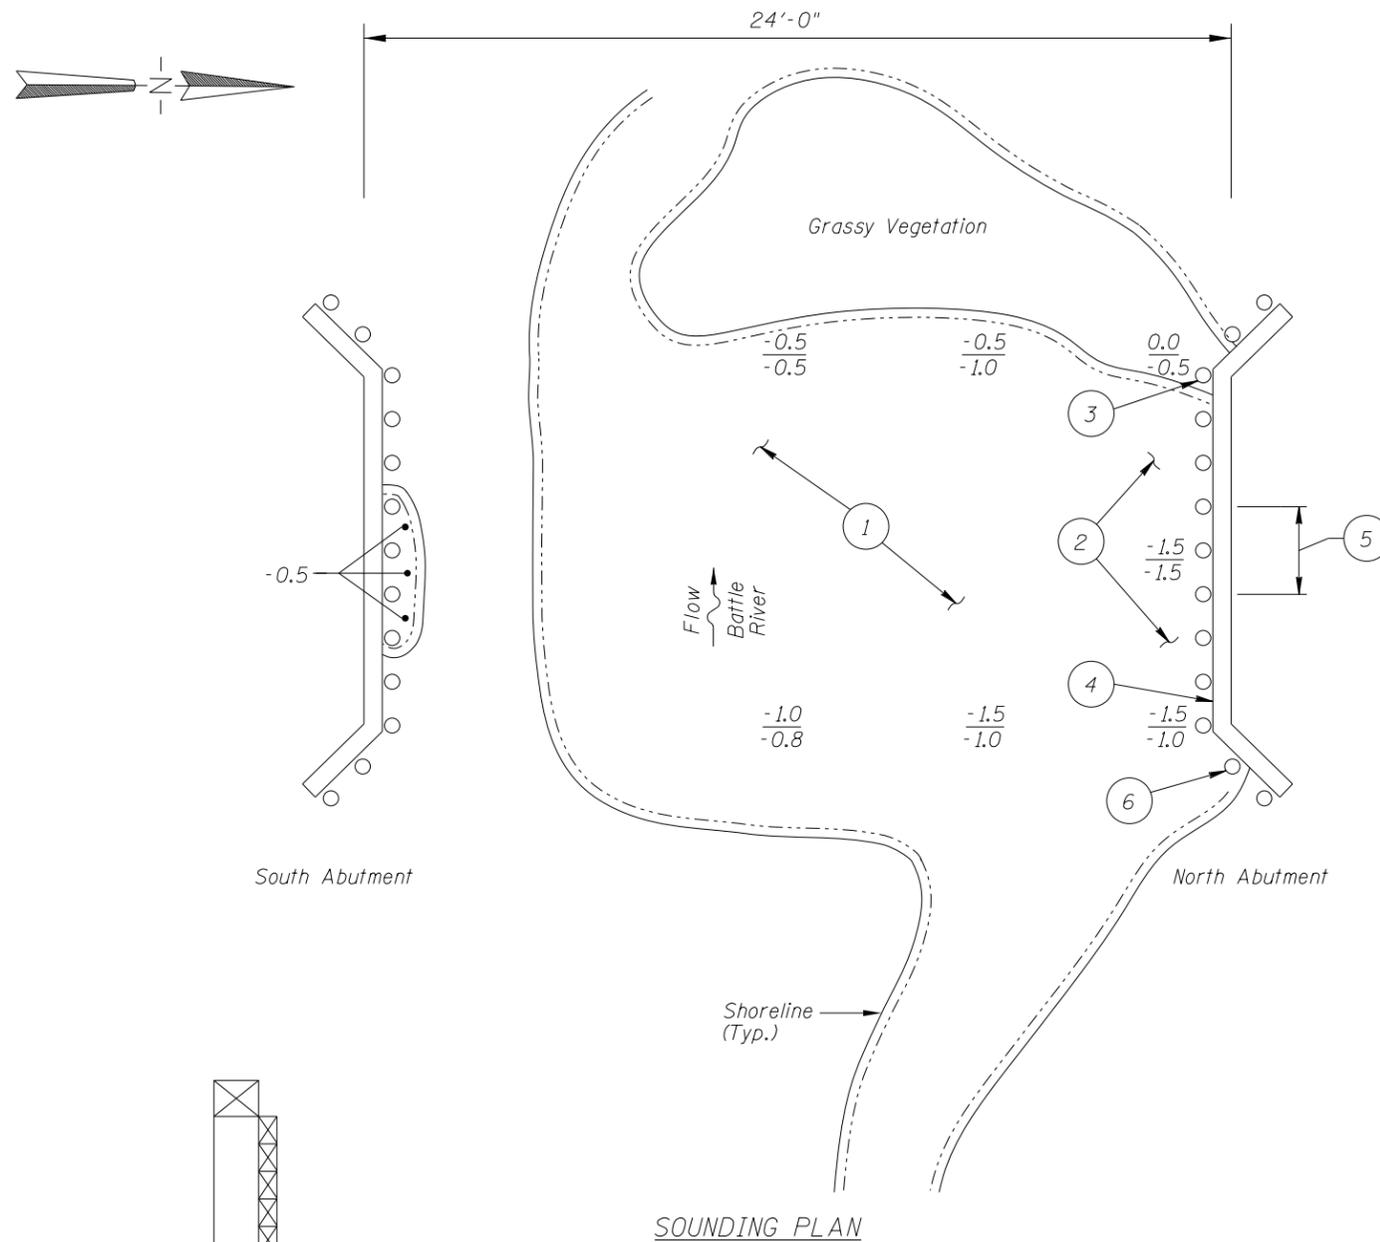
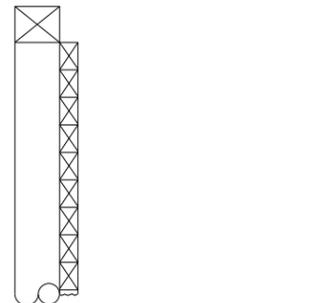
TYPICAL END VIEW OF NORTH ABUTMENT

- 1 The channel bottom material primarily consisted of silty clay and sand allowing up to 1.5 feet of probe rod penetration.
- 2 The channel bottom material at the North Abutment consisted of soft silt over firm clay and gravel allowing minimal probe rod penetration.

- 3 Split in pile at North Abutment, at the top 3 feet of the pile, 1/2 inch wide with 2 inches of penetration.
- 4 Wood splintered off breastwall plank of the North Abutment at the waterline, 2 inches wide by 3 feet long, with 6 inches of penetration. There appeared to be some gravel escaping from behind the breastwall.

- 6 A 1/4 inch split, with up to 3 inches of penetration, was observed from the top of the pile down 2.5 feet on the second pile from the east end of the northeast wingwall.
