2017 UNDERWATER BRIDGE INSPECTION REPORT

BRIDGE # 36514 CSAH 18 over RAPID RIVER

DISTRICT: District 1 COUNTY: Koochiching CITY/TOWNSHIP: T - 160 R - 29
STATE: Minnesota

Date of Inspection: 08/03/2016

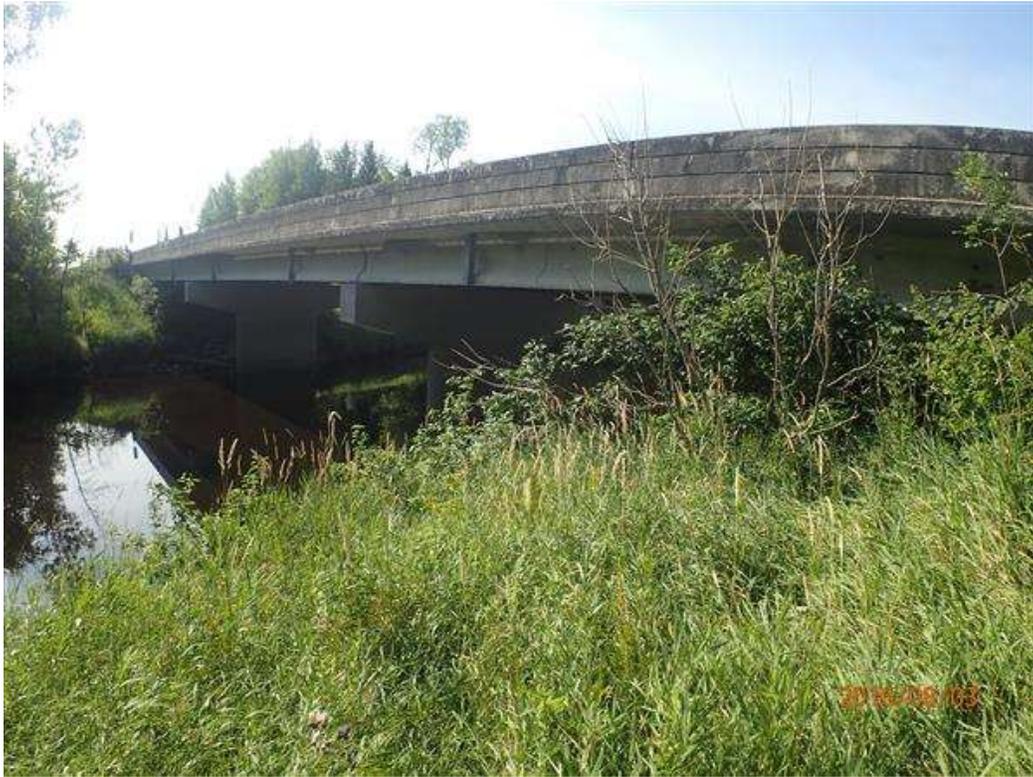
Photo 1 - Overall looking southeast.

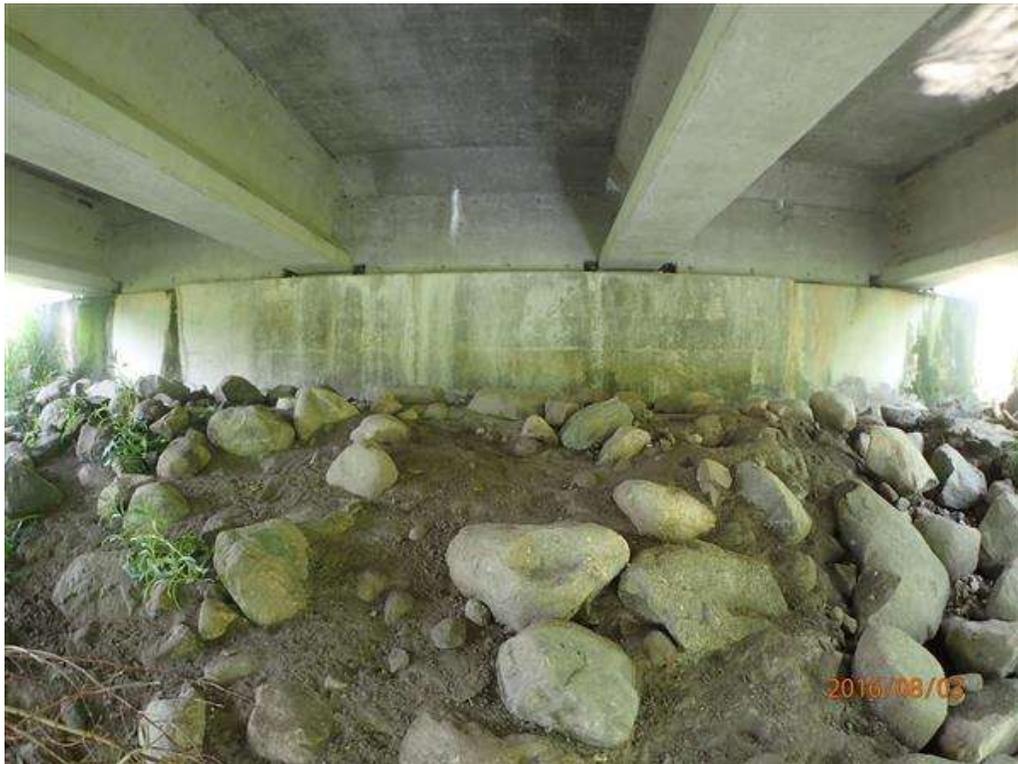
Photo 2 - West Abutment looking west.

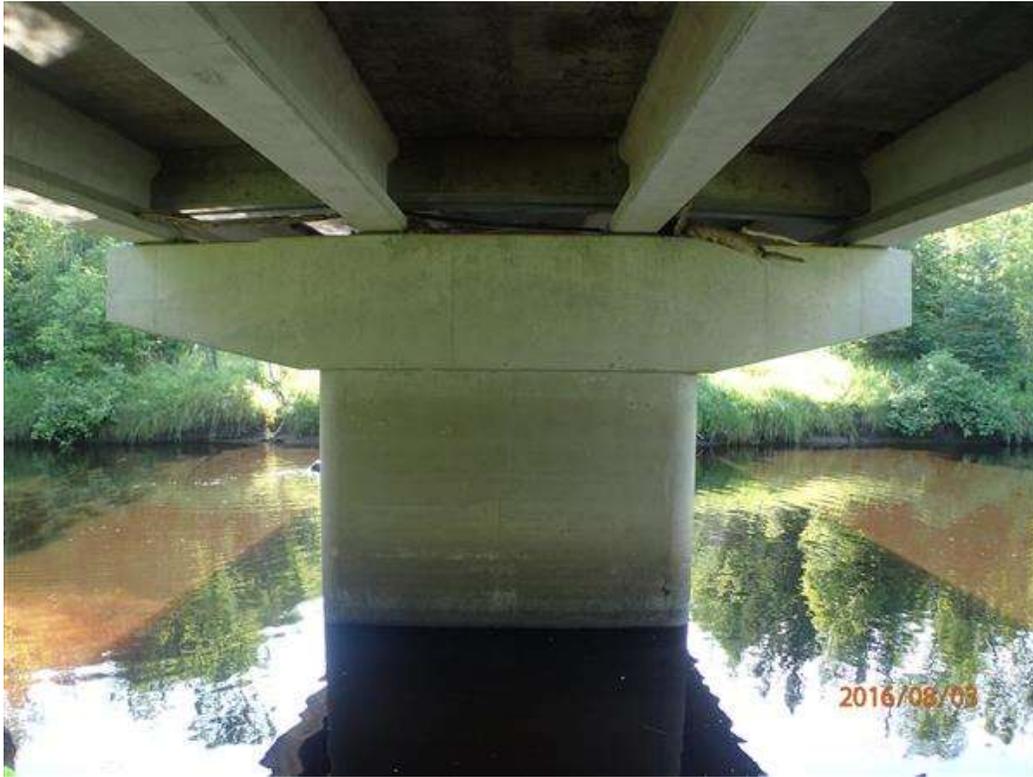
Photo 3 - Pier 1 looking east.

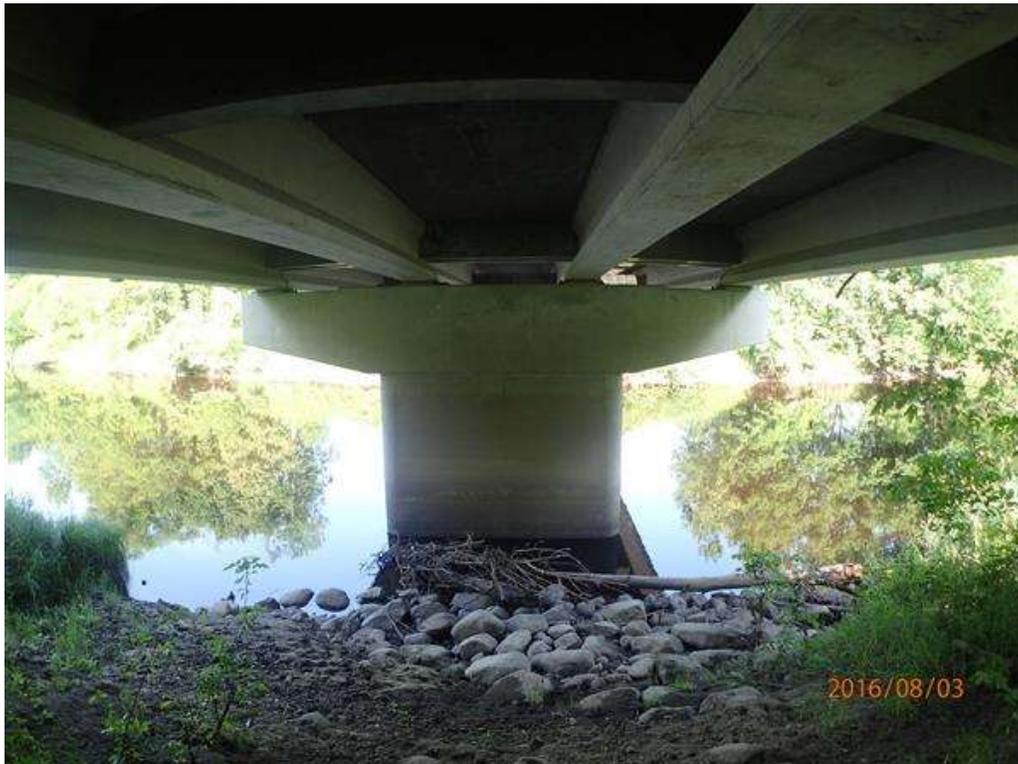
The substructure units inspected at Bridge No. 36514, Piers 1 and 2, were generally in good condition with no defects of structural significance observed. An accumulation of timber debris were observed at the upstream noses and east face of Pier 2. The channel bottom appeared to be in stable condition with no evidence of significant scour.

Photo 4 - Pier 2 looking west.

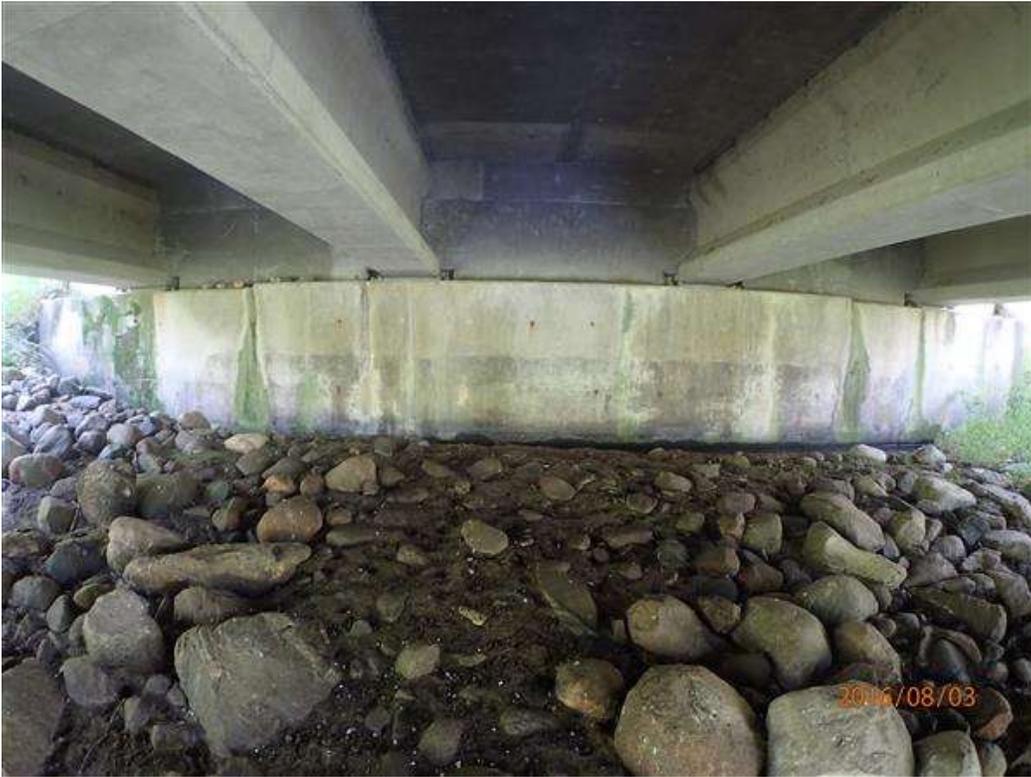
Photo 5 - East Abutment looking east.

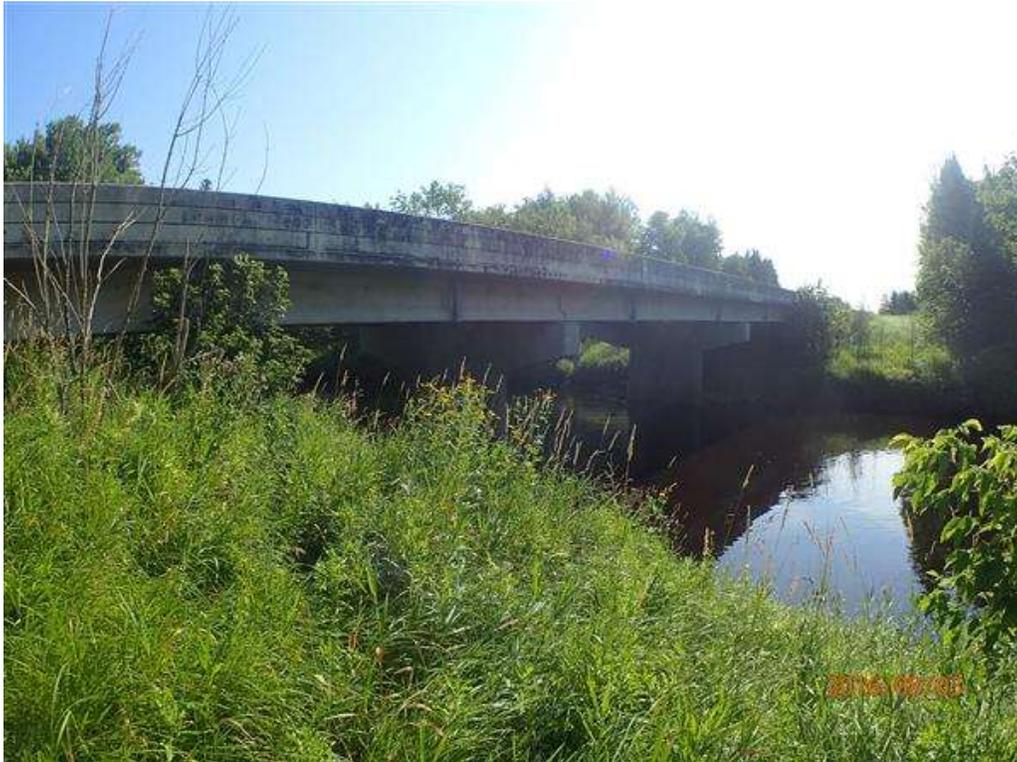
Photo 6 - Overall looking northeast.

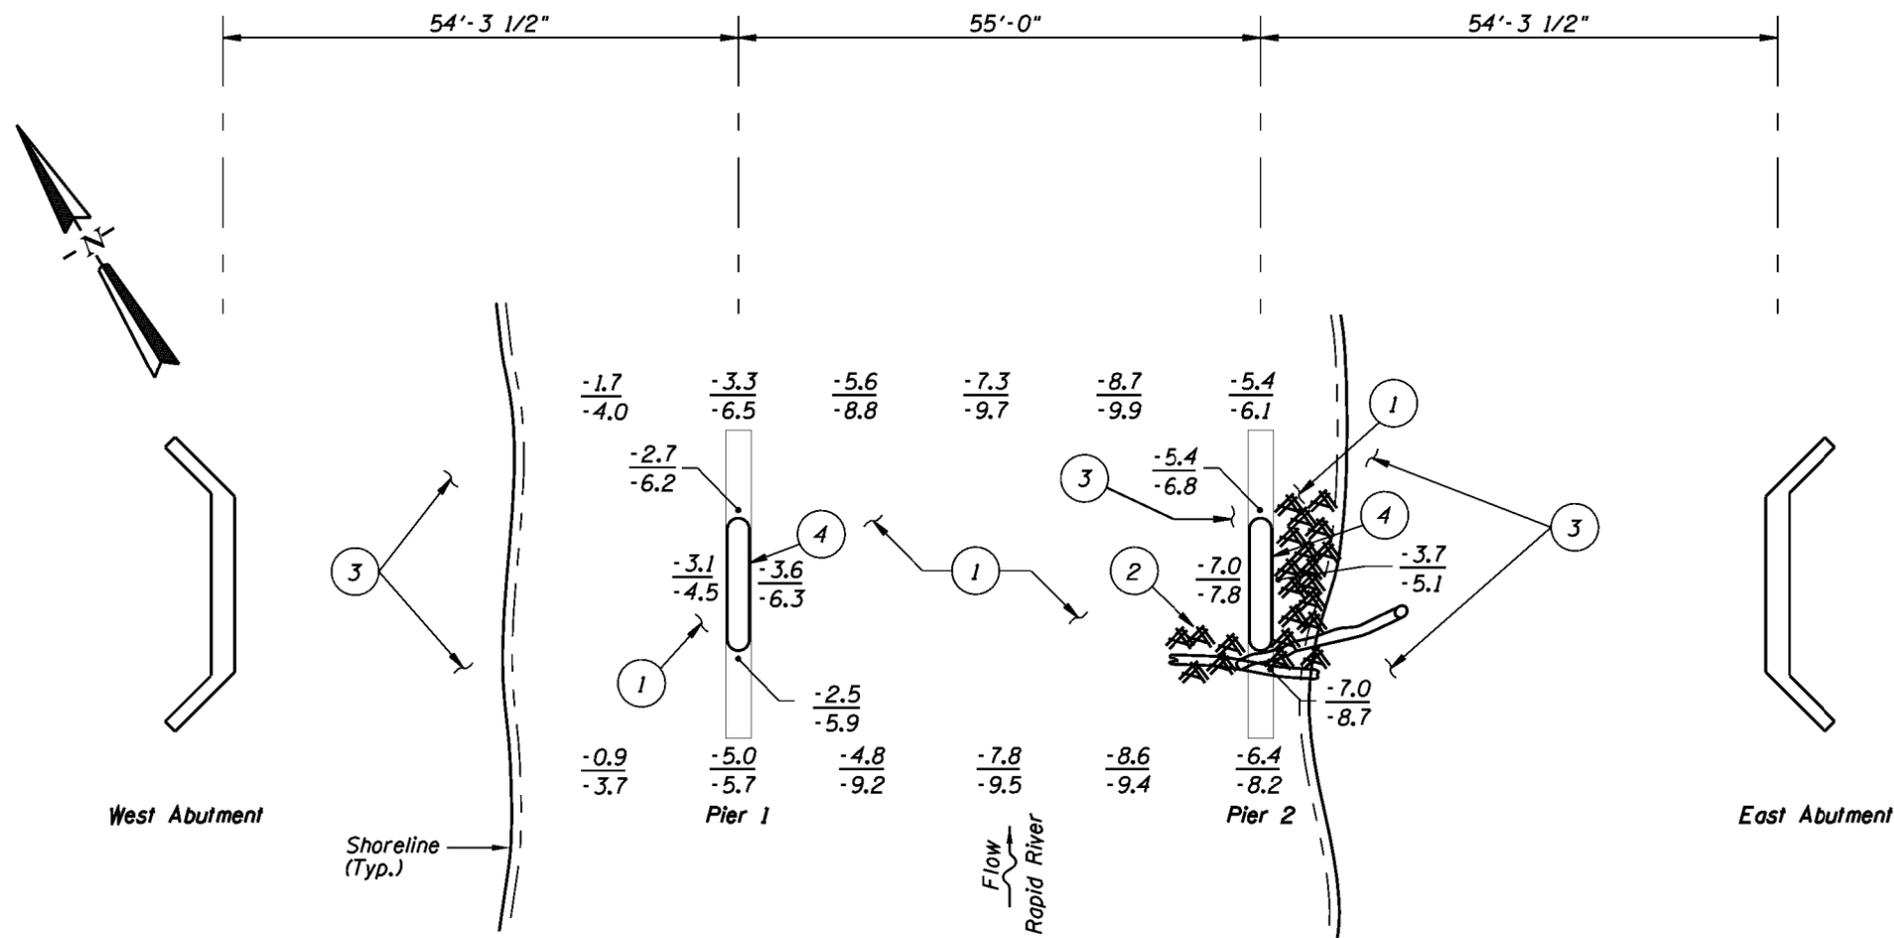
SOUNDING PLAN

- 1 The channel material consisted of sand and gravel with some silt and up to 6 inches of probe rod penetration.
- 2 A moderate accumulation of timber debris was observed, consisting of numerous logs and tree trunks measuring up to 1 foot in diameter lying across the upstream nose and extending to the easterly shoreline. Debris extended from channel bottom up 3 feet at Pier 2.
- 3 The shoreline consisted of up to 2 feet diameter riprap.
- 4 Light scaling from 3 feet above the waterline to the channel bottom with 1/8 inch typical to 1/4 inch maximum penetrations was observed along the entire perimeter of Pier 1 and Pier 2.

- (A) Reinspect the submerged substructure units at the normal maximum recommended (NBIS) interval of sixty (60) months.
