# 2016 UNDERWATER BRIDGE INSPECTION REPORT

## BRIDGE # 36517 CSAH 75 over LITTLE FORK RIVER

Date of Inspection: 06/01/2016

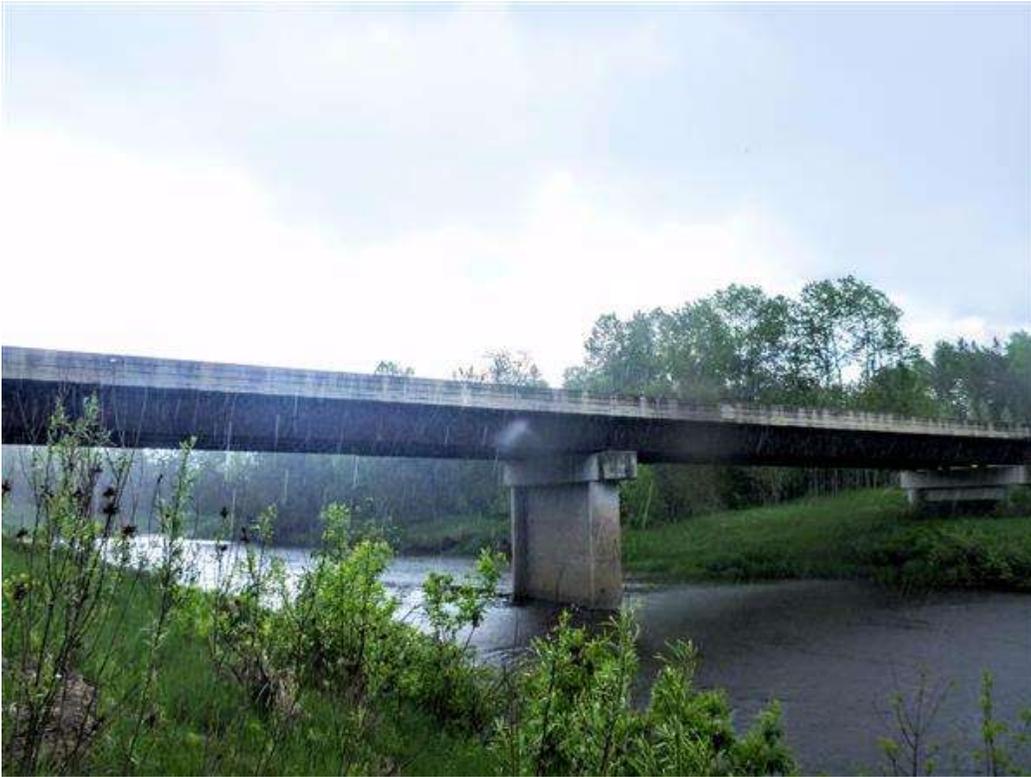
Photo 1 - Upstream Fascia, Looking Southeast

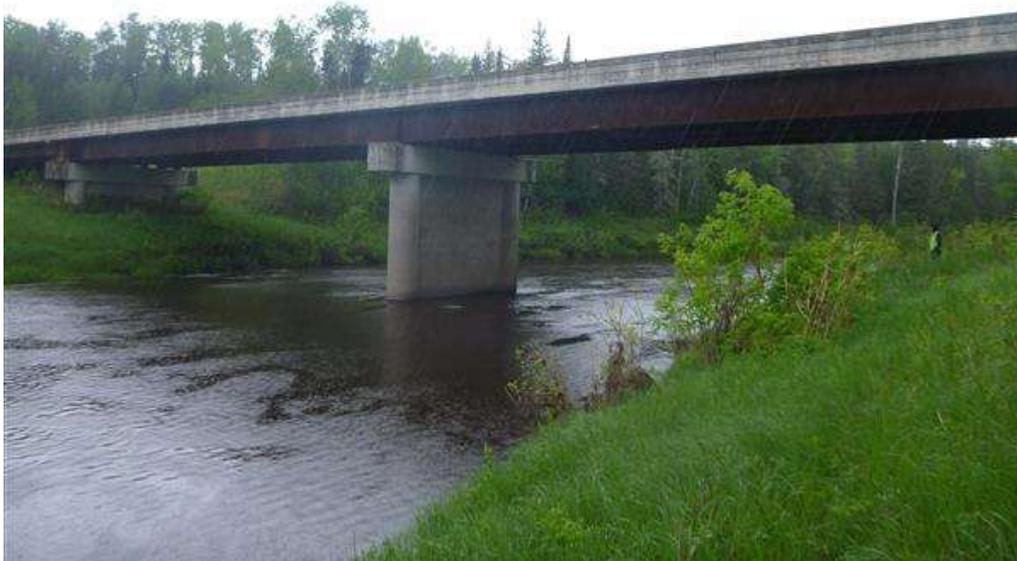
Photo 2 - Downstream Fascia, Looking Southwest

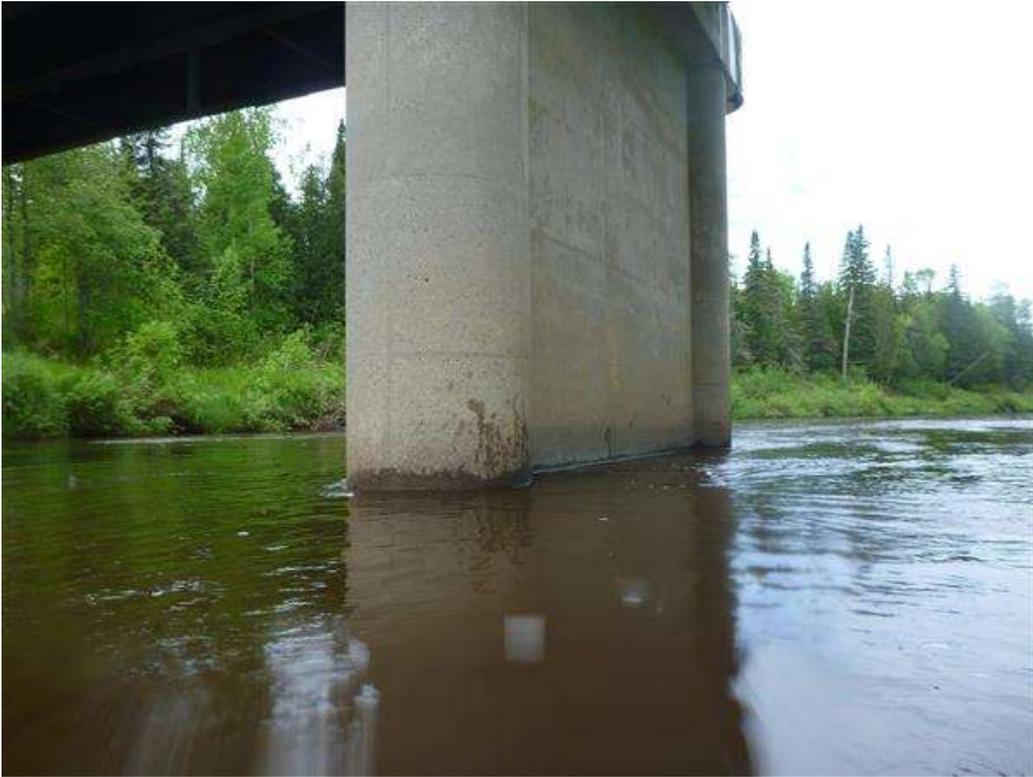
The substructure unit inspected at Bridge No. 36517, Pier 2, was found to be in good condition below water with no defects of structural significance. The channel bottom around Pier 2 was firm in makeup and appeared stable with no significant changes since the last inspection. The top of the footing was exposed at the upstream nose of the pier with no observed vertical exposure.

Photo 3 - Pier 2, Looking Southwest

(A) Reinspect the submerged substructure units at the normal maximum recommended (NBIS) interval of sixty (60) months

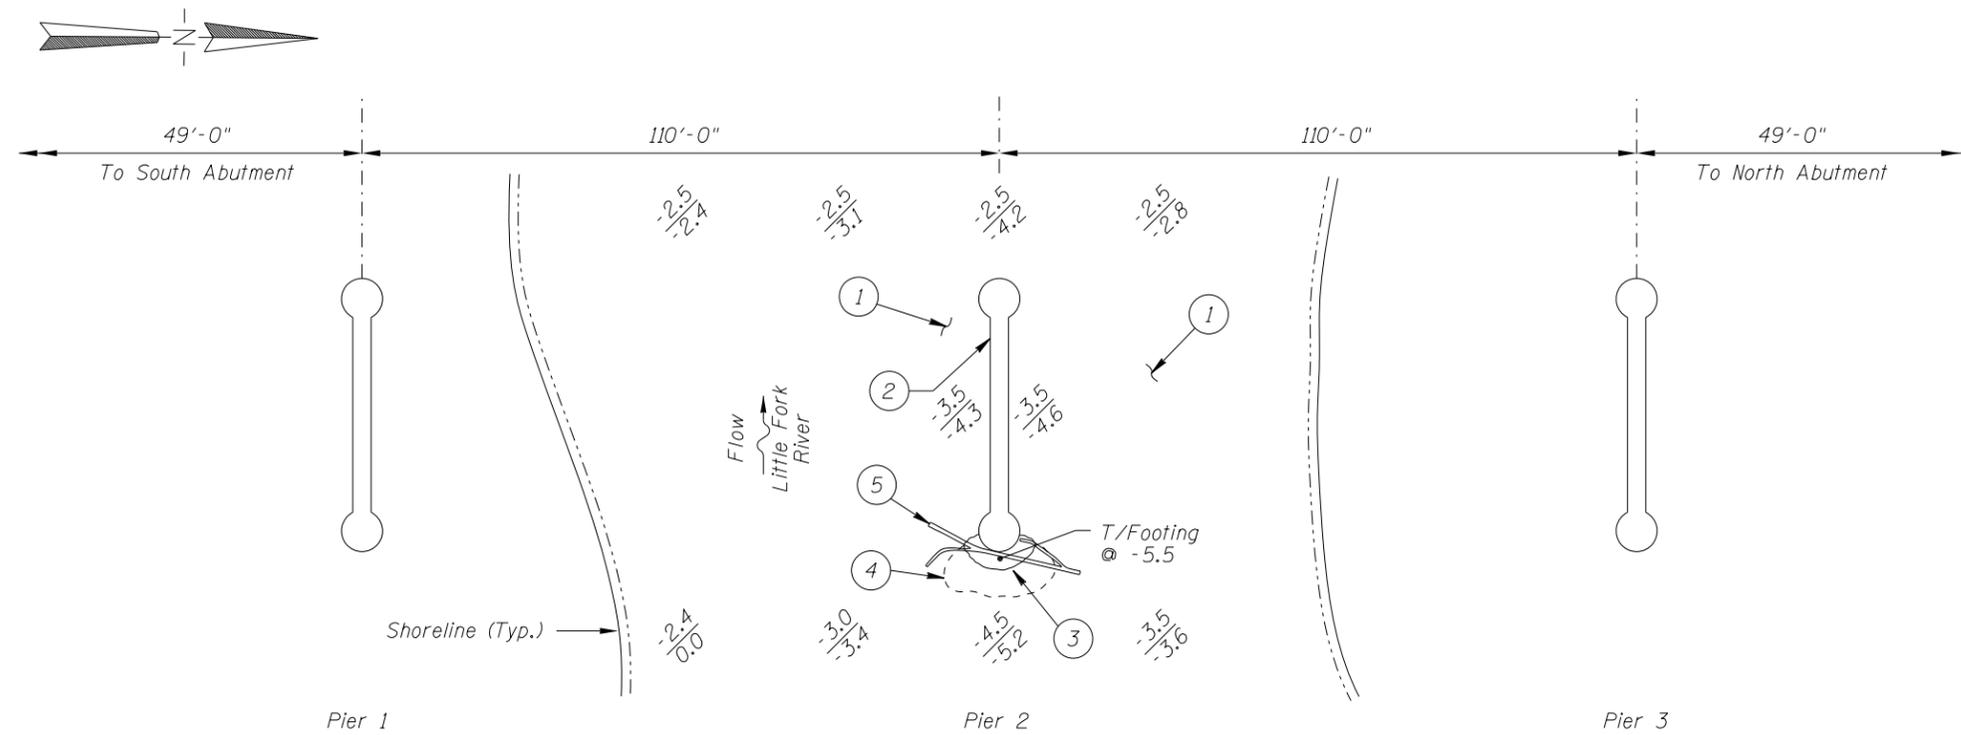
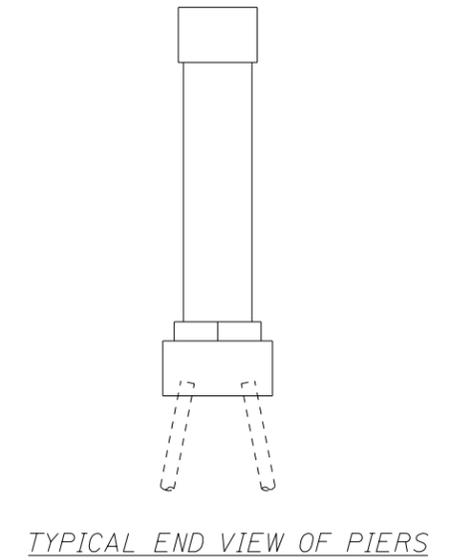
SOUNDING PLAN

- ① The channel bottom material consisted of a firm, sandy gravel and riprap up to 1-foot-diameter allowing up to 1 inch probe rod penetration.
- ② A band of minor scaling was present 2 feet above the waterline to 3 feet below water with 1/4 inch maximum penetration.
- ③ The footing was exposed at the upstream nose of the pier approximately as shown. The exposure was only the top of the footing with no vertical exposure.
- ④ A minor scour depression was present around the upstream nose with an approximate 10-foot-radius and 1 foot depth.
- ⑤ A 6-inch-diameter tree branch was present across the upstream nose of the pier.
