2017 UNDERWATER BRIDGE INSPECTION REPORT

BRIDGE # 58525 CSAH 46 over KETTLE RIVER

Date of Inspection: 09/23/2016

Contractor: Collins Engineers, Inc.

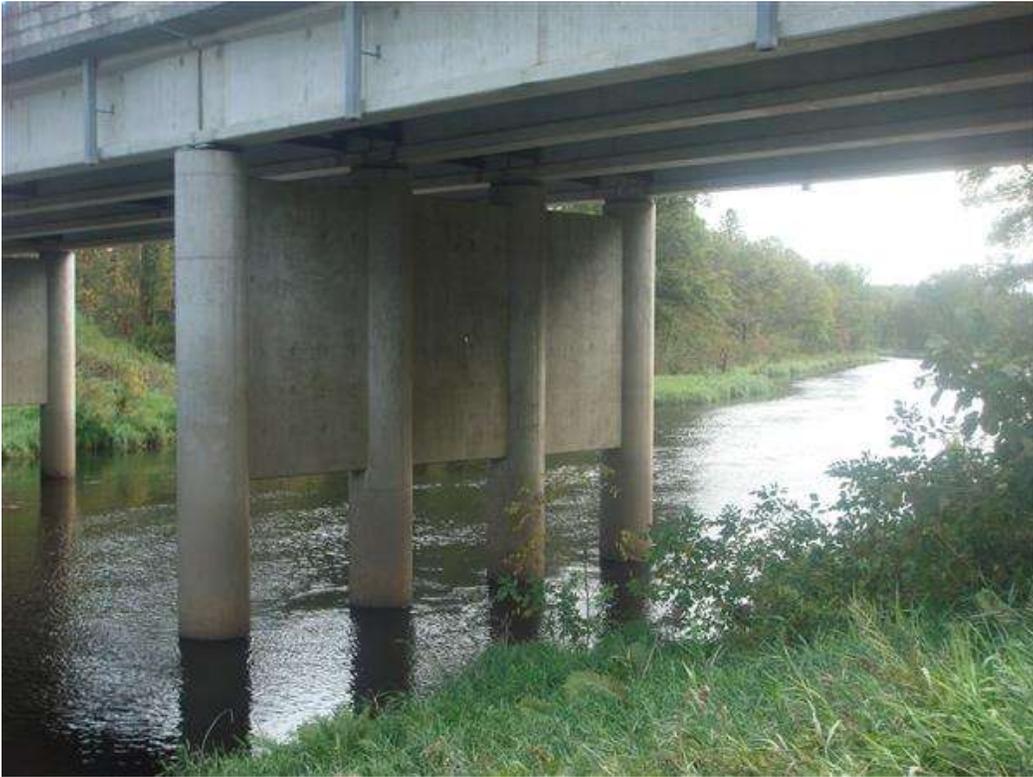
- A. The concrete columns exhibited moderate scaling from 1.5 foot below the waterline to 2.5 feet below the waterline with up to 1/2 inch penetrations.

- B. A scour depression, measuring 3 feet in radius and 1 foot deep, was observed at the upstream end of Pier 1. The scour depression has exposed the top of the footing at the upstream end of the pier. No vertical footing exposure was present.

- H. A 10 foot long log, up to 9 inches in diameter, was observed at the upstream nose of Pier 1 approximately 1 foot below the waterline.

Photo 3 - View of Pier 1, Looking Northeast

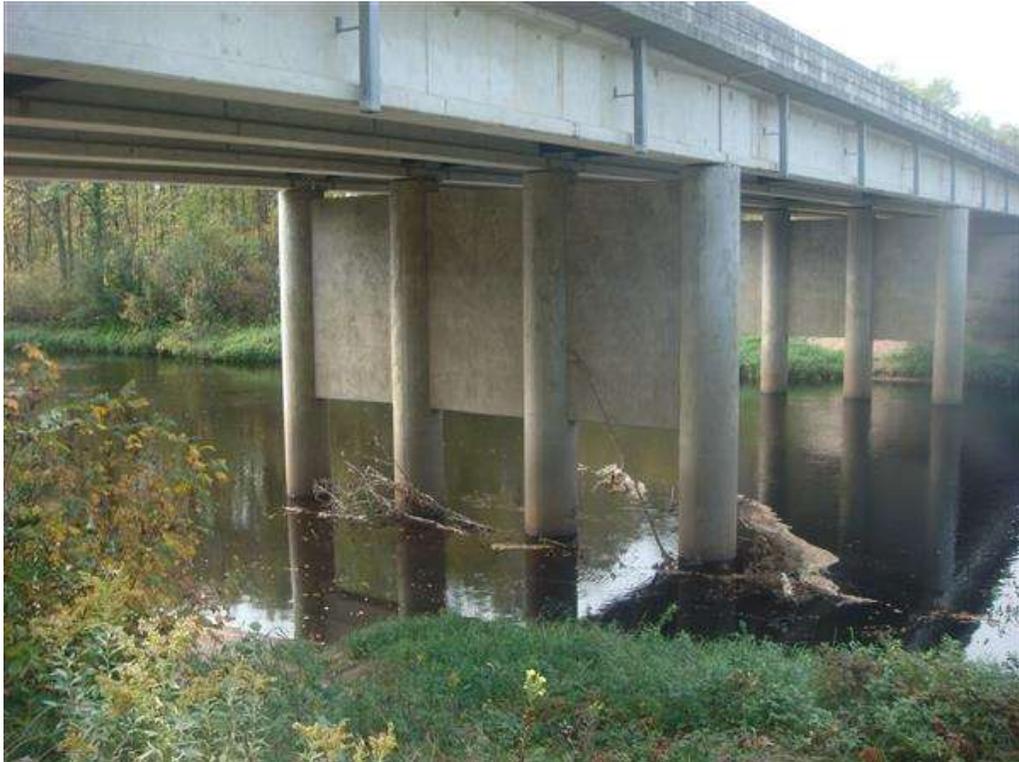
- C. The channel bottom consisted of sandy gravel with cobbles up to 6 inches in diameter allowing minimal probe rod penetration.
- D. An area of poorly consolidated concrete was observed 3 feet above the waterline and measured 2 foot high by 1 foot wide with up to 1.5 inches of penetration at both upstream and downstream sides of the 2nd column from upstream end of Pier 2.

- F. An area of poorly consolidated concrete and section loss was observed at waterline, 9 inches in diameter with 3 inch maximum penetration, at the downstream side of second column from upstream end of Pier 2. Also at waterline, an area of poorly consolidated concrete and section loss, 1 foot high by 2.5 feet wide with 2 inch maximum penetration, was observed at the upstream side of the second column from upstream end of Pier 2. Reinforcing steel was exposed and lightly corroded in both places.

- G. A moderate accumulation of timber debris, consisting of pieces up to 1 foot in diameter, was present from the channel bottom to 6 inches above the waterline at Pier 2. Debris was observed at the upstream nose and along both sides of Pier 2 and extended up to 40 feet off the nose and up to 10 feet off the west face.

Photo 4 - View of Pier 2, Looking Southwest

- (A) Remove timber debris accumulation at Pier 2. Removal of the timber debris will reduce excessive lateral loads on the pier, limit further debris accumulation, and reduce the likelihood of channel bottom degradation resulting from obstructed flow. Until the timber debris can be removed, monitor for any significant increases in accumulation.
- (B) Reinspect the submerged substructure units at the normal maximum recommended (NBIS) interval of sixty (60) months.

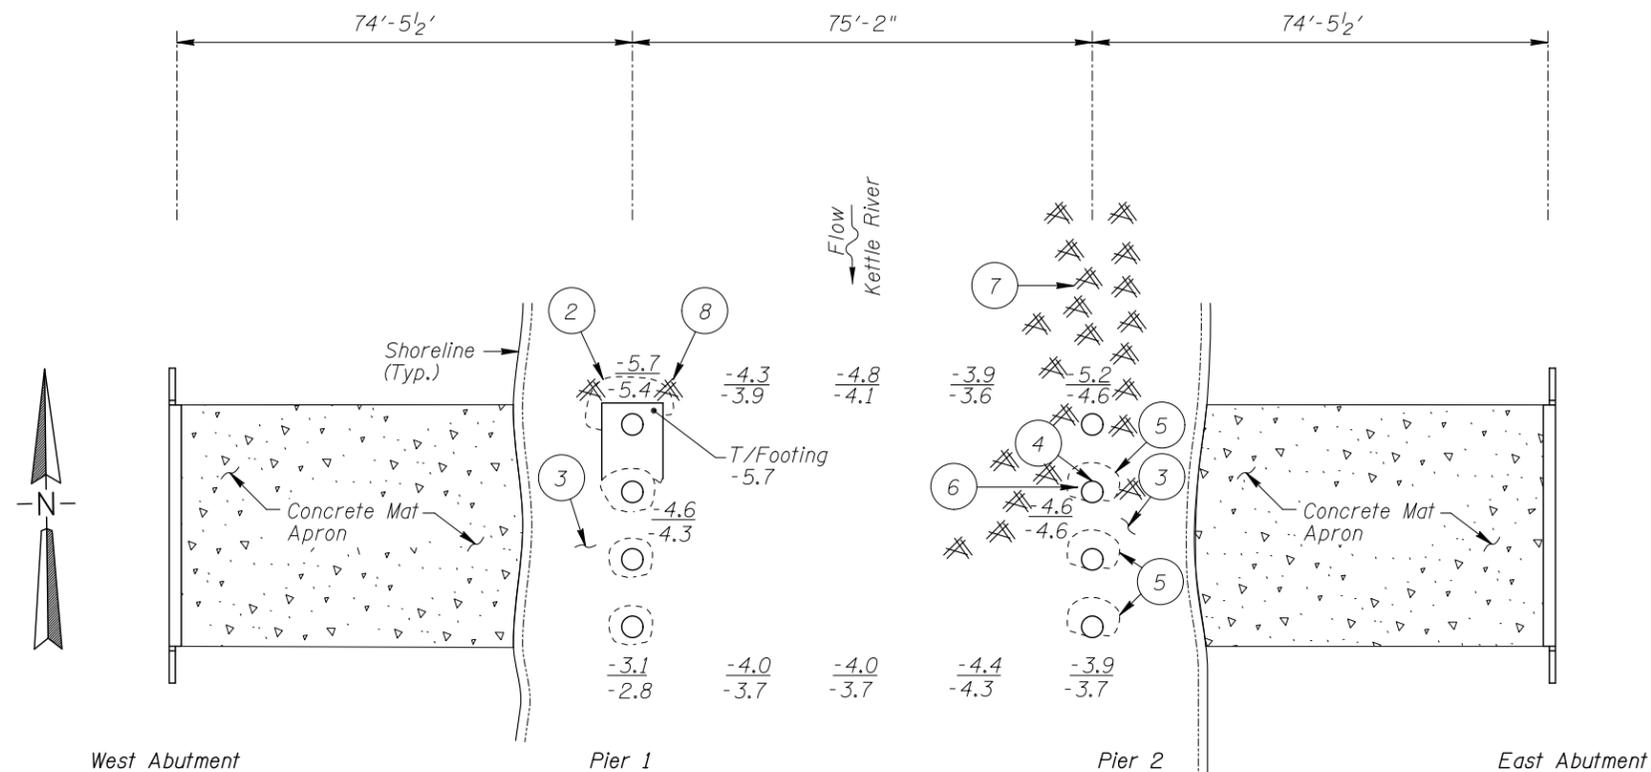
SOUNDING PLAN

- 1 The concrete columns exhibited moderate scaling from 1.5 foot below the waterline to 2.5 feet below the waterline with up to 1/2 inch penetrations.

- 2 A scour depression, measuring 3 feet in radius and 1 foot deep, was observed at the upstream end of Pier 1. The scour depression has exposed the top of the footing at the upstream end of the pier. No vertical footing exposure present.

- 3 The channel bottom consisted of sandy gravel with cobbles up to 6 inches in diameter allowing minimal probe rod penetration.
- 4 An area of poorly consolidated concrete was observed 3 feet above the waterline and measured 2 foot high by 1 foot wide with up to 1.5 inches of penetration at both upstream and downstream sides of the 2nd column from upstream end of Pier 2.

- 5 Scour depressions, measuring up to 2 feet in radius and up to 1 foot deep, were observed at each of the three downstream columns of Pier 1 and 2. The top of footing was exposed at the upstream side of the columns; 1 to 2 feet exposed horizontally. The localized scour pockets partially exposed the top of footing at each of the columns with no vertical face exposure detected.

- 6 An area of poorly consolidated concrete and section loss was observed at waterline, 9 inches in diameter with 3 inches maximum penetration, at the downstream side of second column from upstream end of Pier 2. Also at waterline, an area of poorly consolidated concrete and section loss, 1 foot high by 2.5 feet wide with 2 inch maximum penetration was observed at the upstream side of the second column from upstream end of Pier 2. Reinforcing steel was exposed and lightly corroded in both places.

- 7 A moderate accumulation of timber debris, consisting of pieces up to 1 foot in diameter, was present from the channel bottom to 6 inches above the waterline at Pier 2. Debris was observed at the upstream nose and along both sides of Pier 2 and extended up to 40 feet off the nose and up to 10 feet off the west face.

- 8 A 10 foot long log, up to 9 inches in diameter, was observed at the upstream nose of Pier 1 approximately 1 foot below the waterline.
