2016 UNDERWATER BRIDGE INSPECTION REPORT

BRIDGE # 69533 CSAH 5 over WHITEFACE RIVER

Date of Inspection: 06/24/2016

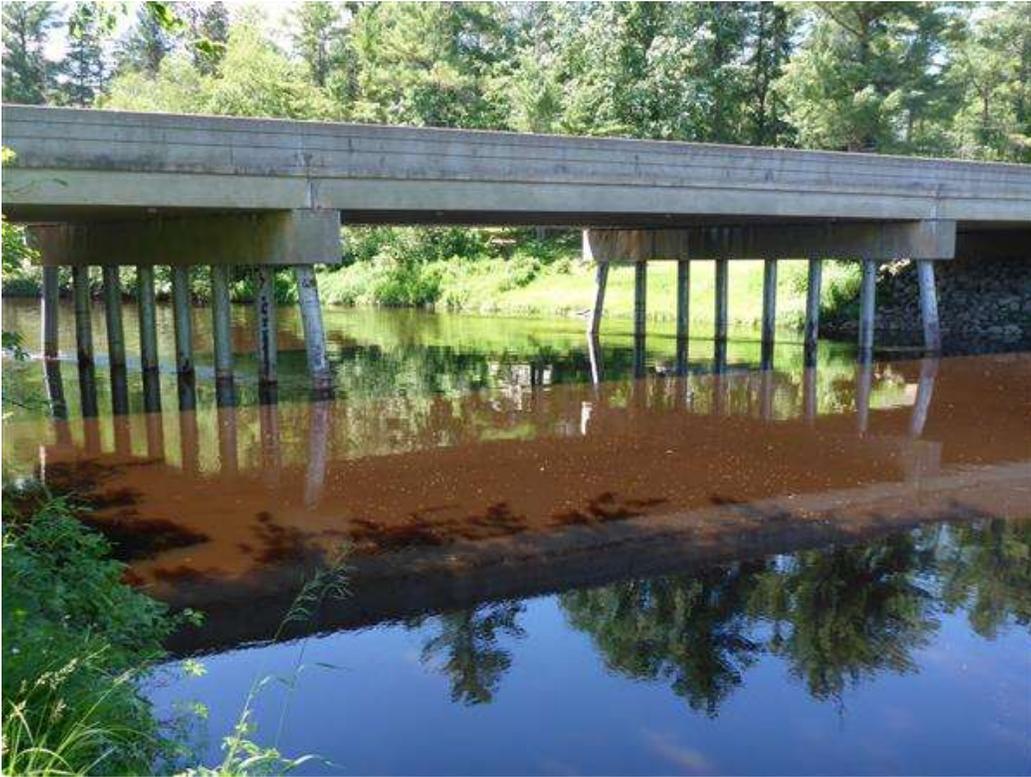
Photo 1 - Upstream Fascia, Looking Northwest

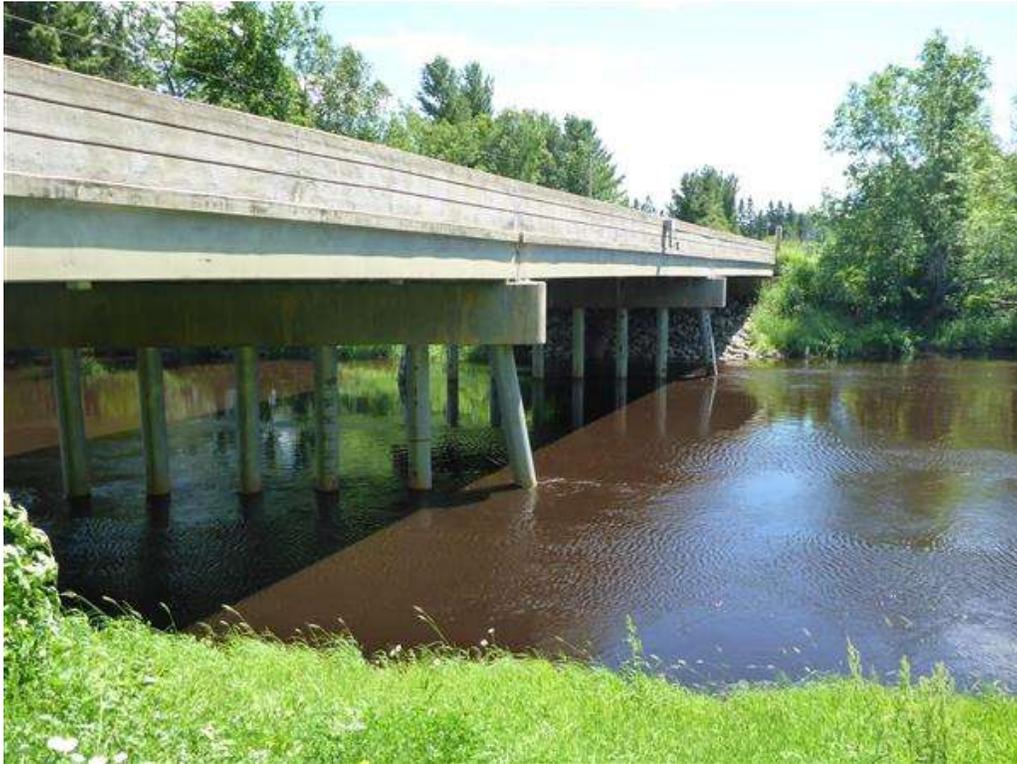
Photo 2 - Downstream Fascia, Looking Southeast

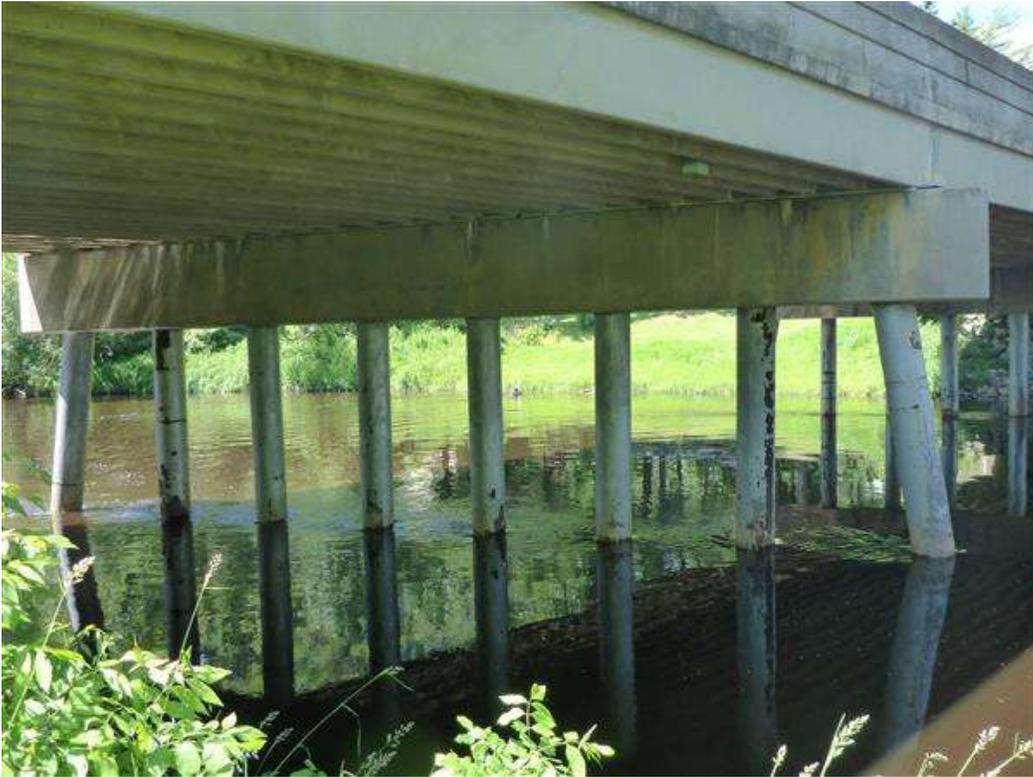
- (A) The channel bottom material consisted of sandy silt allowing up to 6 inches of probe rod penetration.
- (B) A light accumulation of timber debris, consisting of logs and branches 3 inch diameter and smaller, was observed around the perimeter of Pier 1 extending 5 feet off all faces and from the channel bottom to 2 feet below the waterline.
- (C) The steel piles typically exhibited pitting 1/4 inch diameter with up to 1/8 inch penetration observed from 2 feet below the waterline to the channel bottom.
- (D) The steel piles from 1 foot above the waterline to the pile cap exhibited coating failure on approximately 25% of the surface area. Surface corrosion was present with no appreciable loss of section. The battered piles exhibited more significant coating failure covering up to 50% of the surface area.

Photo 3 - Pier 1, Looking Northwest

- (A) Monitor the extent of surface corrosion during future underwater inspections.
- (B) Monitor the timber debris accumulation at the piers, during future inspections, and if found to be increasing to a more detrimental extent, removal operations may become warranted at that time.
- (C) Reinspect the submerged substructure units at the normal maximum recommended (NBIS) interval of sixty (60) months.

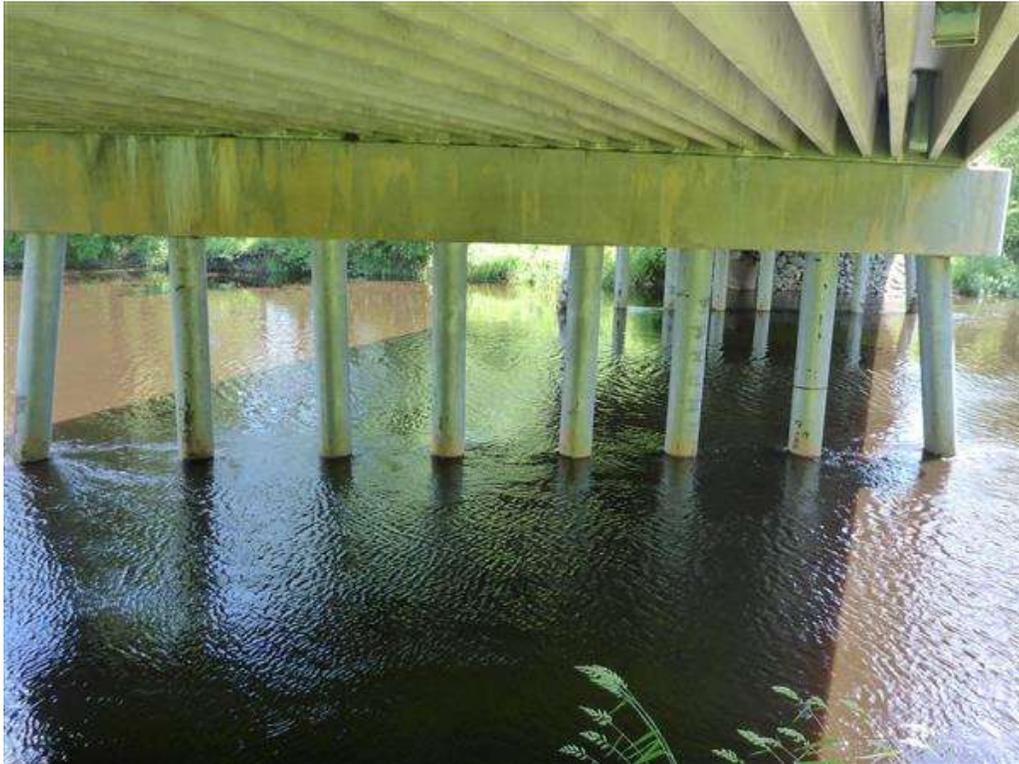
Photo 4 - Pier 2, Looking South

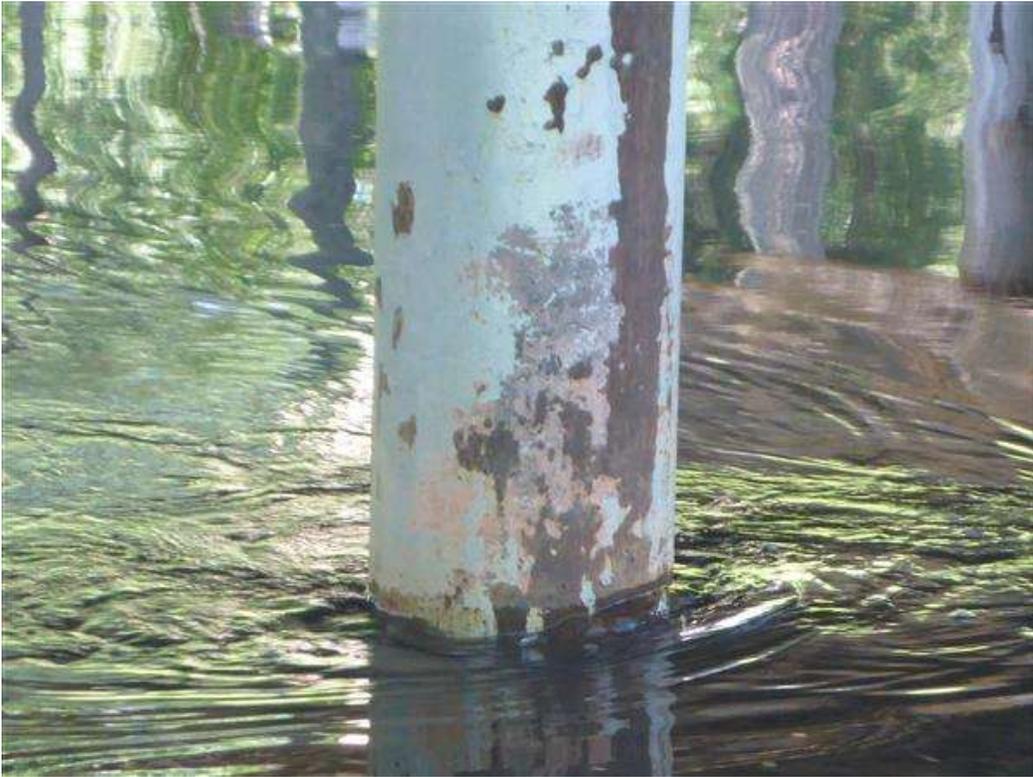
The substructure units inspected below water at Bridge No. 69533, Piers 1 and 2, were in satisfactory condition with no defects of structural significance. The steel piles typically exhibited minor surface corrosion with pitting and coating failure. Timber debris was present around the entire Pier 1, but was not restricting channel flow. Overall the structure condition was comparable to findings of the previous underwater inspection.

Photo 5 - Typical Steel Condition (Pier 1 Pile Shown), Looking North

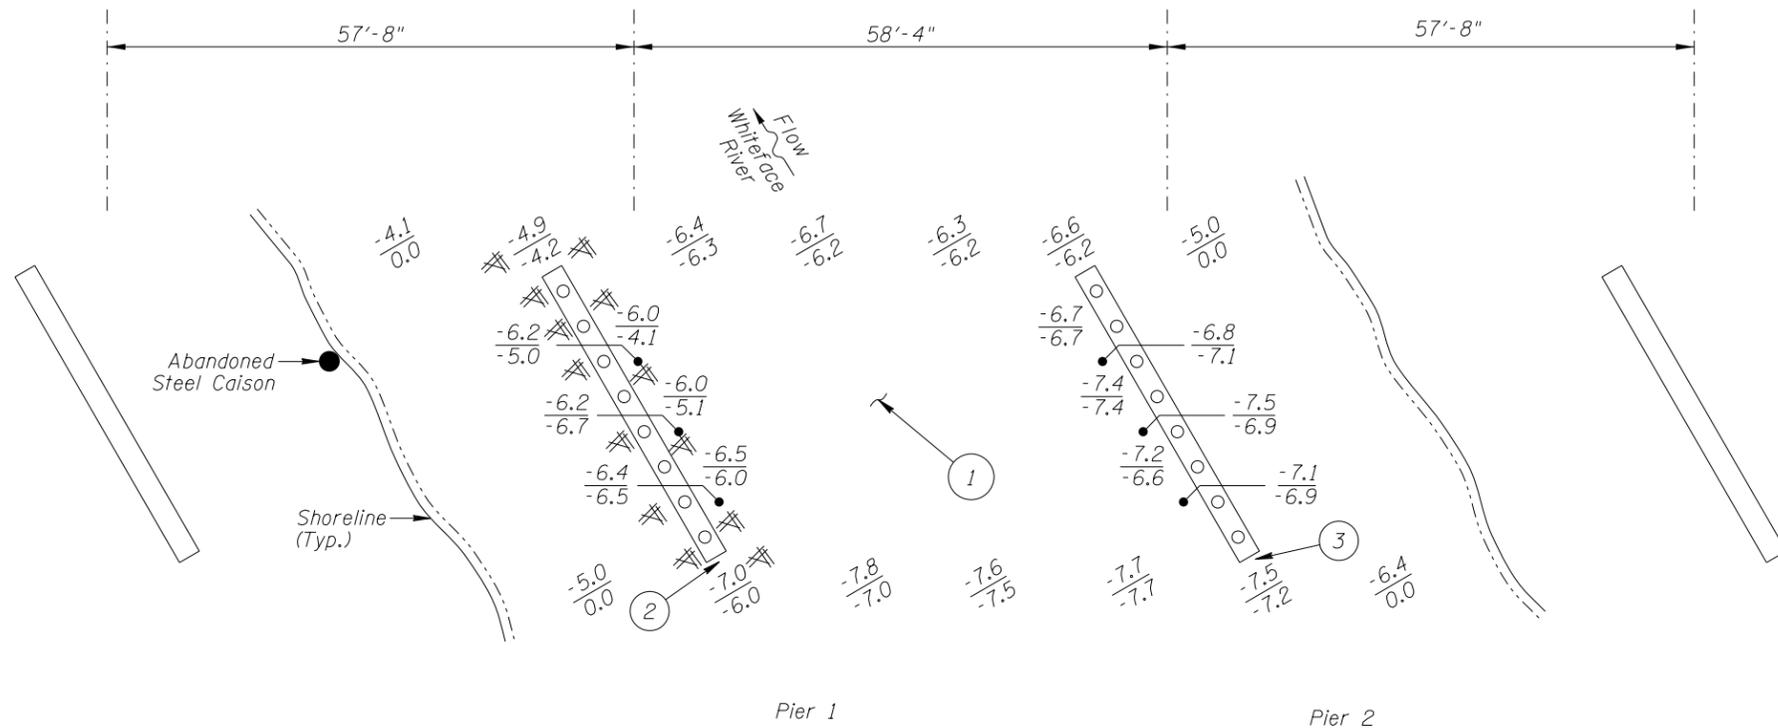
SOUNDING PLAN

- ① The channel bottom material consisted of sandy silt allowing up to 6 inches of probe rod penetration.
- ② A light accumulation of timber debris, consisting of branches 3 inch diameter and smaller, was observed around the perimeter of Pier 1 extending 5 feet off all faces and from the channel bottom to 2 feet below the waterline.
- ③ The steel piles typically exhibited pitting 1/4 inch dia. with up to 1/8 inch penetration observed from 2 feet below the waterline to the channel bottom.
- ④ The steel piles from 1 foot above the waterline to the cap exhibited coating failure on approximately 25% of the surface area. Surface corrosion was present with no appreciable loss of section. The battered piles exhibited more significant coating failure covering up to 50% of the surface area.
