2016 UNDERWATER BRIDGE INSPECTION REPORT

BRIDGE # 69536 TWP 415 over CHAN LAKE VERMILLION

Date of Inspection: 06/21/2016

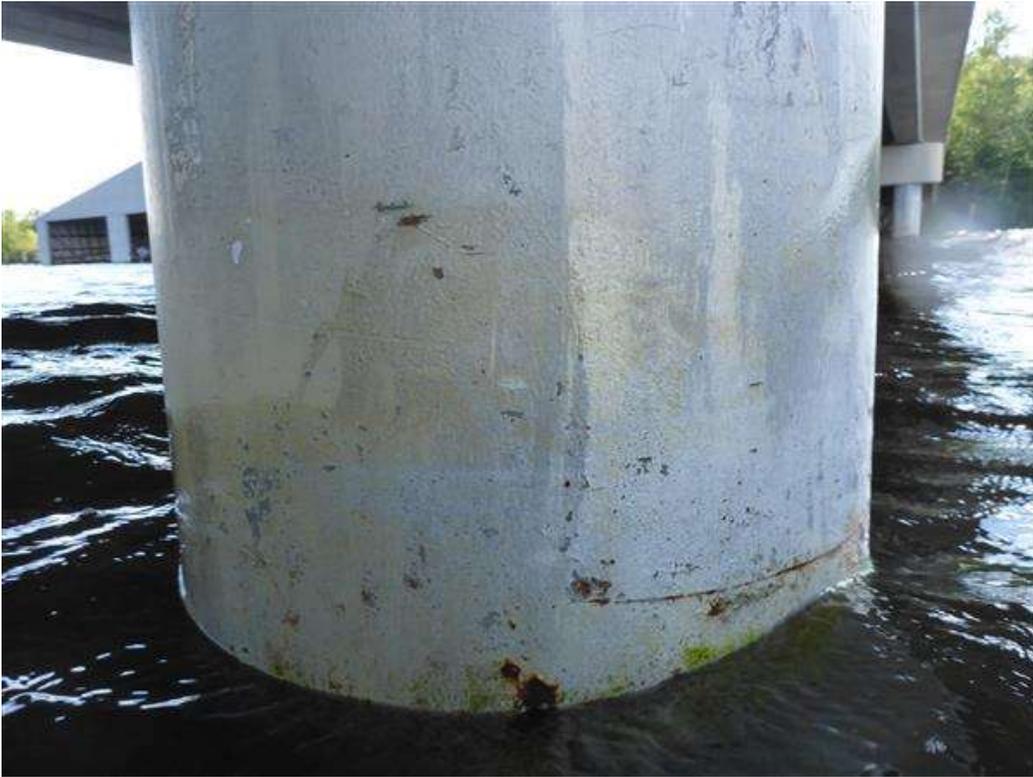
(C) From 1 foot below the waterline to the top of steel pipe piles there were small areas of coating failure with surface corrosion on the exposed steel. These areas had no measurable loss of section.

Photo 5 - Typical Steel Condition at Waterline (Bent 2 Shown), Looking West

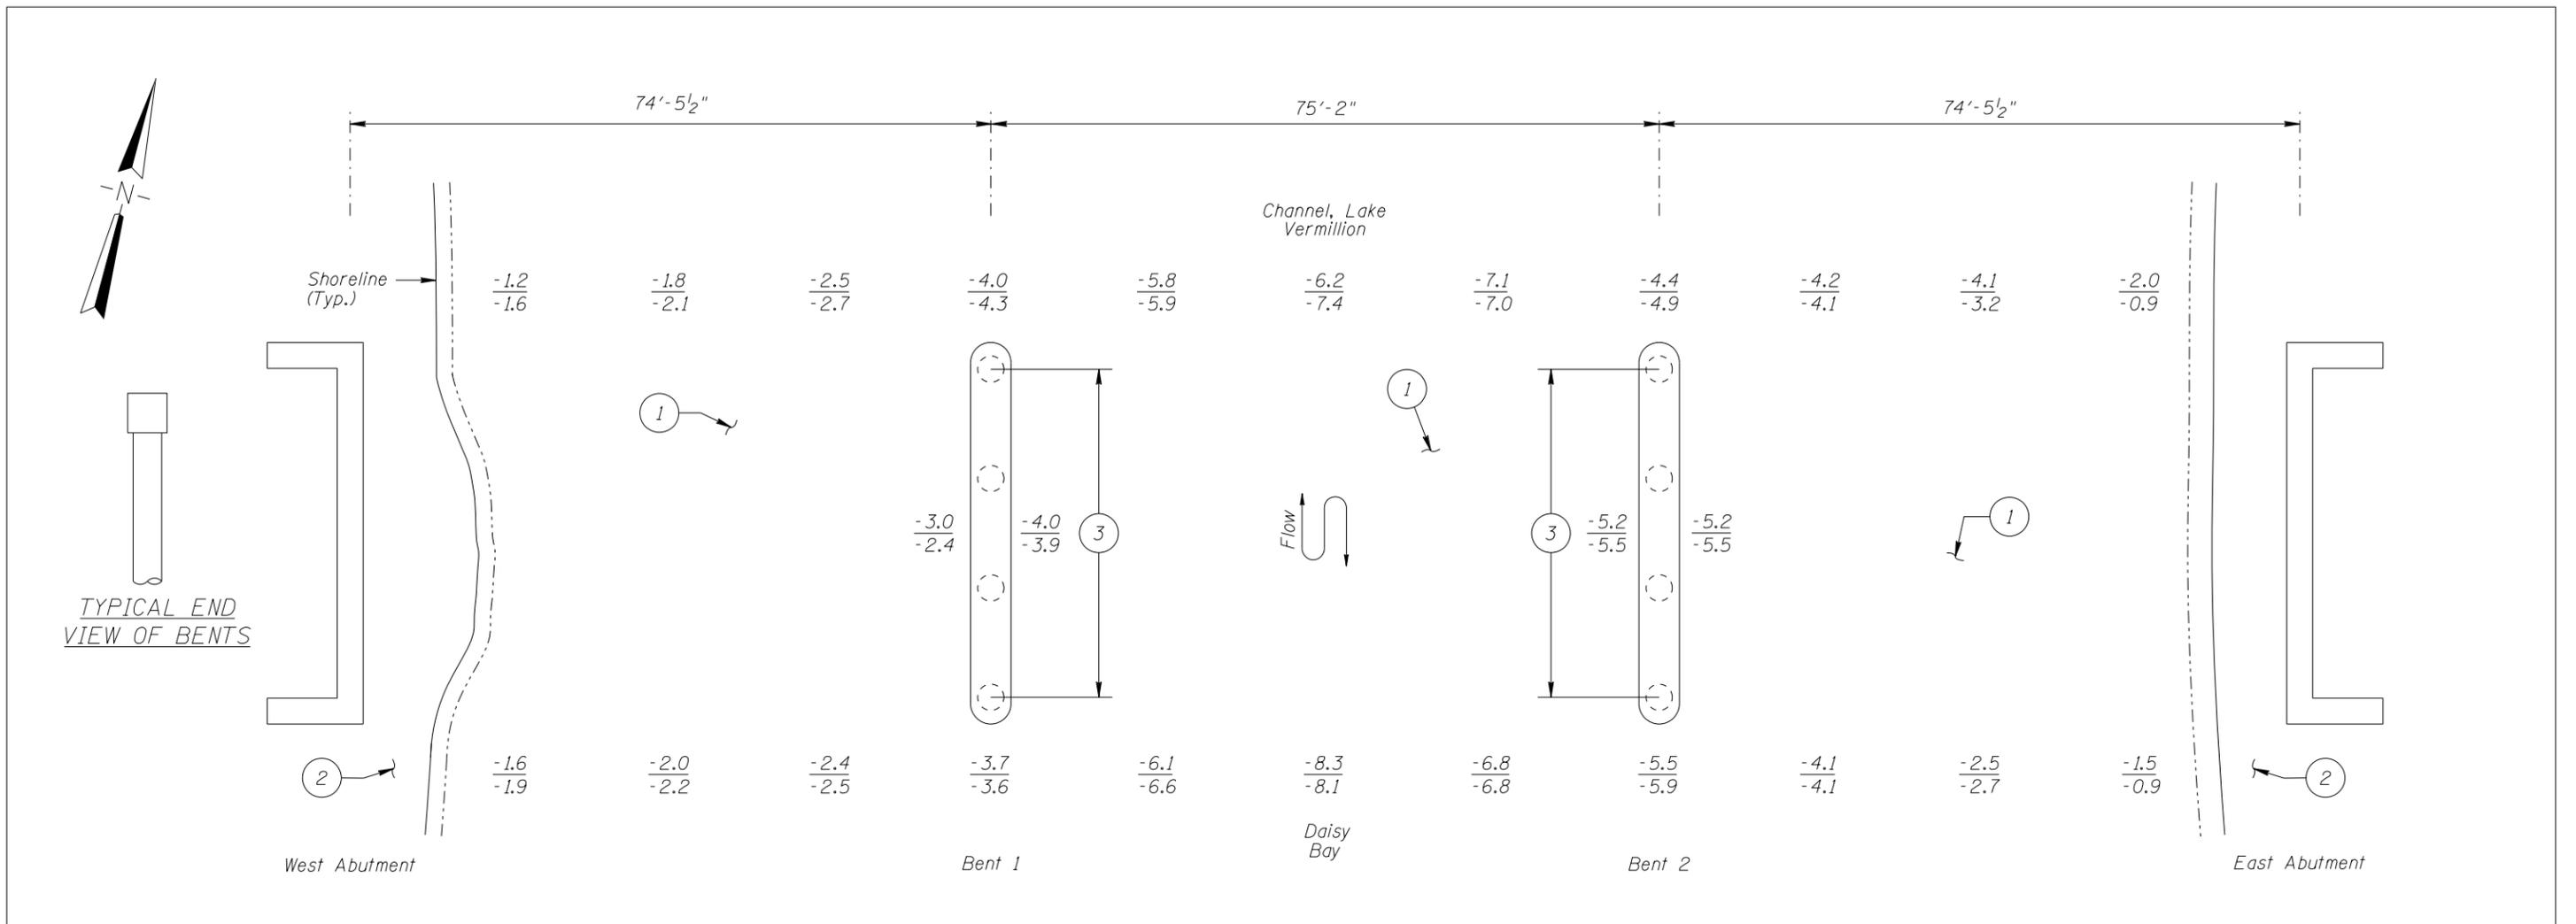
1. The channel bottom material typically consisted of firm sand with scattered rocks up to 18 inches in diameter allowing a maximum probe rod penetration of 3 inches.
2. Both shorelines were well protected with 12 inch to 3 foot diameter riprap material along the banks.
3. The steel pipe piles exhibited 50 to 75 percent coating loss from 1 foot below the waterline to the channel bottom with widespread nodular corrosion (50 percent coverage), ranging in size from 1 to 1.5 inches in diameter. Rust nodules exhibited typical pitting of 1/32 inch deep and a maximum of 1/16 inch deep.
4. From 1 foot below the waterline to the top of steel pipe piles there were random small areas of coating failure with surface corrosion on the exposed steel. These areas had no measurable loss of section.
