2017 UNDERWATER BRIDGE INSPECTION REPORT

BRIDGE # 69541 CSAH 52 over ST LOUIS RIVER

Date of Inspection: 09/13/2016

UNDERWATER INSPECTION

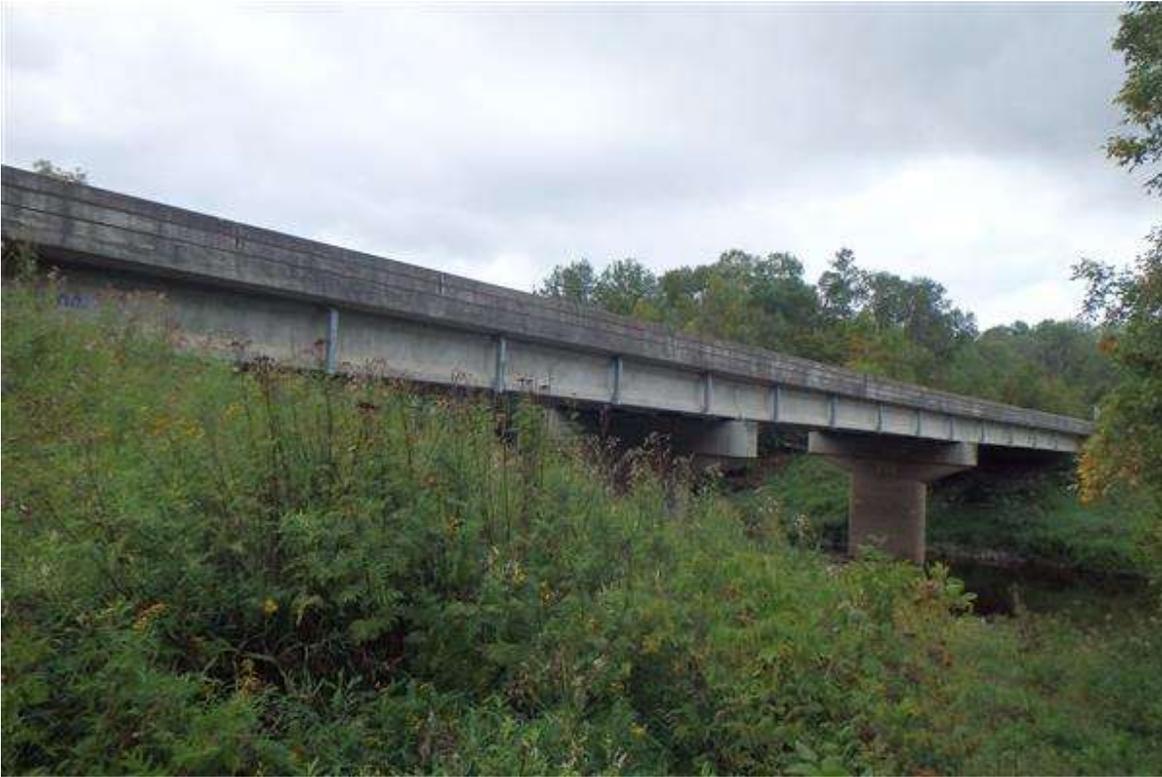
Photo 1 - Upstream Fascia, Looking Southwest

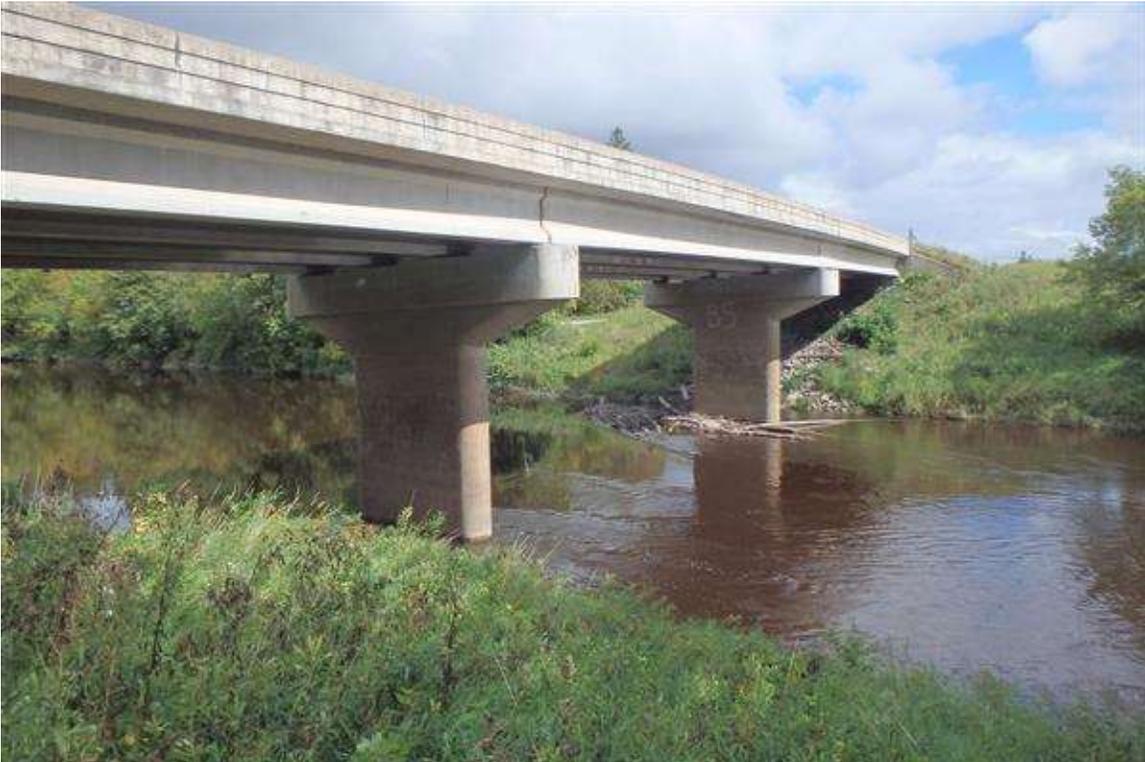
Photo 2 - Downstream Fascia, Looking Northeast

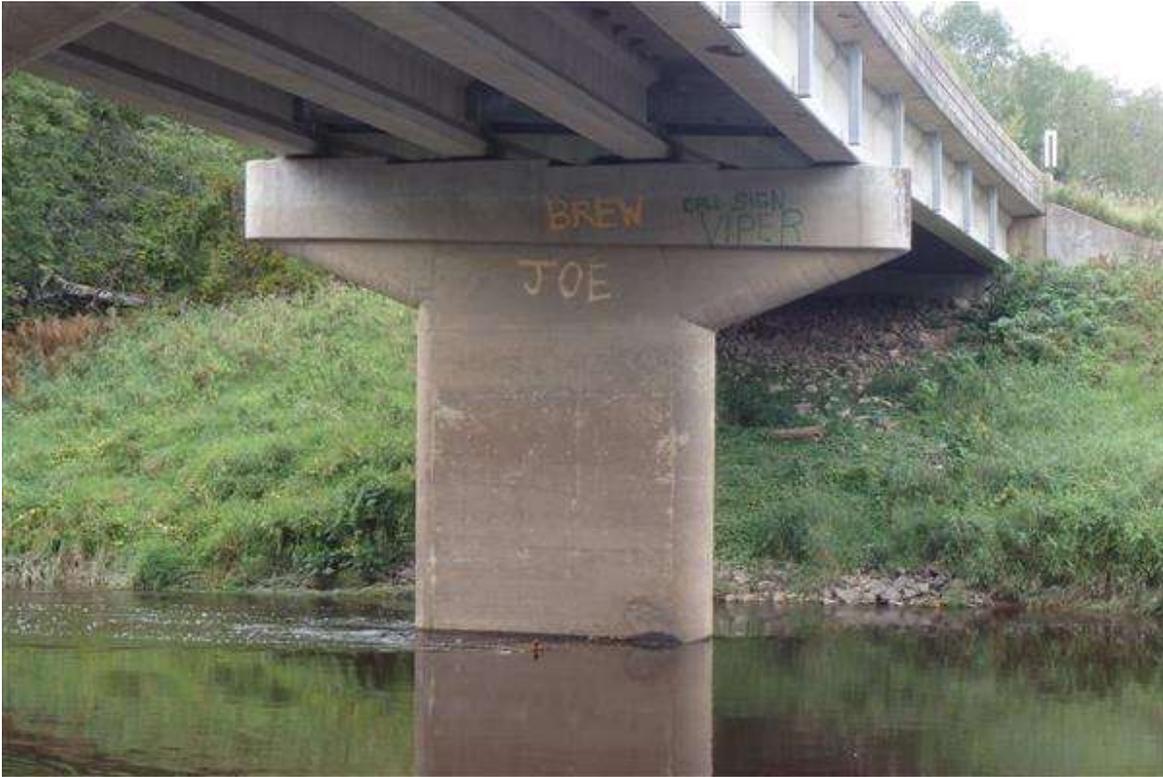
Photo 3 - Pier 1, Looking West

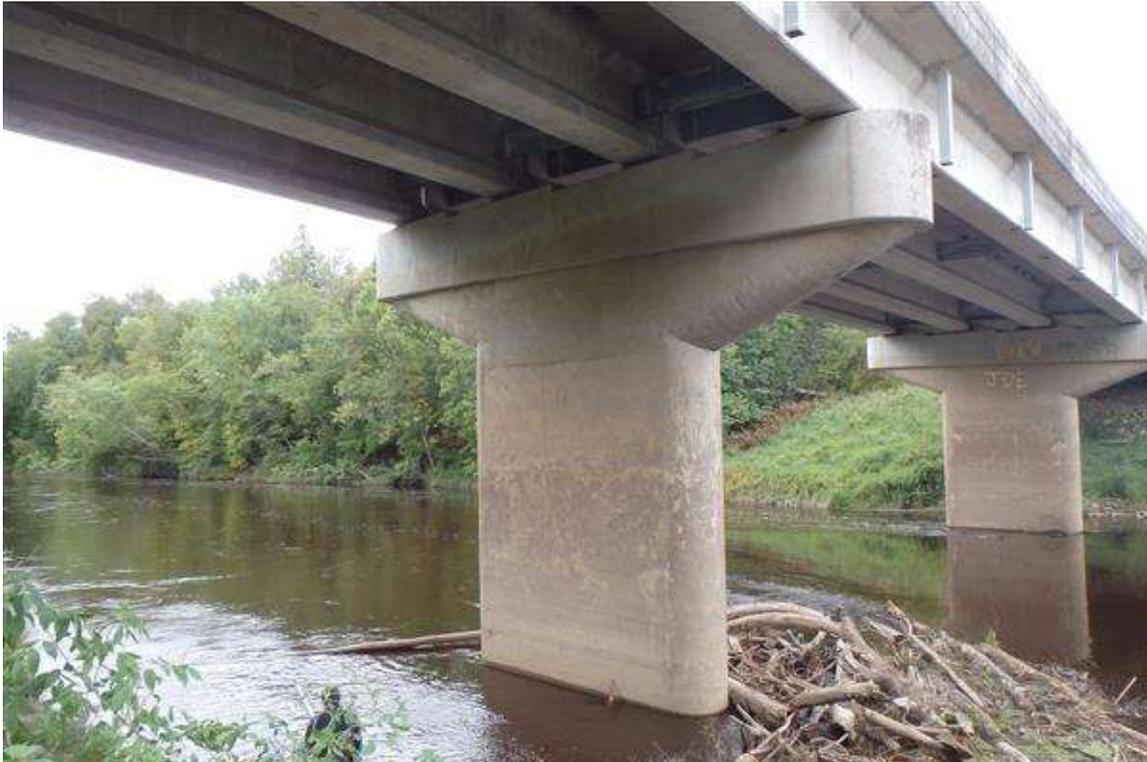
Photo 4 - Pier 2, Looking Southwest

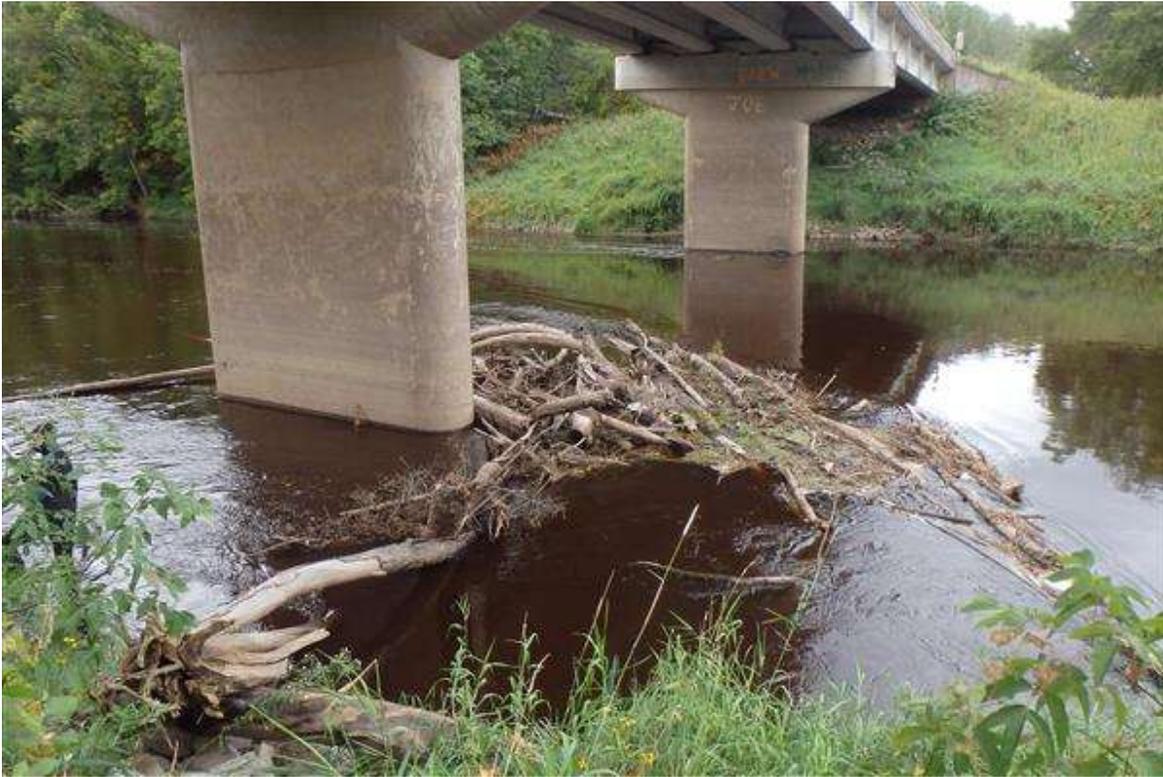
The substructure units inspected below water at Bridge No. 69541, Piers 1 and 2, were in good condition with no defects of structural significance below water. Light scaling was observed from 1 to 3 feet above the water line to the channel bottom, with a maximum of 1/8 inch penetration. Heavy to light timber debris accumulations were observed at both piers, with the most significant accumulation occurring upstream and along the west face of Pier 2 with up to 2 foot diameter logs.

Photo 5 - Timber Debris Accumulation at Pier 2, Looking Southwest

- (A) Reinspect the submerged substructure units at the normal maximum recommended (NBIS) interval of sixty (60) months.
- (B) The heavy timber accumulation at Pier 2 was not significantly affecting the hydraulic capacity of the St. Louis River at the time of the inspection. However, the accumulation should be monitored to ensure size and extent of the accumulation does not increase significantly, affecting the channel flow.

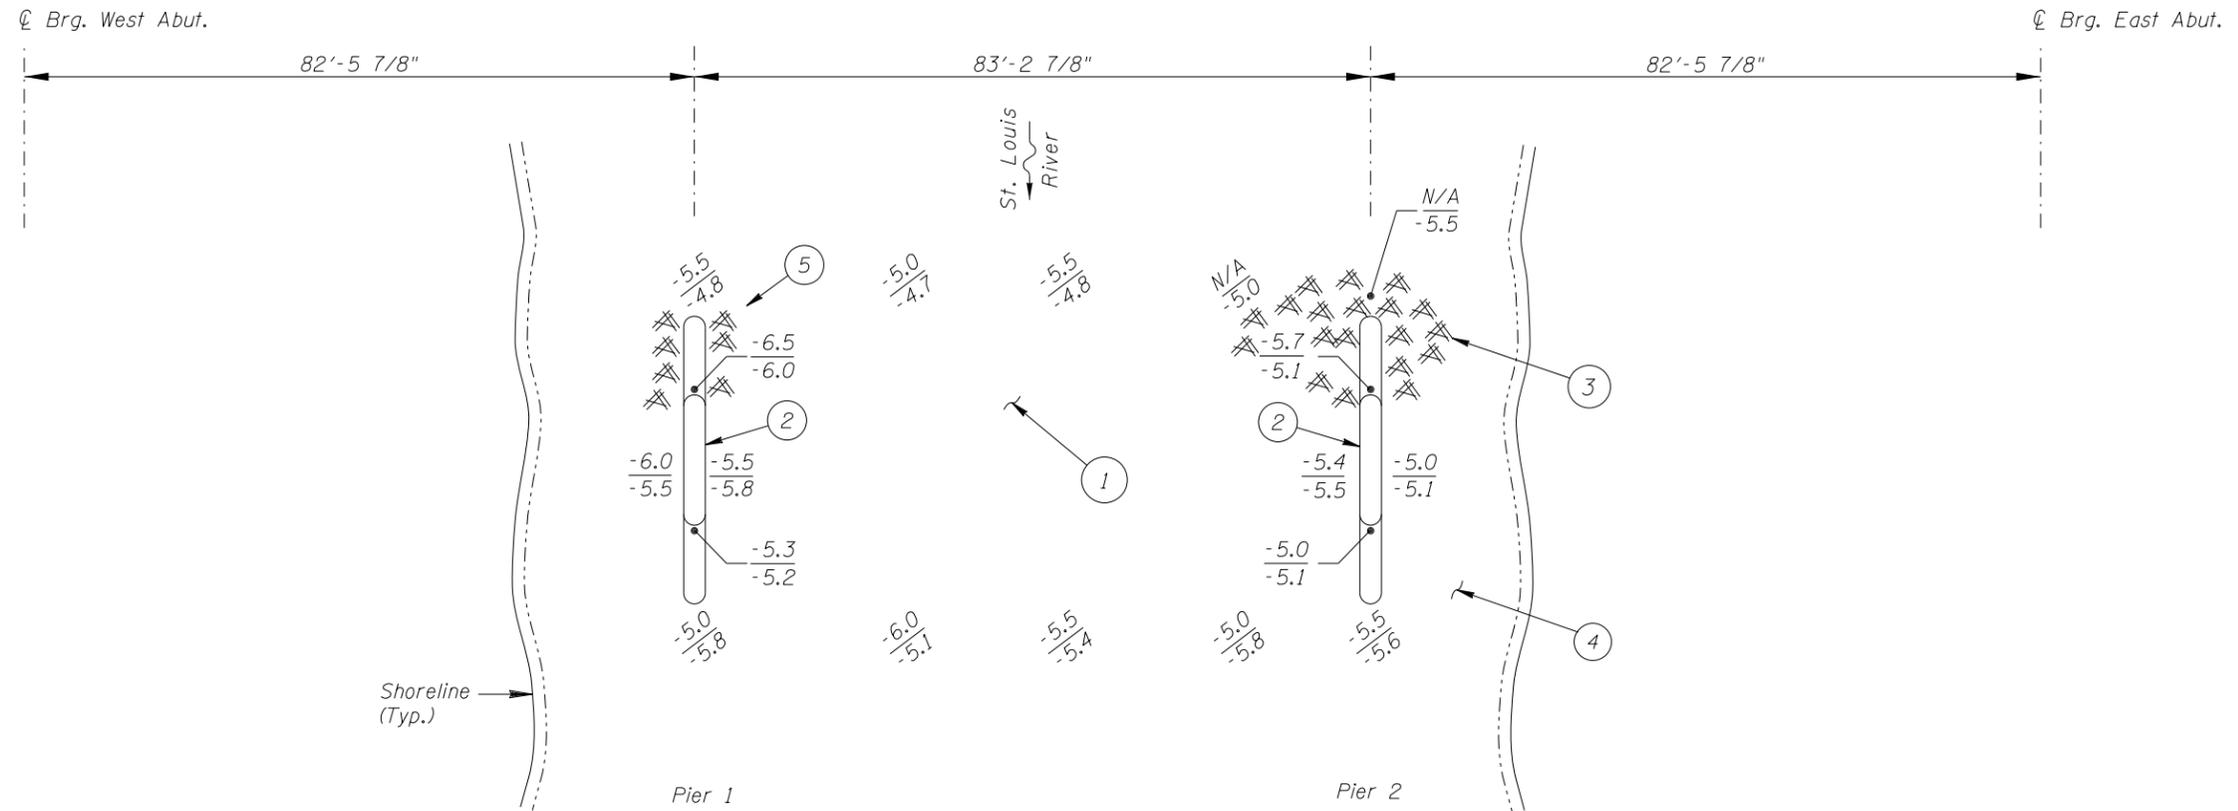
SOUNDING PLAN

1. The channel bottom material consisted of sand and gravel with random pieces of riprap 6 to 8 inches in diameter and smaller, allowing up to 3 inches of probe rod penetration.
2. Light concrete scaling, with up to 1/8 inch penetration was observed from 1 foot above the waterline to the channel bottom, and up to 3 feet above the waterline at the upstream noses.
3. Heavy accumulation of timber debris consisting of logs and branches up to 2 foot in diameter was present at the upstream half and along the west face of Pier 2 extending from the channel bottom to 3 feet above the waterline and approximately 20 feet off the pier face.
4. Channel bottom material consisted of silt with up to 6 inches of probe rod penetration.
5. Light accumulation of timber debris up to 6 inches in diameter was present around the upstream half of Pier 1.
