2016 UNDERWATER BRIDGE INSPECTION REPORT

BRIDGE # 7183 CSAH 100 over ST LOUIS RIVER

Date of Inspection: 06/23/2016

Contractor: Collins Engineers, Inc.

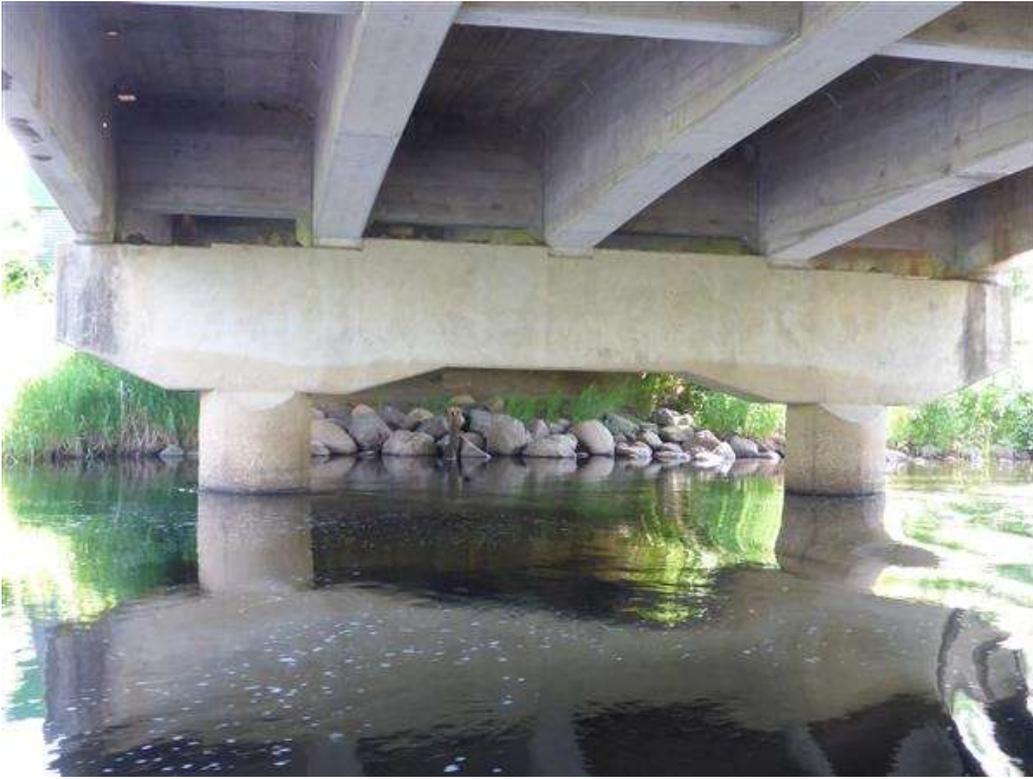
Photo 3 - Pier 1, Looking Southwest

(D) An area of heavy scaling/section loss was observed around the downstream column of Pier 1, 2 foot high by 2.5 feet wide extending from the waterline to 2 feet below the waterline with a maximum penetration of 2.5 inches. The concrete within this area was flaky and unsound.

(E) A scour depression measuring 5 feet in radius with a depth of 3 feet, was observed at the downstream column of Pier 2 and the upstream and downstream column of Pier 1.

(F) A 6 to 12 inch diameter log was observed from the channel bottom to the waterline along the upstream column of Pier 1.

(A) Consideration should be given to repairing the concrete defects at the columns of Piers 1 and 2. Until the repairs are implemented, the defected areas should be monitored during future underwater inspections for any progression of section loss and/or exposure of reinforcing steel.

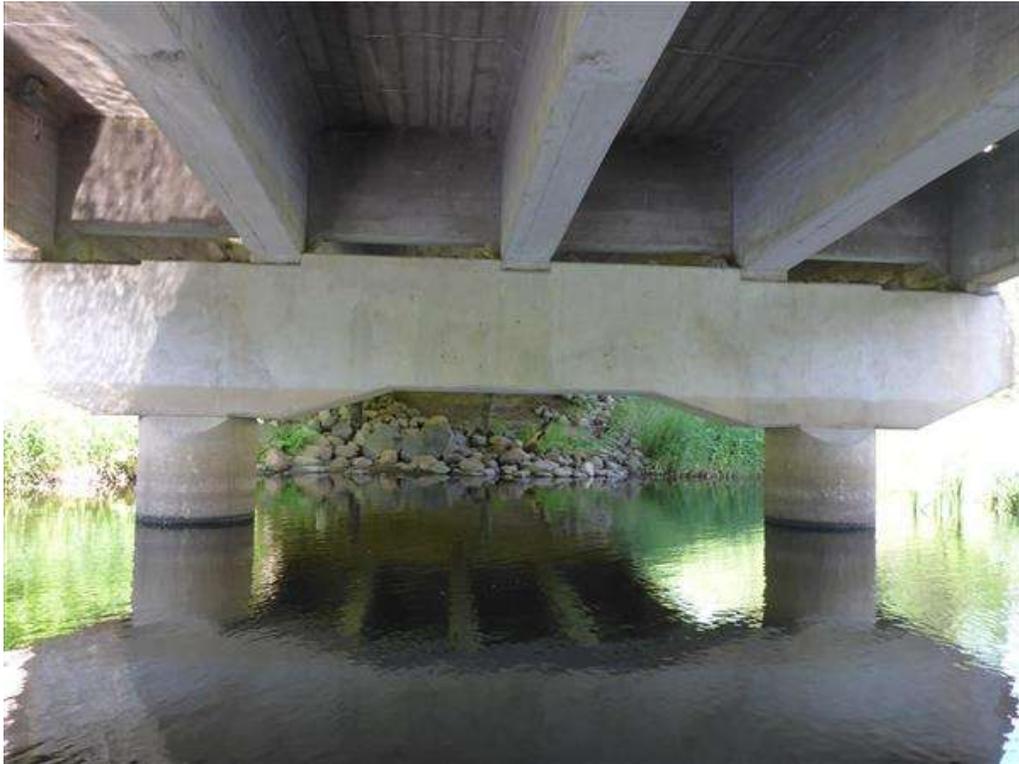
Photo 4 - Pier 2, Looking Northeast

(B) The channel bottom around Pier 2 consisted of soft silt and organic material allowing typical 1.5 feet of probe rod penetration.

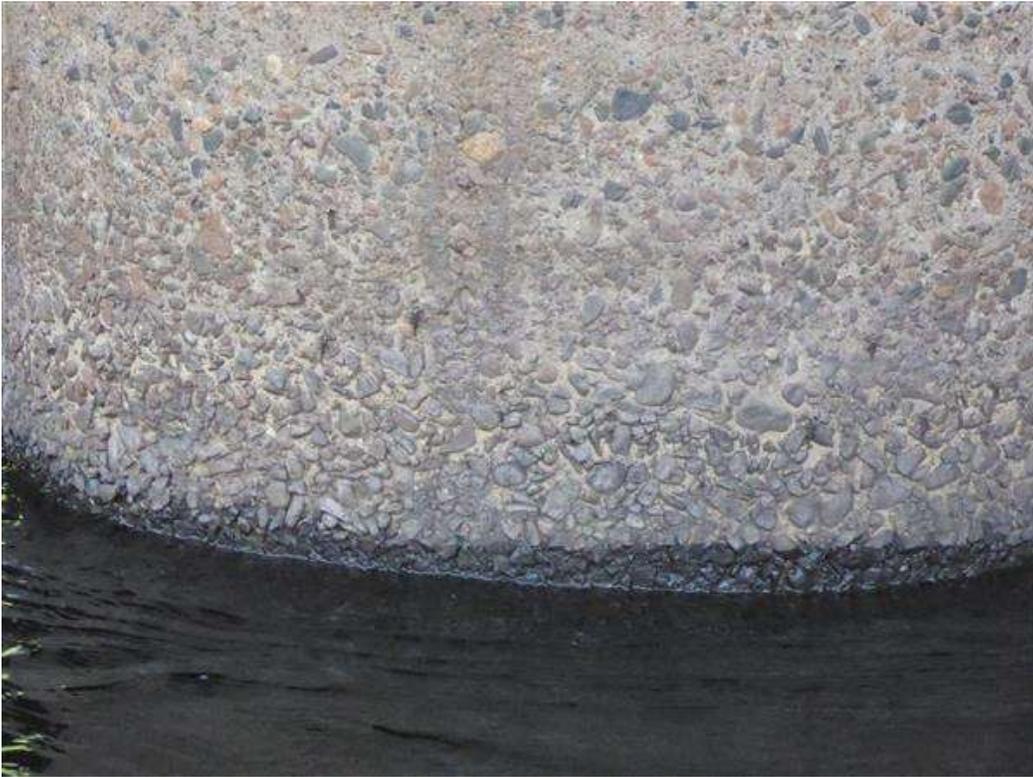
Photo 5 - Typical Concrete Condition at Waterline, Looking Northwest

(C) Moderate scaling with large aggregate exposure from 3 feet above the waterline to 1.5 feet below the waterline with typical penetrations of 1/8 to 1/4 inch and up to 1 inch maximum was observed around all columns of both piers.

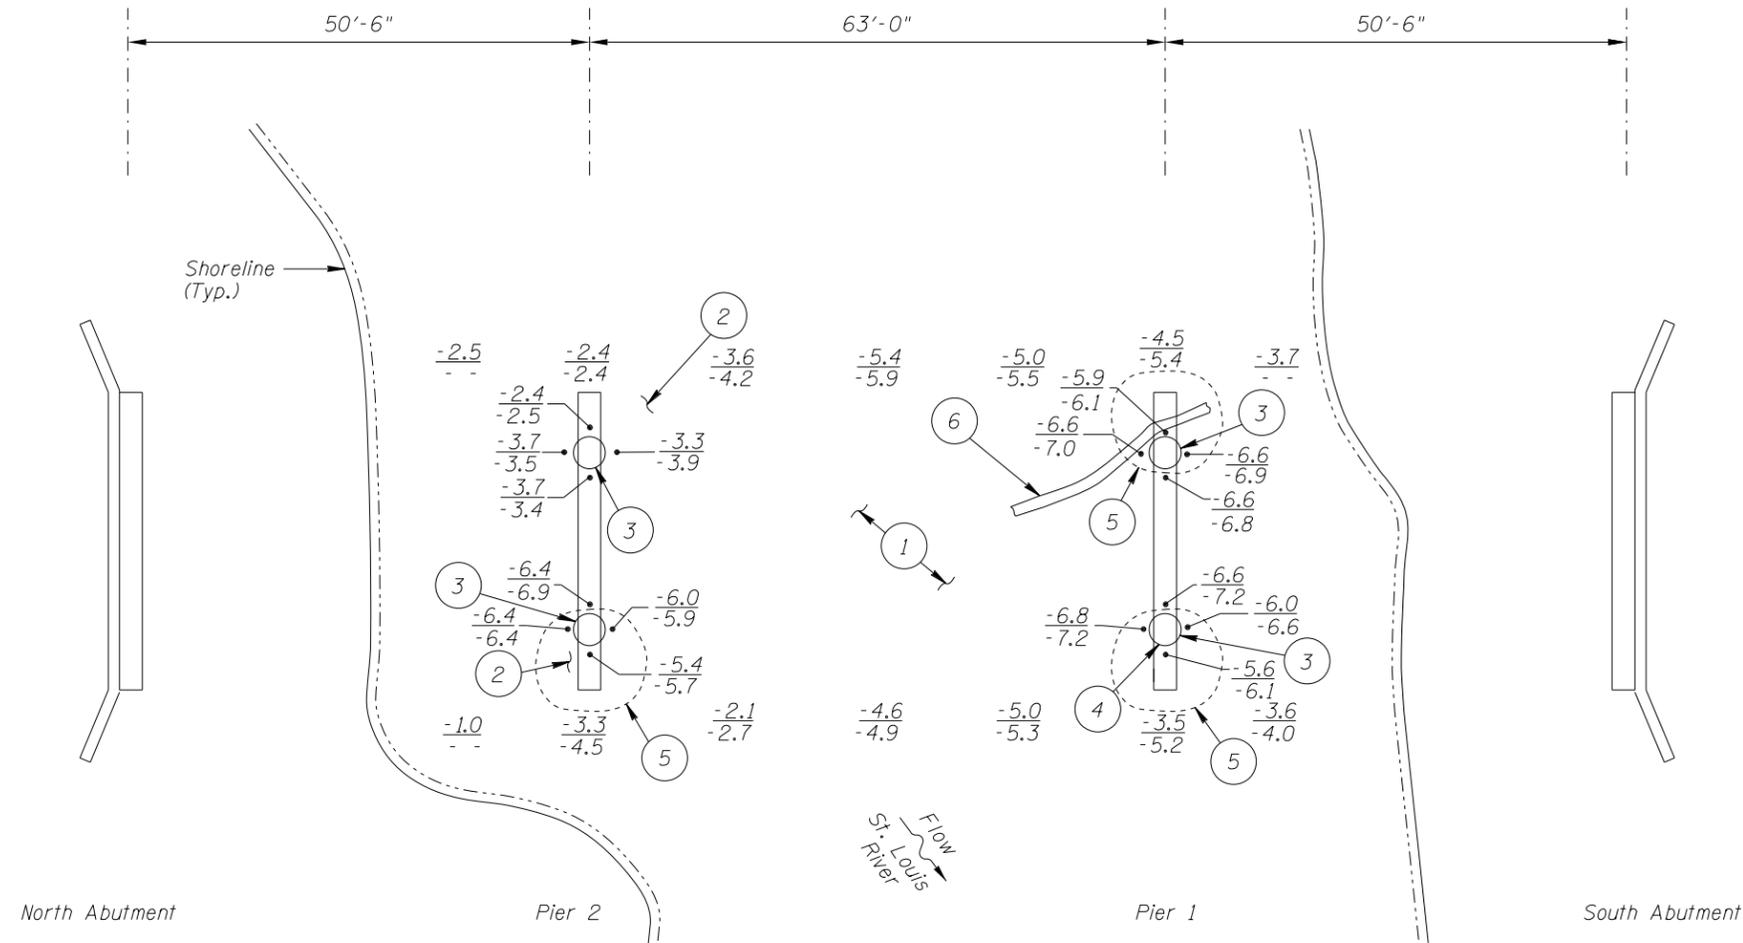
SOUNDING PLAN

- 1 The channel bottom typically consisted of sand and gravel with a maximum probe rod penetration of 1 inch and 6 inch diameter and smaller cobbles with random 1 foot diameter riprap.

- 2 The channel bottom consisted of soft silt and organic material allowing typical 1.5 feet of probe rod penetration at the upstream column of Pier 2.

- 3 Moderate scaling with some aggregate exposure from 3 feet above the waterline to 1.5 feet below the waterline with typical penetrations of 1/8 inch and up to 1 inch maximum was observed around all columns of both piers.

- 4 An area of heavy scaling/section loss was observed around the downstream column of Pier 1, 2 foot high by 2.5 feet wide extending from the waterline to 2 feet below the waterline with a maximum penetration of 2.5 inches. The concrete within the area was flaky and unsound.

- 5 A scour depression, 5 feet in radius with a depth of 3 feet, was observed at the downstream column of Pier 2 and both columns of Pier 1.
- 6 A 6 to 12 inch diameter log was observed from the channel bottom to the waterline along Pier 1 as shown.
