2016 UNDERWATER BRIDGE INSPECTION REPORT

BRIDGE # 7678 CSAH 22 over SAND RIVER

Date of Inspection: 06/20/2016

Contractor: Collins Engineers, Inc.

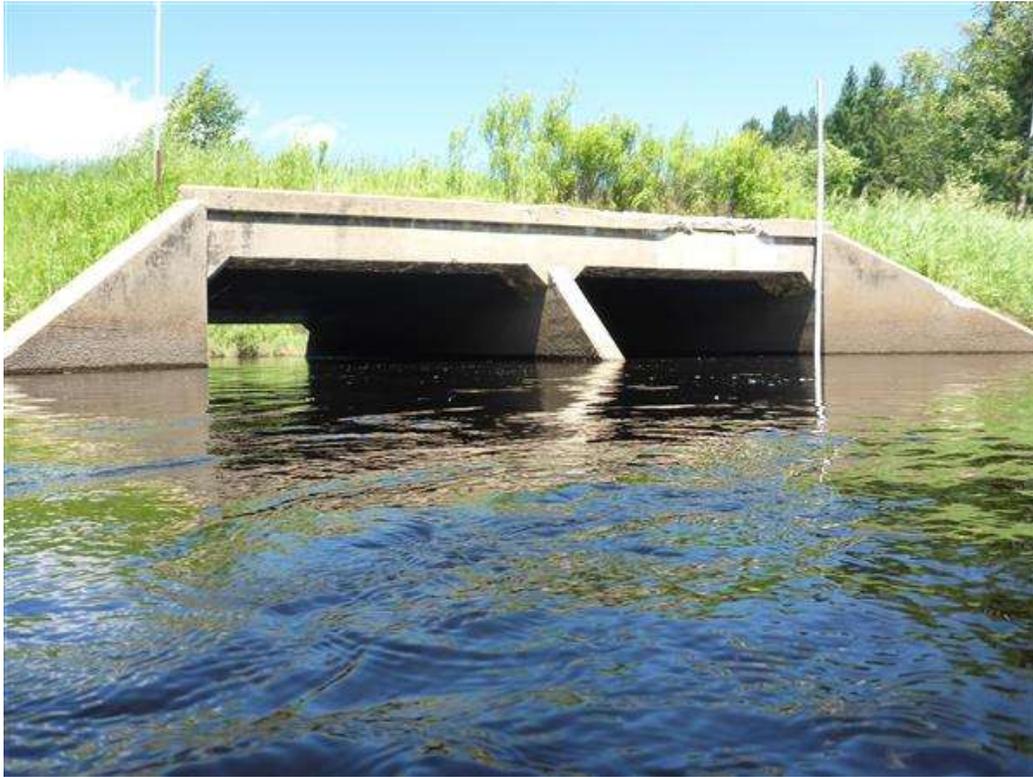
Photo 1 - Upstream Opening, Looking Northeast

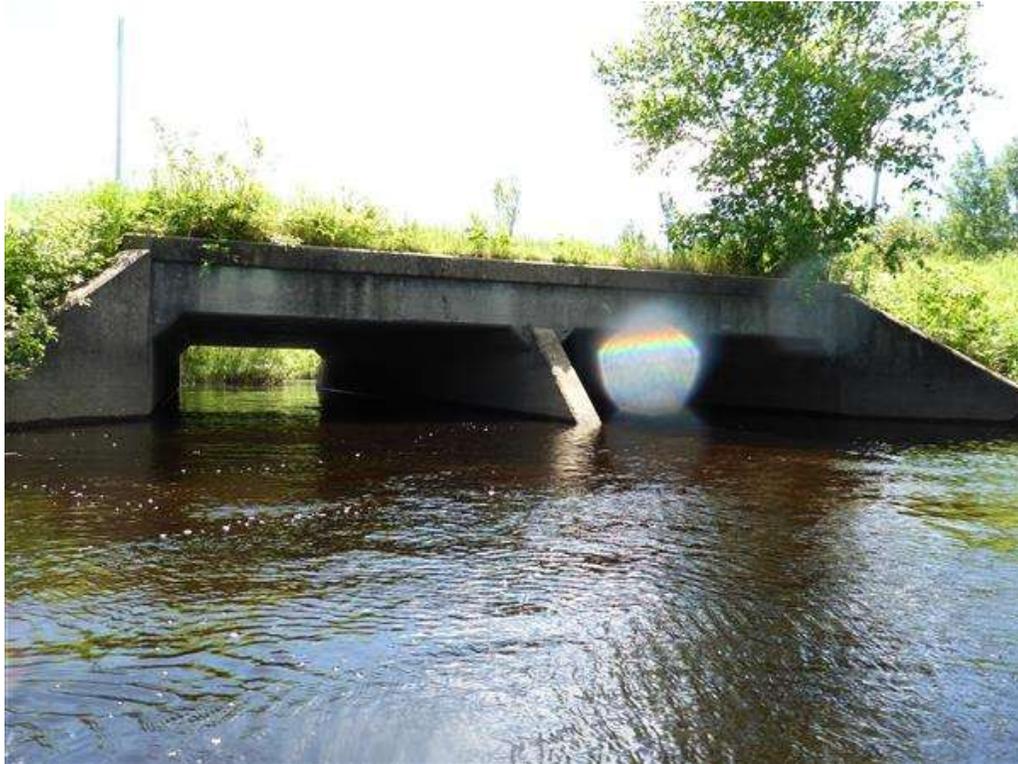
Photo 2 - Downstream Opening, Looking Southwest

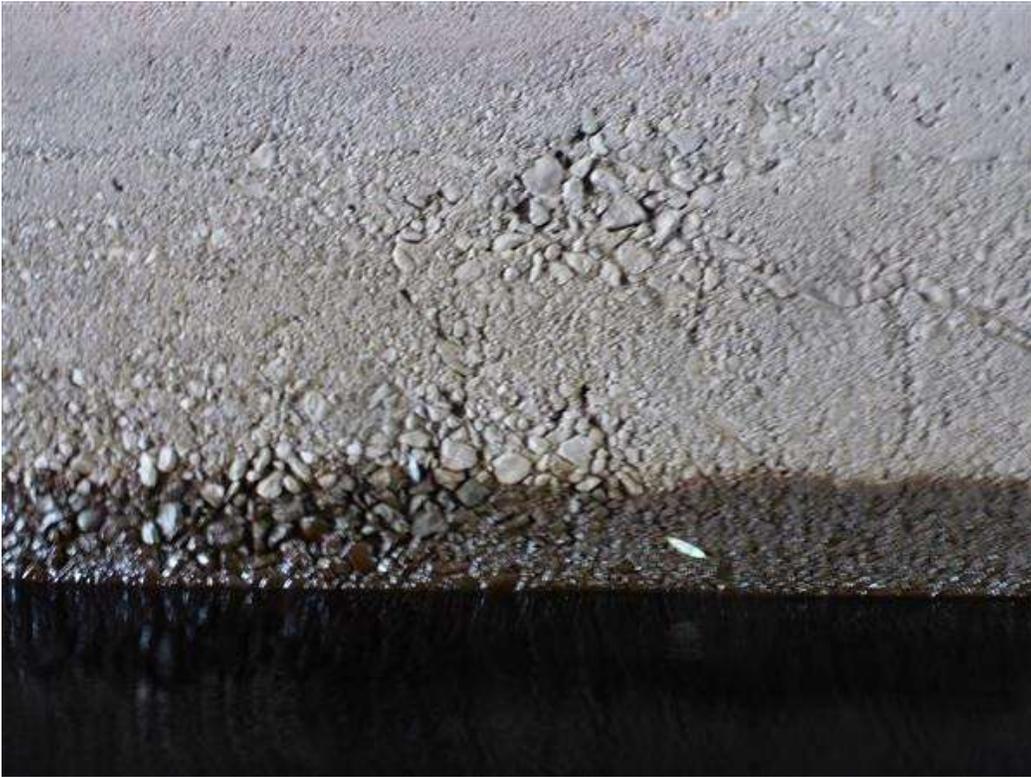
- (B) A band of light scaling and random areas of poor concrete consolidation were observed on the culvert floor, ceiling and walls extending from the floor to 1 foot above the waterline. The scaling had a maximum penetration of 1/4 inch and the poor concrete consolidation had a maximum penetration of 1.5 inches.

Photo 3 - Typical Concrete Condition (Box 1 Shown), Looking West

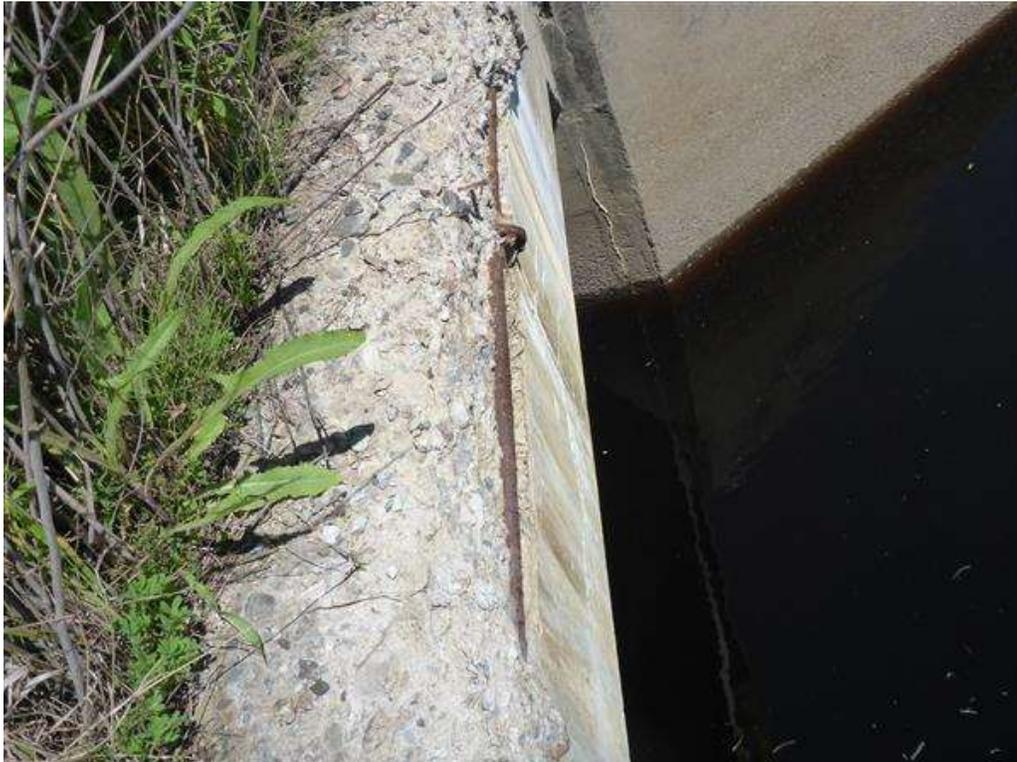
- (G) A spall was observed on the south headwall above Box 2. The spall measured 15 feet long by 1 foot high with a maximum penetration of 3 inches. Several reinforcing bars were exposed exhibiting less than 10 percent loss of section.

Photo 4 - Spall along top of Upstream Headwall, Looking East

- (A) The areas of concrete section loss and spalling with exposed reinforcing steel are not structural concerns at this time; however, it ideally should be repaired to prevent further deterioration. The repairs should include removal of concrete to a minimum of 1 inch behind the reinforcing steel, cleaning and replacing reinforcing steel as required, and placing concrete designed to provide high durability with low permeability.
- (B) Reinspect the submerged substructure units at the normal maximum recommended (NBIS) interval of sixty (60) months.

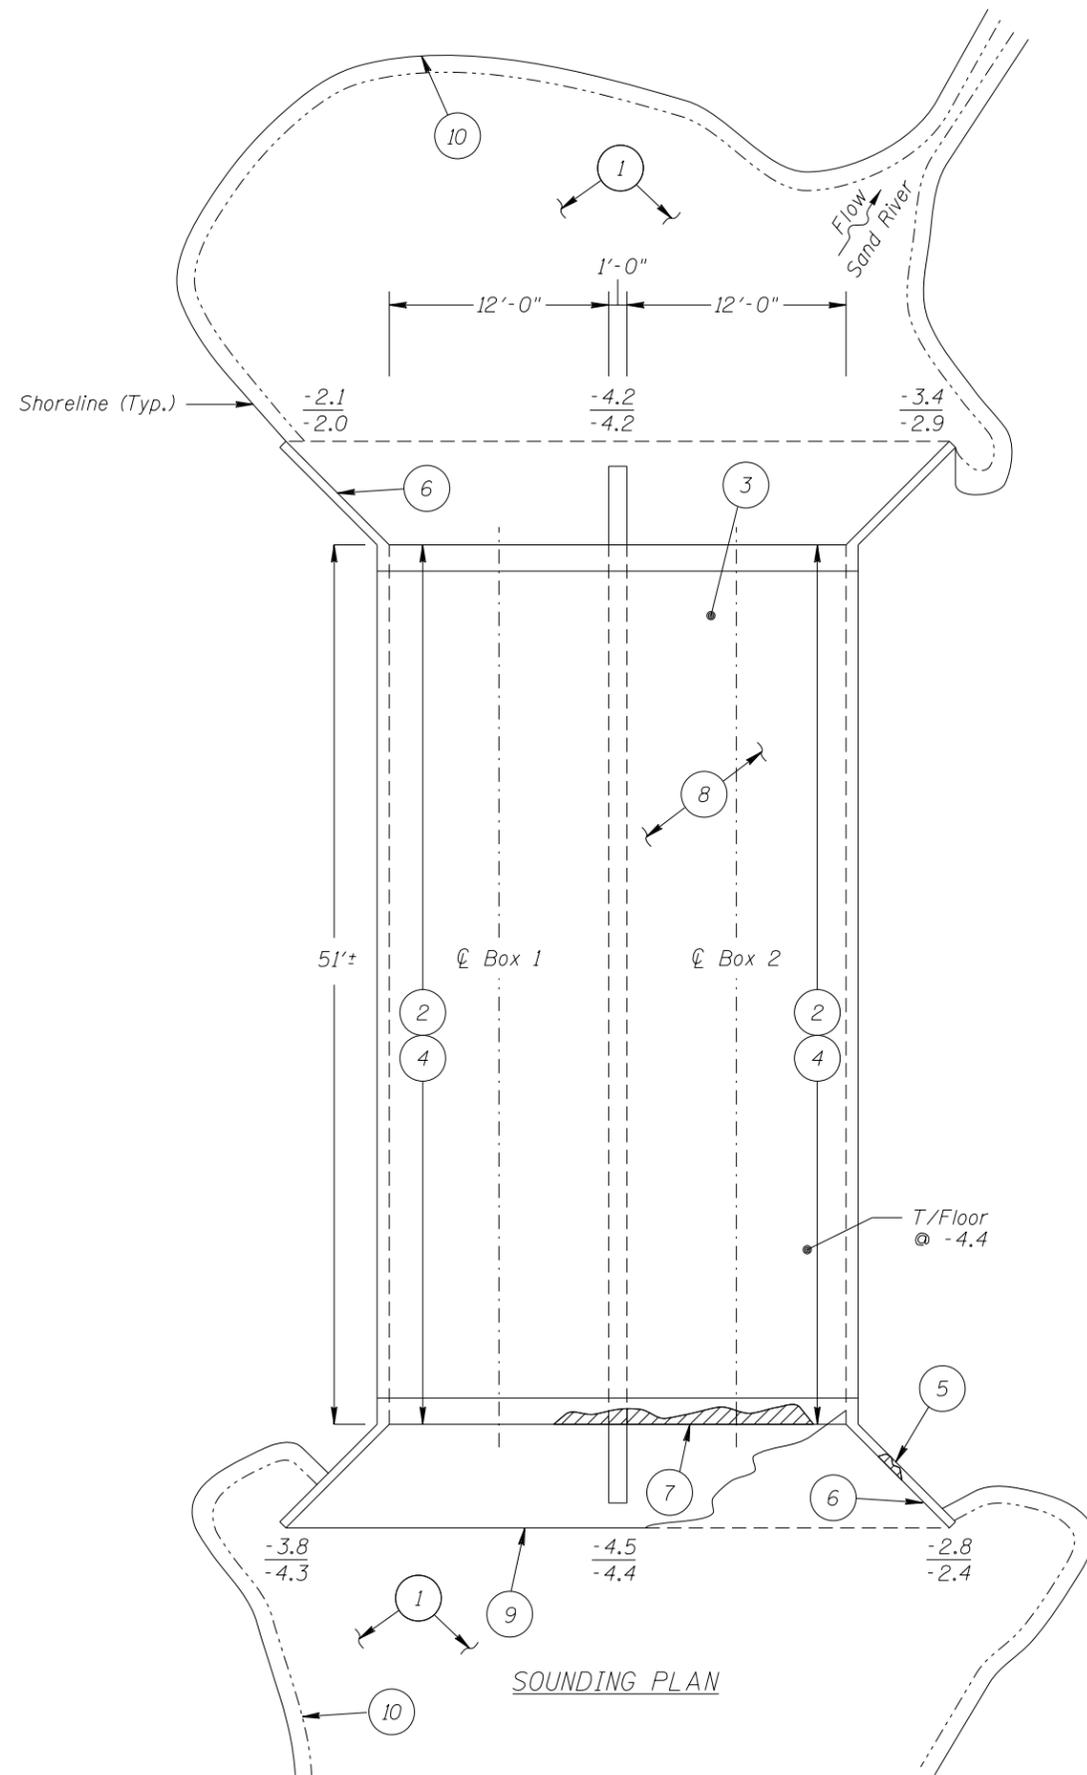
- 1 The channel bottom material upstream and downstream of the culvert apron consisted of rocks, cobbles and silt with a maximum probe rod penetration of 4 inches.

- 2 A band of light scaling and random areas of poor concrete consolidation were observed on the culvert floor, ceiling and walls extending from the floor to 1 foot above the waterline. The scaling had a maximum penetration of 1/4 inch and the poor concrete consolidation had a maximum penetration of 1.5 inches.

- 3 An area of concrete section loss and residual 2"x4" form work was observed in the ceiling of Box 2, 1 foot from the north opening. The area of section loss measured 6 inches long by 3 inches wide with a maximum penetration of 1.5 inches and one exposed reinforcing bar exhibiting less than 5 percent loss of section.

- 4 Areas of concrete section loss and poor concrete consolidation were observed along the horizontal construction joints of all the top haunches of both Box 1 and 2. The areas had a maximum penetration of 3/4 inch.

- 5 An area of concrete section loss was observed on the top of the southeast wingwall. The area measured 15 inches wide by 6 inches high with a maximum penetration of 2 inches. No exposed reinforcing steel was observed.

- 6 A diagonal crack, up to 1/4 inch wide, was observed on the southeast and northwest wingwalls extending from the apron to the top of the wingwall.
- 7 A spall was observed on the south headwall above Box 2. The spall measured 15 feet long by 1 foot high with a maximum penetration of 3 inches. Several reinforcing bars were exposed exhibiting less than 10 percent loss of section.

- 8 The Box 2 culvert floor was covered with a 5 inch thick layer of silt from the midpoint to the downstream opening. The culvert floor within Box 1 was typically clear of any infill.

- 9 The apron toe was exposed at the upstream opening of Box 1 with no vertical exposure present.
- 10 The upstream and downstream banks exhibited minor erosion.
