2017 UNDERWATER BRIDGE INSPECTION REPORT

BRIDGE # 7688 CSAH 25 over BEAR RIVER

Date of Inspection: 09/12/2016

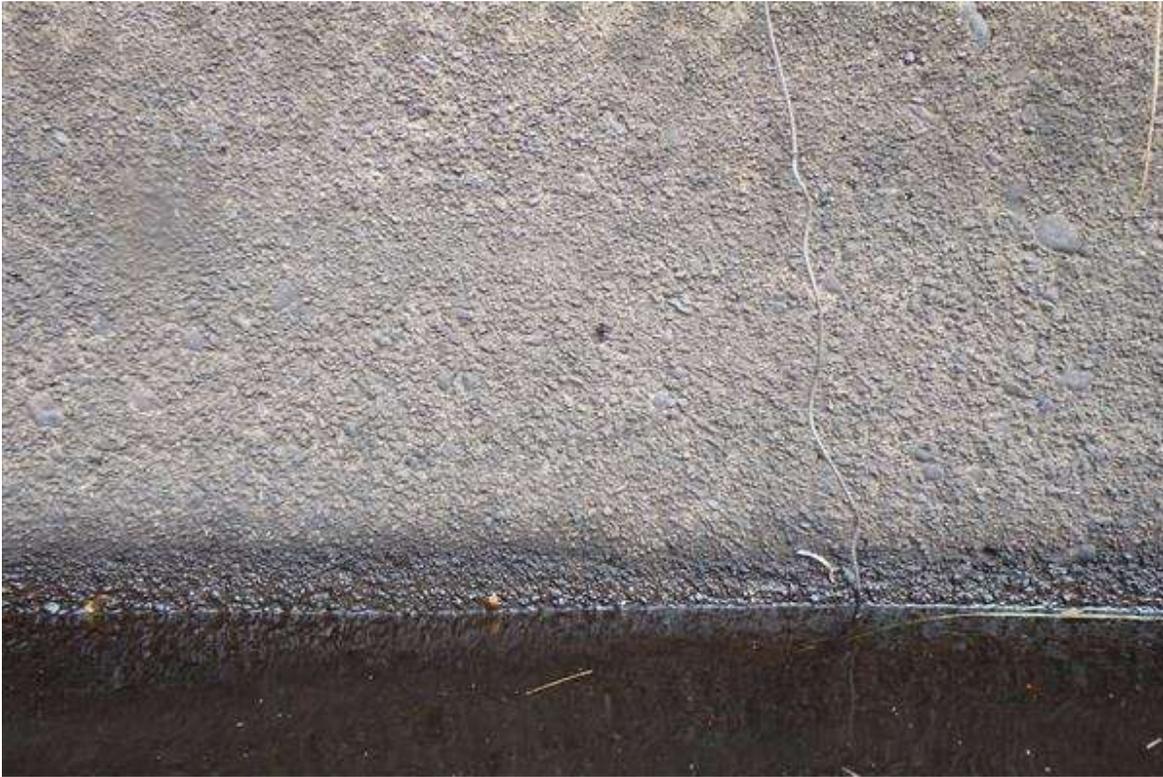
(B) The concrete of both culvert boxes and headwalls exhibited light scaling on all surfaces with a typical penetration of 1/8 inch and a maximum penetration of 1/2 inch.

Photo 3 - Typical Concrete Condition at the Waterline (North Barrel Shown), Looking South

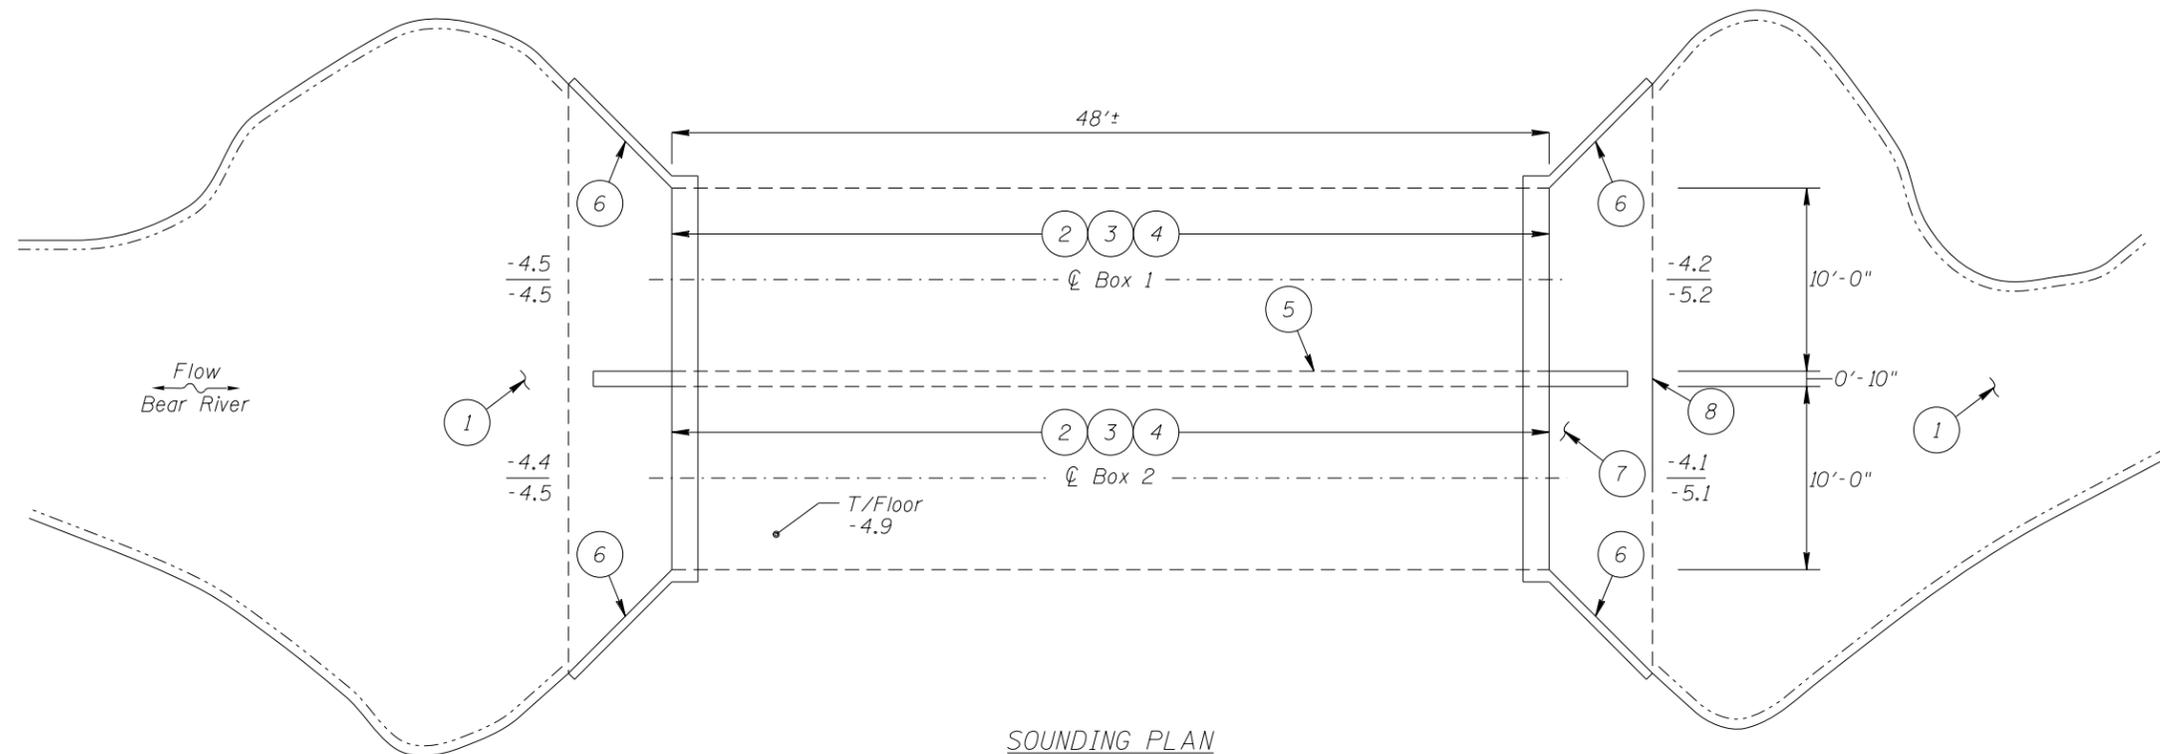
SOUNDING PLAN

- 1 The channel bottom material upstream and downstream of the culvert apron consisted of rocks and sand with a maximum probe rod penetration of 1 foot.

- 2 The concrete of both culvert boxes and headwalls exhibited light scaling on all surfaces with a typical penetration of $\frac{1}{8}$ inch and a maximum penetration of $\frac{1}{2}$ inch.

- 3 Random areas of poor concrete consolidation were observed on the walls of both culvert boxes. The areas exhibited a maximum penetration of 1 inch.
- 4 Widespread areas of poor concrete consolidation were observed on the haunches and culvert ceilings. The areas exhibited a maximum penetration on 2 inches with random areas of longitudinal and transverse reinforcing steel exposed. The areas of poor consolidation with exposed reinforcing steel covered approximately 15 percent of the total ceiling surface area and the steel exhibited less than 5 percent loss of section.

- 5 A spall was observed at the waterline, 6 feet from the east opening, on the north face of the center wall. The spall measured 1 foot in diameter with a maximum penetration of 3 inches.

- 6 Vertical hairline to $\frac{1}{16}$ inch wide cracks were observed at the midpoint of all four wingwalls, extending from the top of the wall to the concrete apron.

- 7 The culvert floor was exposed throughout the length of both culvert boxes. Random areas of silt and debris buildup, less than 1 foot thick, were observed throughout Box 1 with no significant reduction in hydraulic opening.

- 8 The concrete apron was observed at the east opening end of the culvert boxes from the midpoint of Box 1 to the midpoint of Box 2. The apron had a maximum vertical exposure of 2 inches. No undermining was observed at the apron toe.

(A) The areas of poor concrete consolidation with exposed reinforcing steel are not structural concerns at this time; however, they should be repaired to prevent further deterioration. The repairs should include removal of concrete to a minimum of 1 inch behind the reinforcing steel, cleaning and replacing reinforcing steel as required, and placing concrete designed to provide high durability with low permeability.
