2016 UNDERWATER BRIDGE INSPECTION REPORT

BRIDGE # 7773 CSAH 116 over PICKET RIVER

Date of Inspection: 06/19/2016

Contractor: Collins Engineers, Inc.

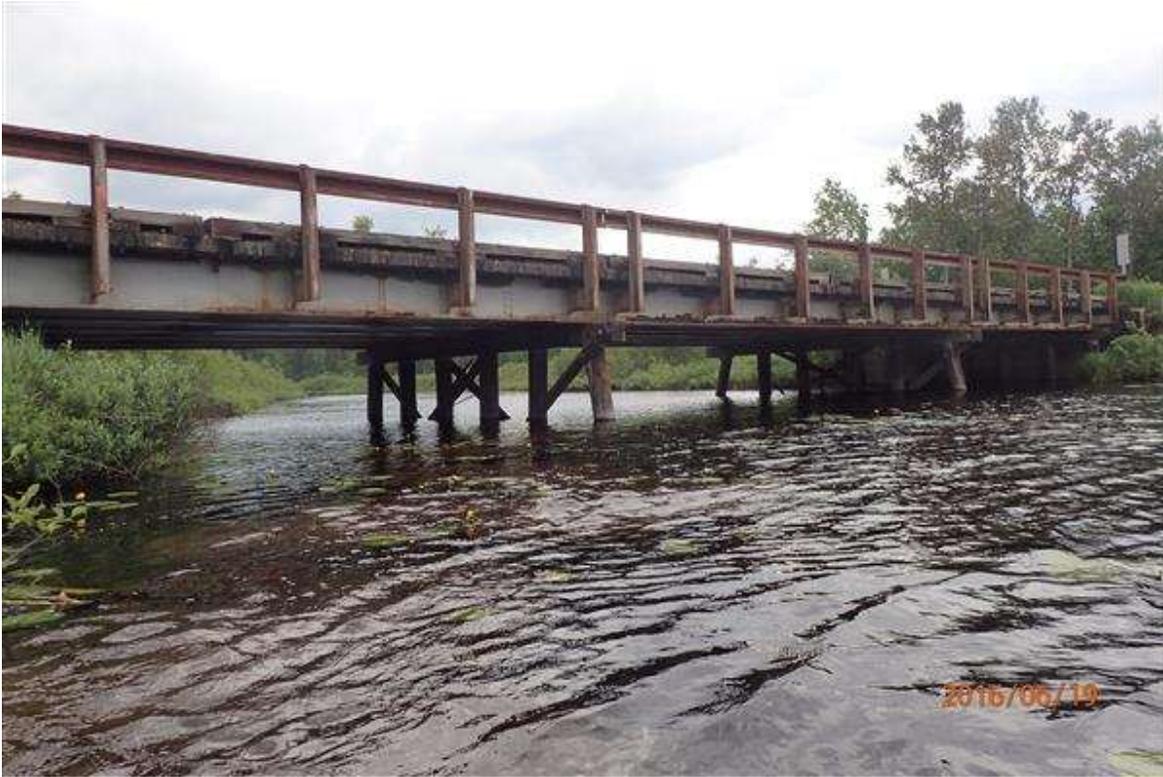
Photo 1 - Upstream Fascia, Looking Northeast

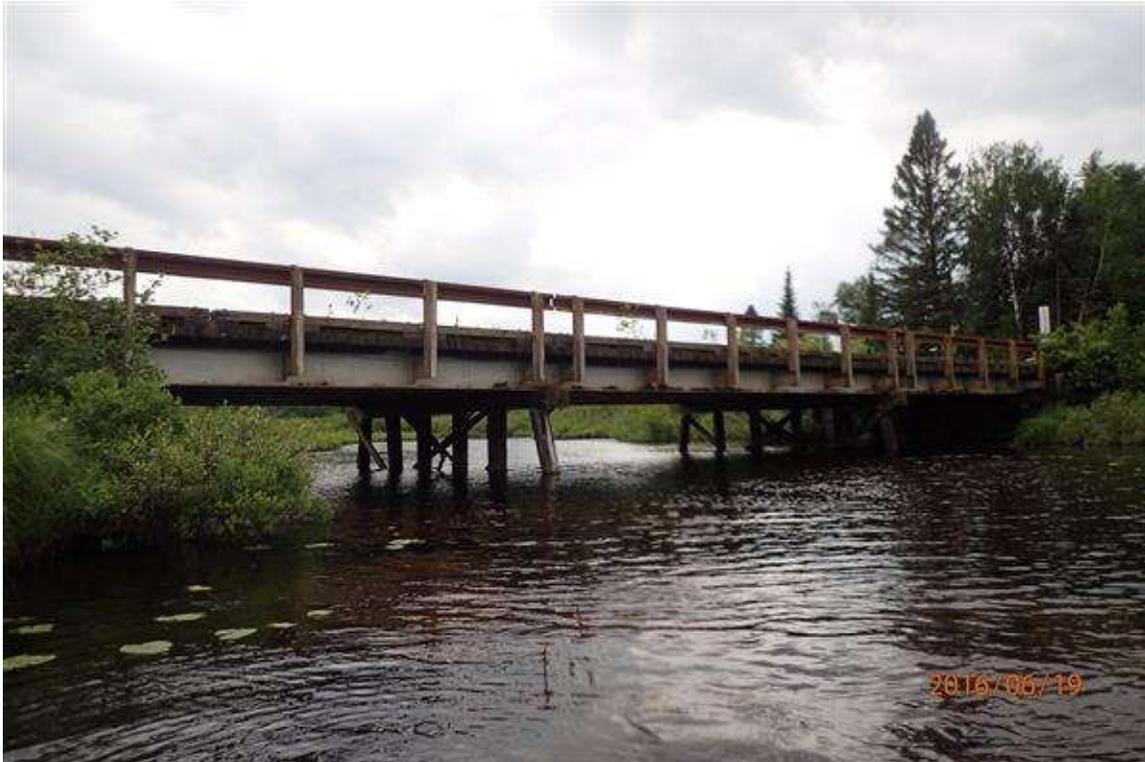
Photo 2 - Downstream Fascia, Looking Southwest

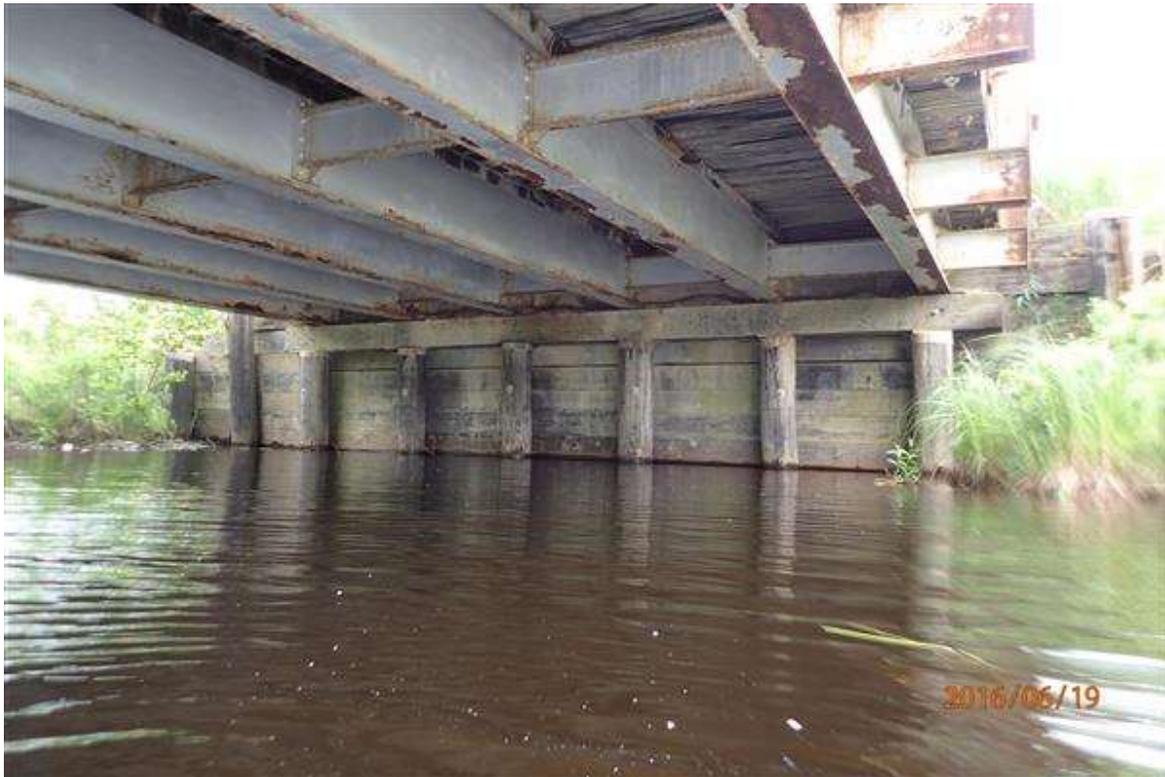
- (D) The timber pile cap at Piles A, B, C, E, and F of the East Abutment was bearing on shim.
- (E) A timber cross-brace was missing on the west and east side of Piles D through F of Bent 1.

Photo 3 - East Abutment, Looking Northeast

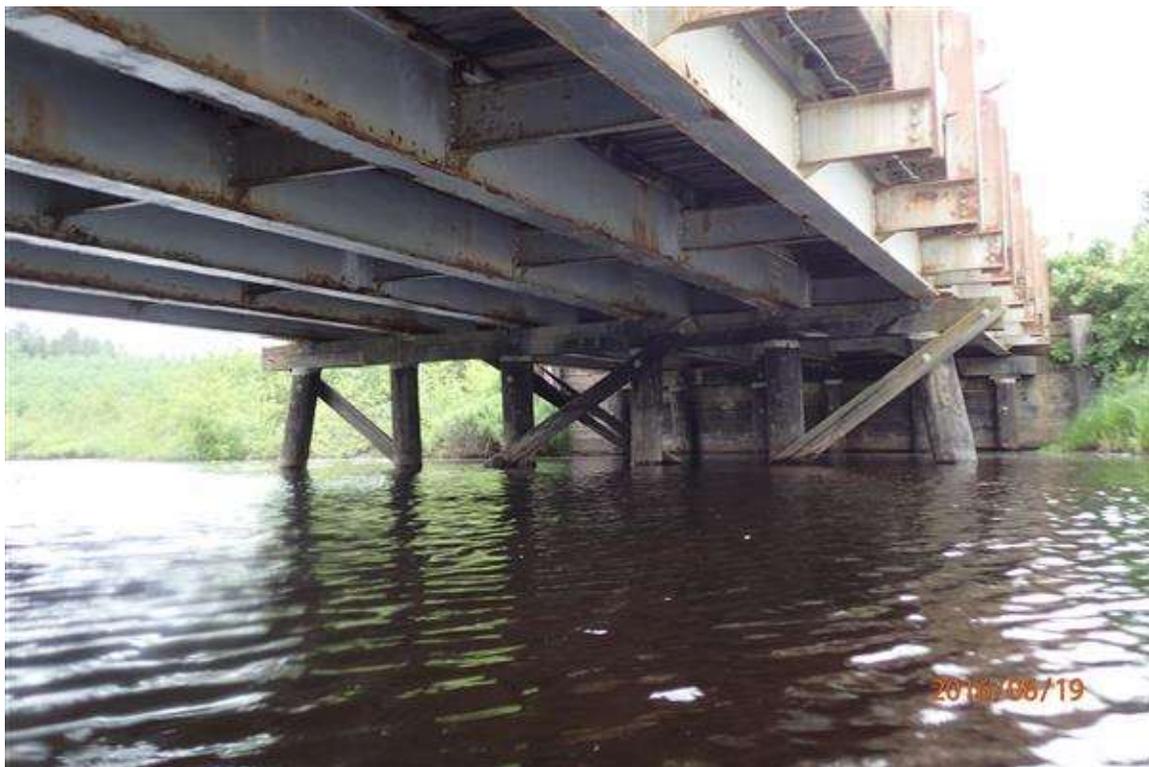
- (F) The timber cross-bracing on the east side of Piles C and D of Bent 1 exhibited heavy deterioration and splitting with up to 100 percent section loss.

- (G) A split in the cross-brace, measuring up to 4 inches wide, was observed on the west side of Bent 1 extending from Pile D to Pile A. The cross-brace to pile connection at Pile D was compromised.

Photo 4 - Bent 1, Looking Northeast

- (A) Repair or replace the deficient timber cross-bracing particularly the bracing at Bent 1.
- (B) Repair the bearing at Pile F of the West Abutment.
- (C) Reinspect the submerged substructure units at the normal maximum recommended (NBIS) interval of sixty (60) months.

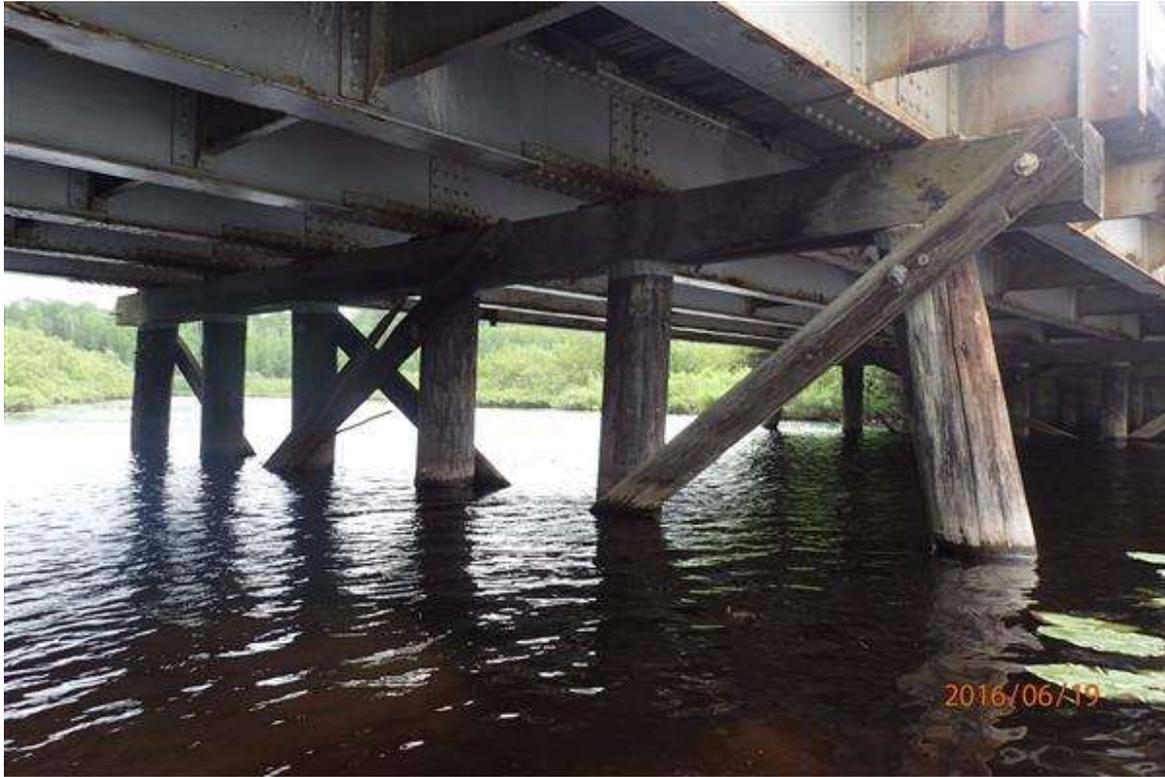
- (H) A split in the cross-brace, measuring up to 2 inches wide, was observed on the west side of Bent 2 extending from Pile C to Pile E. The cross-brace to pile connection at Pile D was compromised. Also, the cross-brace along the east side of the bent between Piles D and F was split approximately 1/2 inch (full depth).

Photo 5 - Bent 2, Looking Northeast

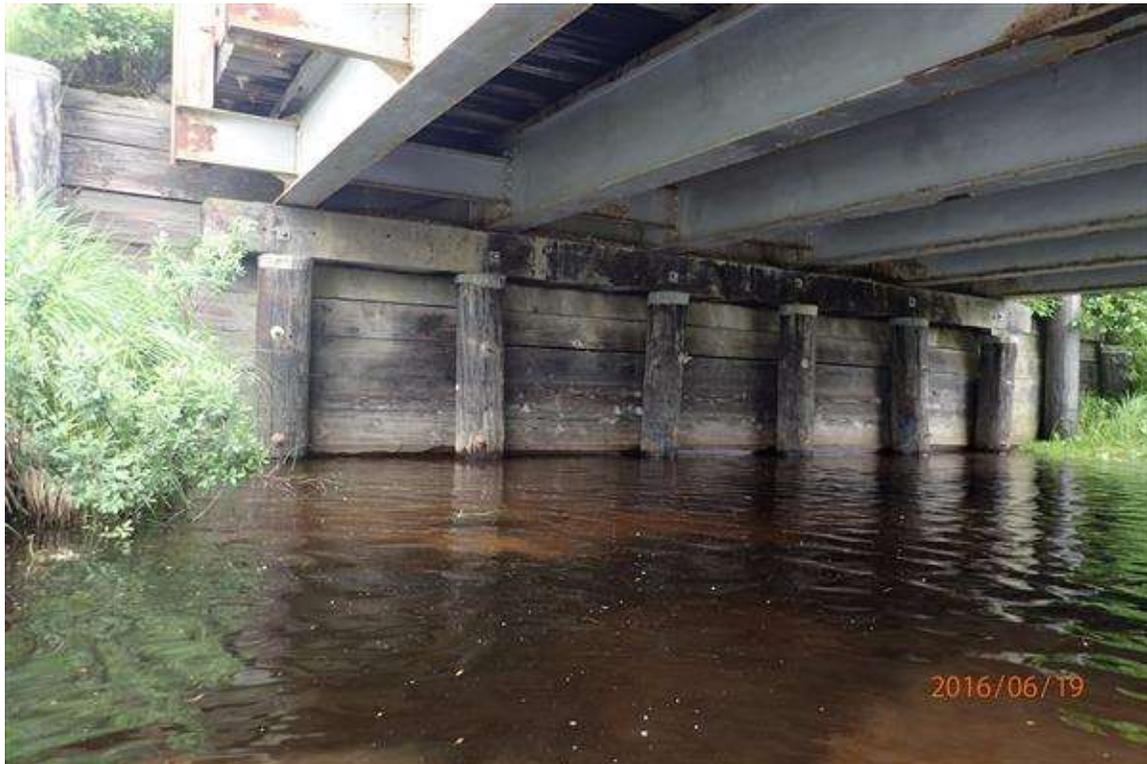
Photo 6 - West Abutment, Looking Northwest

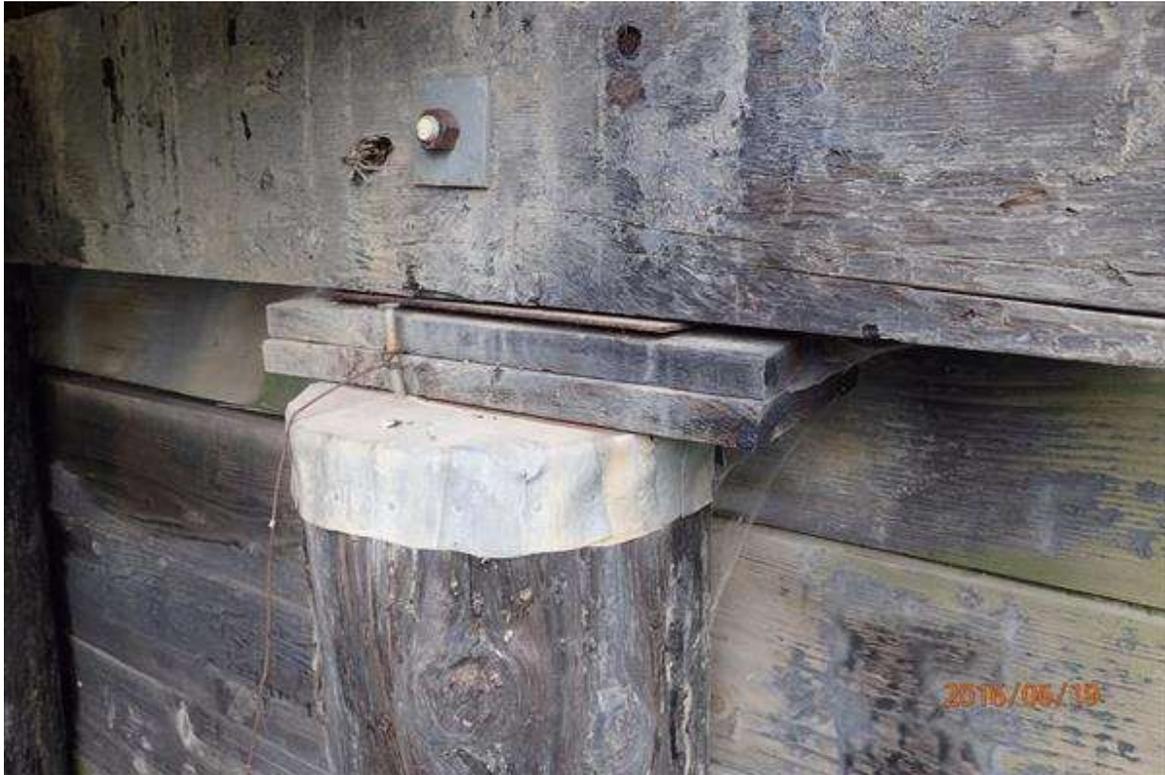
- (I) A light accumulation of timber debris, consisting of 2 inch diameter and smaller branches, was noted around Pile A of Bent 1.
- (J) The timber pile cap at Pile F of the West Abutment was not fully bearing. Shims were installed, but appeared loose.

Photo 7 - Loose Shim at Pile F of the West Abutment, Looking Southwest

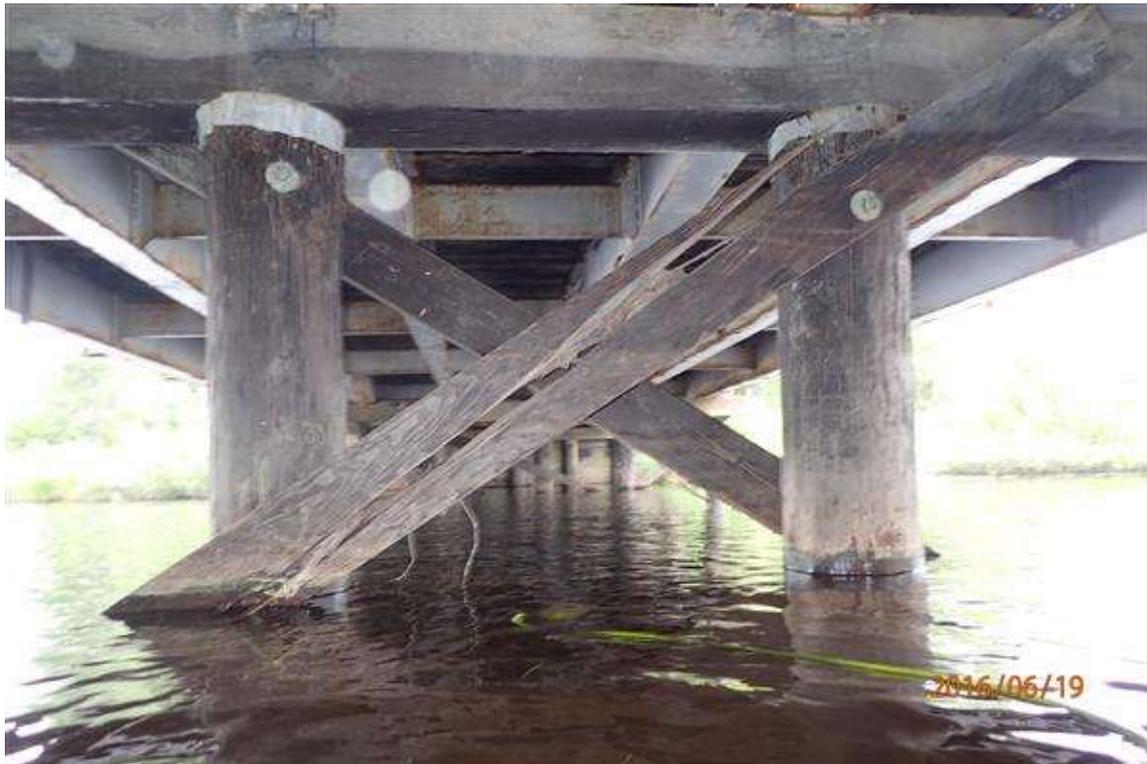
Photo 8 - Split at Timber Cross Brace (Bent 2 Shown), Looking East

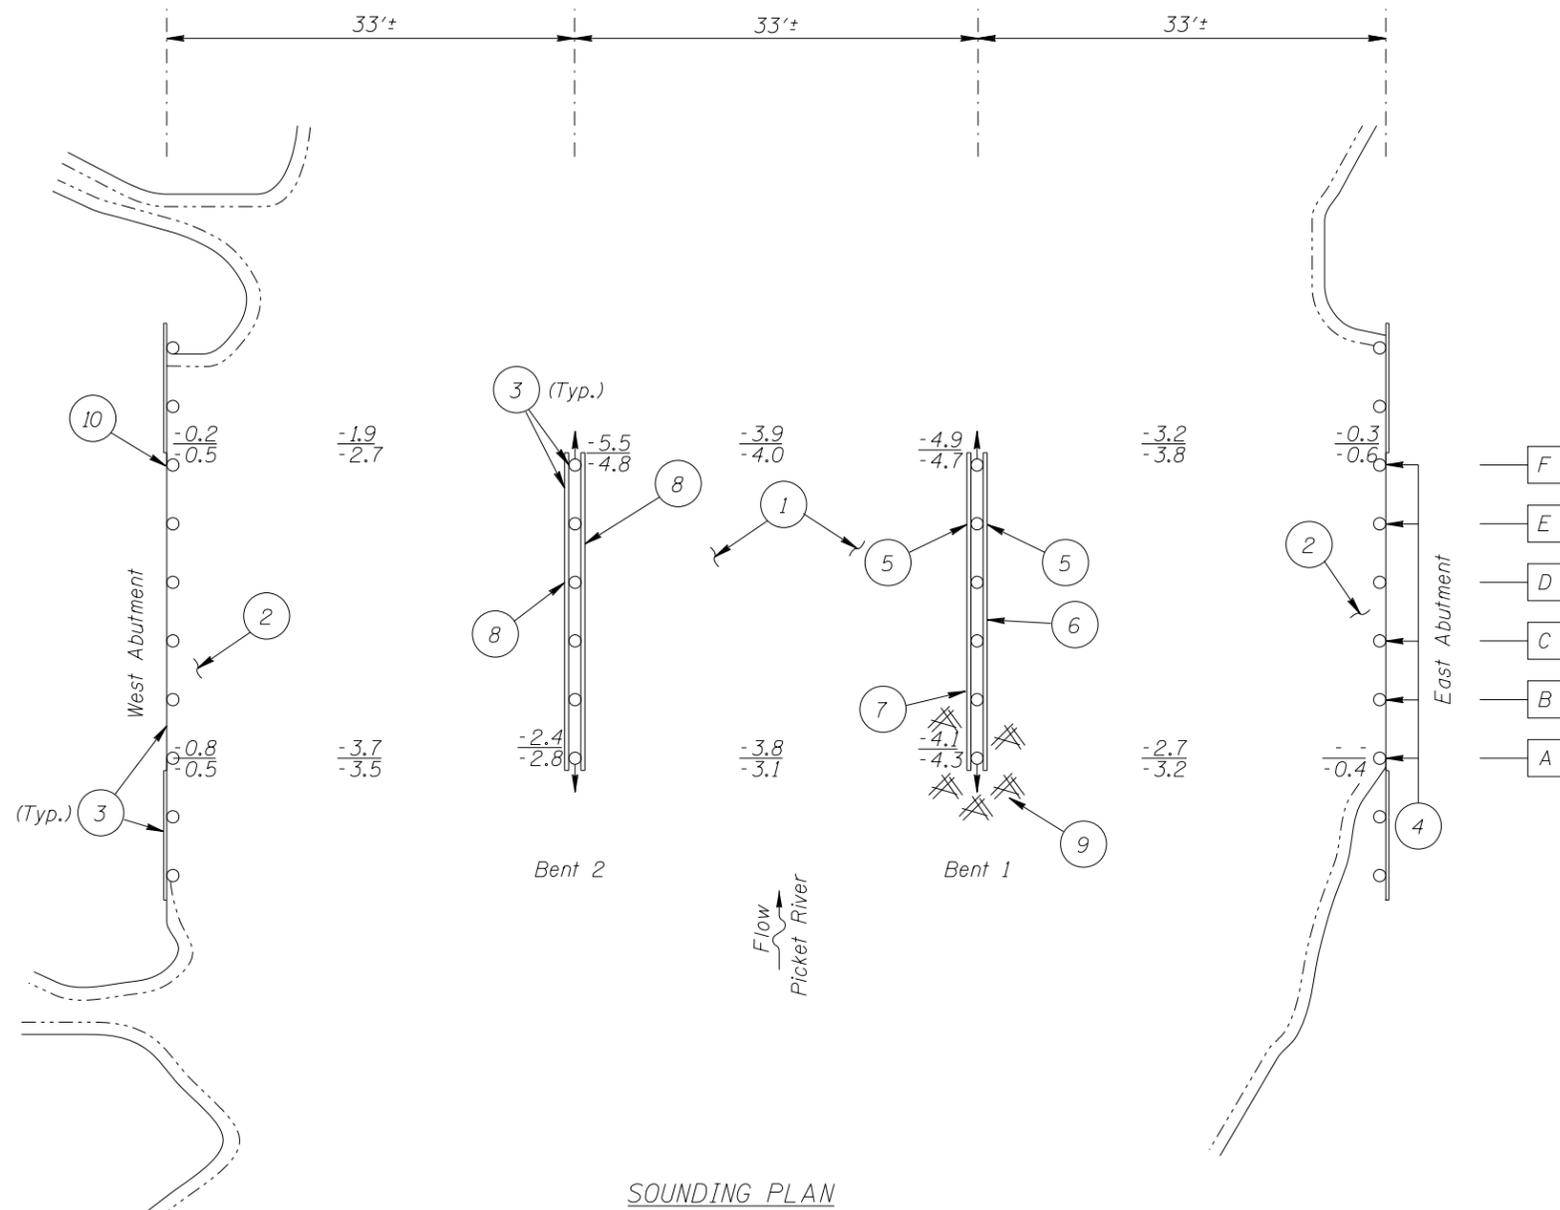
SOUNDING PLAN

- 1 The channel bottom material typically consisted of silty sand allowing 12 inches of probe rod penetration.
- 2 The channel bottom material in the vicinity of both abutments consisted of riprap 1.5 feet in diameter and smaller.

- 3 The timber piles, cross-bracing, wingwalls, and backwall planking were generally sound allowing a typical timber awl penetration of 1/16 to 1/8 inch.

- 4 The timber pile cap at the East Abutment was bearing on shims at the top of Piles A, B, C, E, and F.
- 5 A timber cross-brace was missing on the west and east side of Piles D through F of Bent 1.

- 6 The timber cross-bracing on the east side of Piles C and D of Bent 1 exhibited heavy deterioration and splitting with up to 100 percent section loss.

- 7 A split in the cross-brace, measuring up to 4 inches wide, was observed on the west side of Bent 1 extending from Pile D to Pile A. The cross-brace to pile connection at Pile D was compromised.

- 8 A split in the cross-brace, measuring up to 2 inches wide, was observed on the west side of Bent 2 extending from Pile C to Pile E. The cross-brace to pile connection at Pile D was compromised. Also, the cross-brace along the east side of the bent between Piles D and F was split approximately 1/2 inch (full depth).

- 9 A light accumulation of timber debris, consisting of 2 inch diameter and smaller branches, was observed around Pile A of Bent 1.
- 10 Timber pile cap at Pile F of the West Abutment was not fully bearing. Shims were installed, but appeared loose.
