2016 UNDERWATER BRIDGE INSPECTION REPORT

BRIDGE # 7780 CSAH 133 over DITCH

Date of Inspection: 09/13/2016

Contractor: Collins Engineers, Inc.

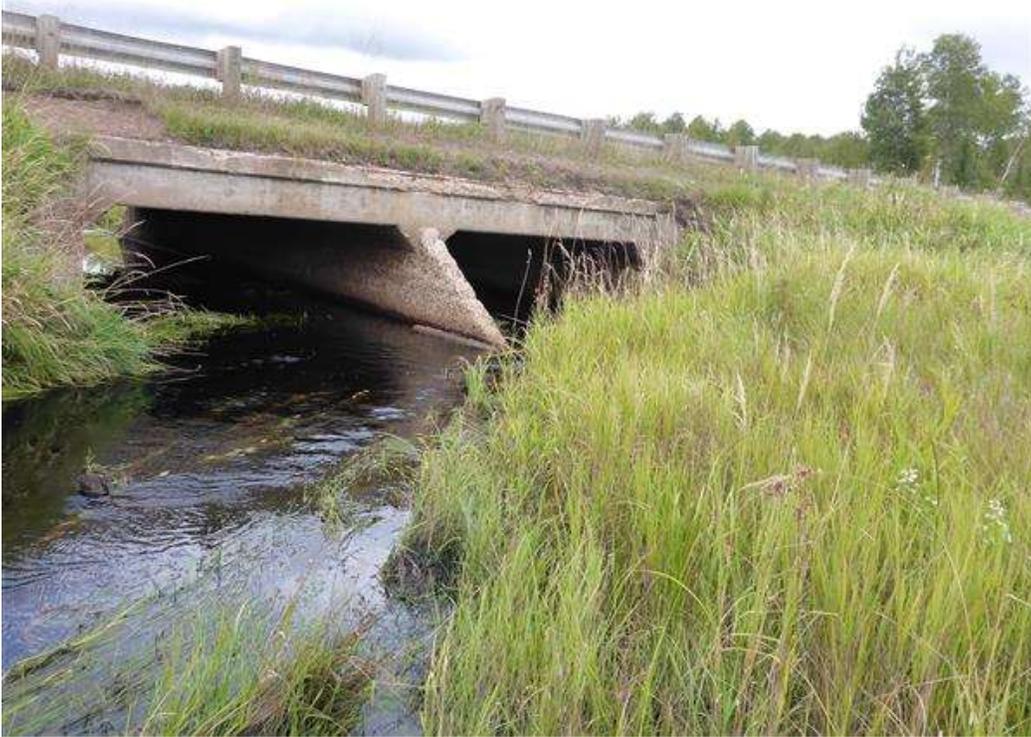
Photo 1 - Upstream Opening, Looking Northeast

(G) A 12 foot wide by 8 inch high area of concrete section loss was observed at the upstream headwall with up to 1.5 inches of penetration and exposed reinforcing steel exhibiting approximately 30 percent loss of section.

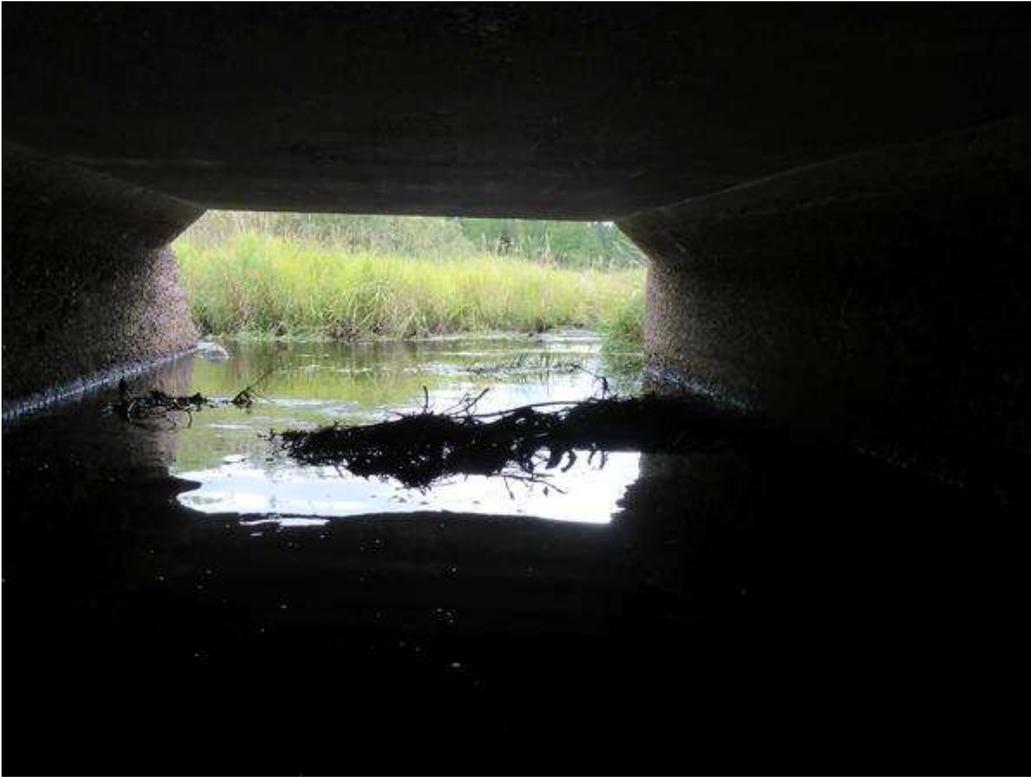
Photo 3 - Interior of Box 1, Looking South

(A) The culvert floor was typically covered in a layer of silty sand allowing a maximum probe rod penetration of 4 inches. Within Box 1 the culvert floor was at times exposed/clean of any infill material.

(E) A moderate timber debris accumulation of 4 inch diameter and smaller branches was observed slightly obstructing the flow within Box 1. The debris extended from the channel bottom to 1 foot above the waterline.

(A) Remove the timber debris accumulation in Box 1 before it becomes more detrimental. If the debris accumulation increases in size or density or the flow through the culvert increases, it may become more imperative to remove the debris to reduce excessive lateral loads on the culvert, limit further debris accumulation, and reduce the likelihood of channel bottom degradation resulting from obstructed flow.

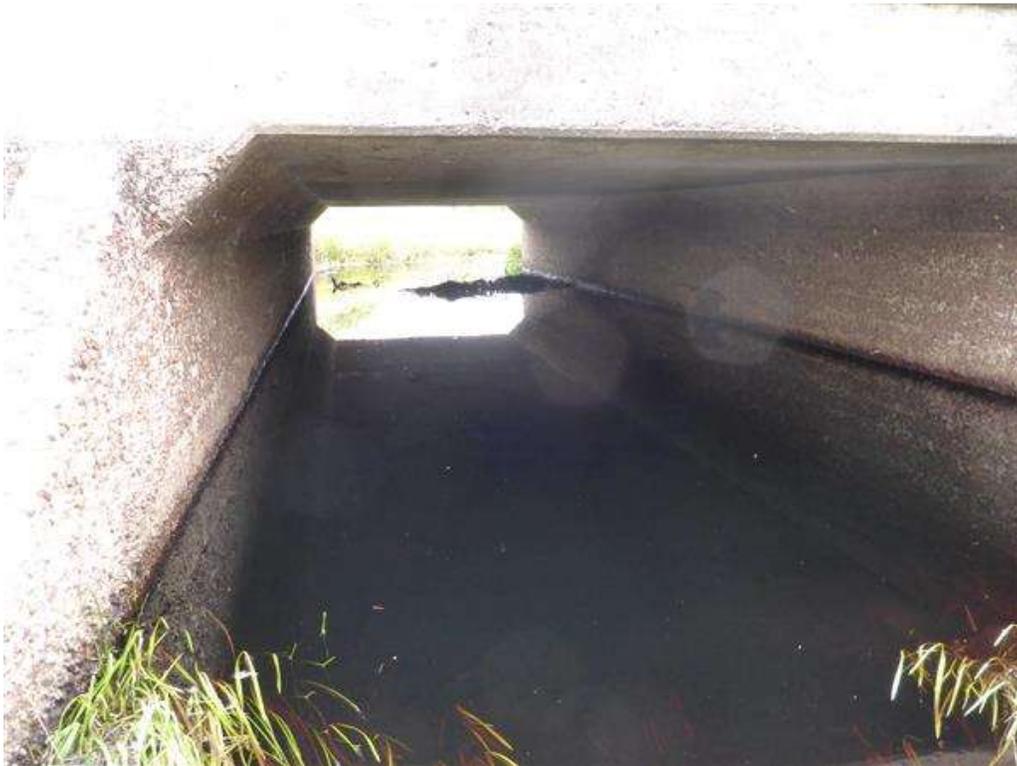
Photo 4 - Interior of Box 2, Looking South

(C) The concrete of the culvert walls and haunches exhibited moderate to heavy scaling with a typical penetration of 1/2 inch and a maximum penetration of 3/4 inch.

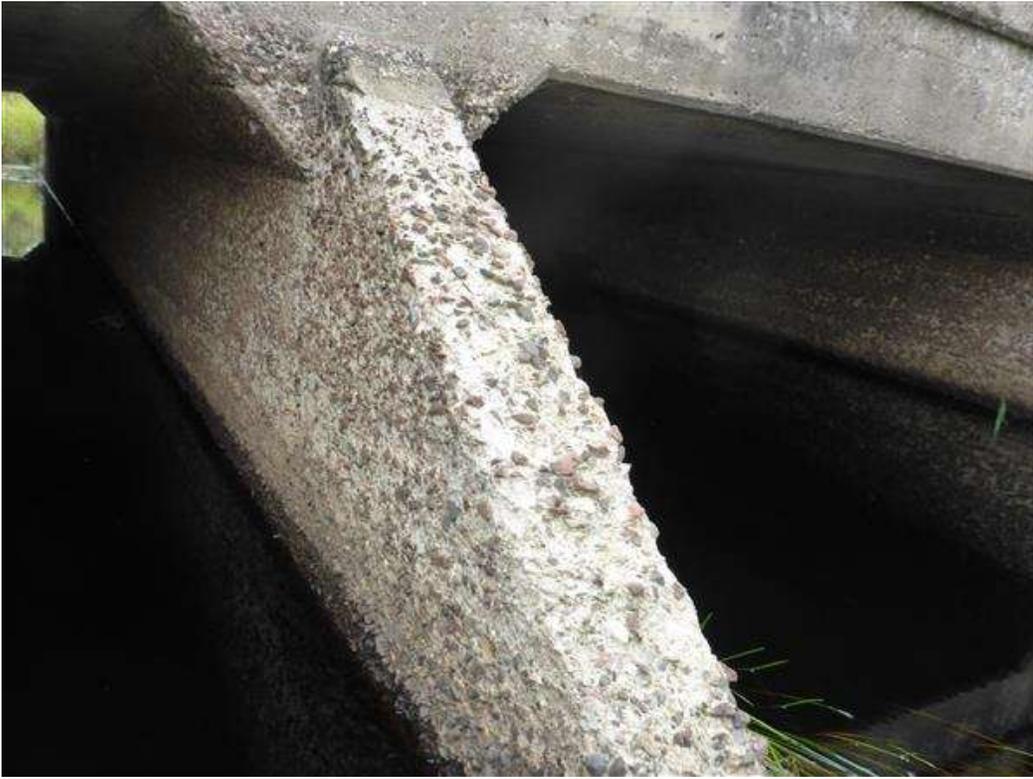
Photo 5 - Downstream Center Wall Condition, Looking Southwest

(F) The concrete of the center wall extension at the upstream and downstream ends of the culvert exhibited heavy scaling with a maximum penetration of 2 inches.

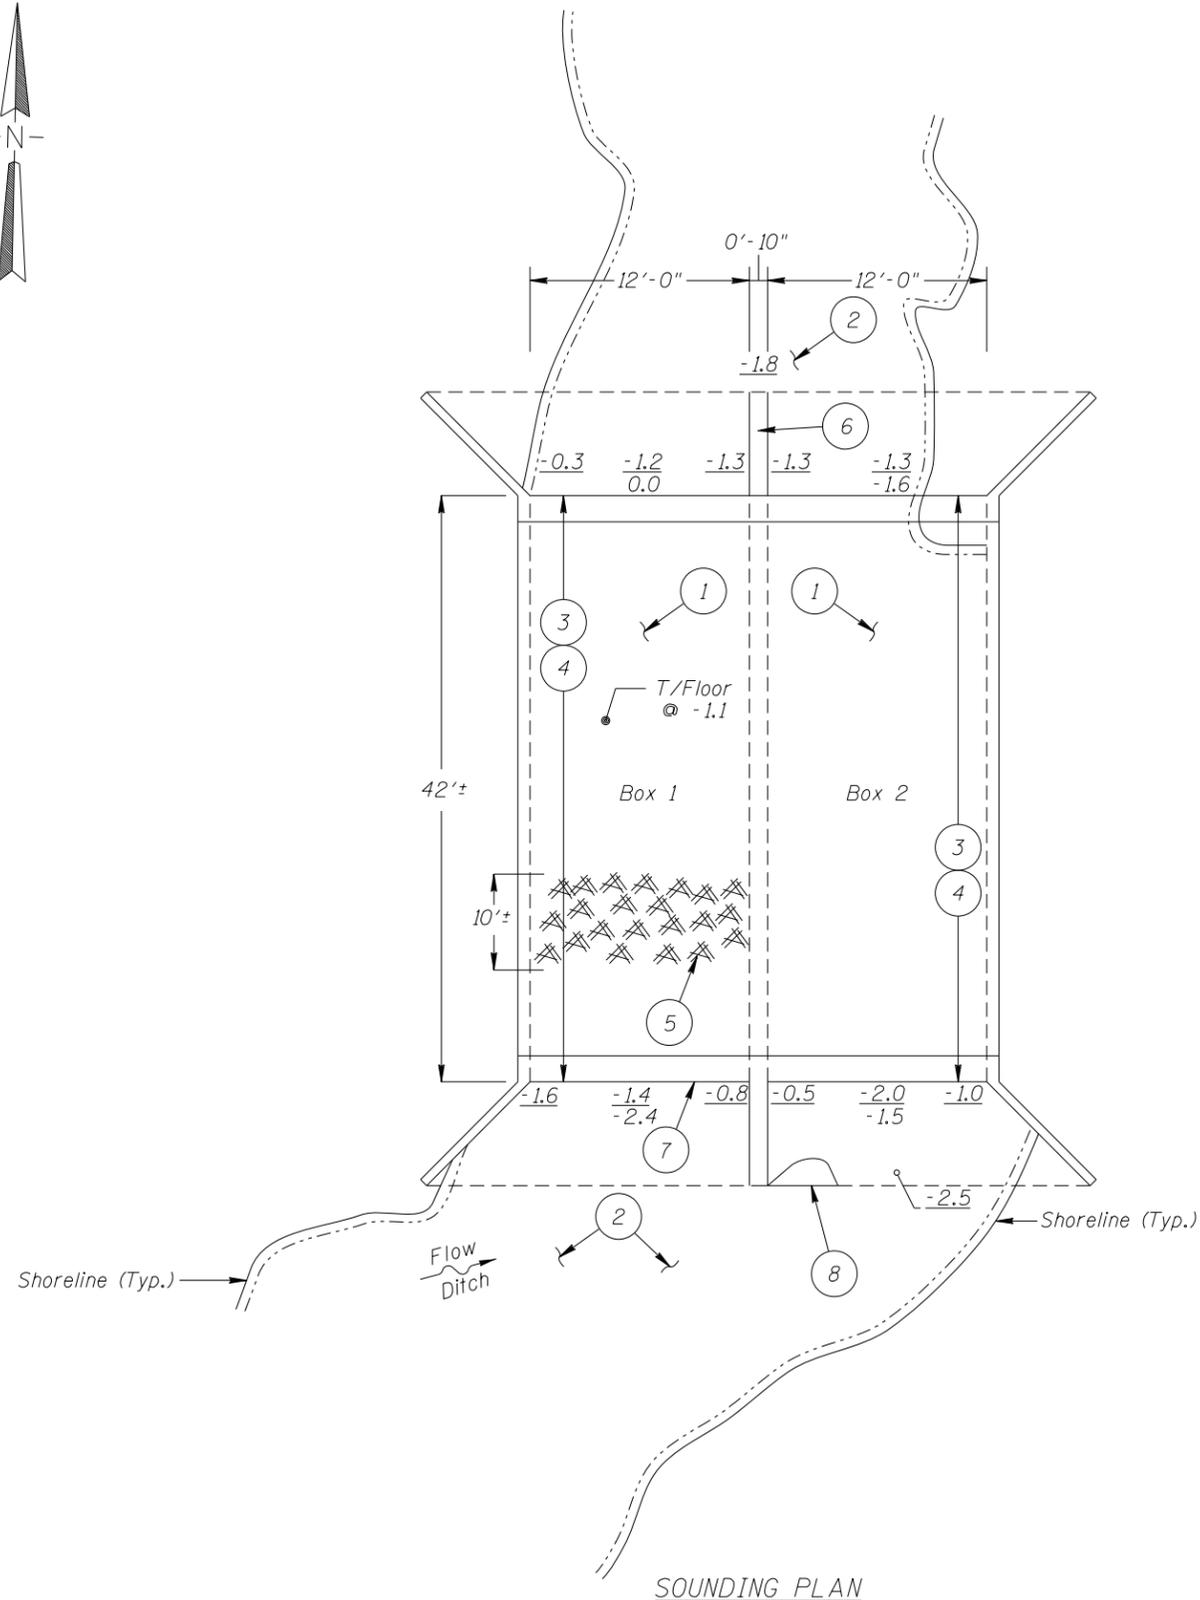
SOUNDING PLAN

- ① The culvert floor was typically covered in a layer of silty sand allowing a maximum probe rod penetration of 4 inches. Within Box 1 the culvert floor was at times exposed/clean of any infill material.

- ② The channel bottom material upstream and downstream of the culvert apron consisted of silty sand allowing a maximum probe rod penetration of 8 inches.

- ③ The concrete of the culvert walls and haunches exhibited moderate to heavy scaling with a typical penetration of 1/2 inch and a maximum penetration of 3/4 inch.

- ④ The concrete of the culvert ceiling exhibited light scaling with a maximum penetration of 1/4 inch and random areas of poor concrete consolidation with a maximum penetration of 1 inch.

- ⑤ A moderate timber debris accumulation of 4 inch diameter and smaller branches was observed slightly obstructing the flow within Box 1. The debris extended from the channel bottom to 1 foot above the waterline.

- ⑥ The concrete of the center wall extension at the upstream and downstream ends of the culvert exhibited heavy scaling with a maximum penetration of 2 inches.

- ⑦ A 12 foot wide by 8 inch high area of concrete section loss was observed at the upstream headwall with up to 1.5 inches of penetration and exposed reinforcing steel exhibiting approximately 30 percent loss of section.

- ⑧ Apron toe was locally detected at the upstream opening with no measurable vertical exposure.
