# 2016 UNDERWATER BRIDGE INSPECTION REPORT

## BRIDGE # 88620 CSAH 133 over JOULA CREEK

Date of Inspection: 06/24/2016

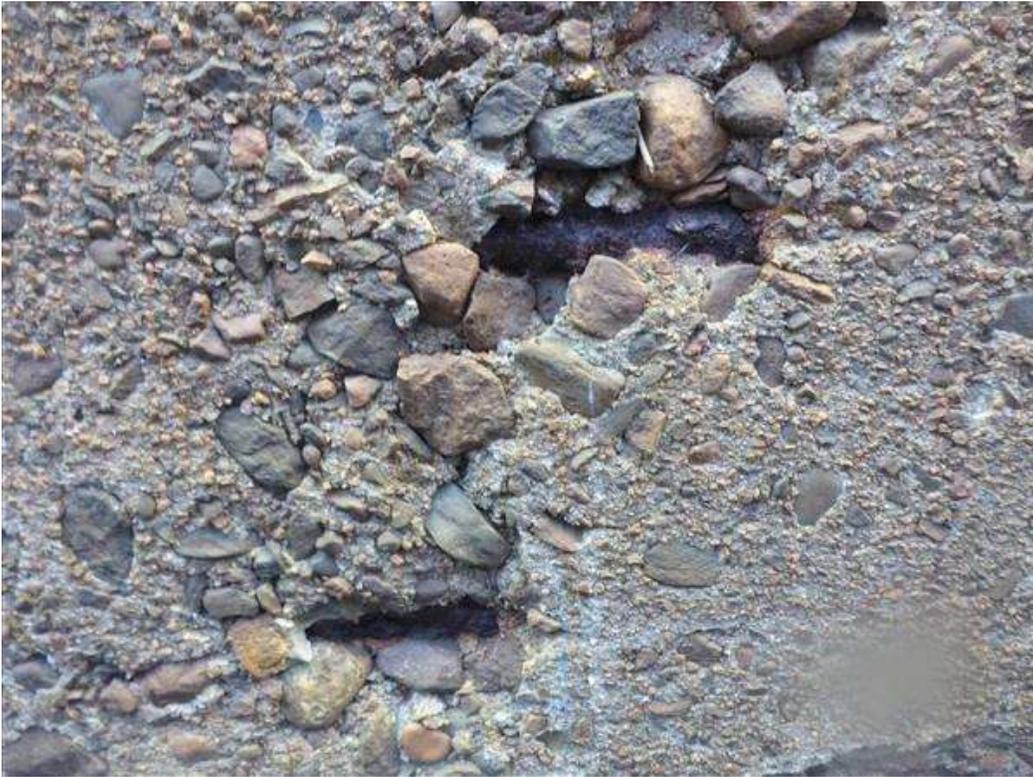
(F) Random areas of poor consolidation were observed on the concrete ceiling of the structure with up to 2 inches of penetration. Exposed reinforcing steel was present at several locations. The exposed reinforcing steel typically exhibited less than 5 percent section loss.

Photo 3 - Typical Poor Consolidation with Exposed Reinforcing Steel (Ceiling Shown)

(C) Monitor the concrete deterioration during future underwater inspections.

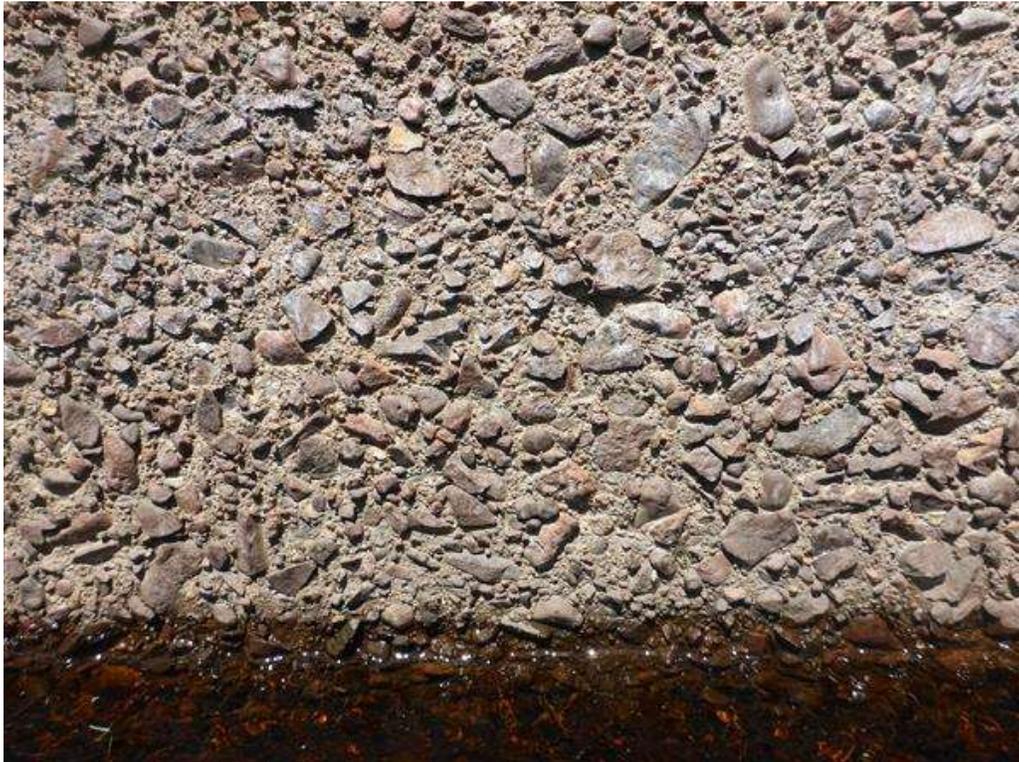
(G) The concrete surfaces typically exhibited moderate scaling with up to 1/4 inch of penetration and exposed large aggregate extending from the culvert bottom to 2 feet above the waterline.

Photo 4 - Typical Concrete Scaling, Looking West

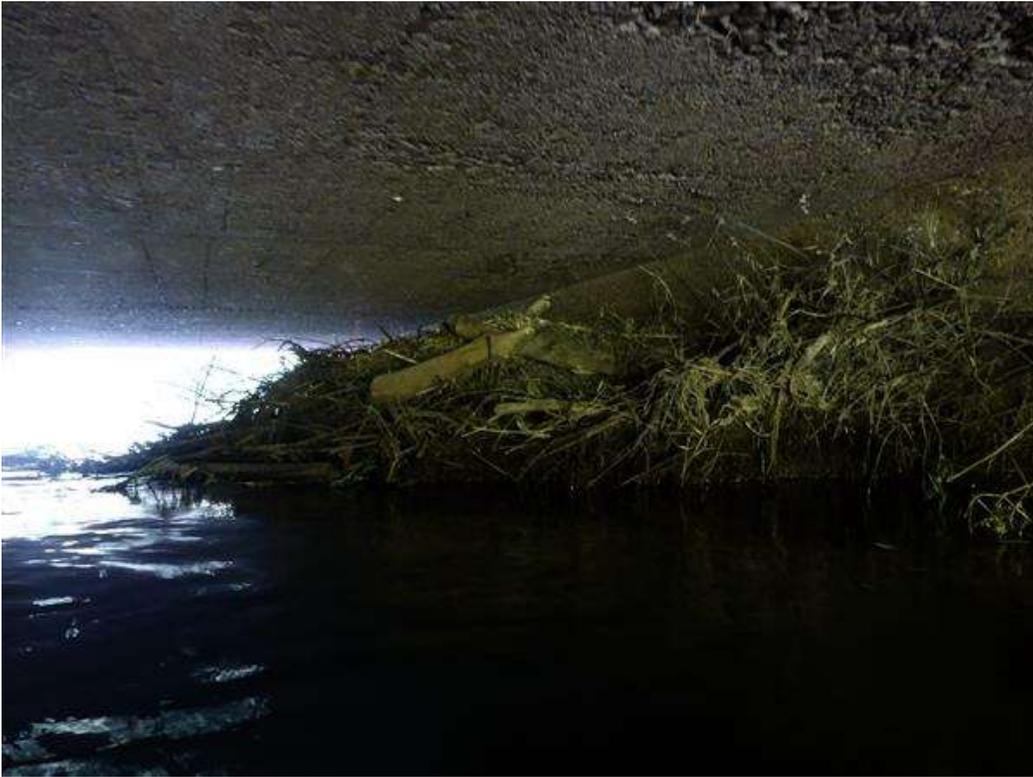
(D) A heavy accumulation of timber debris between the downstream quarter-point and the midpoint extended from the culvert bottom to 2 feet above the waterline along the west half and from the culvert bottom to the waterline along the east half of the structure. Due to the accumulation a hydraulic drop of approximately 2 inches was observed along the west half of the culvert.

(E) A moderate accumulation of timber debris from the downstream fascia to the downstream quarter-point of the structure extended from the culvert bottom to 2 feet below the waterline.

Photo 5 - Timber Debris Accumulation, Looking South

(B) Remove the timber debris to restore the full hydraulic capacity.

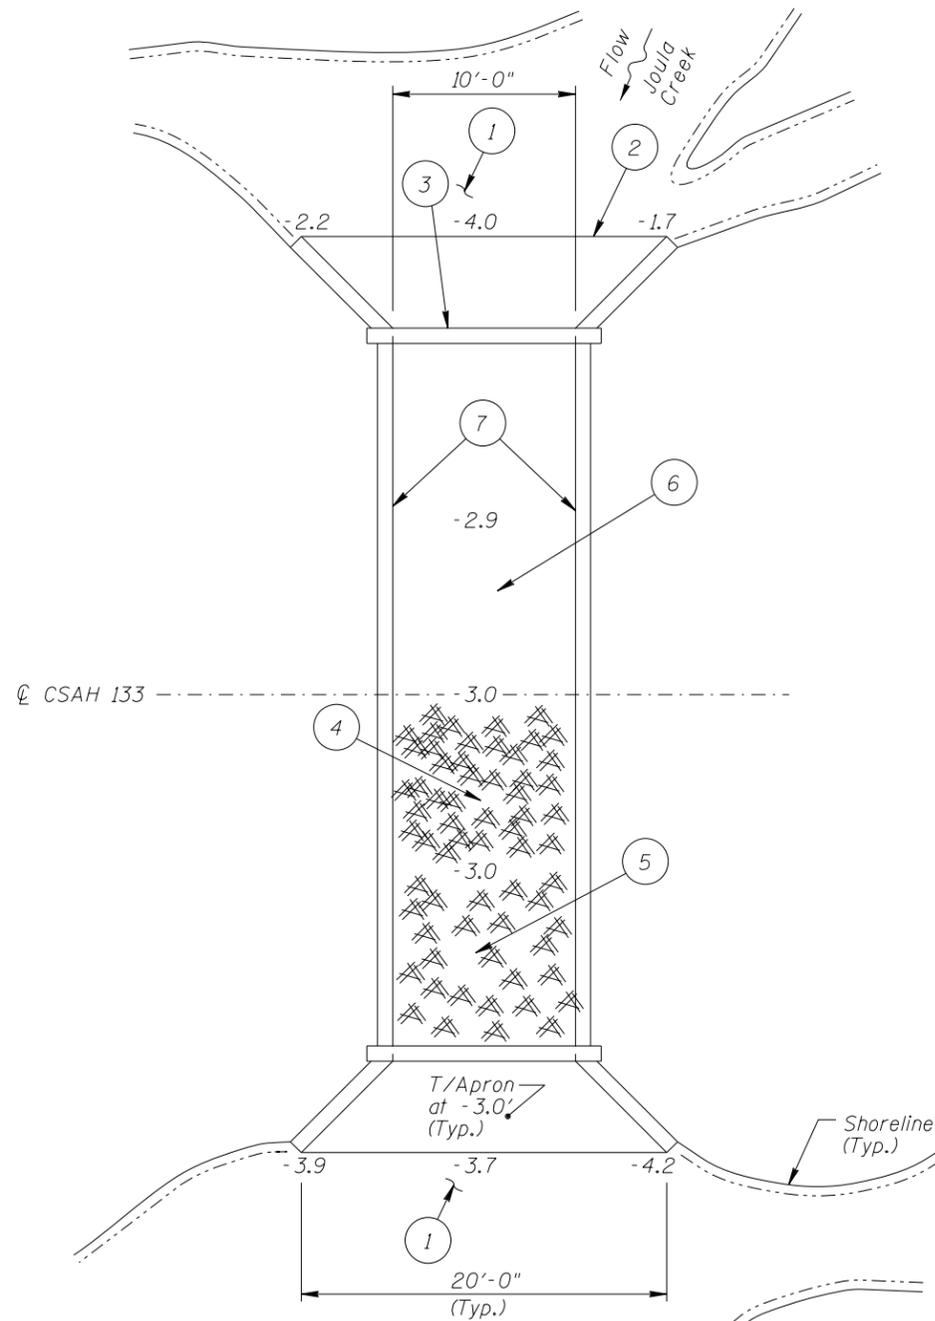
SOUNDING PLAN

- 1 Channel bottom material along the upstream and downstream toe consisted of soft silt allowing 6 inches of probe rod penetration.
- 2 Toe at the upstream and downstream apron was exposed with 0.9 feet of maximum vertical exposure. No apron undermining was observed.

- 3 Spall with exposed reinforcing steel measured 2 feet wide by 6 inches long along the bottom of the upstream headwall. Exposed reinforcing steel typically exhibited less than 5 percent section loss.

- 4 Heavy accumulation of timber debris between the downstream quarter-point and the midpoint extended from the culvert bottom to 2 feet above the waterline along the west half and from the culvert bottom to the waterline along the east half of the structure. Due to the accumulation a hydraulic drop of approximately 2 inches was observed along the west half of the culvert.

- 5 Moderate accumulation of timber debris from the downstream fascia to the downstream quarter-point of the structure extended from the culvert bottom to 2 feet below the waterline.

- 6 Random areas of poor consolidation were observed on the concrete ceiling of the structure with up to 2 inches of penetration. Exposed reinforcing steel was present at several locations. The exposed reinforcing steel typically exhibited less than 5 percent section loss.

- 7 Concrete surfaces typically exhibited moderate scaling with up to 1/4 inch of penetration and exposed large aggregate extending from the culvert bottom to 2 feet above the waterline.
