2016 UNDERWATER BRIDGE INSPECTION REPORT

BRIDGE # 88621 CR 675 over LESTER RIVER

Date of Inspection: 09/15/2016

UNDERWATER INSPECTION

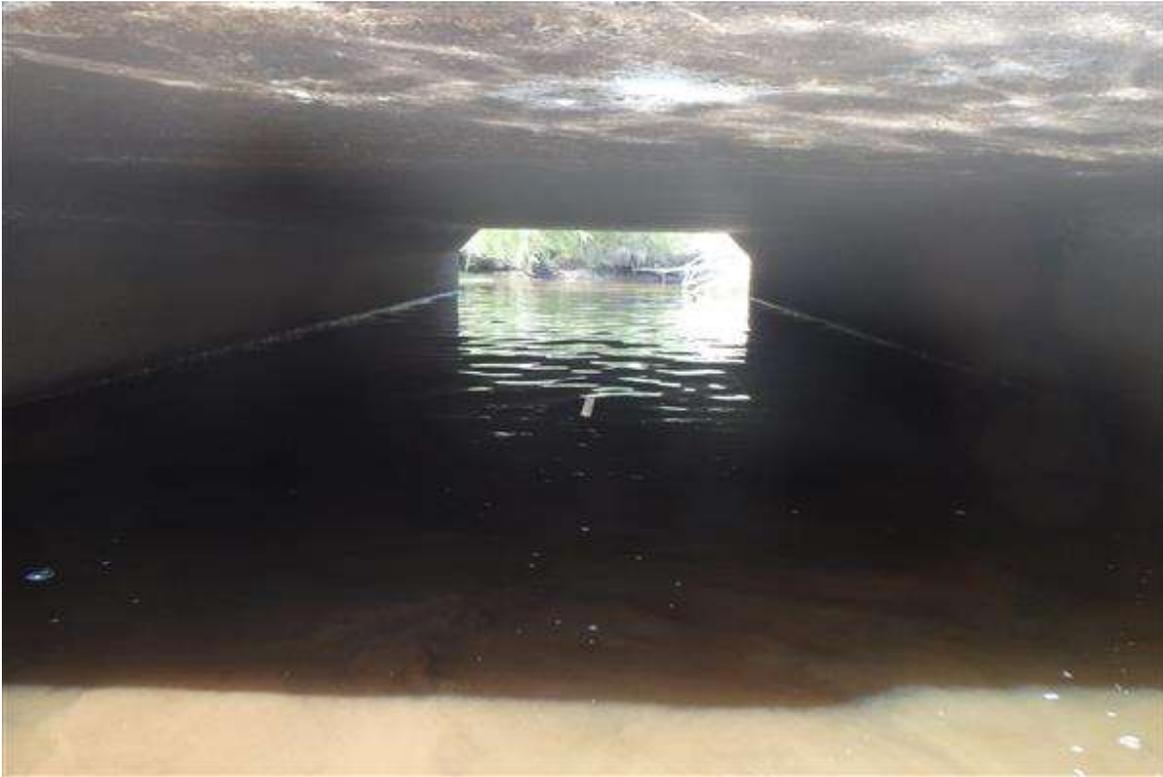
Photo 3 - Through Barrel, Looking West

(C) The culvert floor was exposed from 5 feet in from the upstream end to 5 feet in from the downstream end and free of any debris.

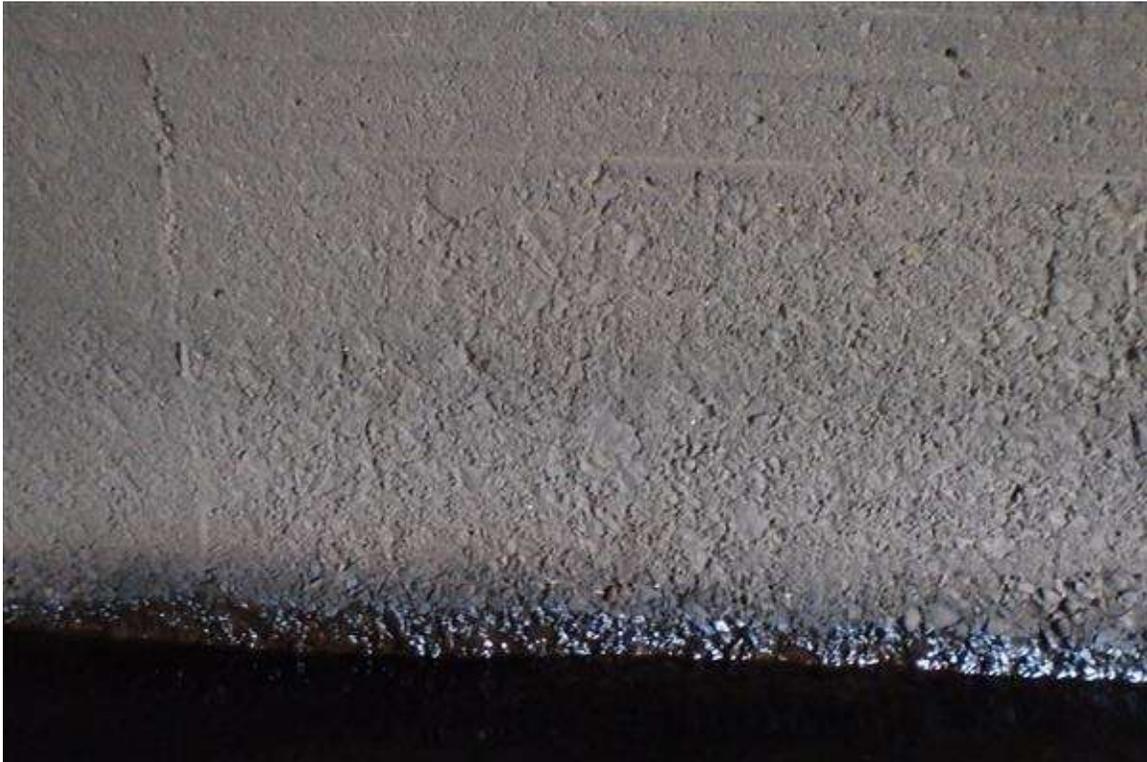
Photo 4 - Typical Concrete Condition at Waterline, Looking South

(A) The concrete walls and floor typically exhibited moderate scaling up to 1/2 inch deep. The concrete headwalls, haunch, and ceiling typically exhibited light scaling up to 1/4 inch deep.

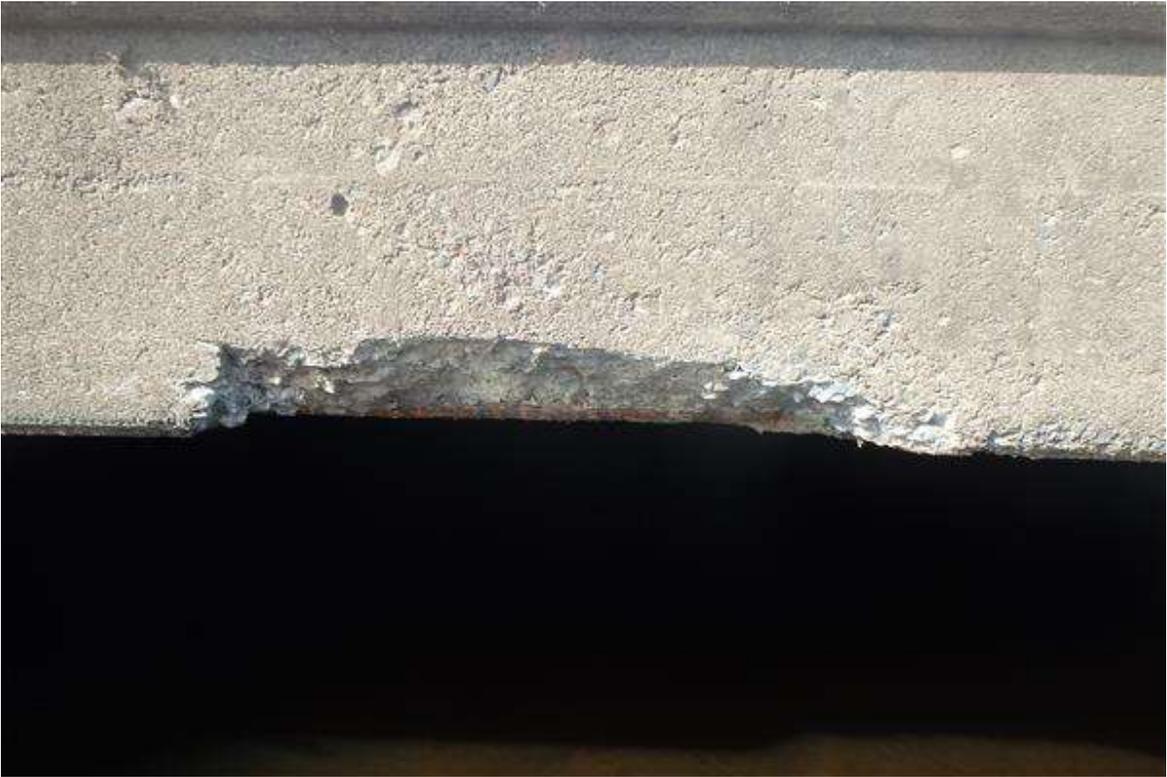
Photo 5 - Spall at Downstream Headwall, Looking West

(D) A concrete corner spall was present on the downstream headwall 3 feet long, extending 4 inches on both faces with up to 2 inches of penetration with one exposed reinforcement bar with less than 10 percent section loss.

Notes: [2016 U/W] Spall at downstream headwall.
 [2016 Sept] Scale along wetted perimeter exposing aggregates but aggregates remain sound.
 [2016] 1.5' spall on bottom of east headwall with exposed corroding rebar.
 [2014] Water within 2" of culvert top.
 [2013] Scaling at and below waterline.
 CURB SPALLED ON NW CORNER.

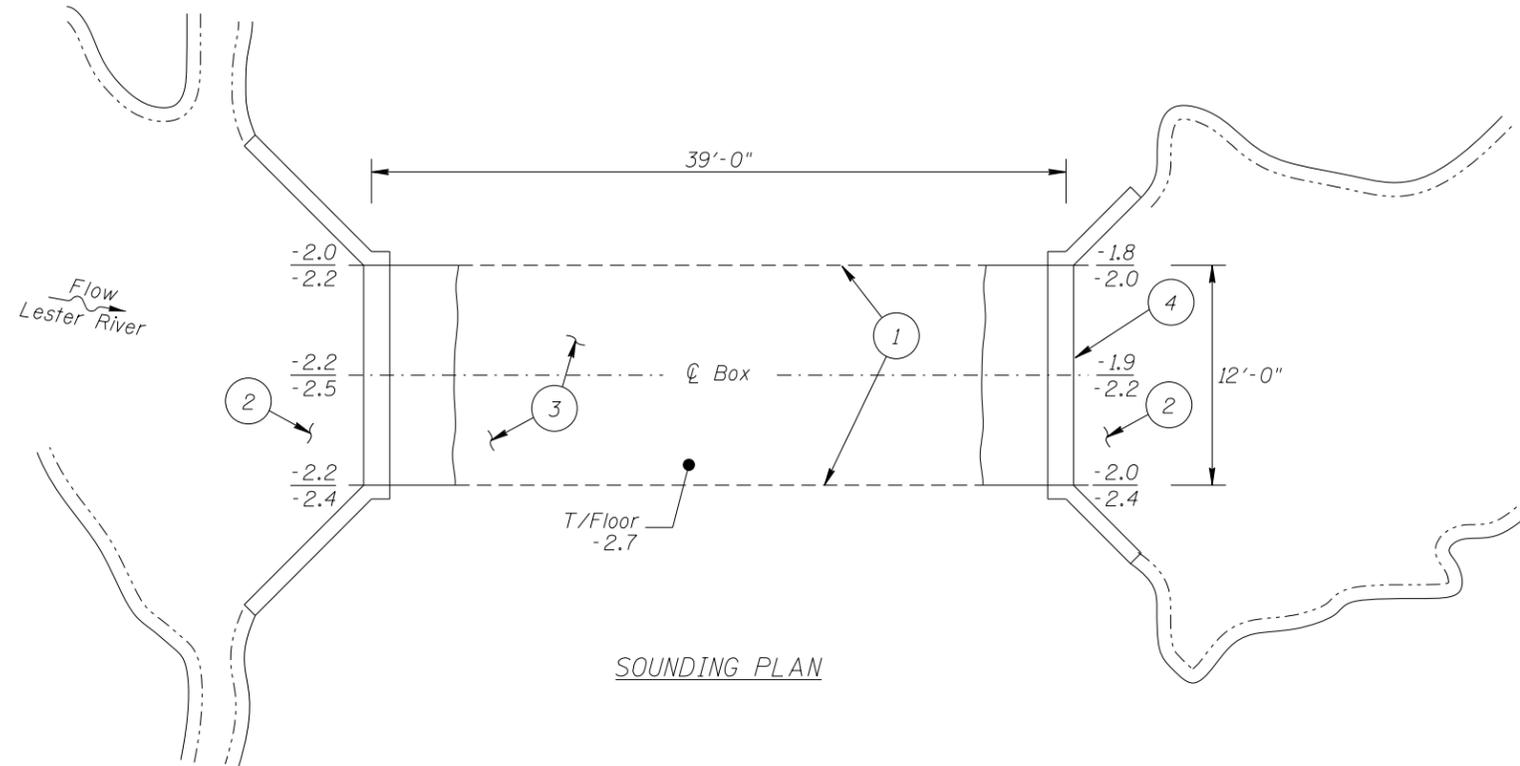
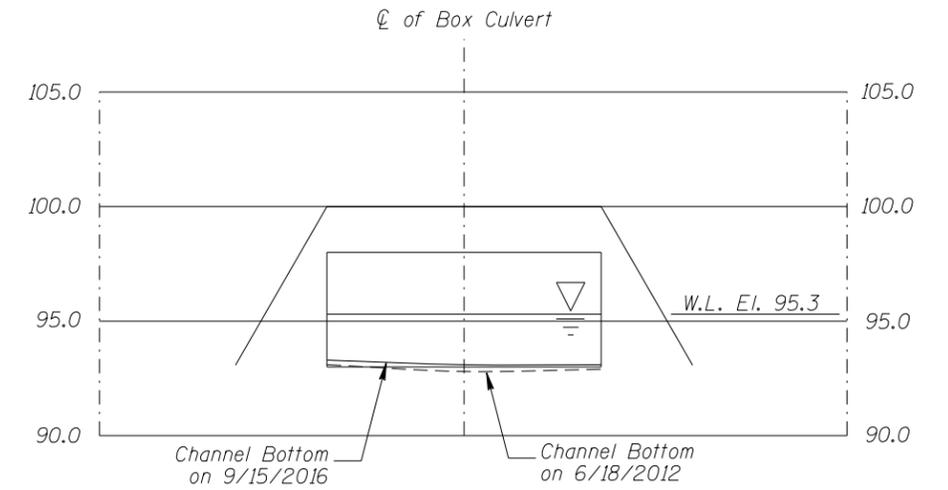
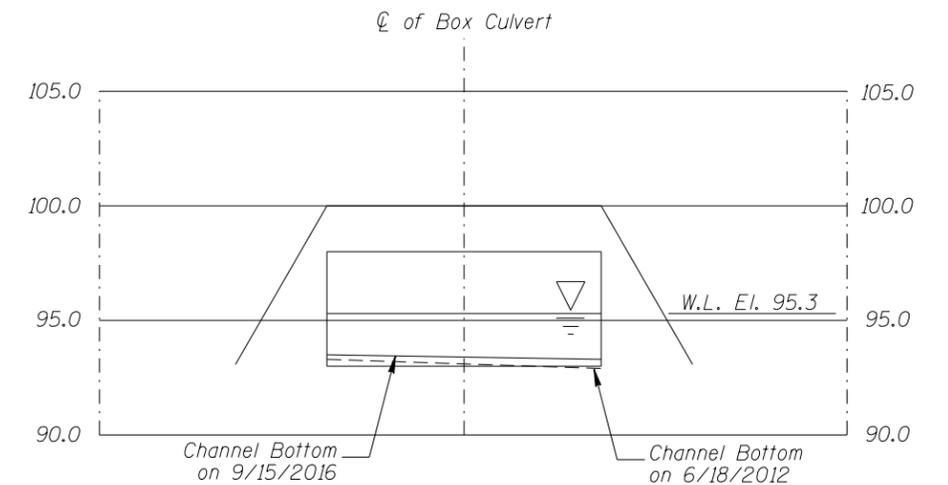
SOUNDING PLAN

- 1 The concrete walls and floor typically exhibited moderate scaling up to 1/2 inch deep. The concrete headwalls, haunch, and ceiling typically exhibited light scaling up to 1/4 inch deep.
- 2 The channel bottom at the upstream and downstream concrete aprons consisted of gravel and scattered rocks up to 6 inches in diameter.
- 3 The culvert floor was exposed from 5 feet in from the upstream end to 5 feet in from the downstream end and free of any debris.
- 4 Concrete corner spall on downstream headwall 3 feet long, extending 4 inches on both faces with up to 2 inches of penetration with one exposed reinforcement bar with less than 10% section loss.
