2016 UNDERWATER BRIDGE INSPECTION REPORT

BRIDGE # 88631 CR 958 over STREAM

Date of Inspection: 06/22/2016

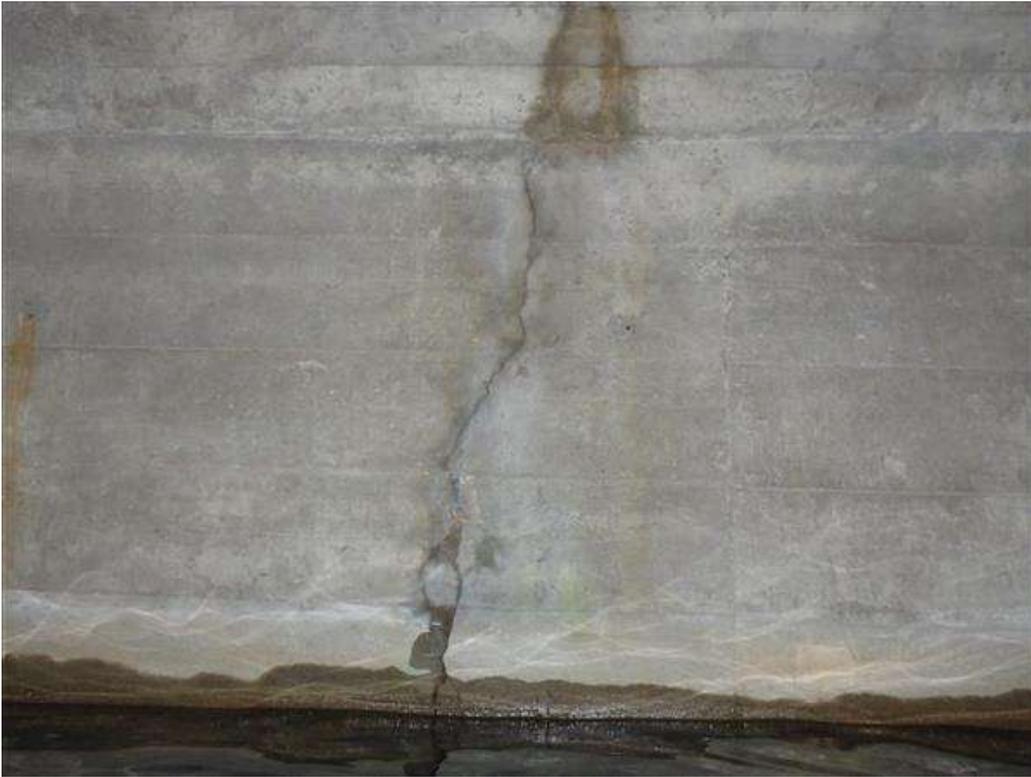
- (D) Several vertical cracks with efflorescence, up to 1/8 inch wide, were observed on both walls of the culvert extending from the channel bottom to the ceiling at the upstream end, near the midpoint, and the downstream end of the culvert. The cracks had associated areas of concrete section loss up to 2 inches wide with 1 inch of penetration.

Photo 3 - Typical Vertical Cracking, Looking West

- (A) Monitor the vertical cracks and associated areas of concrete section loss during future underwater inspections.
- (B) Reinspect the submerged substructure units at the normal maximum recommended (NBIS) interval of sixty (60) months.

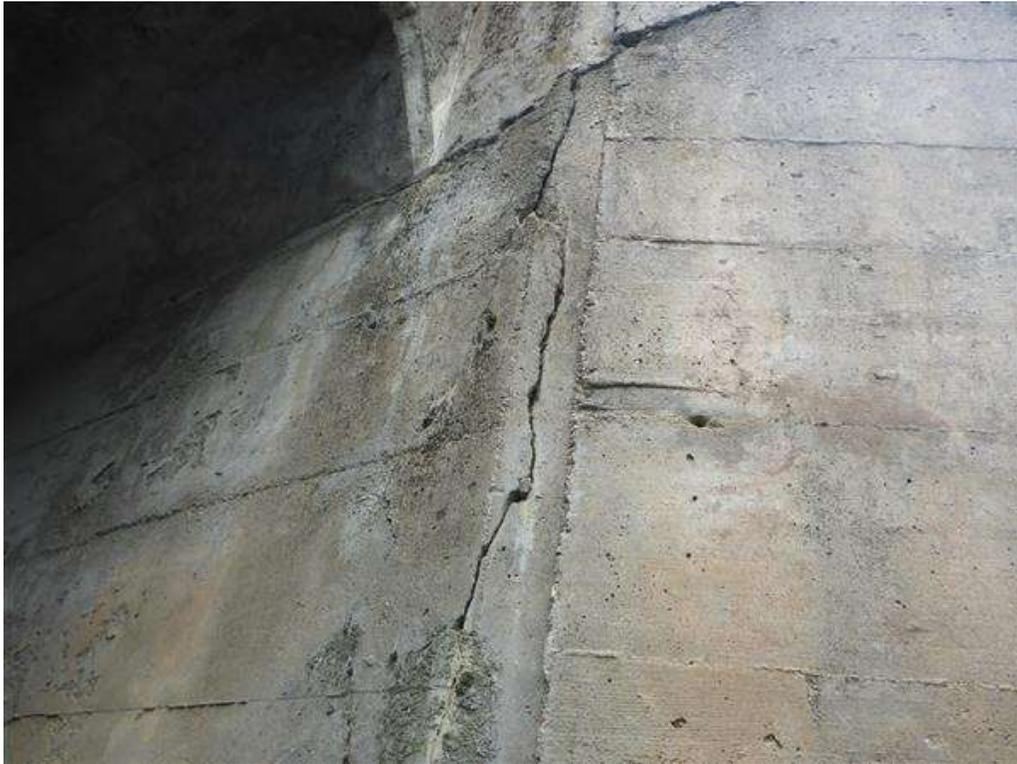
- (G) All four wingwalls exhibited random vertical cracks with efflorescence extending from the channel bottom to the top of the wingwall. The cracks had a maximum width of 1/16 inch.

Photo 4 - Typical Wingwall Cracking (Southeast Shown), Looking Northeast

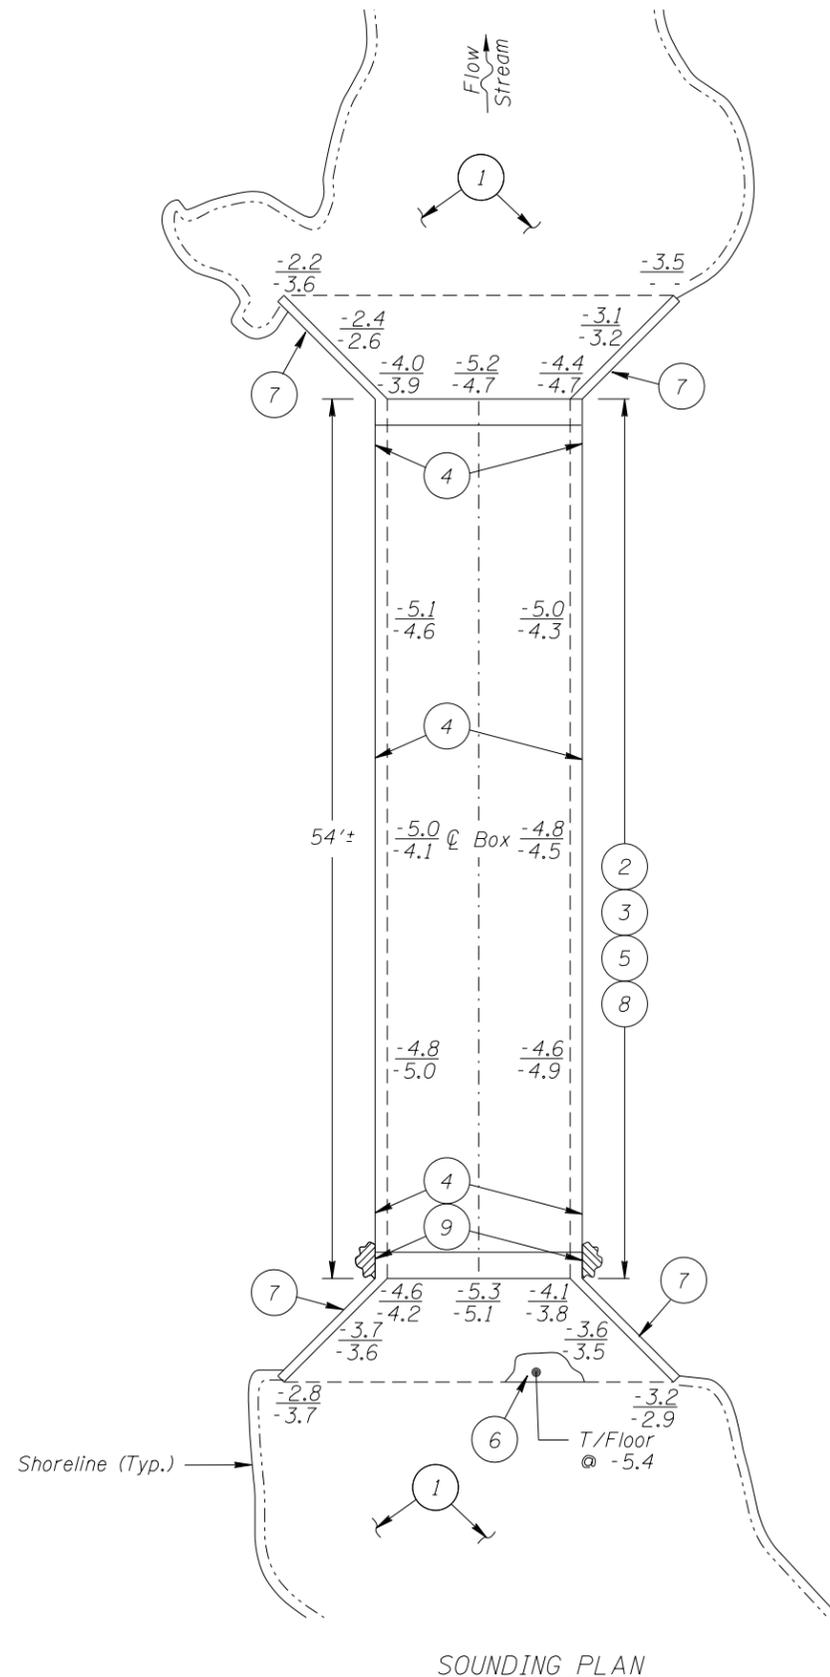
- ① The channel bottom material consisted of soft silt allowing a maximum probe rod penetration of 1 foot.
- ② The concrete of the culvert was typically smooth and sound unless noted otherwise.

- ③ Voids with efflorescence ($\frac{1}{2}$ inch ϕ holes) were observed throughout the culvert spaced at approximately 5 feet on center, at 3 feet above the waterline on both walls. Voids appeared to be formed.

- ④ Vertical cracks with efflorescence, up to $\frac{1}{8}$ inch wide, were observed on both walls of the culvert extending from the channel bottom to the ceiling at the upstream end, near the midpoint, and the downstream end of the culvert. The cracks had areas of associated concrete section loss up to 2 inches wide with 1 inch of penetration.

- ⑤ A longitudinal crack was observed along the bottom of the haunch on both sides of the culvert. The cracks were up to $\frac{1}{32}$ inch wide and ran the entire length of the culvert.

- ⑥ A 3 foot diameter area of the apron was exposed at the upstream end of the culvert. Only the top of the apron was exposed, no vertical exposure was observed.

- ⑦ All four wingwalls exhibited random vertical cracks with efflorescence extending from the channel bottom to the top of the wingwall. The cracks had a maximum width of $\frac{1}{16}$ inch.

- ⑧ Scattered timber debris, consisting of small branches, was observed throughout the culvert length.
- ⑨ There were two areas of minor erosion behind the south headwall measuring approximately 2 feet deep and 3 feet long.
