2016 UNDERWATER BRIDGE INSPECTION REPORT

BRIDGE # 88639 CR 615 over CREEK

UNDERWATER INSPECTION

REPORT SUMMARY

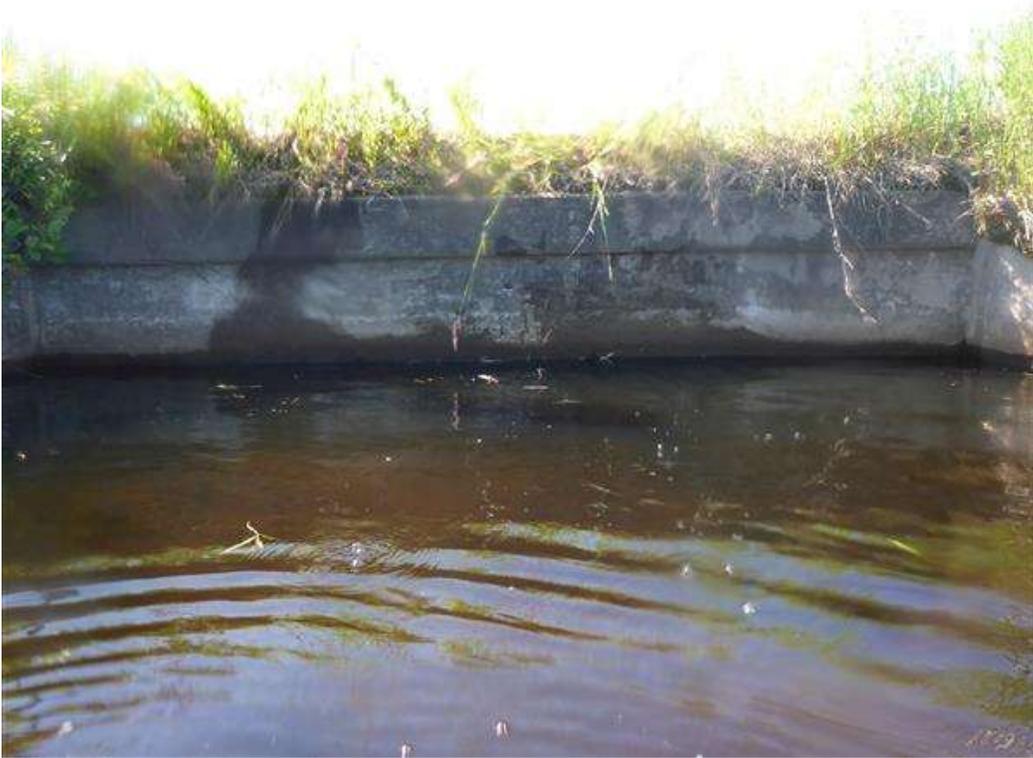
Photo 1 - Overall View of Downstream Culvert Opening, Looking South

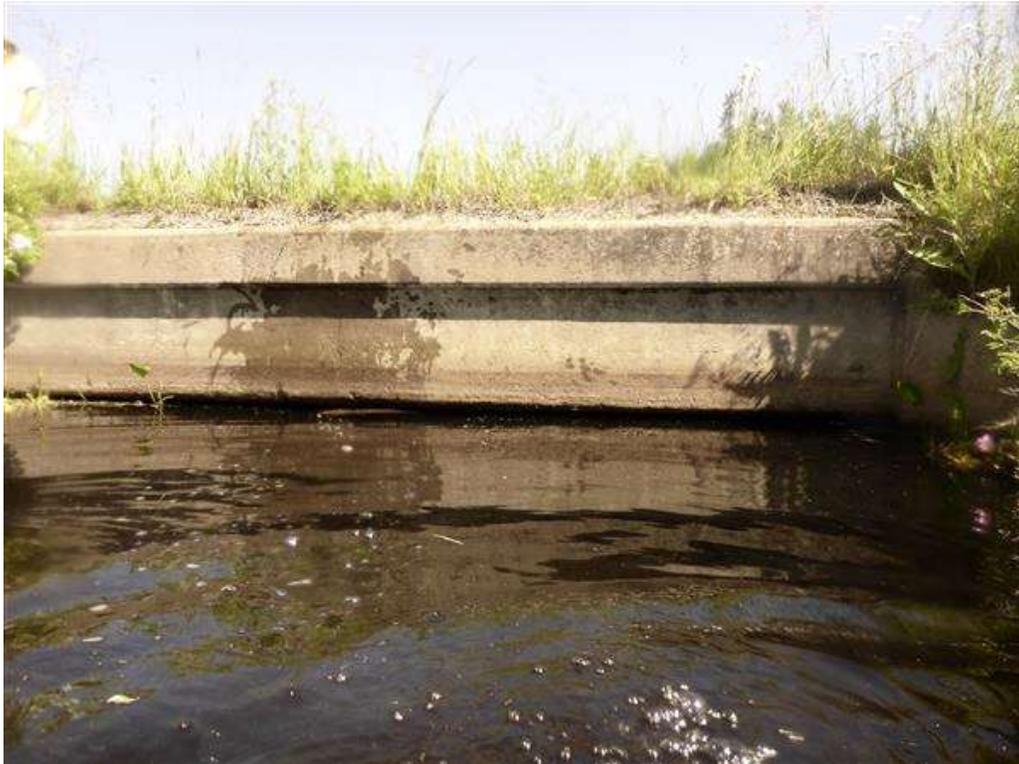
Photo 2 - Overall View of Upstream Culvert Opening, Looking North

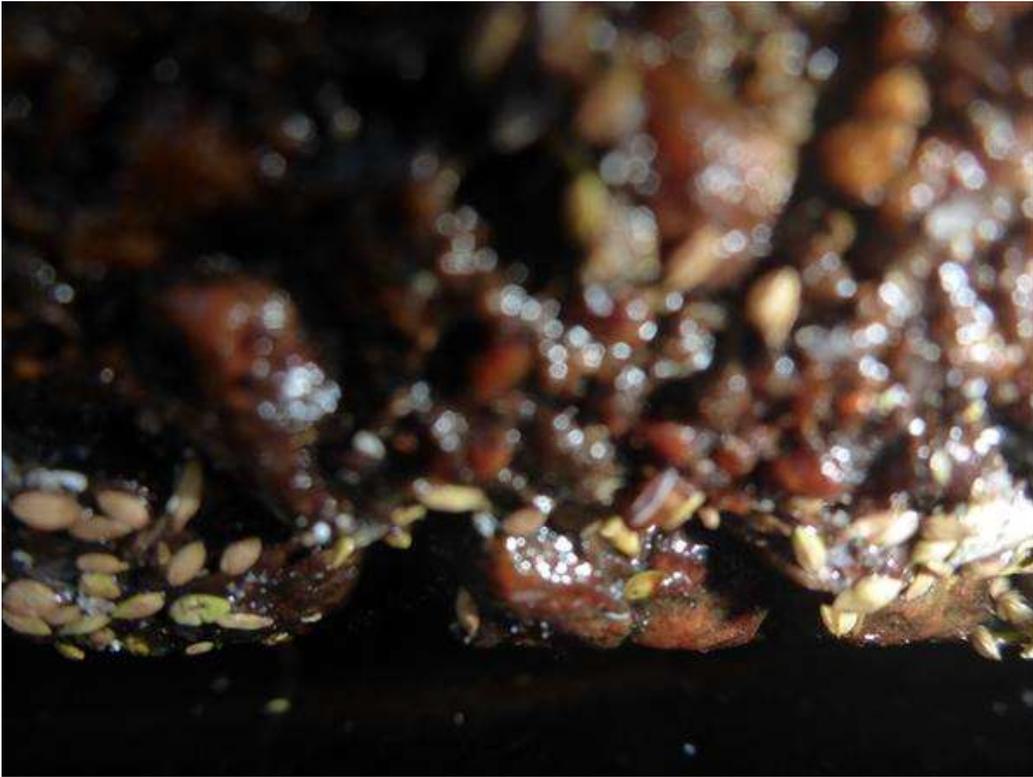
Photo 3 - Typical Concrete Condition at Waterline, Looking North

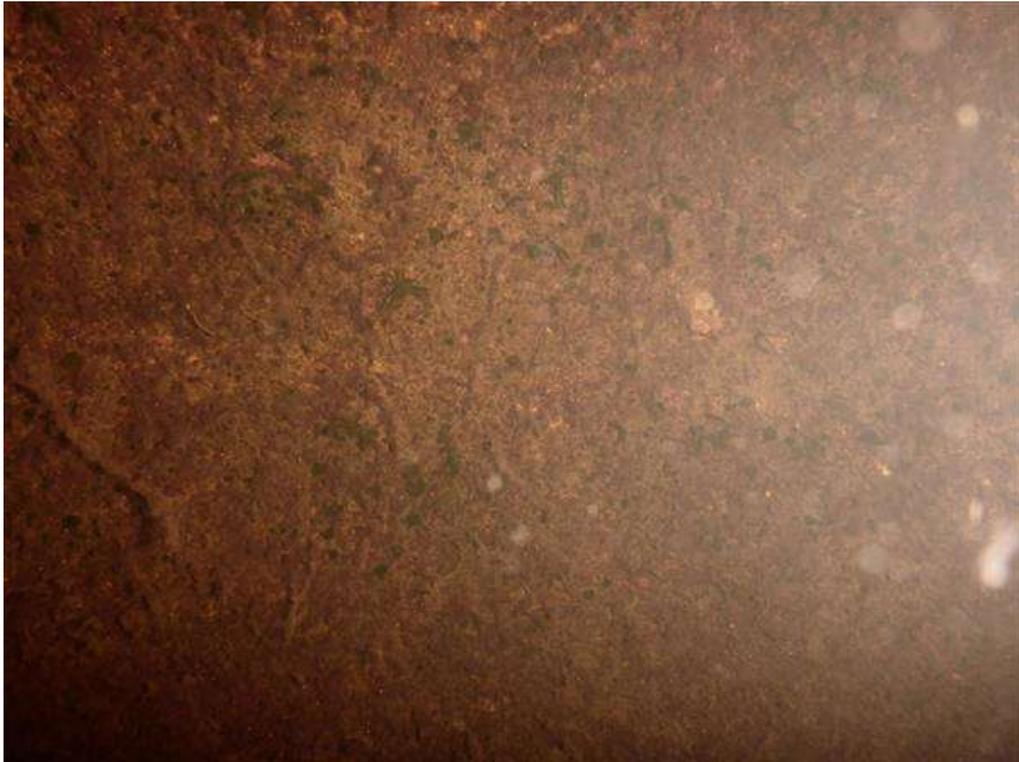
Photo 4 - Typical Concrete Condition Underwater, Looking West

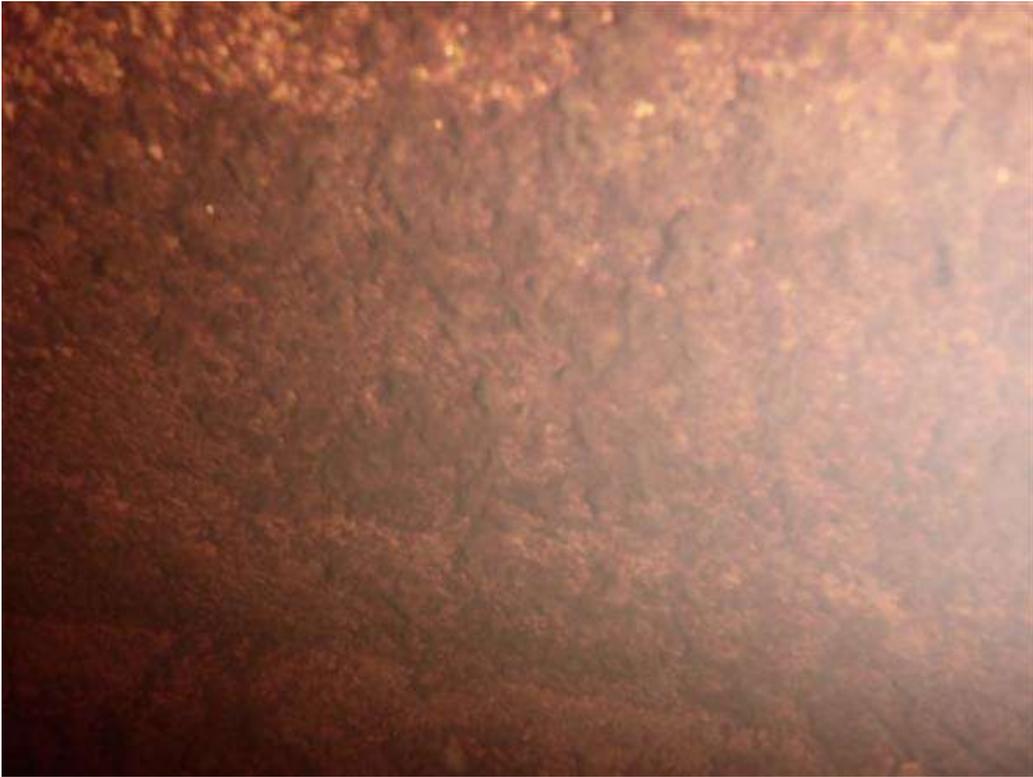
Photo 5 - Typical Concrete Condition Underwater, Looking West

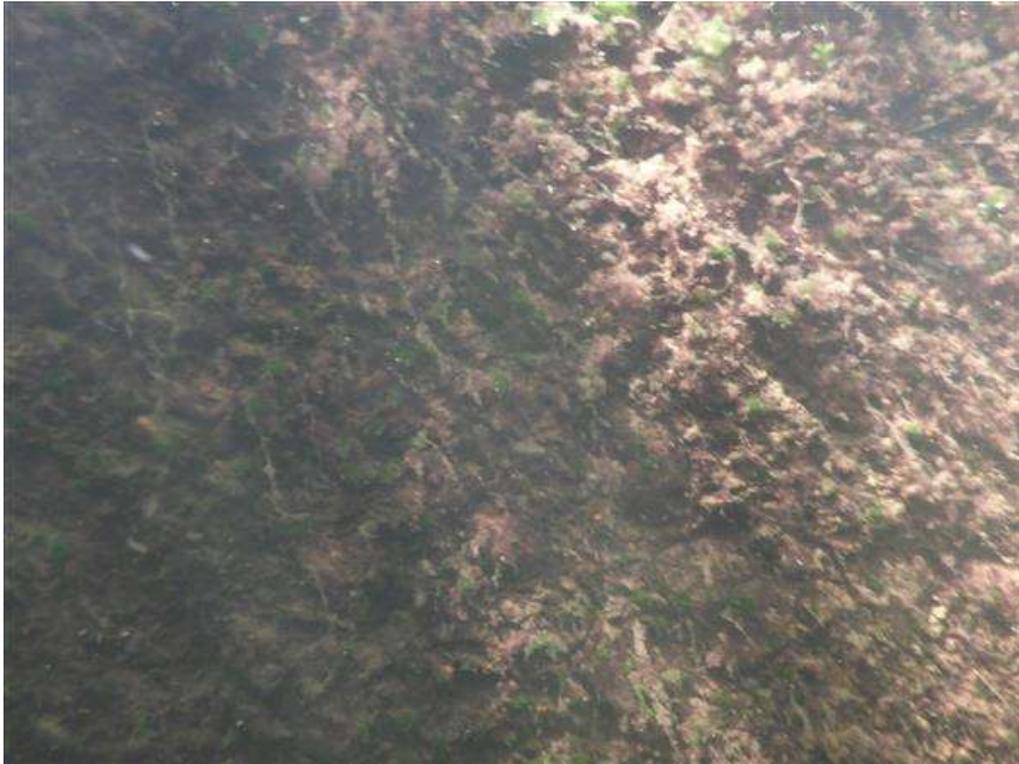
Photo 6 - Typical Concrete Condition Underwater, Looking East

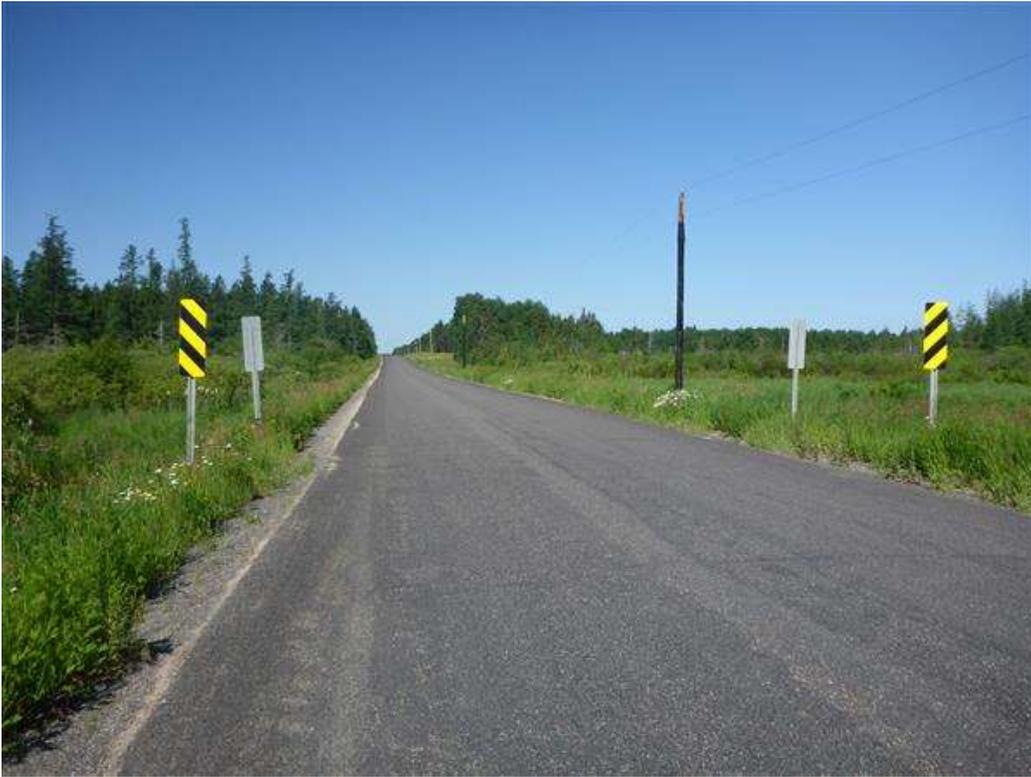
Photo 7 - View of Roadway above the Culvert, Looking West

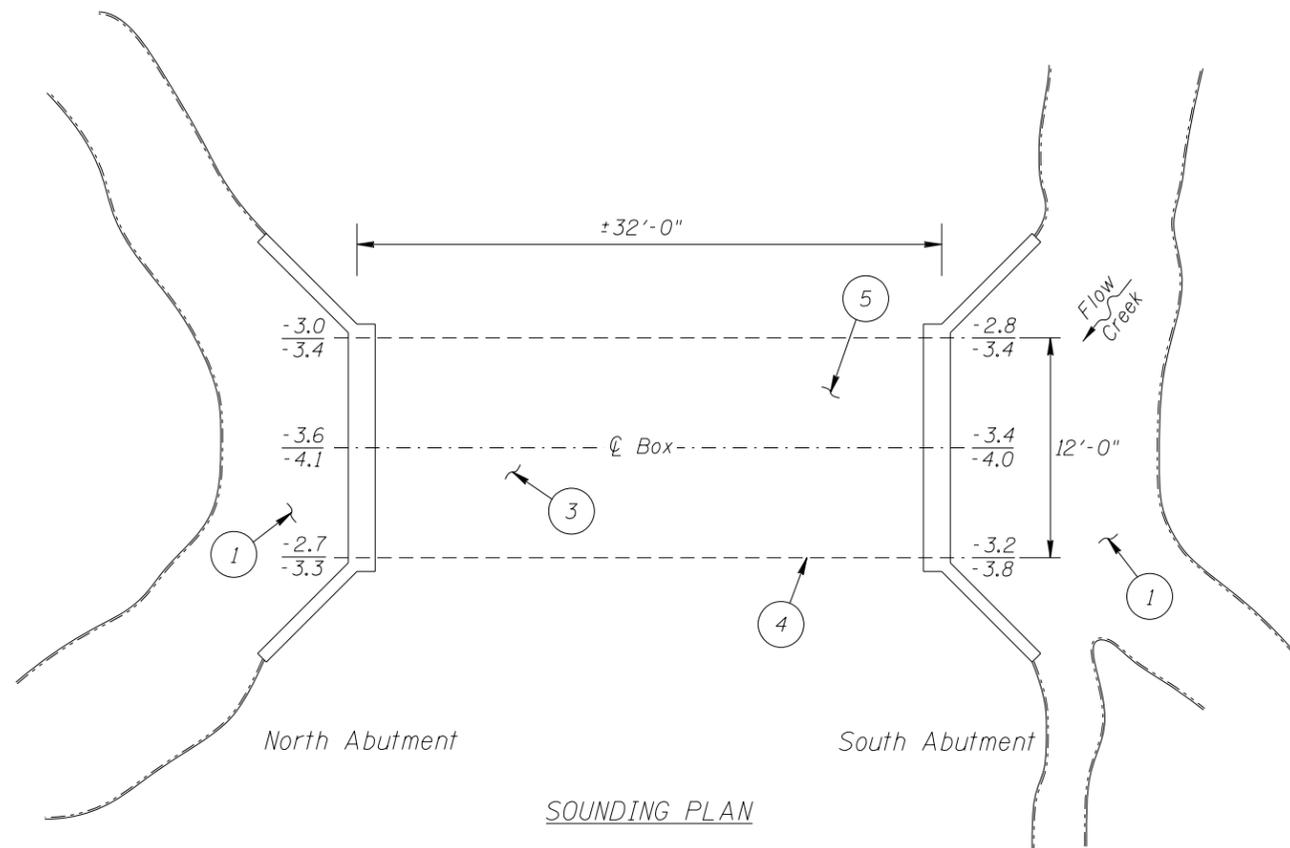
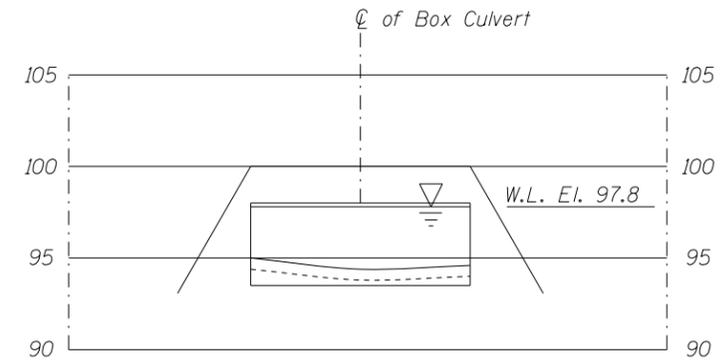
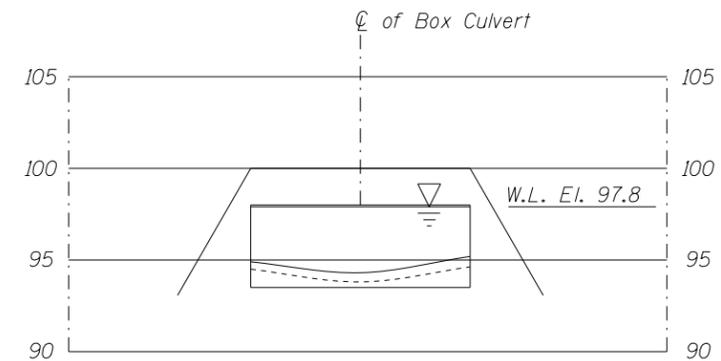
- 1 Channel bottom material consisted of fairly soft sandy silt allowing 6 to 12 inches of probe rod penetration.
- 2 Concrete was in good and sound condition. 1/4 inch deep scaling was observed on all surfaces.
- 3 The culvert floor near the downstream opening was partially covered by a 3 to 6 inch thick layer of silt and gravel, and near the middle portion of the culvert, the floor was typically free of any infill/debris.
- 4 An area of poor consolidation was observed on the west culvert wall with 2 to 3 inches of penetration.
- 5 Upstream 10 to 15 feet of culvert floor was covered by 6 inches to 12 inches of silt infill.
