# 2017 UNDERWATER BRIDGE INSPECTION REPORT

## BRIDGE # 92626 CR 207 over STONE RIVER

Date of Inspection: 09/13/2016

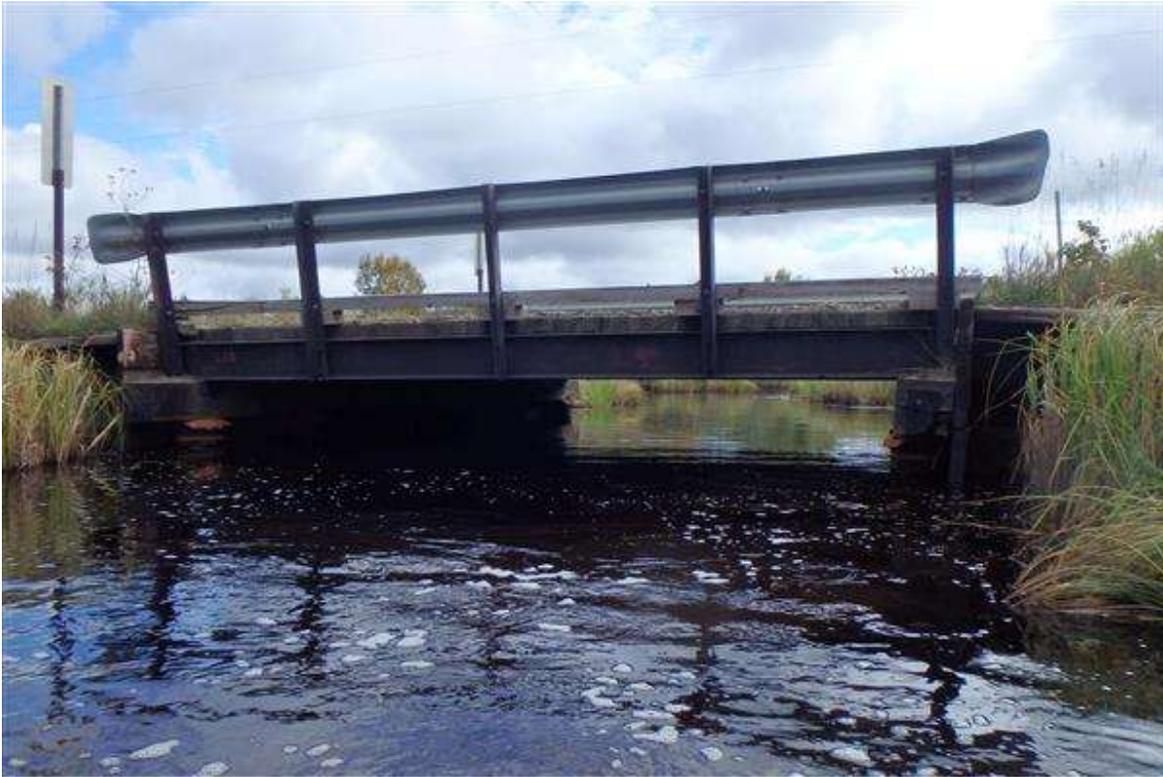
Photo 1 - West Fascia, Looking Northeast

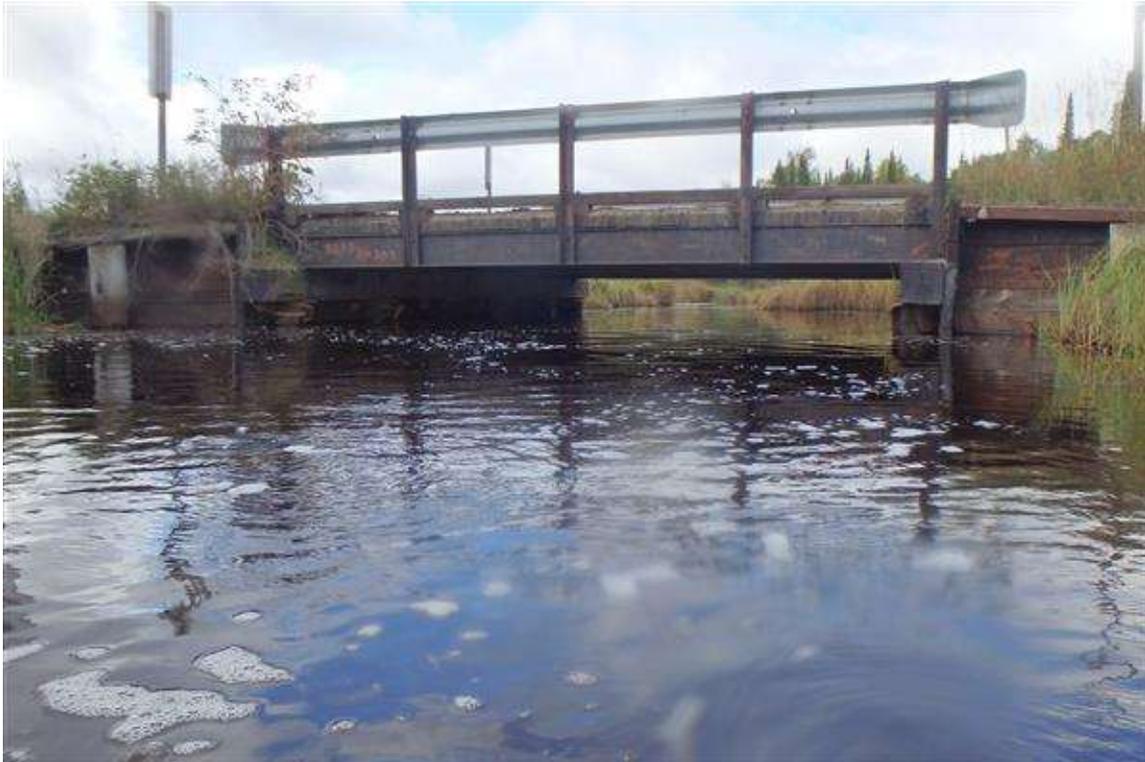
Photo 2 - East Fascia, Looking West

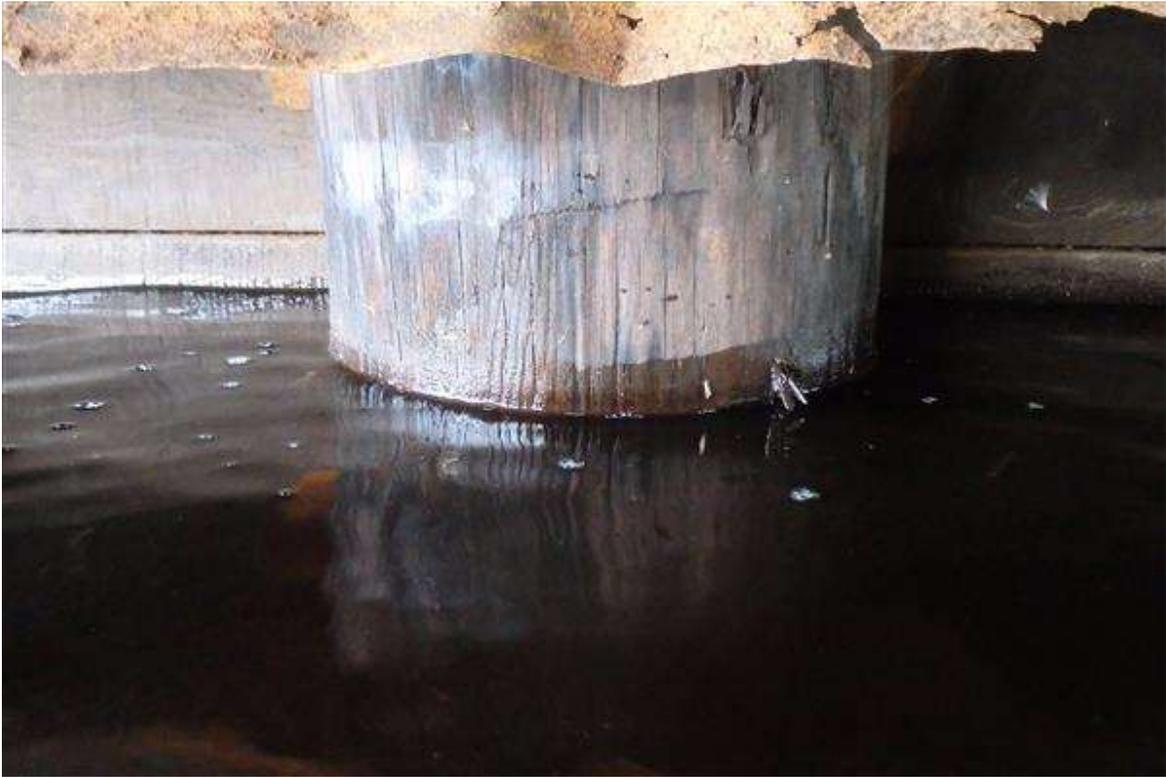
60. Substructure NBI: [2016 U/W] Timber piles exhibit only minor checking/weathering.  
 [2016] 4 out of 6 piling on south abutment have shims and shims are not loose. Caps have 1/16" wide checks with a depth of 1". Caps sound of little to no decay. 1' of piling exposed and sound of minor to moderate deterioration when sounded.  
 [2014] Vegetation growth on east end of south cap. Damage to bottom south corner of west end of south cap.  
 [2012 Underwater] Piles and caps have minor weathering with splitting.

Photo 3 - Typical Timber Pile Condition at Waterline, Looking North

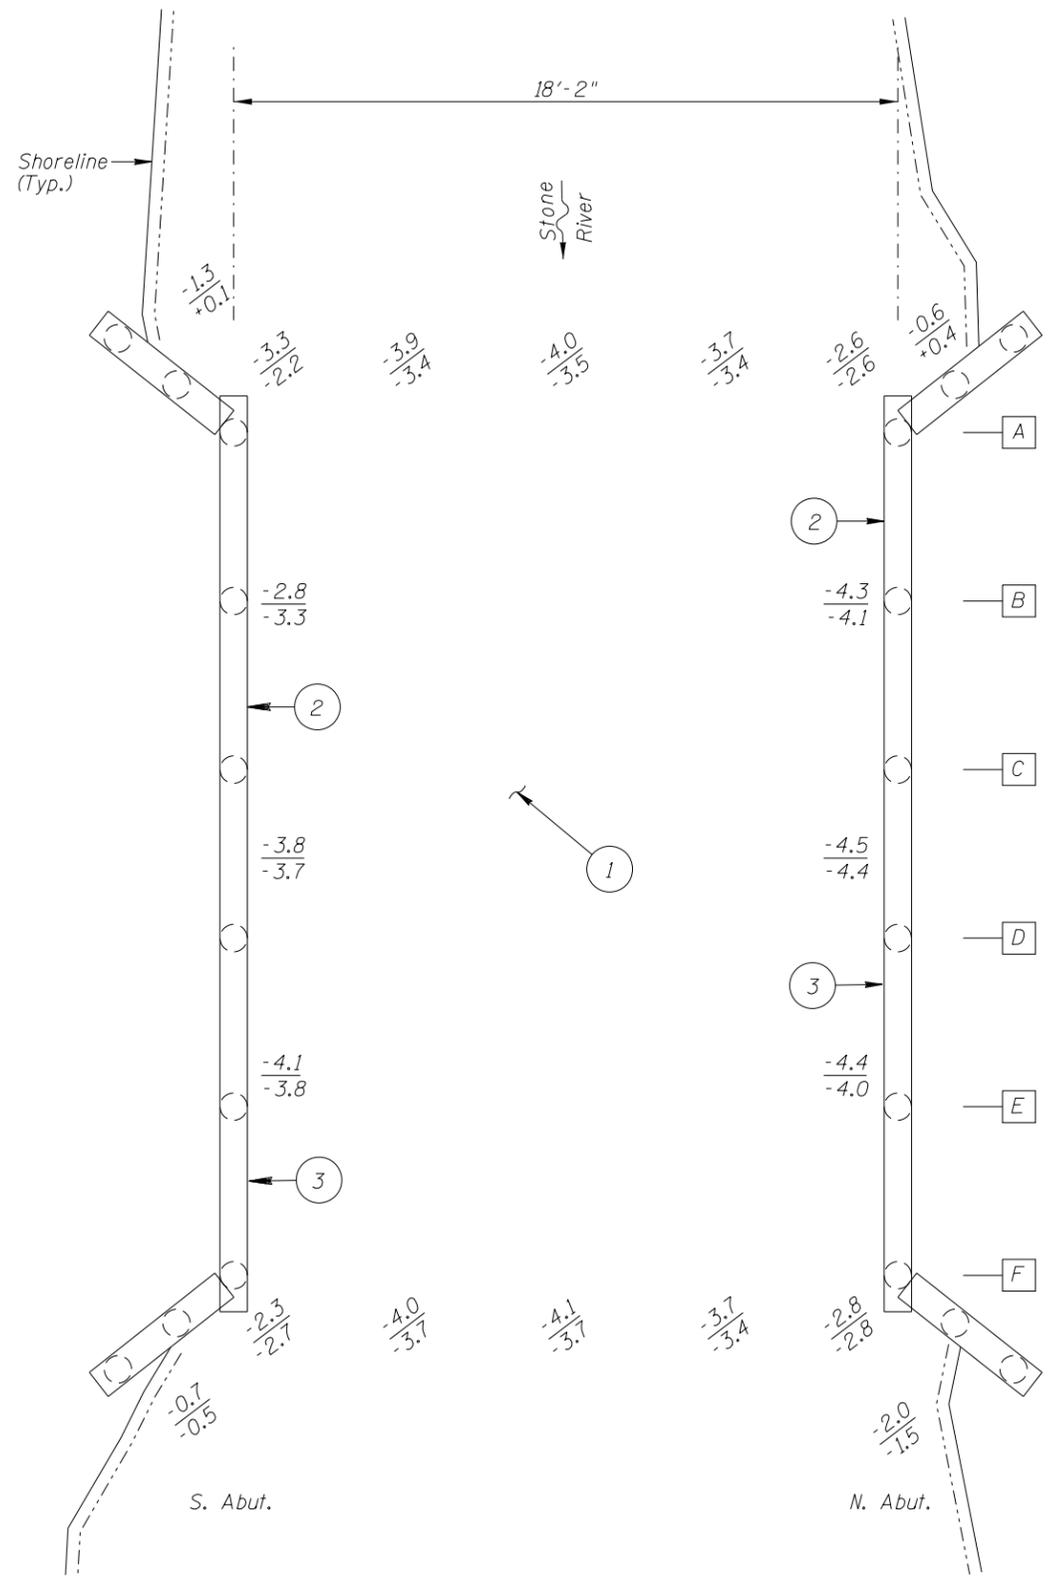
SOUNDING PLAN

- ① The channel bottom consisted of soft silt allowing up to 1 foot of probe rod penetration.
- ② Timber piles and pile caps were generally in good condition, with no significant defects and only minor checking/weathering present.
- ③ The timber backwalls are in good condition with no notable gaps or loss of backfill present.

- (A) Reinspect the submerged substructure units at the normal maximum (NBIS) interval of sixty (60) months.
