# 2016 UNDERWATER BRIDGE INSPECTION REPORT

## BRIDGE # 93290 CR 336 over PRAIRIE RIVER

Date of Inspection: 06/01/2016

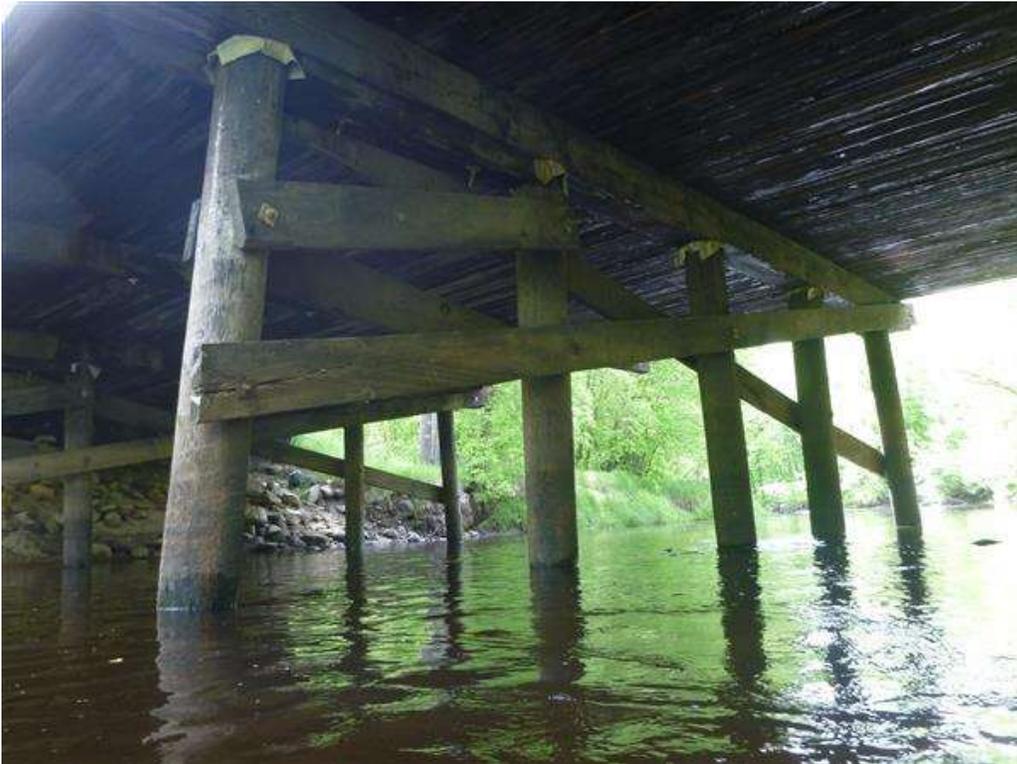
Photo 4 - Pier 2, Looking Southwest

(A) The channel bottom material consisted of firm silty sand with scattered 2-foot-diameter and smaller rock allowing up to 3 inches of probe rod penetration. (B) The lower diagonal cross brace at Pile 1 of Pier 2 had a ½ inch wide split, 2½ feet long and runs through the fastener creating an ineffective connection. (C) Pile 3 of Pier 1 had a softer outer surface from 2 feet above the waterline to 1 foot below water indicating minor decay. (D) The majority of the timber piling was in satisfactory condition with random checking up to 1/8 inch wide. All of the timber cross bracing was in good condition and all of the connections were secure unless otherwise noted. (E) The east shoreline exhibited bank erosion with vertical cuts up to 6 feet tall. The west shoreline also had bank erosion with vertical cuts up to 3 feet tall predominately on the downstream side.

(A) Repair/reinforce the cross brace connection at Pile 1 of Pier 2 during routine maintenance. (B) Reinspect the submerged substructure units at the normal maximum recommended (NBIS) interval of sixty (60) months.

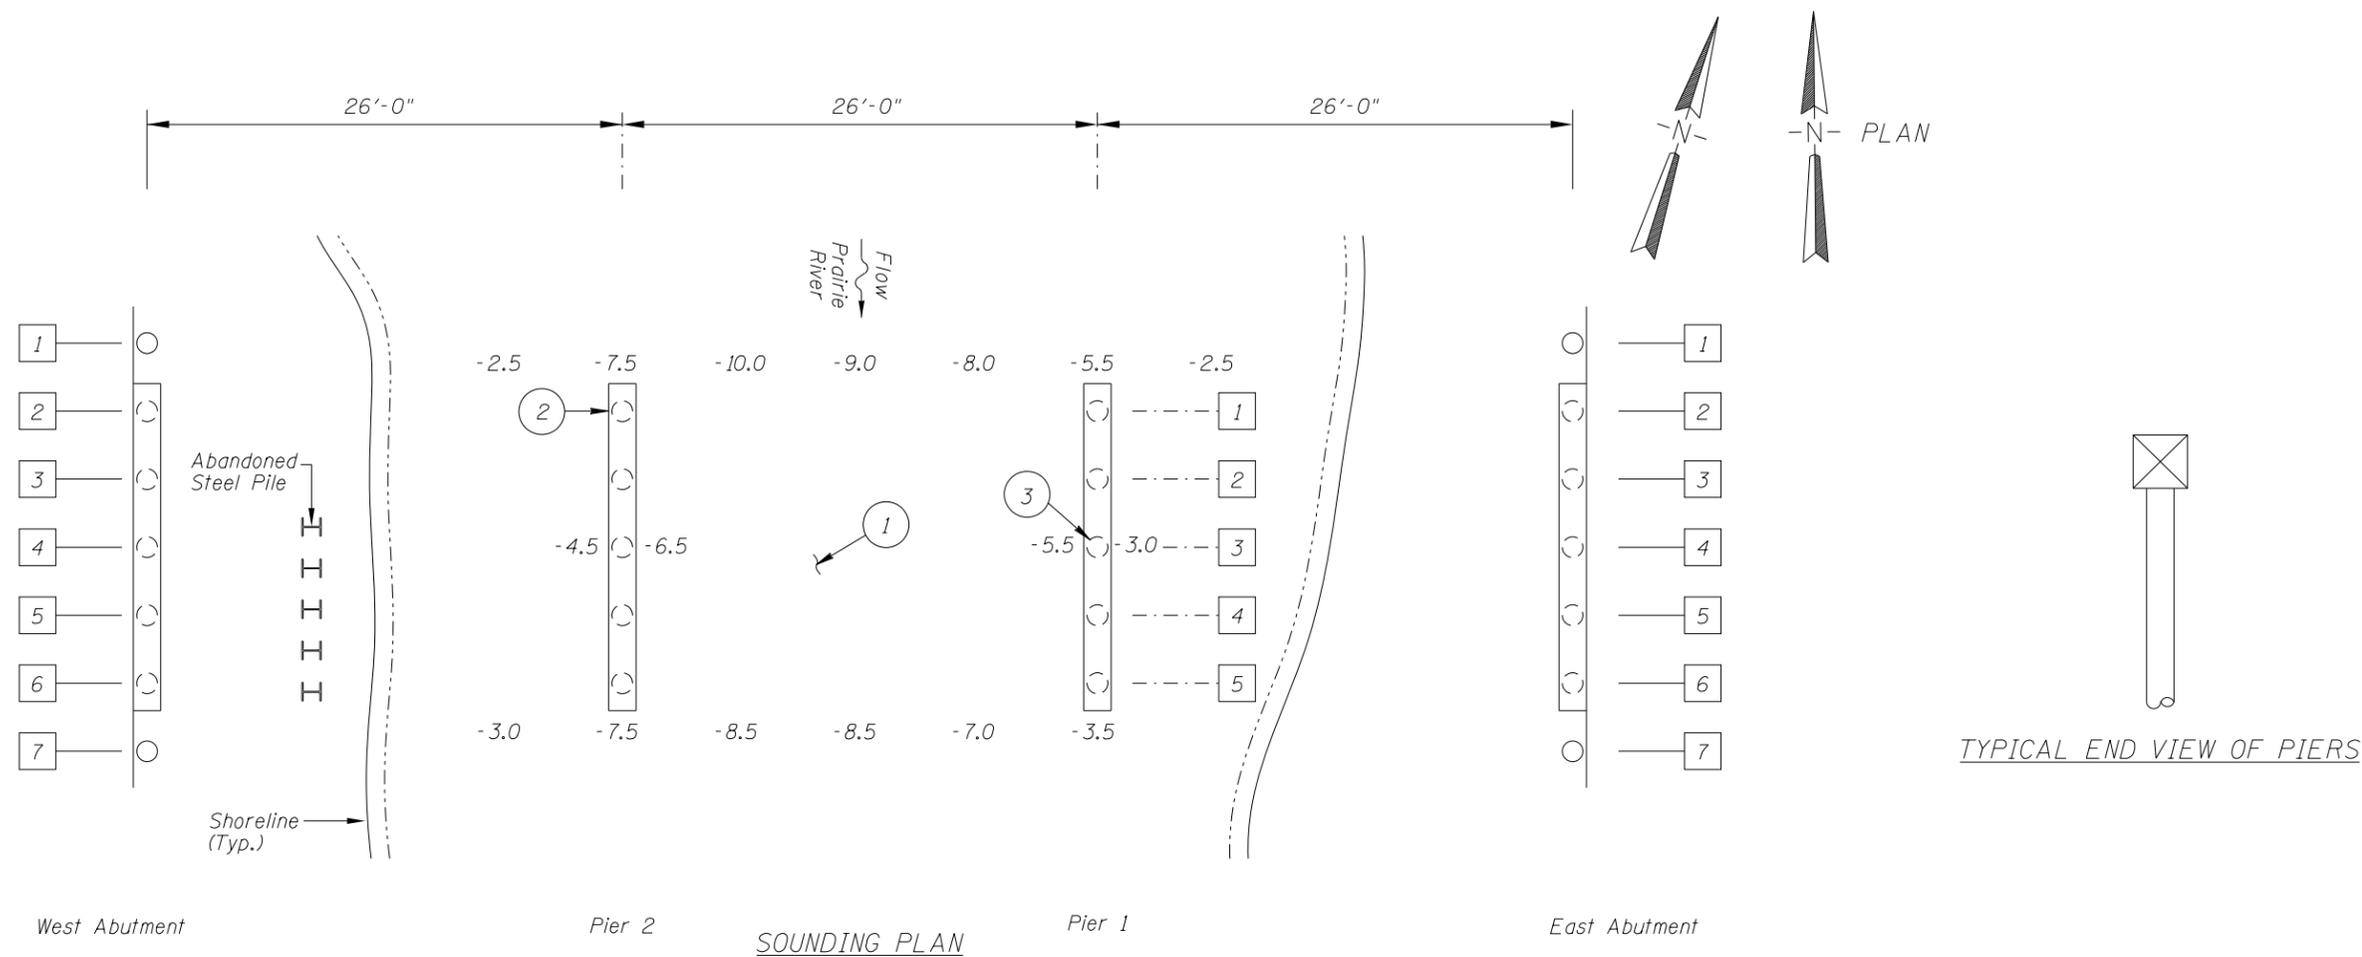
- The majority of the timber piling was in satisfactory condition with random checking up to 1/8 inch wide. All of the timber cross bracing was in good condition and all of the connections were secure unless otherwise noted.

- The east shoreline exhibited bank erosion with vertical cuts up to 6 feet tall. The west shoreline also had bank erosion with vertical cuts up to 3 feet tall predominately on the downstream side.

- The channel bottom material consisted of firm silty sand with scattered 2-foot-diameter and smaller rock allowing up to 3 inches of probe rod penetration.
- The lower diagonal cross brace at Pile 1 of Pier 2 had a 1/2 inch wide split, 2-1/2 feet long and runs through the fastener creating an ineffective connection.
- Pile 3 of Pier 1 had a softer outer surface from 2 feet above the waterline to 1 foot below water indicating minor decay.
