# 2016 UNDERWATER BRIDGE INSPECTION REPORT

## BRIDGE # 96225 CR 923 over STREAM

The routine underwater inspection of Bridge 96225 (C.R. 923 over Stream) was completed on June 20, 2016. The underwater inspection was conducted from shore. The inspection was conducted by a team consisting of a Professional Engineer Diver with a valid MnDOT Team Leader certification, a backup diver and dive tender. The inspection utilized commercial dive equipment and surface supplied air techniques in accordance with OSHA regulations. Channel bottom profiles were taken along the upstream and downstream openings of the culverts to determine the presence, location and area of scour.

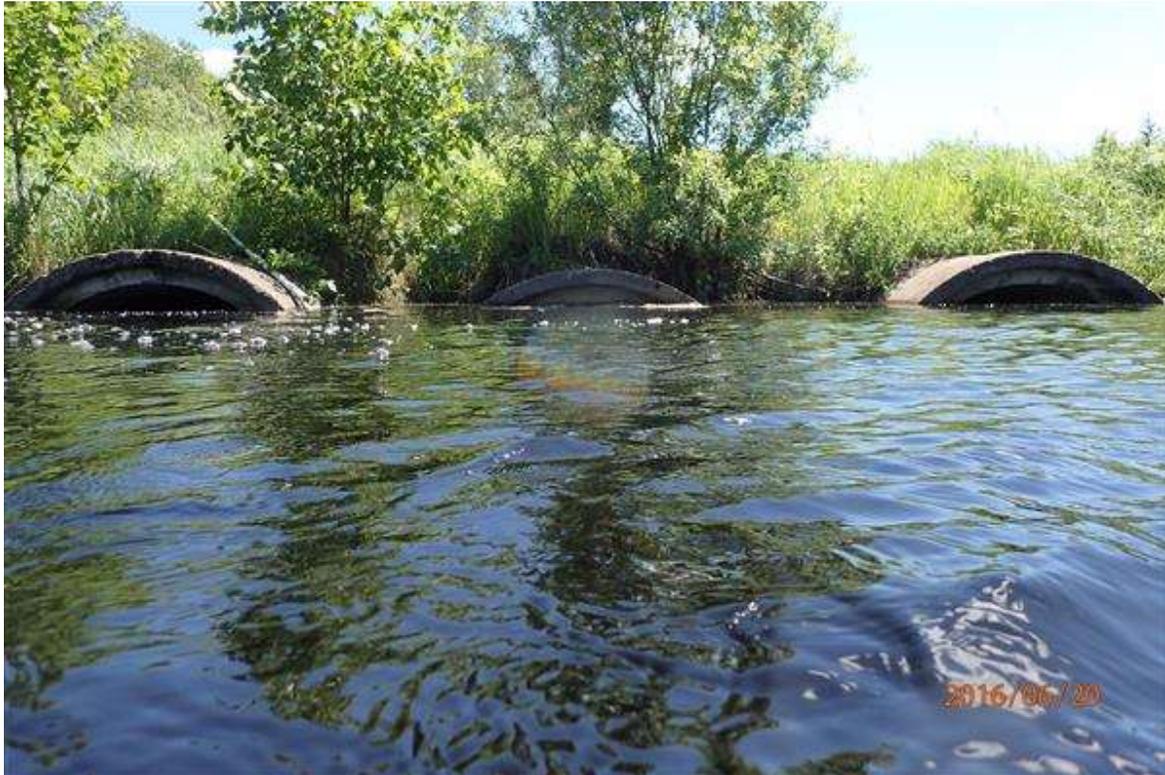
Photo 1 - Upstream Opening, Looking South

- (A) The channel bottom material consisted of silty sand allowing 3 inches of probe rod penetration.
- (B) The exposed surfaces of concrete Pipes 1, 2, and 3 were typically sound with light scaling up to 1/8 inch deep.
- (C) Timber debris consisting of a 12 inch diameter log was observed at the upstream opening of Pipe 2.
- (D) Light accumulation of timber debris was located near the upstream end of Pipe 3.
- (E) A 2 to 3 foot thick layer of silt infill covered the bottom of Pipes 1, 2, and 3.

- (A) Remove the sediment build up in the concrete pipes to restore the full hydraulic capacity.
- (B) Reinspect the submerged substructure units at the normal maximum recommended (NBIS) of sixty (60) months.

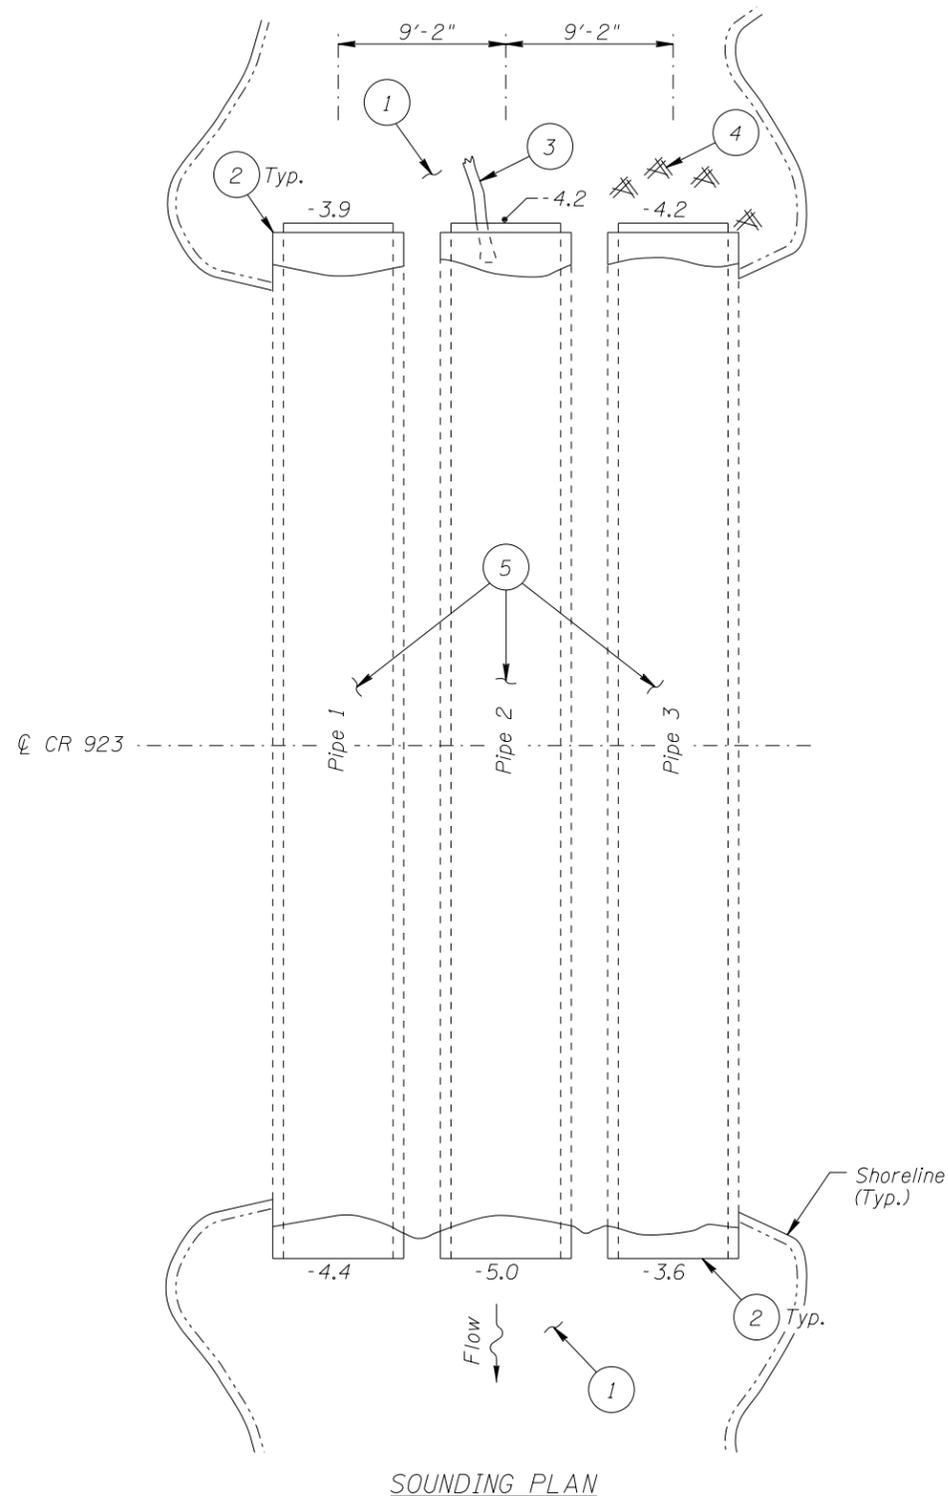
SOUNDING PLAN

- 1 Channel bottom material consisted of silty sand allowing 3 inches of probe rod penetration.
- 2 Exposed surfaces of concrete Pipes 1, 2, and 3 were typically sound with light scaling up to 1/8 inch deep.
- 3 Timber debris consisting of a 12-inch diameter log was observed at the upstream opening of Pipe 2.
- 4 Light accumulation of timber debris was located near the upstream end of Pipe 3.
- 5 A 2 to 3 foot thick layer of silt infill typically covered the bottom of Pipes 1, 2 and 3.
