2017 UNDERWATER BRIDGE INSPECTION REPORT

BRIDGE # 97918 CR 725 over HELLEWEGS CREEK

Date of Inspection: 09/13/2016

Contractor: Collins Engineers, Inc.

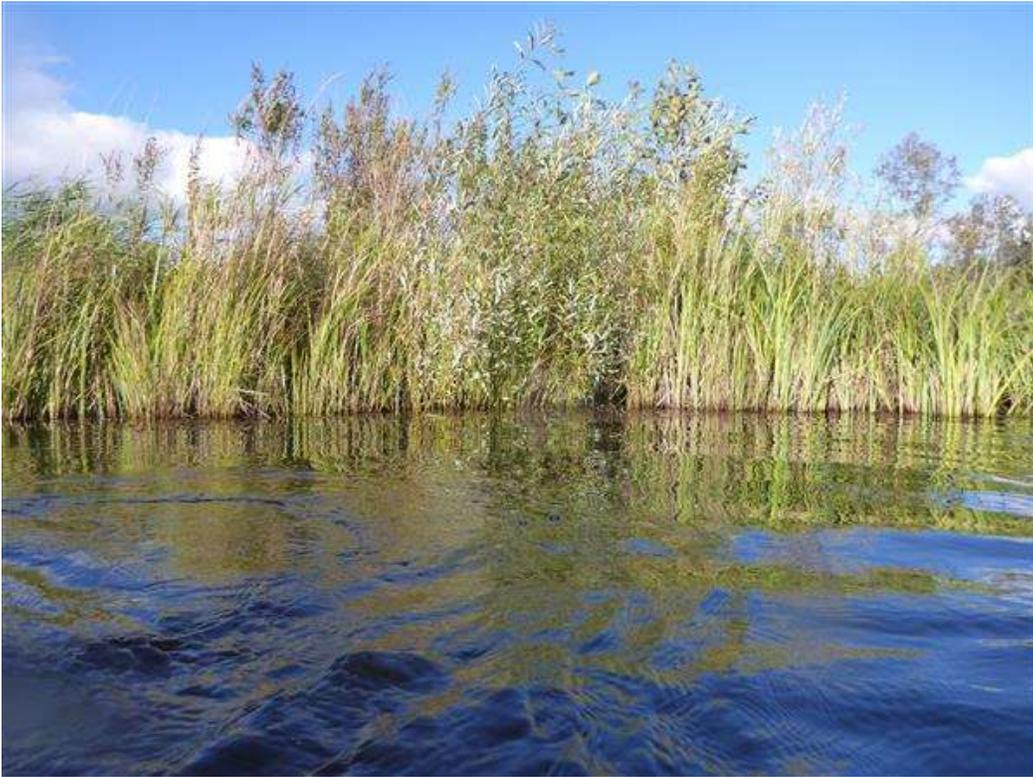
Photo 1 - Upstream Opening (Submerged), Looking Northeast

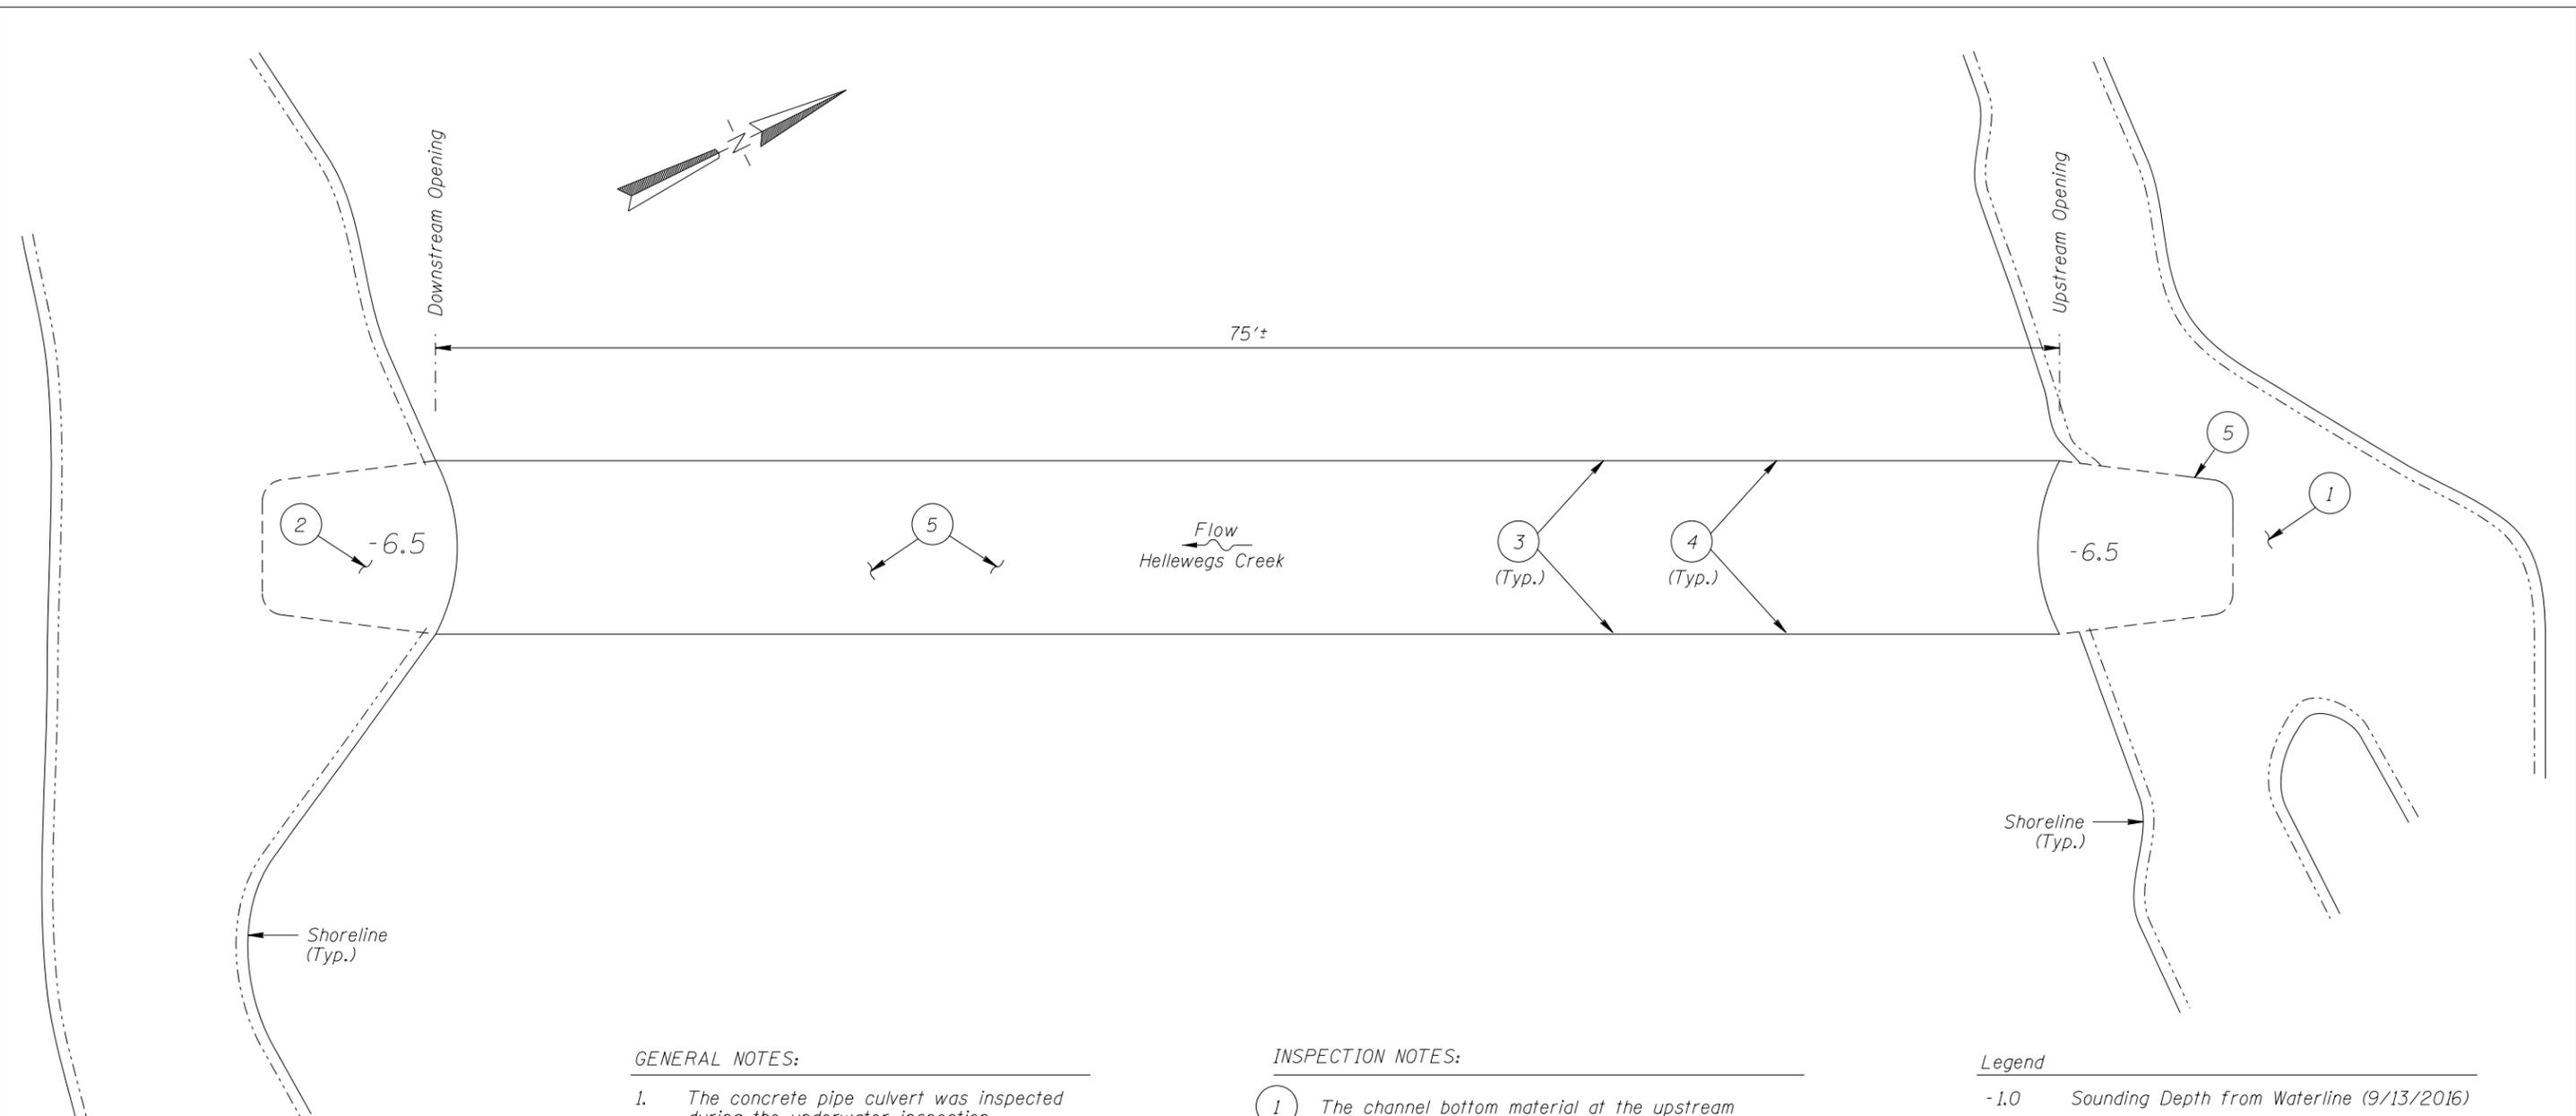
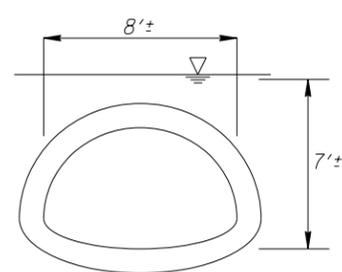
1. The channel bottom material at the upstream opening of the culvert typically consisted of soft silt and small timber debris allowing a maximum probe rod penetration of 1 foot.
2. The channel bottom material at the downstream opening of the culvert typically consisted of sandy silt and stones allowing a maximum probe rod penetration of 6 inches.
3. All exposed concrete surfaces were smooth and sound.
4. All concrete joints were well aligned and with no notable gaps between culvert sections.
5. The floor of the culvert was exposed throughout the length of the culvert and at the upstream toe with a maximum vertical toe exposure of 1 foot.
