2017 UNDERWATER BRIDGE INSPECTION REPORT

BRIDGE # L1244 UTWN 388 over HASTY BROOK

Date of Inspection: 09/24/2016

Contractor: Collins Engineers, Inc.

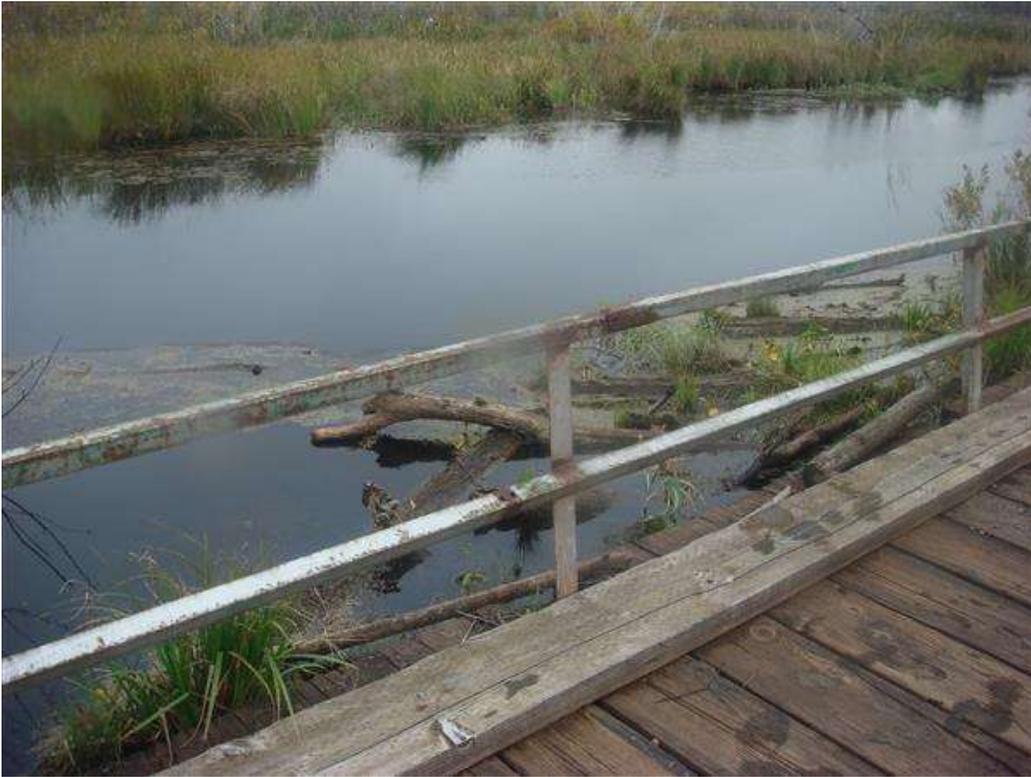
- A. Channel bottom material in the vicinity of the abutments consisted of sand and organics allowing 1 foot of probe rod penetration.
- B. Moderate accumulation of timber debris up to 1 foot in diameter was observed at the waterline along the entire upstream fascia of the bridge and extended 5 feet upstream from the structure.
- C. The timber construction of the abutments was generally sound with no structurally significant deterioration observed. In general, timber was aged and weathered.
- D. A sink hole, 2 feet in diameter and 1.3 feet deep, was observed in the roadway behind the north abutment.

Photo 1 - Overall View of Upstream Fascia and Upstream Channel, Looking Southeast

- (A) Since the bridge is closed for the foreseeable future, the limited access caused by the timber debris is not a concern at this time. Should, however, a decision be made to reopen the bridge (to vehicles other than snowmobiles), debris should be removed and the bridge re-examined.
- (B) Since the bridge is closed, consideration could be given to removing it from the underwater inspection list, otherwise reinspect the submerged substructure units at the normal maximum recommended (NBIS) interval of sixty (60) months.

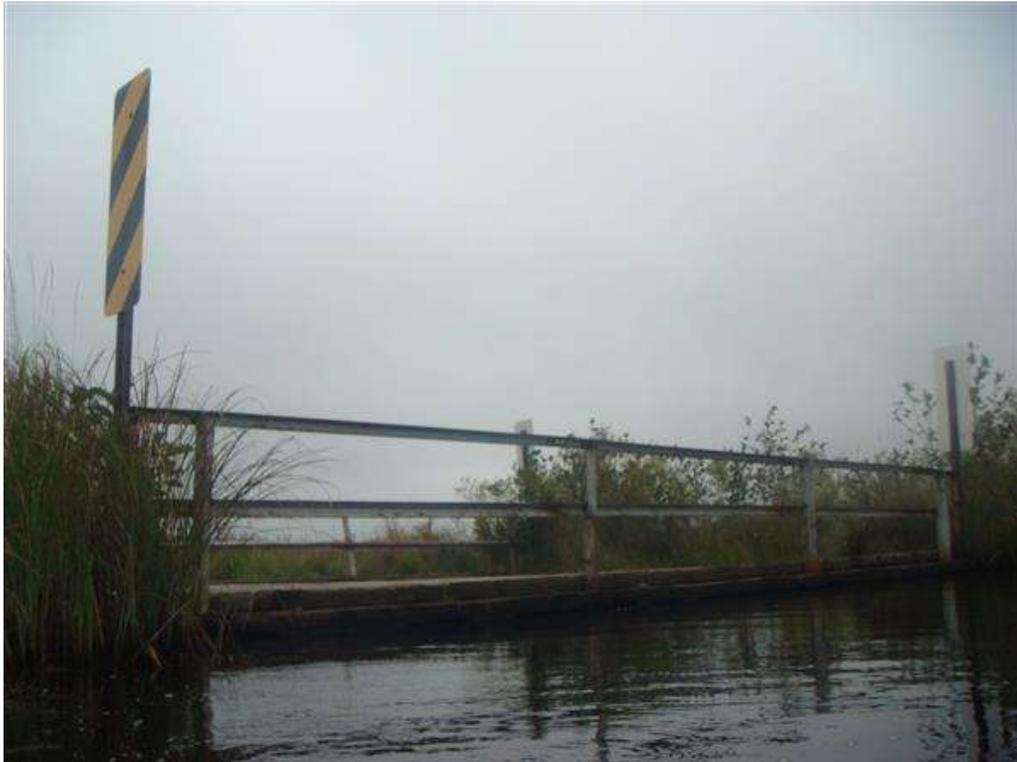
Photo 2 - Overall View of Downstream Fascia, Looking East

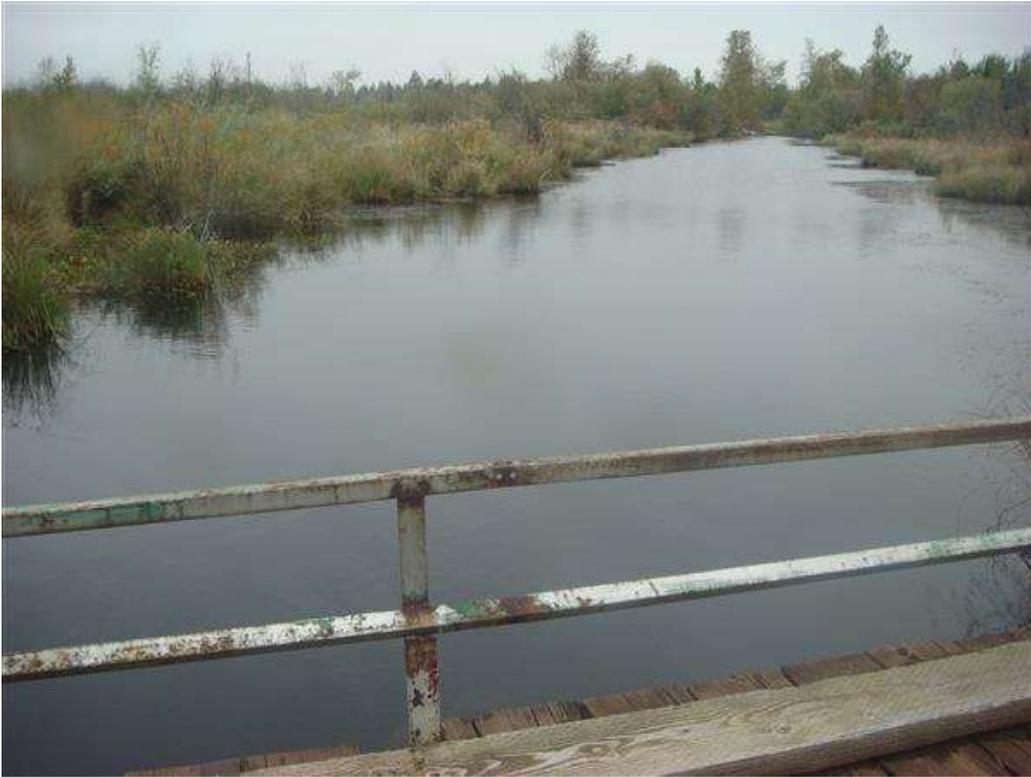
Photo 3 - View of Downstream Channel, Looking Northwest

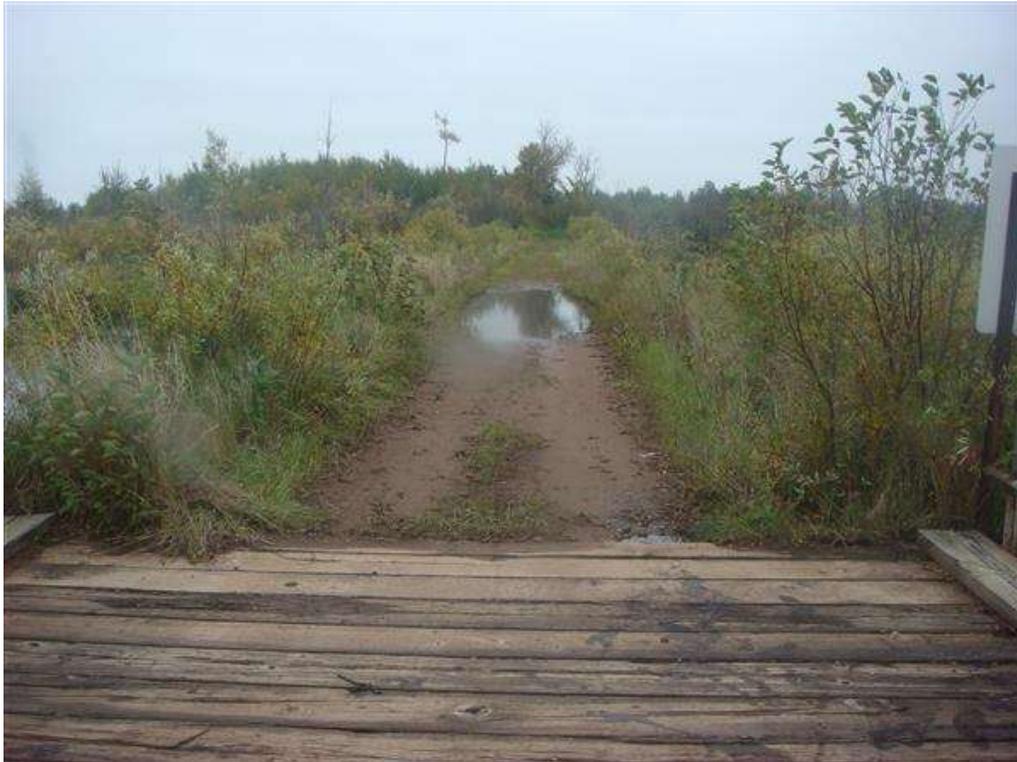
Photo 4 - View of Roadway, Looking North

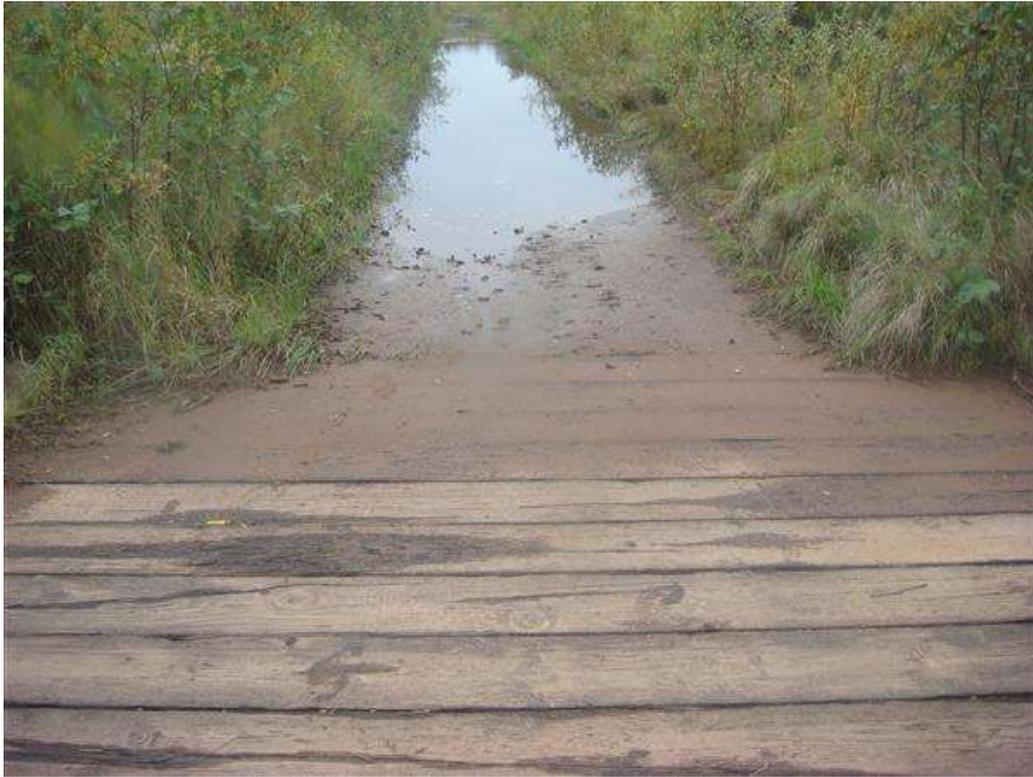
Photo 5 - View of Roadway, Looking South

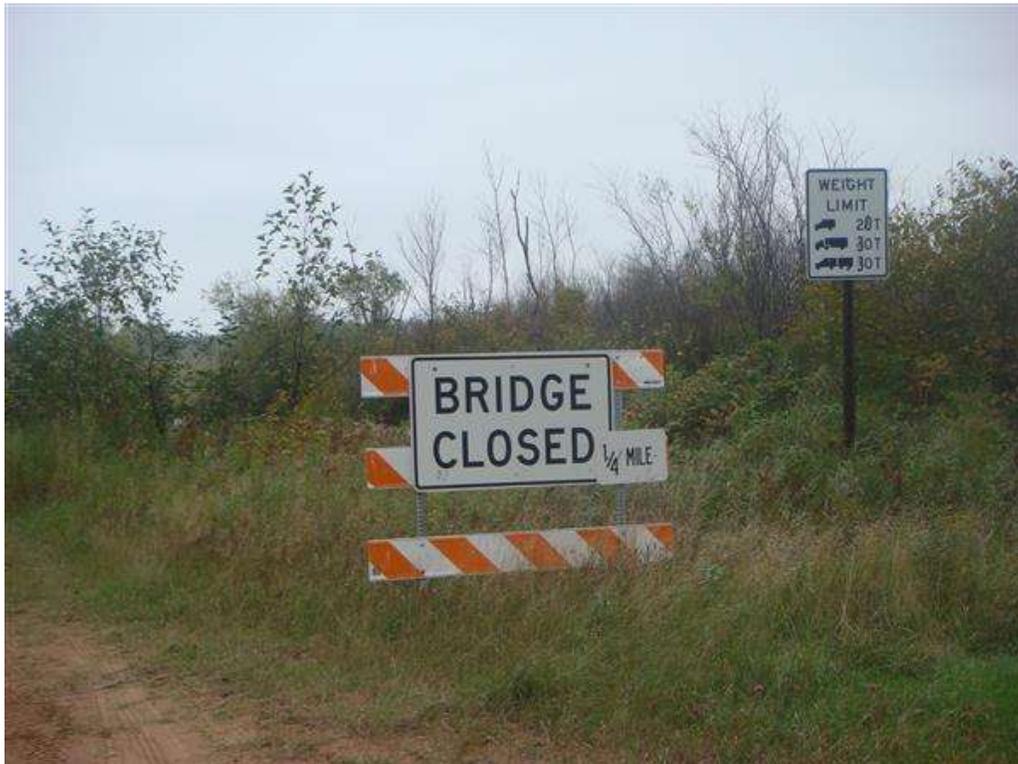
Photo 6 - Bridge Closed and Load Posting Sign, Looking North

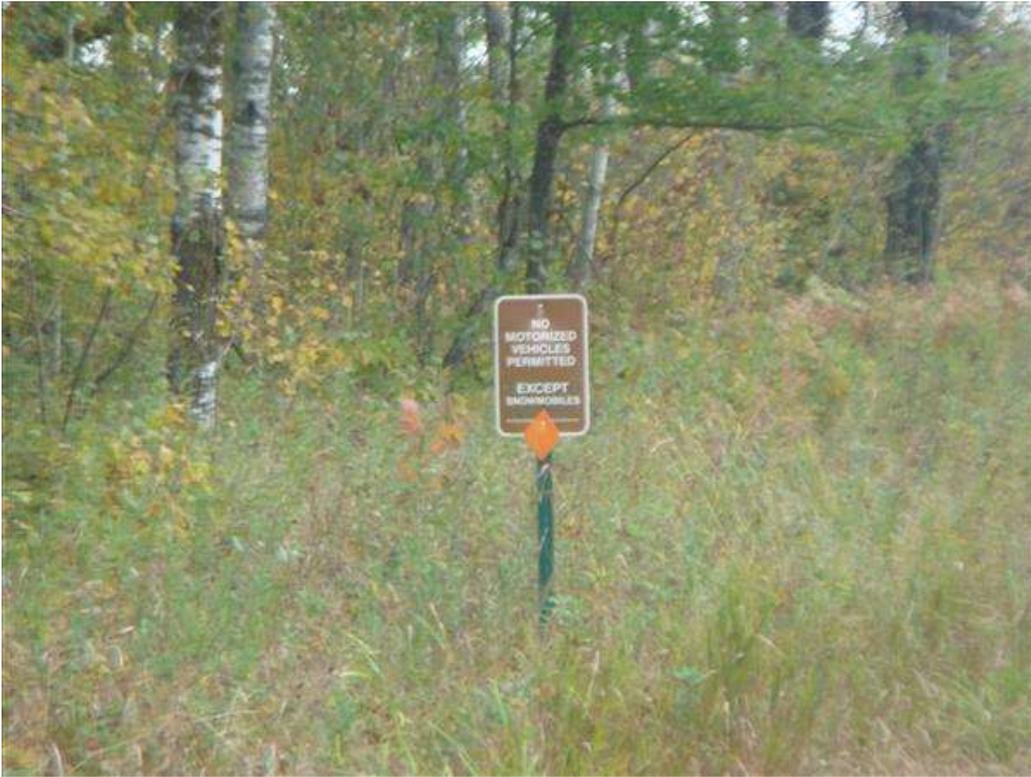
Photo 7 - "No Motorized Vehicles Permitted" Sign, Looking North

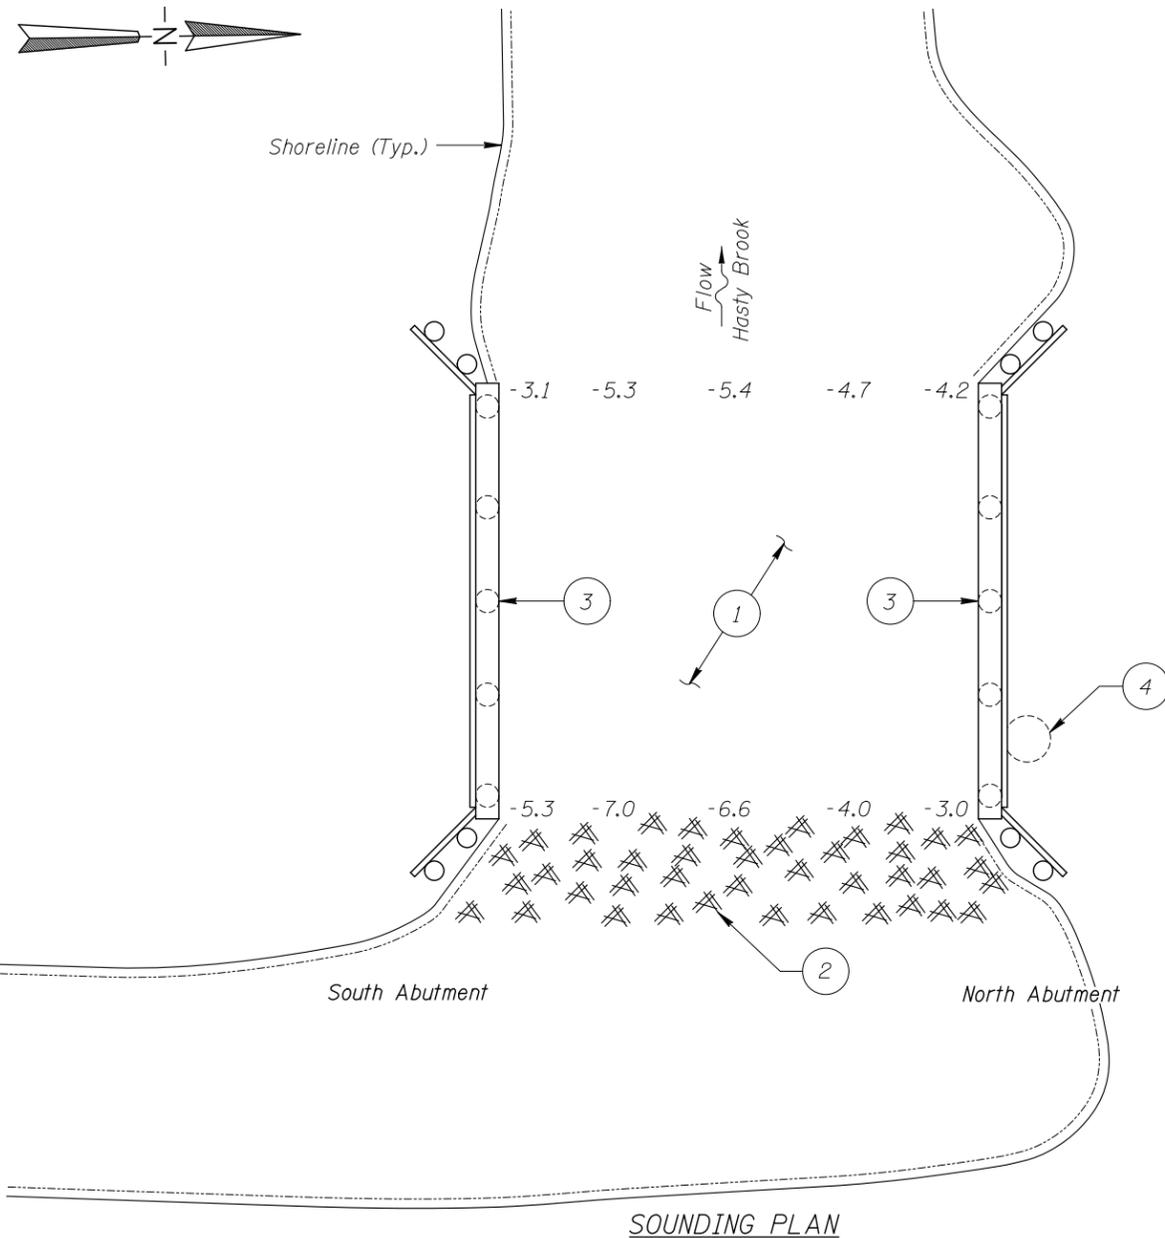
- ① Channel bottom material in the vicinity of the abutments consisted of sand and organics allowing 1 foot of probe rod penetration.
- ② Moderate accumulation of timber debris up to 1 foot in diameter was observed at the waterline along the entire upstream fascia of the bridge and extended 5 feet upstream from the structure.
- ③ The timber construction of the abutments was generally sound with no structurally significant deterioration observed. In general, timber was aged and weathered.
- ④ A sink hole, 2 feet in diameter and 1.3 feet deep, was observed in the roadway behind the north abutment.
