2016 UNDERWATER BRIDGE INSPECTION REPORT

BRIDGE # L4177 CSAH 116 over HUNTING SHACK RIVER

Date of Inspection: 06/19/2016

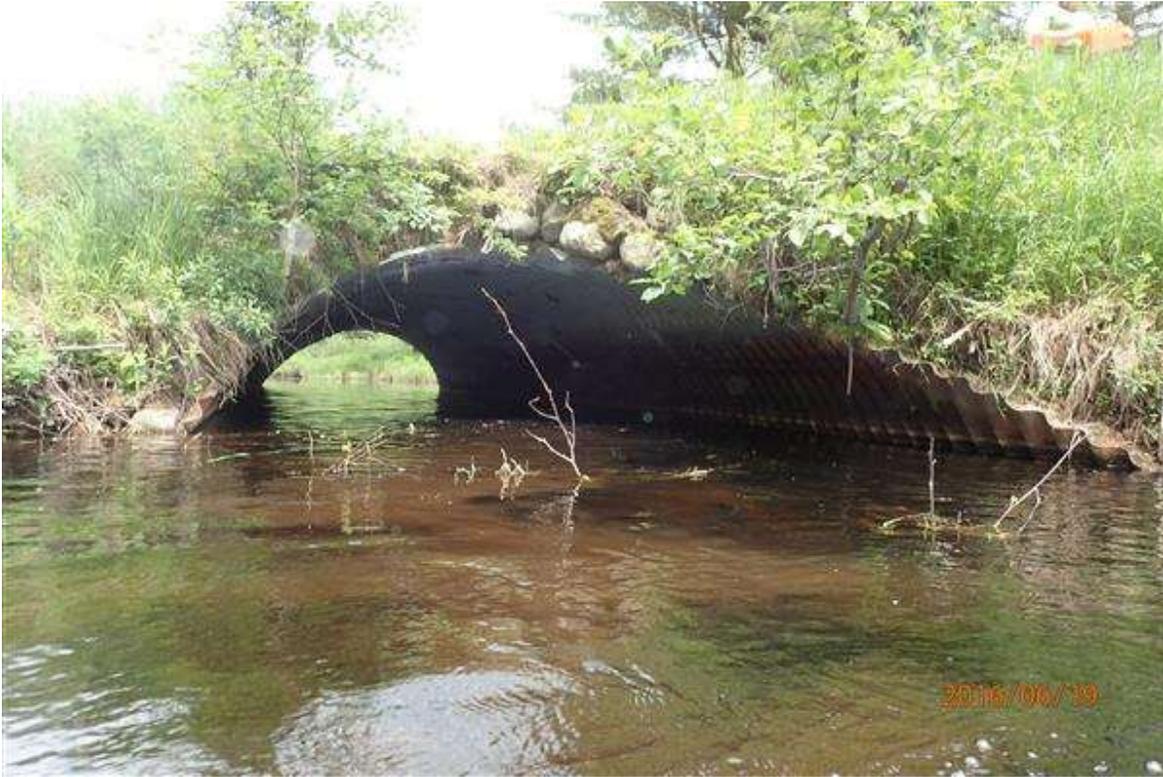
- A) The culvert exhibited good galvanizing and only minor surface corrosion with negligible loss of section.
- B) The culvert alignment was in good condition with no deflections or distortions. The joints/fasteners were in place and secure.
- C) The culvert pipe bottom was fairly clean of any infill with only randomly interspersed sandy gravel as well as small rocks.
- D) The culvert openings were well protected against scour/erosion by up to 1 foot diameter riprap.

Photo 1 - Upstream Opening of the Culvert Pipe, Looking North

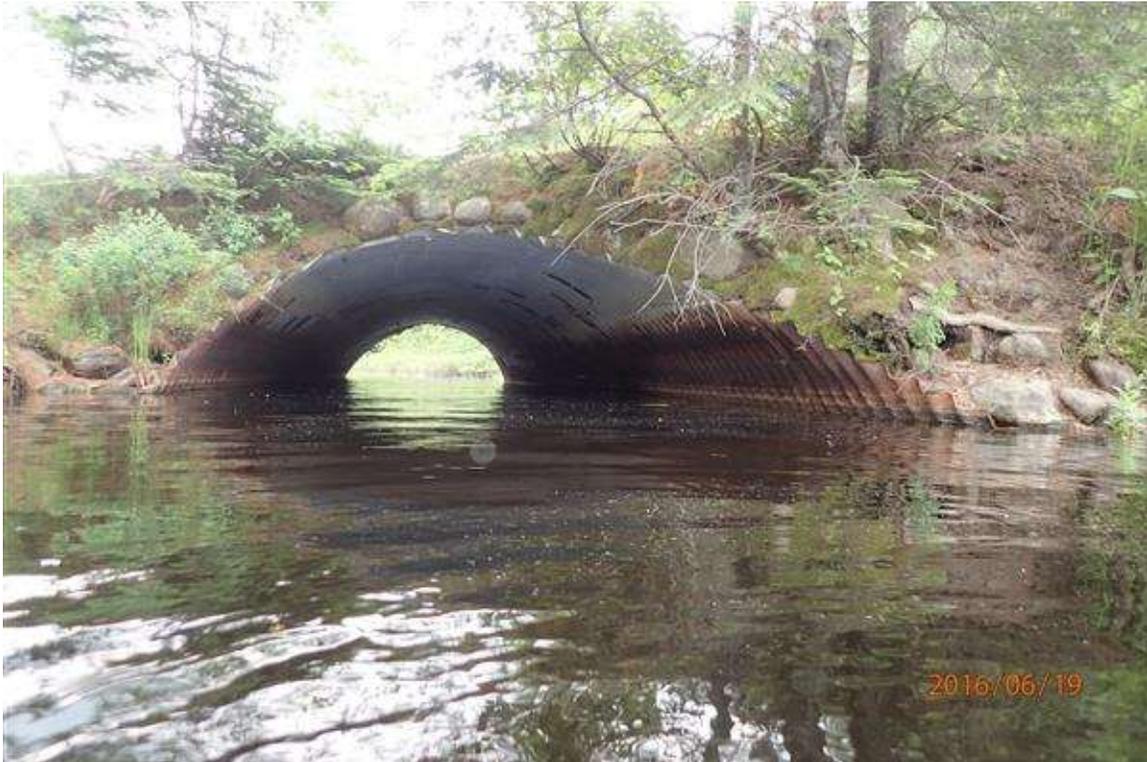
Photo 2 - Downstream Opening of the Culvert Pipe, Looking South

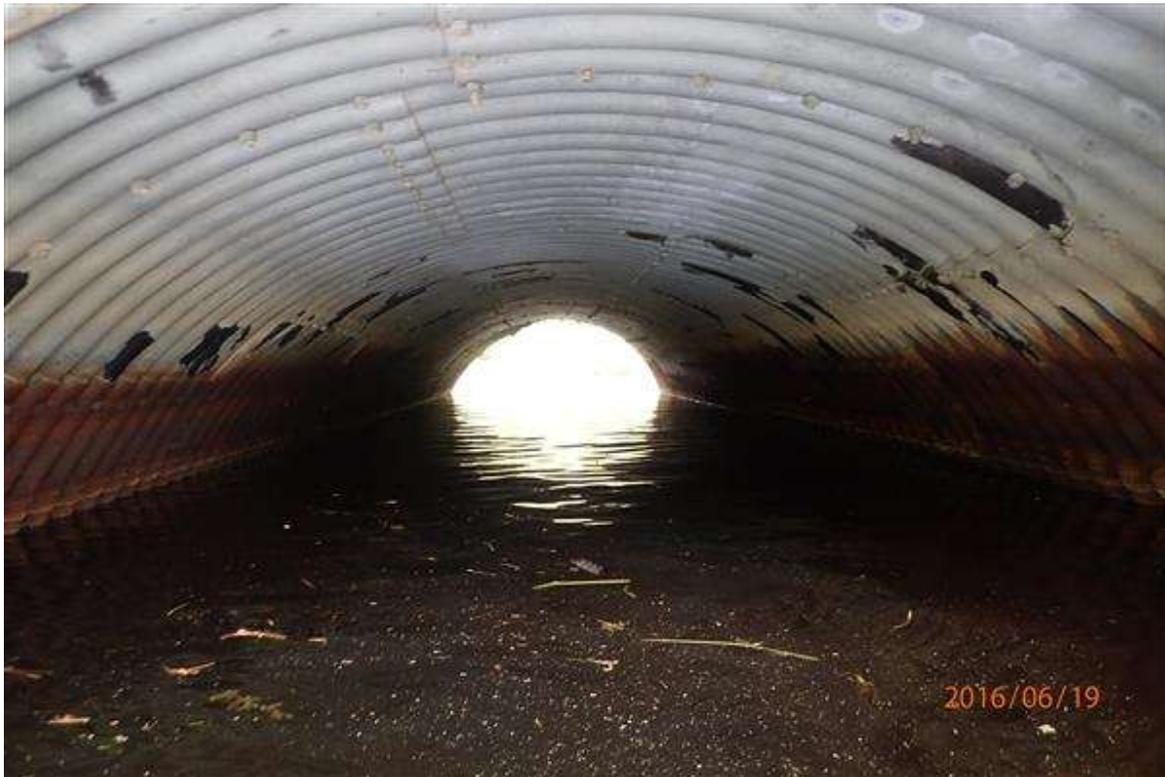
Photo 3 - Overall View through Culvert Pipe, Looking South

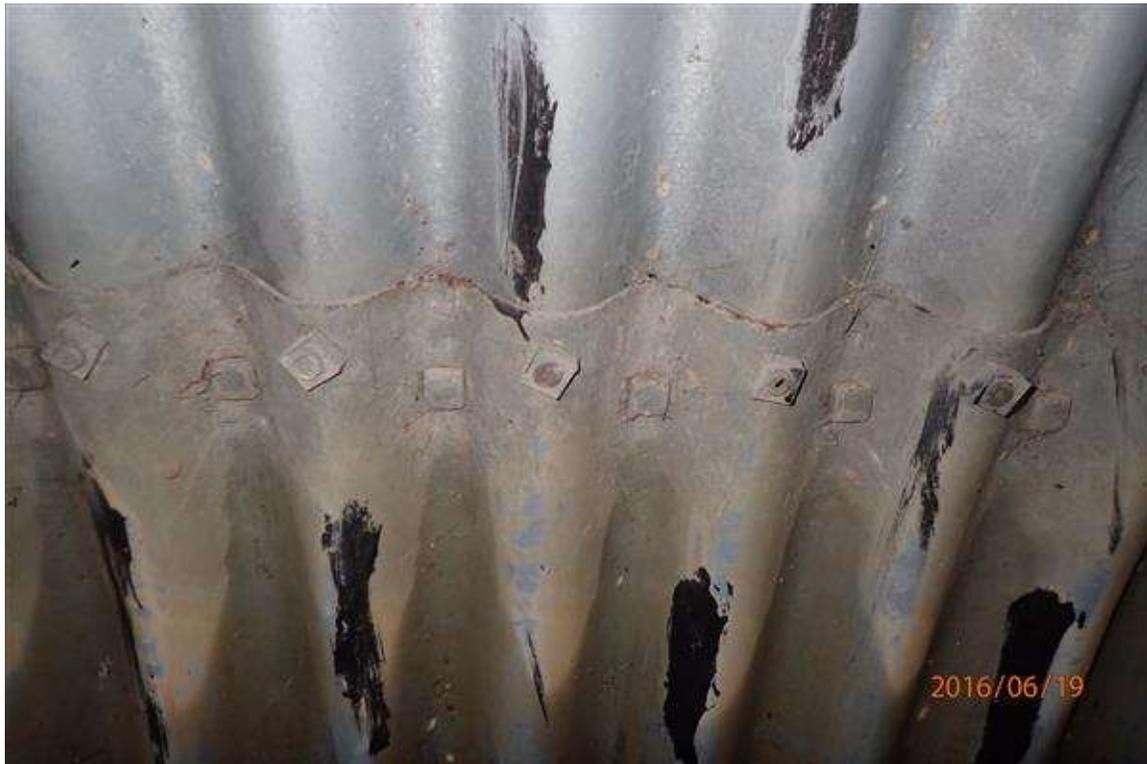
Photo 4 - Typical Culvert Joint Condition, Looking East

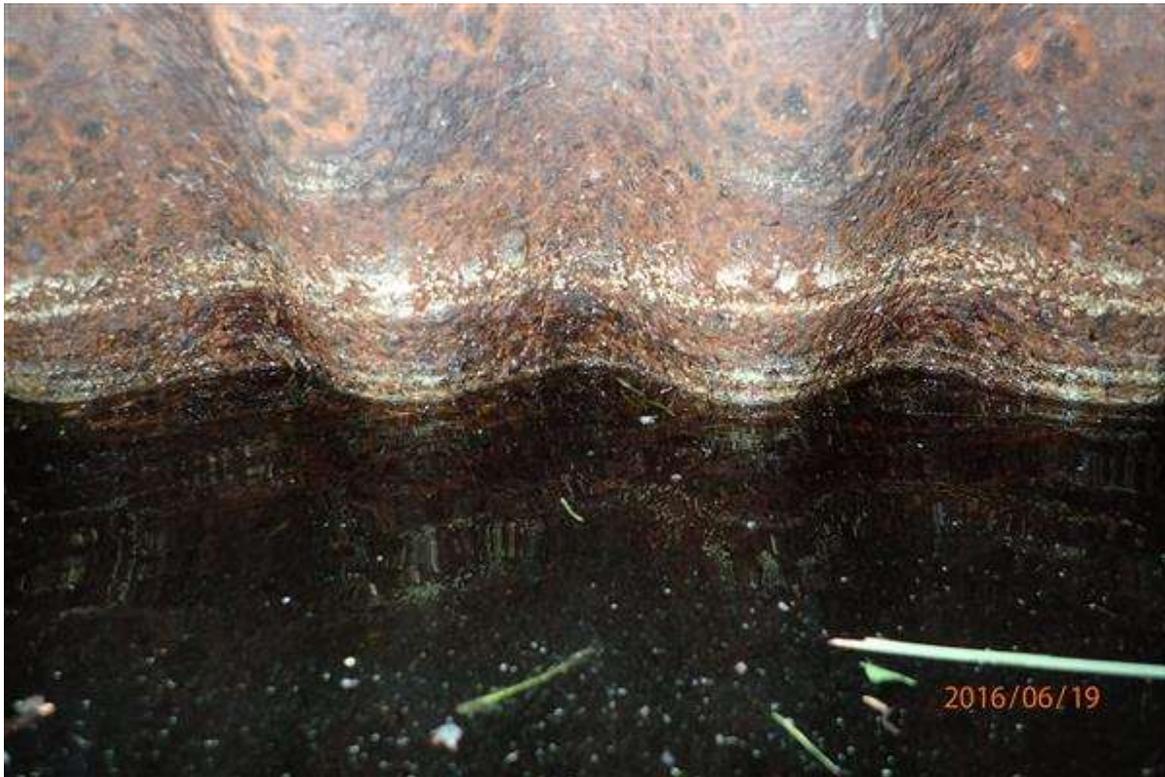
The substructure inspected at structure No. L4177, a corrugated metal pipe culvert, was found to be generally in satisfactory to fair condition below water with no defects of structural significance. The corrugated steel pipe exhibited light surface corrosion at the waterline with no significant loss of section. The culvert openings were well armored with riprap.

Photo 5 - Typical Steel Condition and Surface Corrosion near Waterline, Looking East

- (A) Reinspect the submerged substructure units at the normal maximum recommended (NBIS) interval of sixty (60) months.

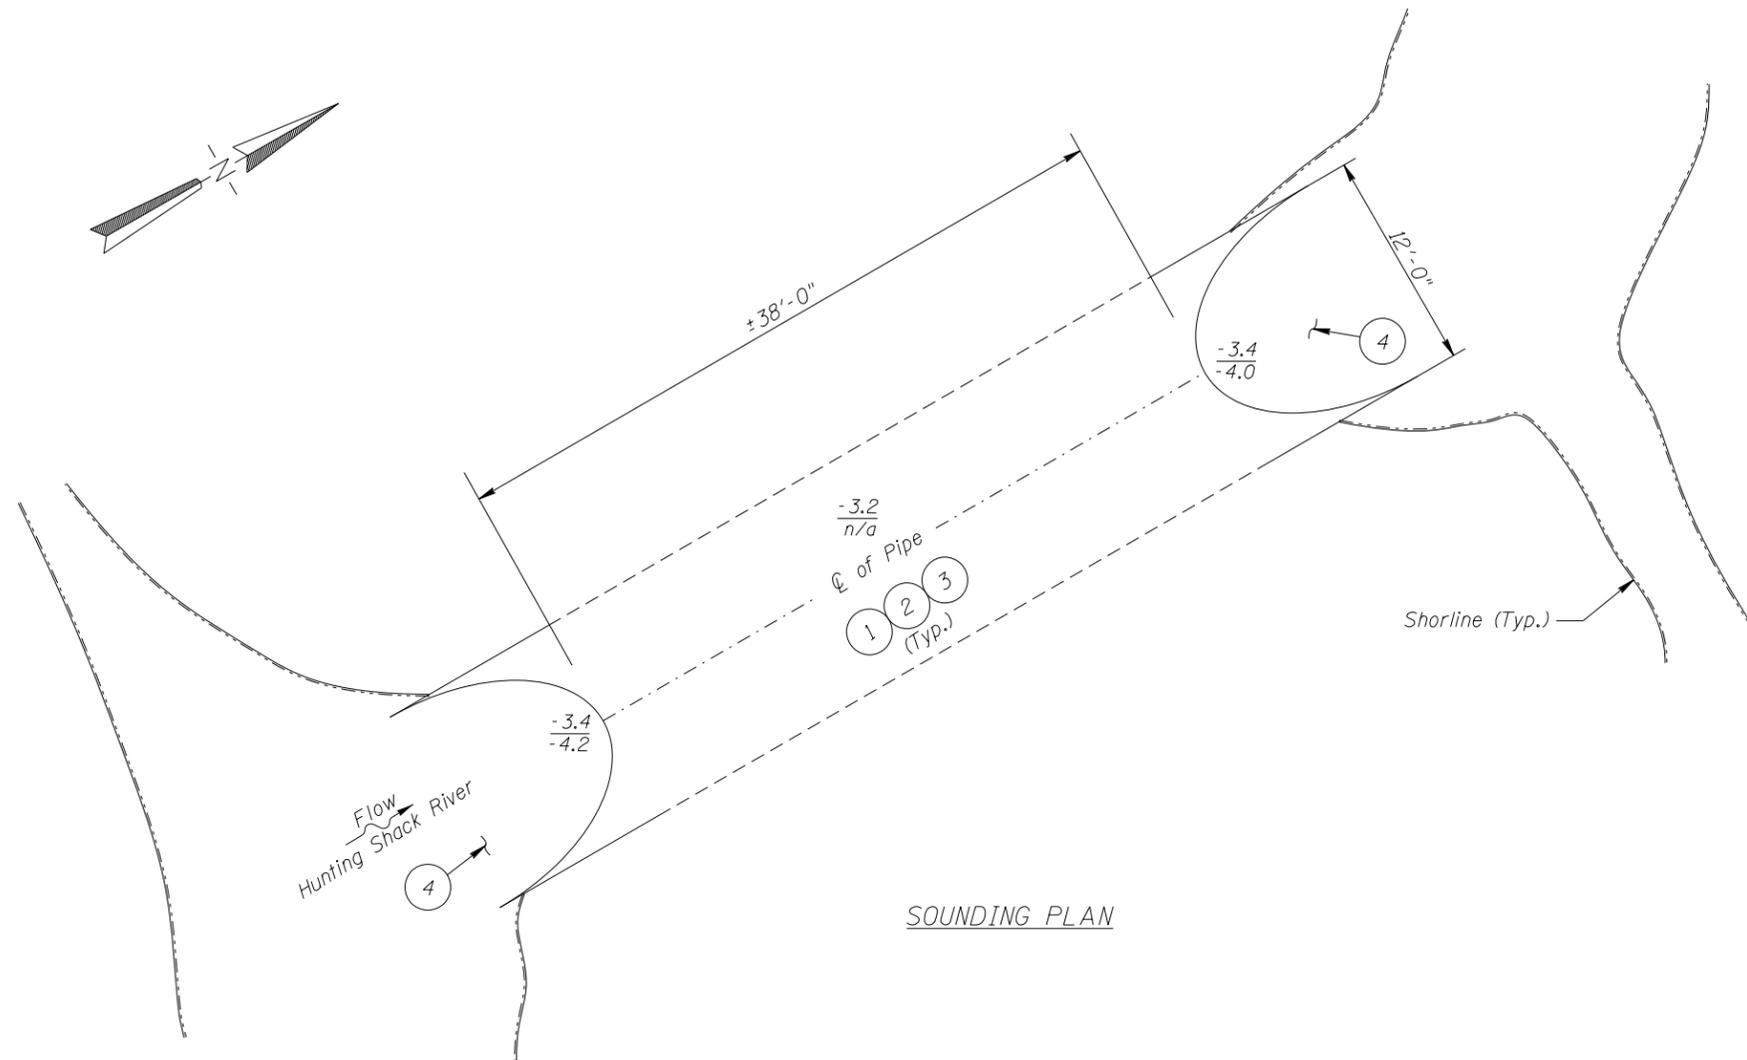
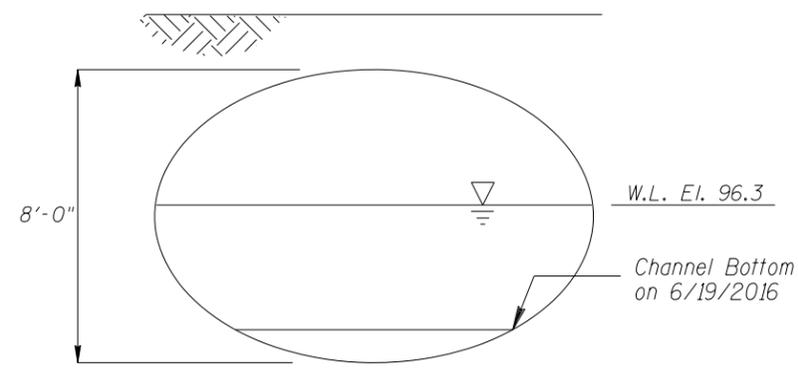
SOUNDING PLAN

- ① The culvert exhibited good galvanizing and only minor surface corrosion with negligible loss of section.
- ② The culvert alignment was in good condition with no deflections or distortions. The joints/fasteners were in place and secure.
- ③ The culvert pipe bottom was fairly clean of any infill with only randomly interspersed sandy gravel as well as small rocks.
- ④ The culvert openings were well protected against scour/erosion by up to 1 foot diameter riprap.
