2016 UNDERWATER BRIDGE INSPECTION REPORT

BRIDGE # L4198 CR 666 over SECOND CREEK

Date of Inspection: 06/23/2016

Contractor: Collins Engineers, Inc.

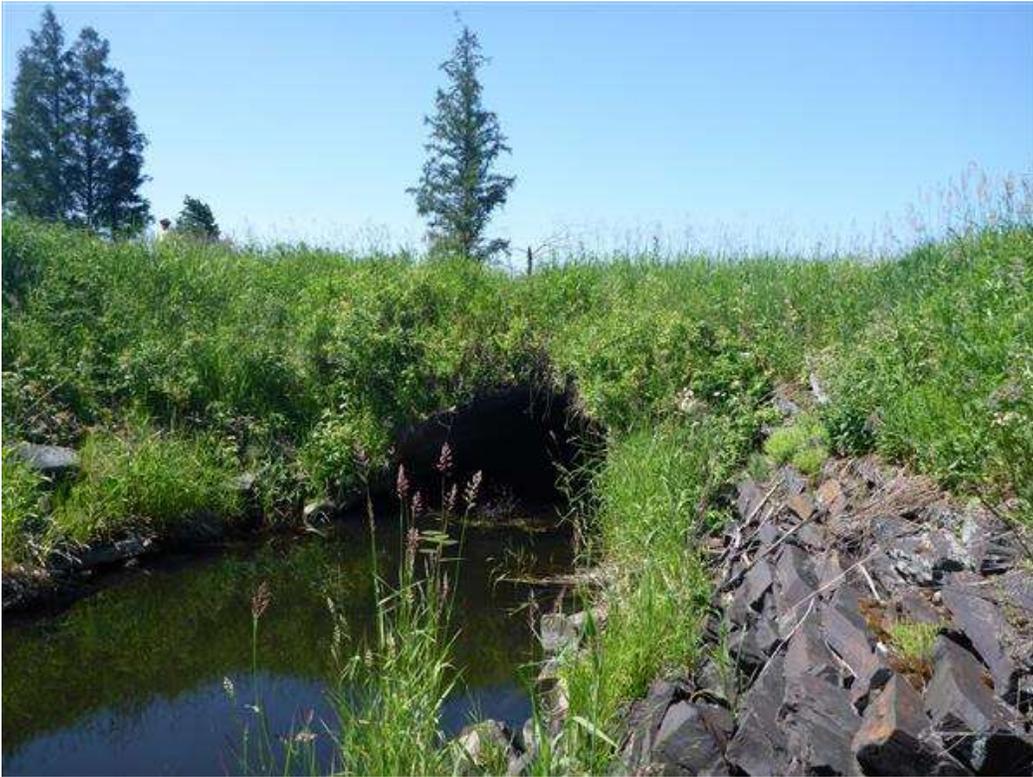
Photo 1 - Upstream Opening, Looking Southwest

(B) A light timber debris accumulation was observed at both ends of the culvert and extended across the width of the opening.

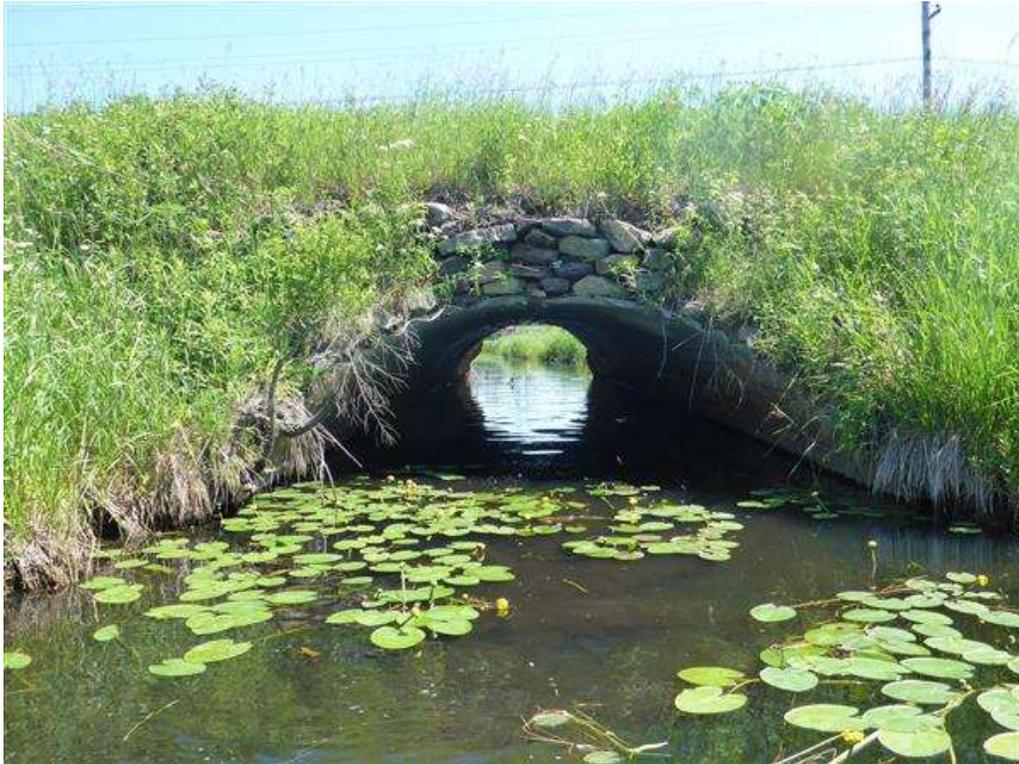
Photo 2 - Downstream Opening, Looking Northeast

59. Superstructure NBI:							
	60. Substructure NBI:							
	61. Channel NBI:	[2016] Sediment and debris buildup on east end of culvert, possibly remnants of old beaver dam.

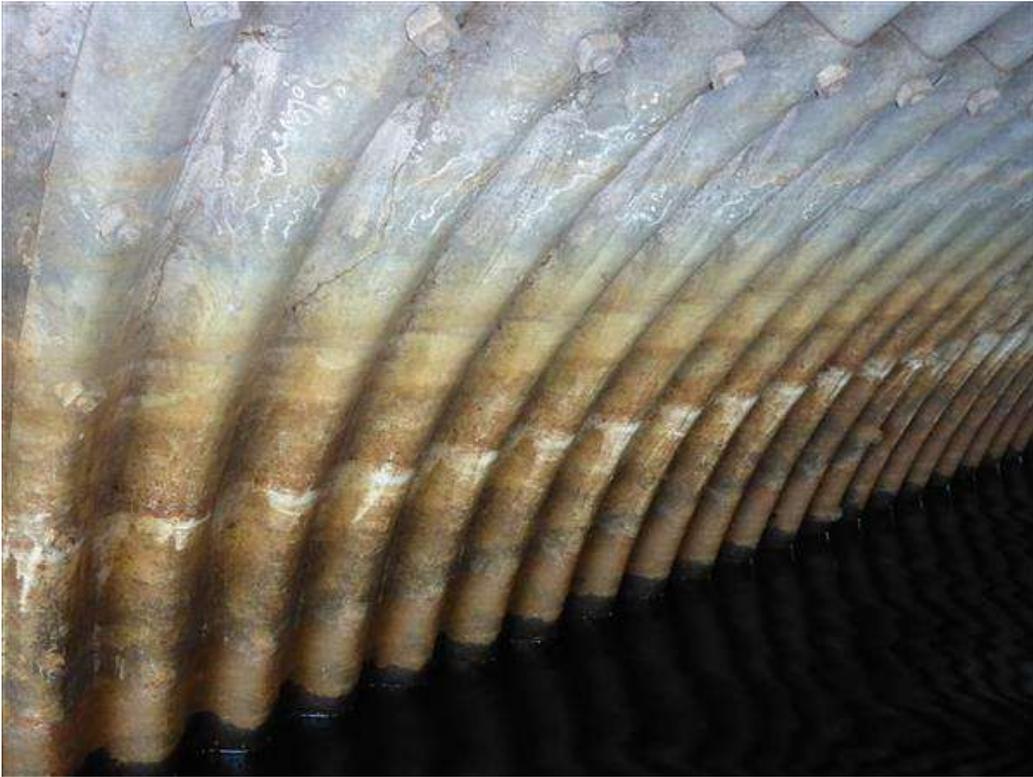
Photo 3 - Typical Steel Condition, Looking Southeast

(C) The corrugated steel pipe exhibited light surface corrosion from 3 feet above the waterline to the channel bottom with no significant loss of section. The joints and alignment was satisfactory with no deflection or distortion.

62. Culvert NBI:	[2016 U/W] A routine inspection has previously assigned a culvert NBI rating (Item 62) of fair-5, however, since no significant deterioration or distortion was observed, the rating has been increased to satisfactory-6 to more accurately represent the condition of the structure. [2016-2013] Surface rust at waterline throughout pipe. E. end beveled edges pushed in approx 6" both sides.

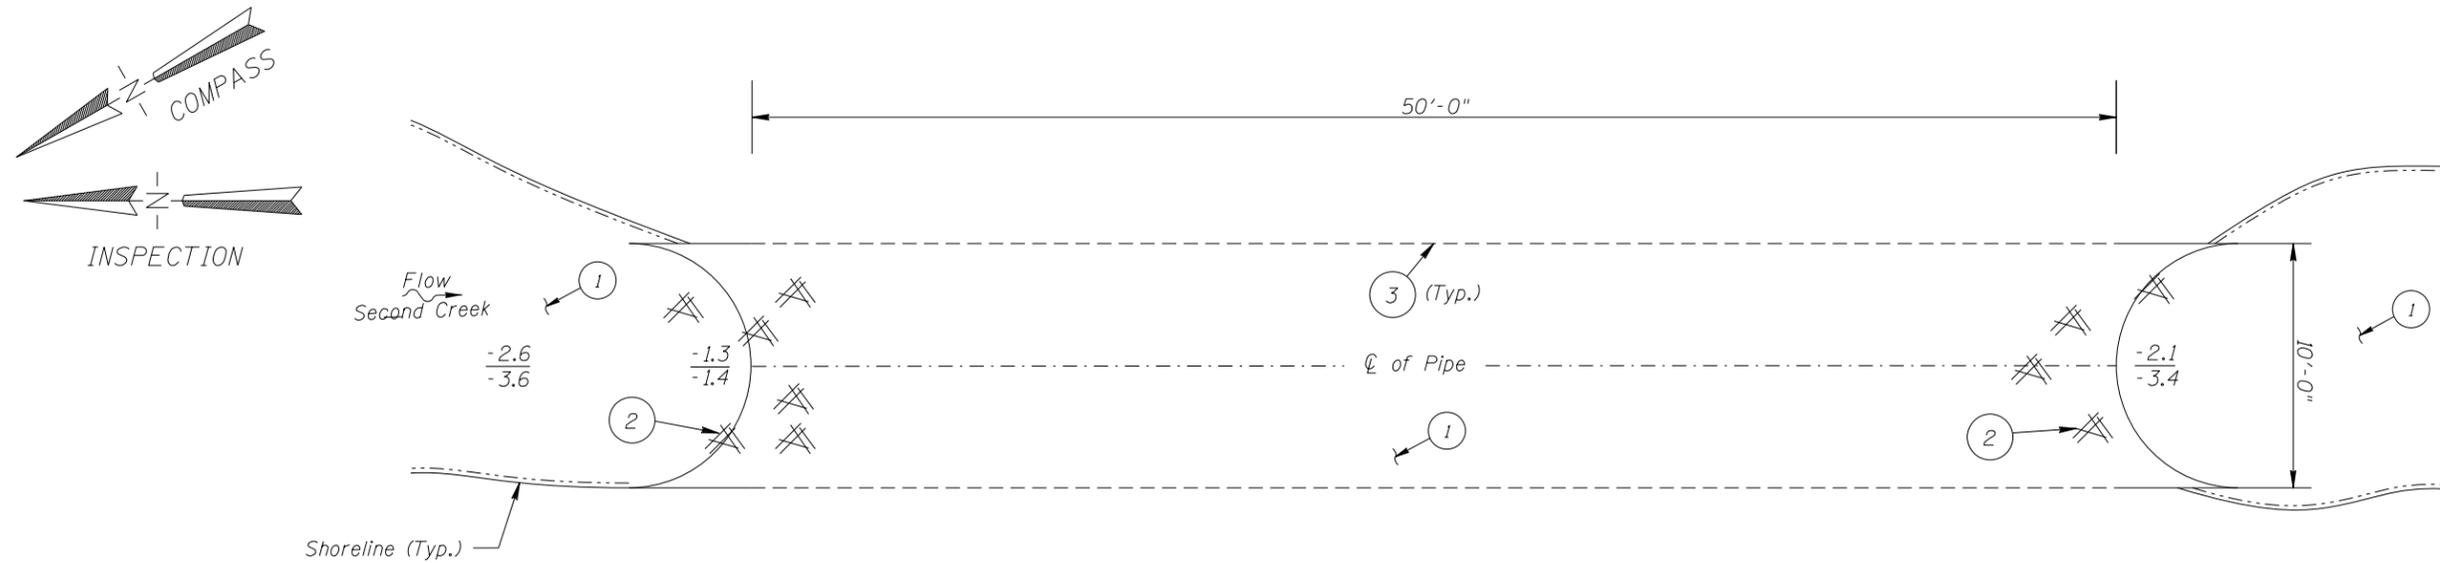
SOUNDING PLAN

- ① The channel bottom material through the culvert consisted of a layer of silt allowing 10 to 12 inches of probe rod penetration.
- ② A light timber debris accumulation was observed at both ends of the culvert and extended across the width of the opening.
- ③ The corrugated steel pipe exhibited light surface corrosion from 3 feet above the waterline to the channel bottom with no significant loss of section. The joints and alignment was satisfactory with no deflection or distortion.
