2016 UNDERWATER BRIDGE INSPECTION REPORT

BRIDGE # L8542 MUN 10 over LITTLE FORK RIVER

Date of Inspection: 06/22/2016

Contractor: Collins Engineers, Inc.

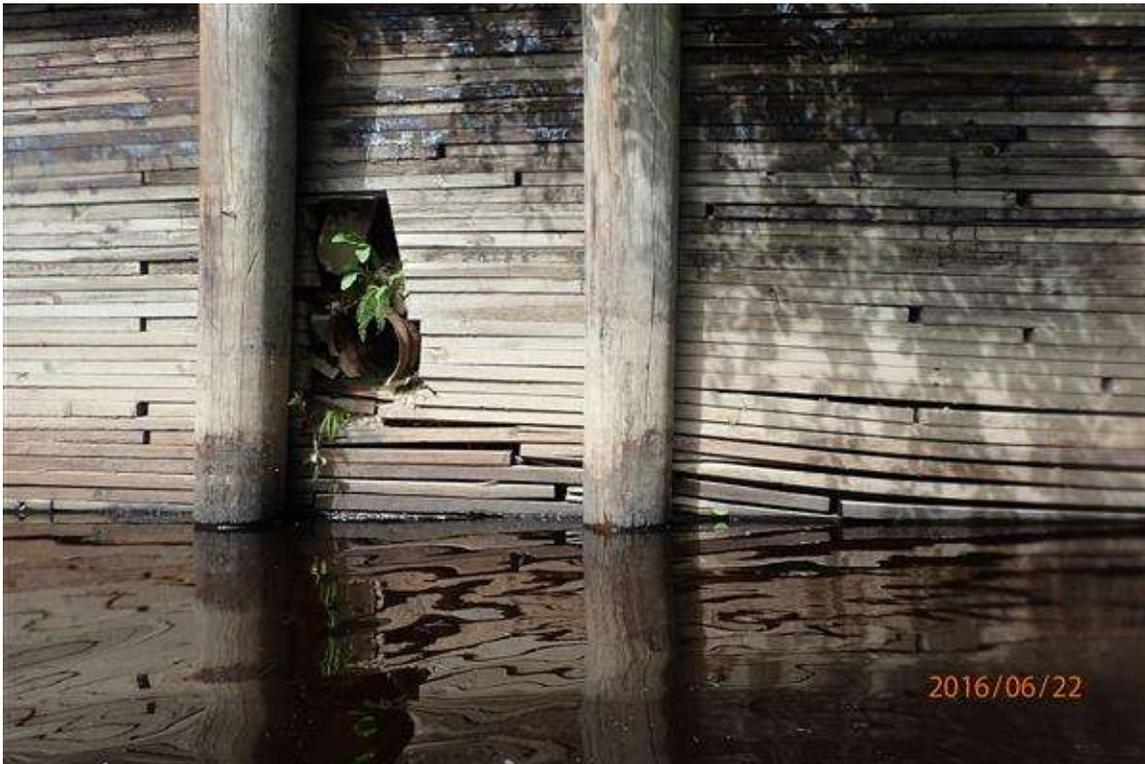
(F) A 1 inch gap was observed in the 2"x4" backwall boards at approximately 4 feet above the waterline extending from Pile H to Pile F of the South Abutment. No significant loss of backfill was observed.

(G) A slight rotation towards the channel was observed at the southeast wingwall. The wall showed no signs of structural inadequacy.

Photo 6 - Deflected/Sagging Backwall Boards and Penetration at Southeast Wingwall, Looking South

(C) Monitor inclination of the southeast wingwall rotation.

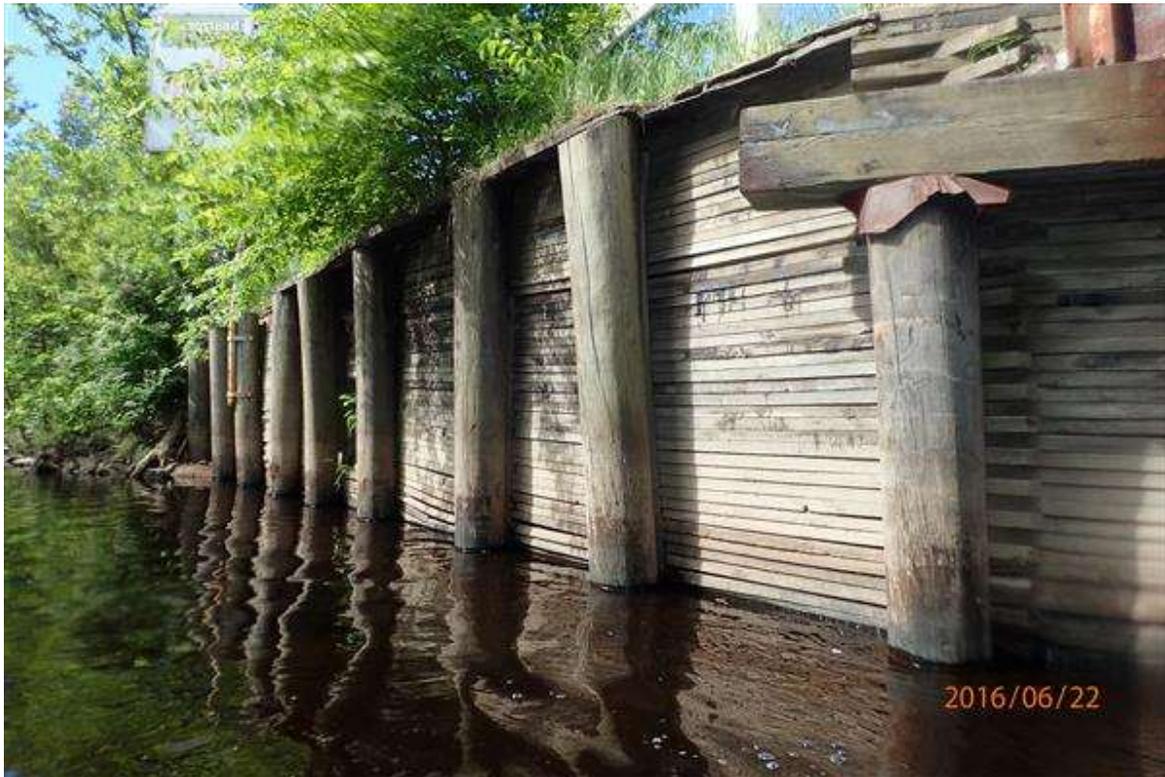
Photo 7 - Deformation of the Southeast Wingwall, Looking Southeast

- 7 A slight rotation towards the channel was observed at the southeast wingwall. Apart from the deflection, the wall showed no signs of structural inadequacy.

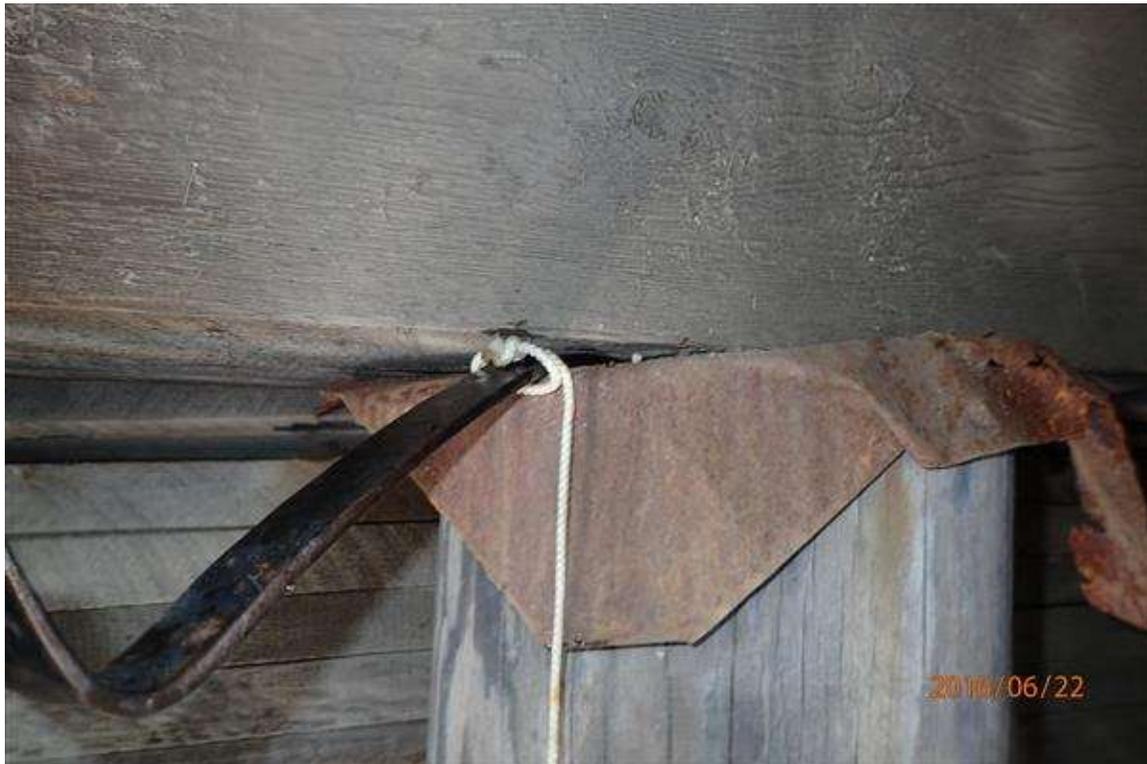
(D) The timber pile cap of the South Abutment was bearing on the southern 25 to 50 percent of Piles A, B, C, F, G, H, I and J.

Photo 8 - Loss of Bearing on Timber Pile at South Abutment Pile H, Looking South

(D) Repair/replace the pile caps at the North and South Abutments and establish full bearing to the timber piles.

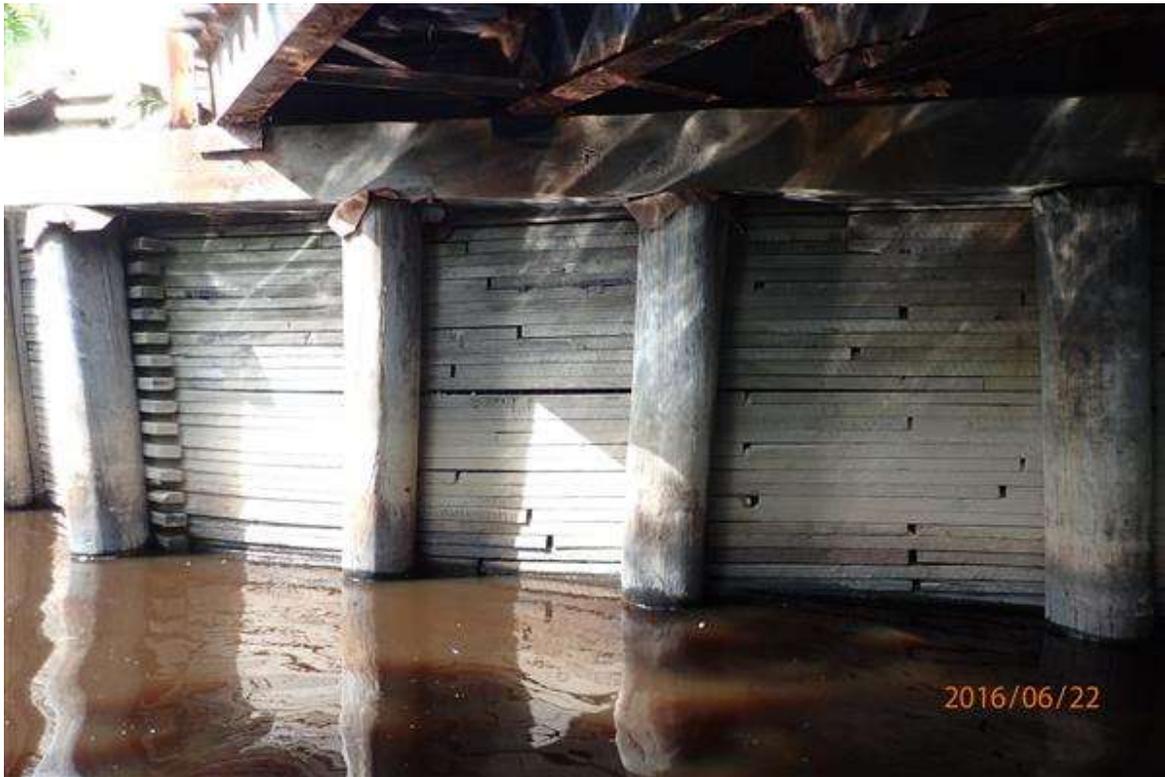
Photo 9 - Gap in Backwall and Sagging Boards at South Abutment, Looking South

- 6 A 1 inch gap was observed in the 2"x4" backwall boards at approximately 3 feet above the waterline extending from Pile H to Pile F of the South Abutment. No significant loss of backfill was observed. In this area backwall boards were sagging 2 to 4 inches.

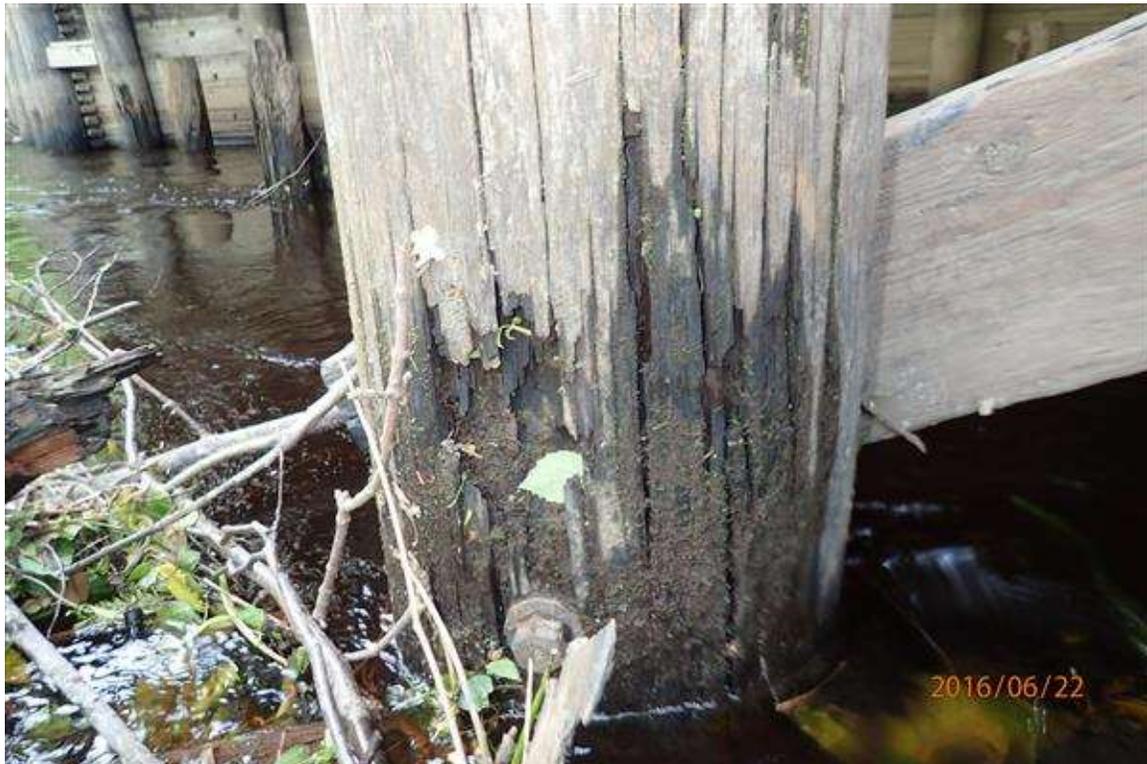
(C) Heavier timber deterioration and decay, allowing a maximum awl penetration of 1 inch, was observed on the west side of Piles A, B and E of Bent 1 and Piles A and B of the North Abutment. The area of deterioration and decay typically extended from the channel bottom to 1 foot above the waterline.

Photo 10 - Timber Decay at Bent 1 Pile A, Looking North

(B) Monitor the timber of the piles with noted heavier deterioration and decay and consider level III testing (core sampling) to verify interior soundness.

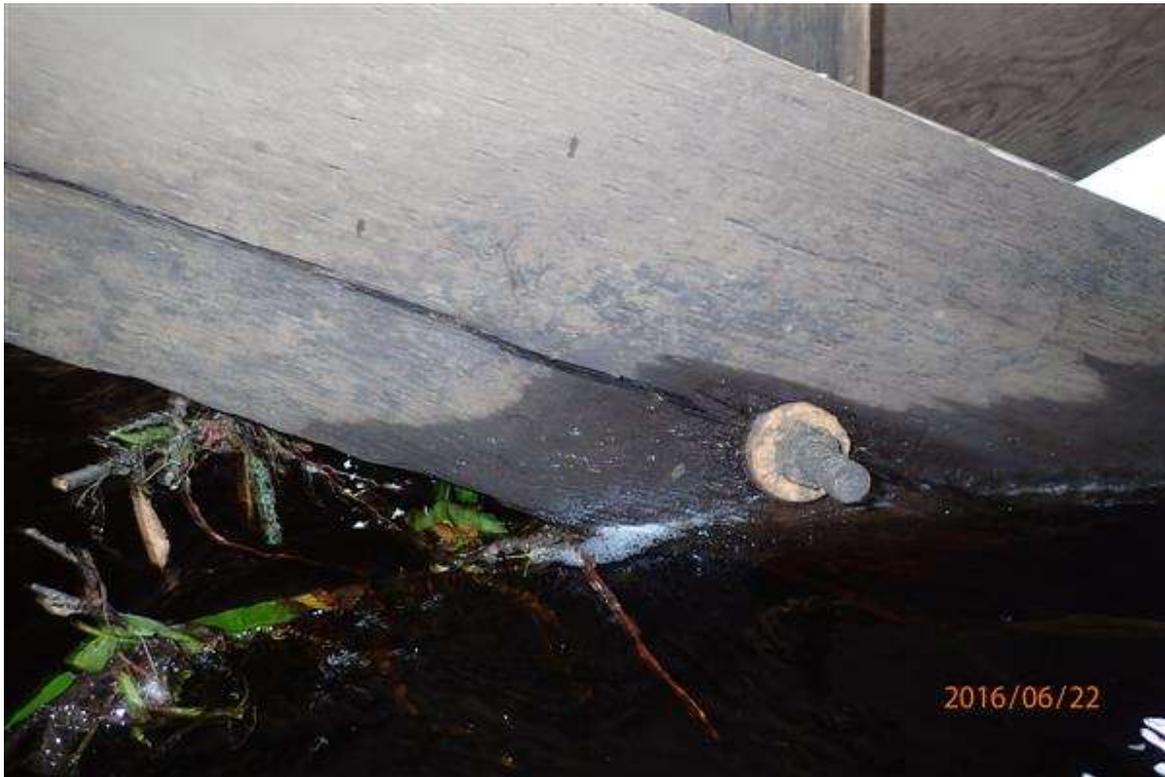
(E) The timber cross-bracing was typically sound with random splitting at the connections up to 1/2 inch wide.

Photo 11 - Typical Split in Bracing Connections, Looking South

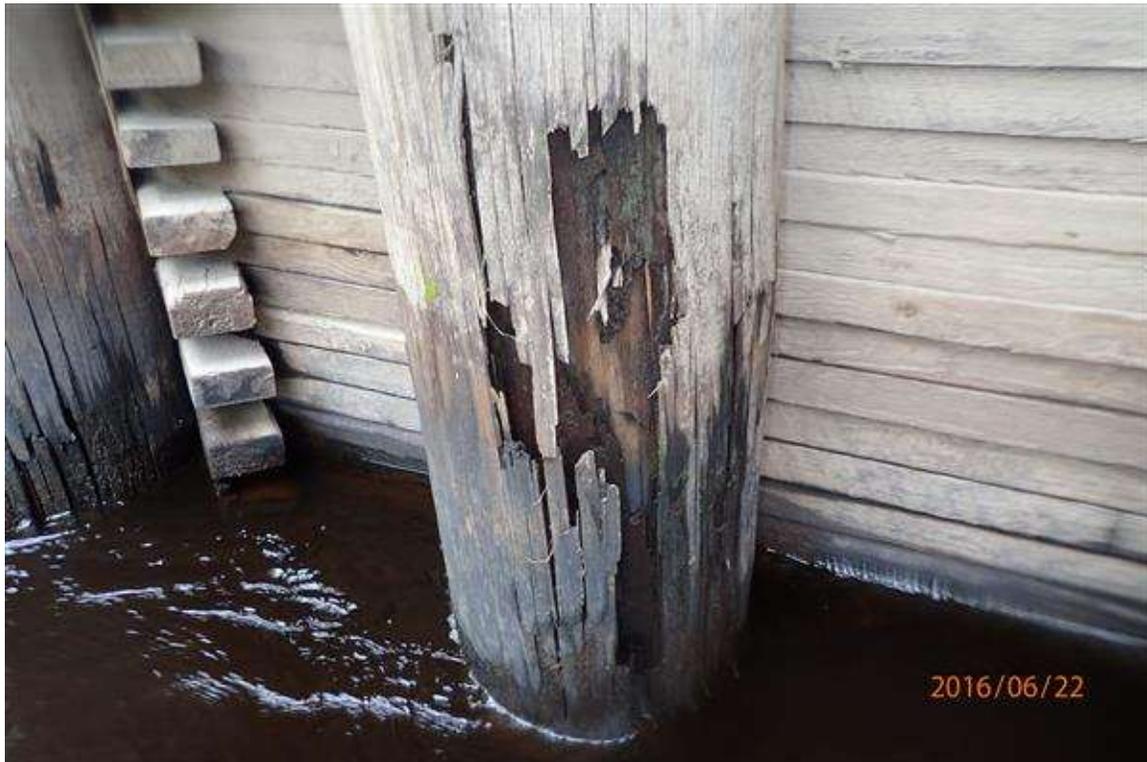
Photo 12 - Timber Pile Decay (North Abutment Pile B Shown), Looking North

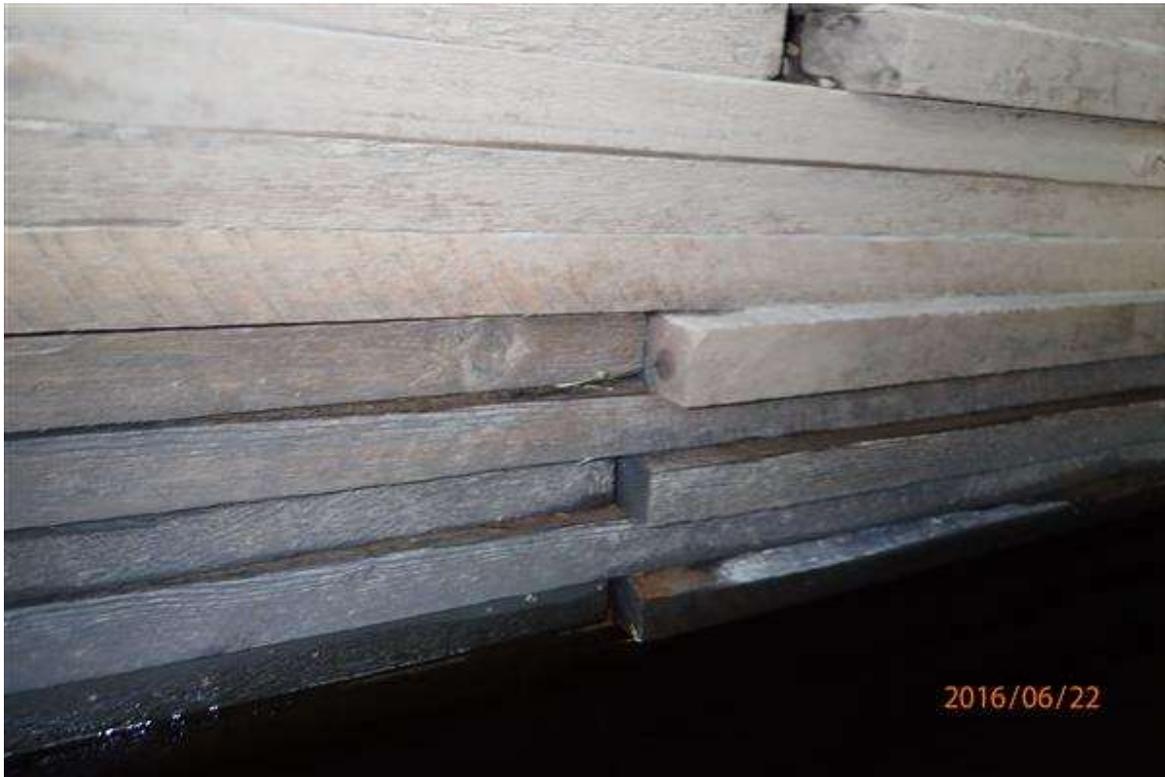
Photo 13 - Displacement of Backwall Boards at North Abutment, Looking Northeast

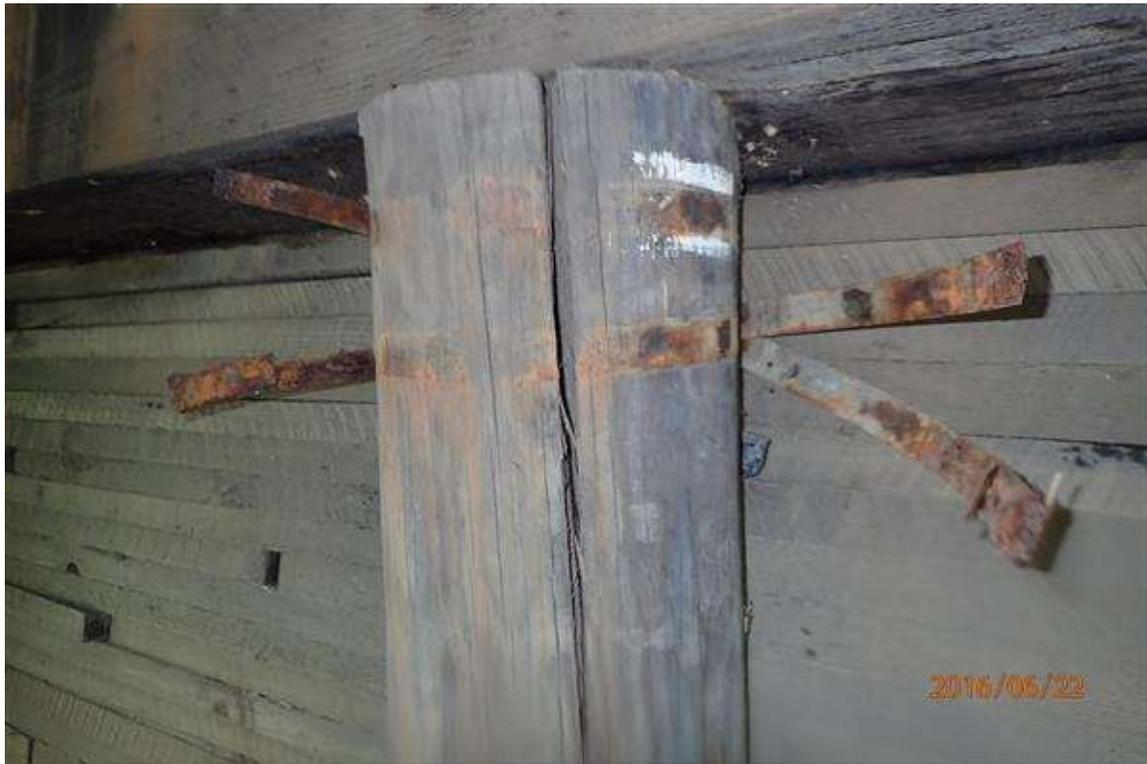
(J) A 1/2-inch wide split in Pile H of the North Abutment extended from the top of the pile down 2 feet with 6 inches of penetration.

Photo 14 - Split in Pile H of North Abutment, Looking Northwest

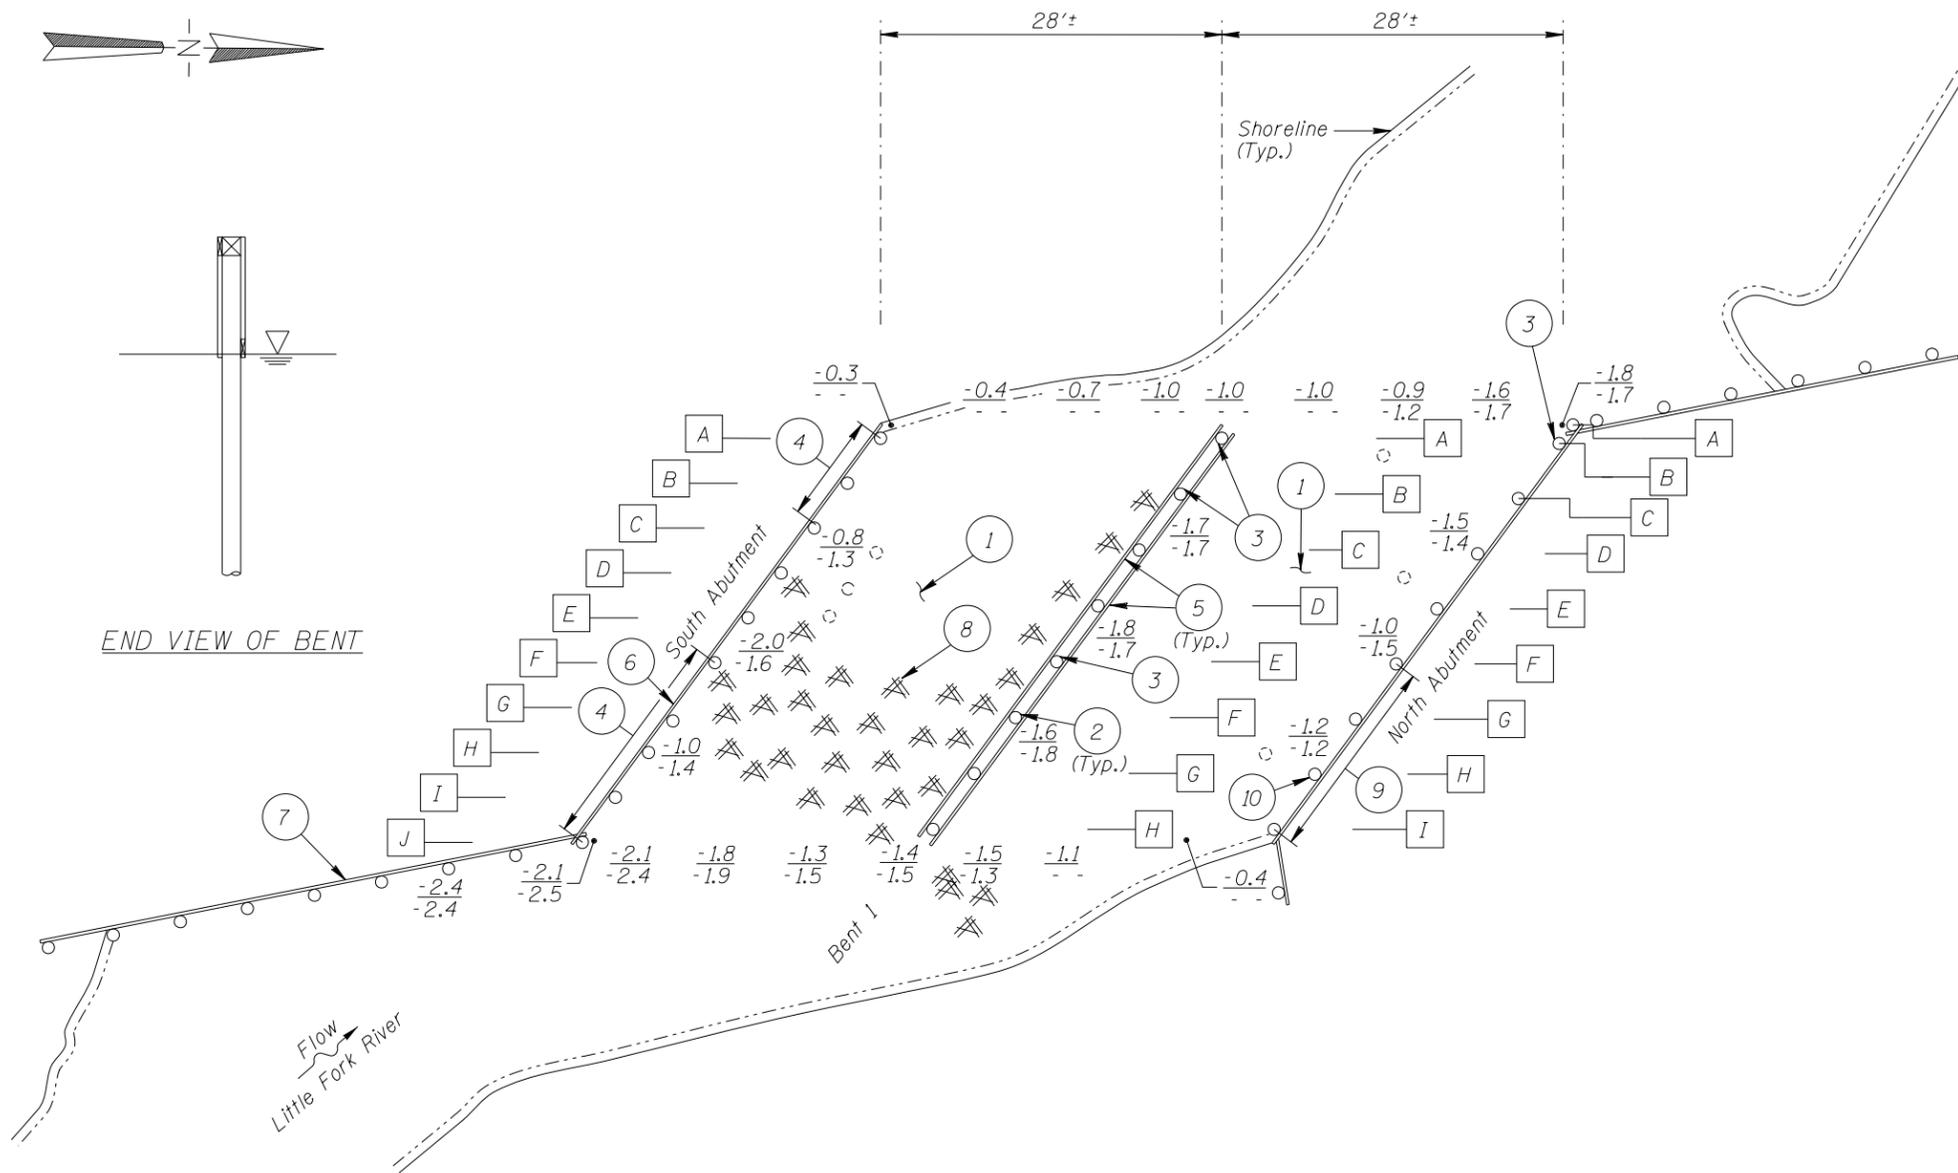
SOUNDING PLAN

- 1 The channel bottom material typically consisted of rocks, gravel and silt allowing a maximum probe rod penetration of 2 inches. Random debris was scattered throughout the channel.

- 2 The timber piles typically exhibited external decay from the channel bottom to 2 feet above the waterline. The timber typically allowed an awl penetration of 1/4 inch and a maximum penetration of 1/2 inch. From 2 feet above the waterline to the top of the piles, the timber was sound with random splitting or checking up to 3/8 inch wide and 1 inch deep.

- 3 Heavier timber deterioration and decay, allowing a maximum awl penetration of 1 1/4 inch, was observed on the west side and south sides of Piles A, B and E of Bent 1 and Piles A and B of the North Abutment. The area of deterioration and decay typically extended from the channel bottom to 2 feet above the waterline.

- 4 Timber pile cap of the South Abutment was partially bearing on the southern 25 to 50% of Piles A, B, C, F, G, H, I and J.
- 5 The timber cross-bracing was typically sound with random splitting at the connections up to 1/2 inch wide.

- 8 A light to moderate accumulation of timber debris consisting of 1 foot diameter and smaller logs and branches was observed extending from Bent 1 to the South Abutment as shown. The debris extended from the channel bottom to 4 feet above the waterline. Random steel and old tires debris was scattered throughout the timber debris.

- 9 Timber pile cap of the North Abutment was not fully bearing on the southern 25 to 50% of Piles F, G, H and I.
- 10 A 1/2-inch wide split in Pile H of the North Abutment extended from the top of the pile down 2 feet with 6 inches of penetration.
