UNDERWATER BRIDGE INSPECTION REPORT

STRUCTURE NO. 60019

RED LAKE RIVER

DISTRICT 2 - POLK COUNTY, CITY OF EAST GRAND FORKS

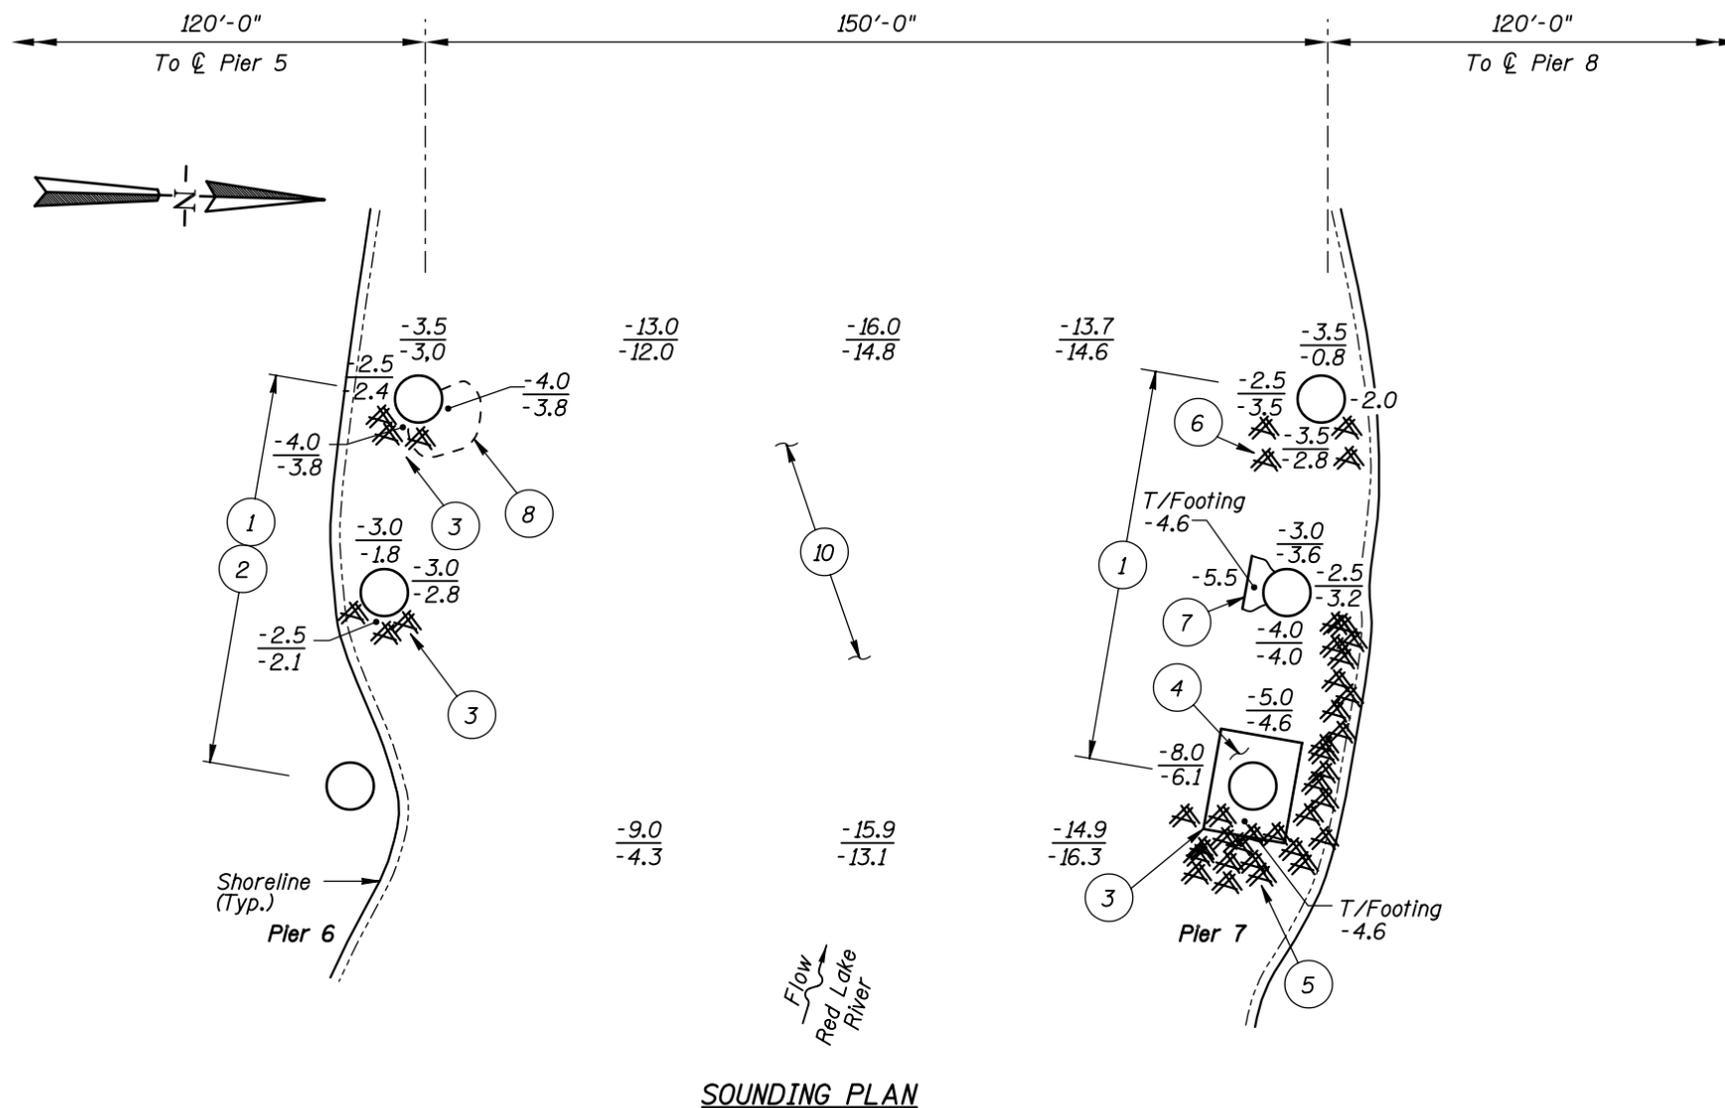
- 1 Overall, the concrete piers were found to be in good and sound condition with no significant deterioration.
- 2 The bottom of the web wall of the pier was located approximately 3 inches above the waterline.

- 3 A light accumulation of timber debris, consisting of 8 to 10 inch diameter branches, was observed at the upstream sides of both the center and downstream columns of the pier.

- 4 The top of the footing of the upstream column of Pier 7 was exposed around the entire column with a maximum vertical face exposure of 3.4 feet along the south face of the column footing. The west side of the column footing could not be accessed due to a heavy accumulation of timber debris.

- 5 A heavy accumulation of timber debris, consisting of 1 to 2 foot diameter logs, was observed around the upstream end of the pier and extended from the channel bottom up to approximately 6 feet above the waterline. The timber debris extended from the pier to the north shore and from the upstream column to the center column of the pier.

- 6 A light accumulation of timber debris, consisting of 6 to 8 inch diameter branches, was observed around the downstream column of Pier 7.
- 7 The top of the footing of the center column of Pier 7 was exposed along the south face for 6 feet with up to 11 inches of vertical face exposure.

- 8 The downstream column of the pier exhibited a local scour depression that measured 2 feet deep by approximately 3 feet in radius.
- 9 The channel bottom consisted of hard packed silt with up to 3 inches of probe rod penetration.

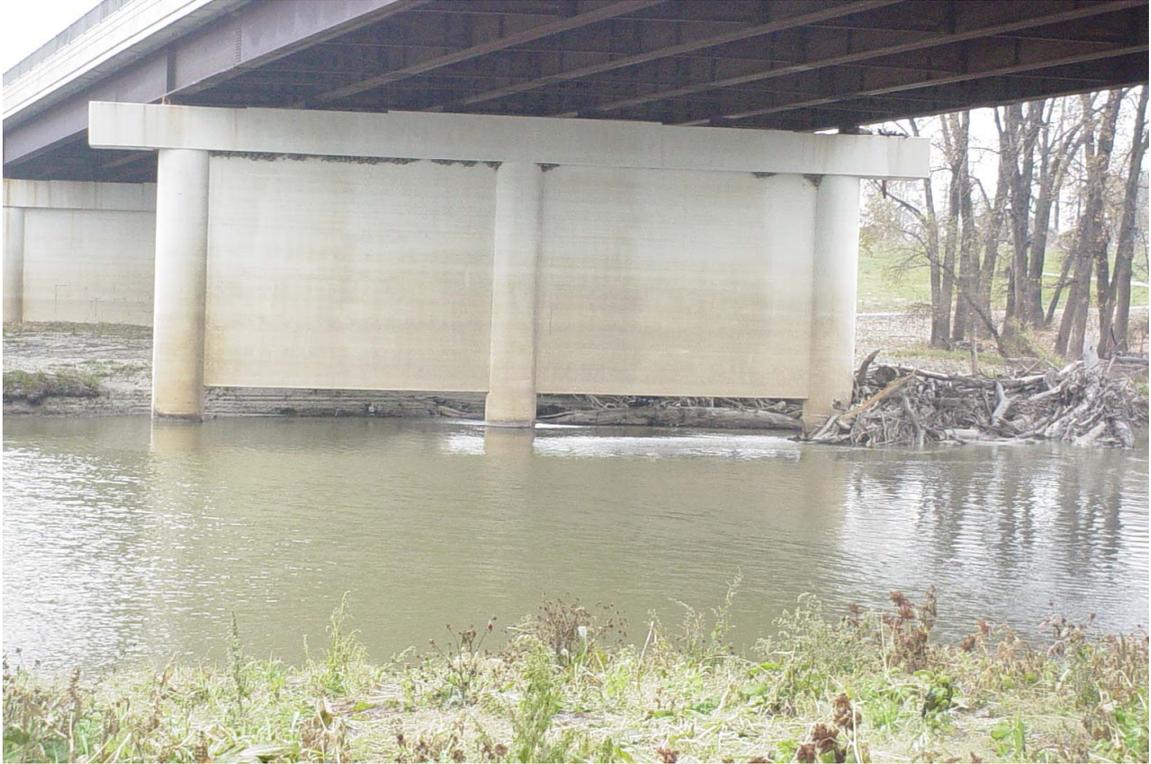
- (A) The concrete surface of both piers was found to be in good condition with no significant structural defects observed.
- (B) The top of the footing of the upstream column at Pier 7 was exposed around the entire column with a maximum vertical face exposure of 3.4 feet along the south face of the column footing. The west side of the column footing could not be accessed due to a heavy accumulation of timber debris.
- (C) The top of the footing of the center column of Pier 7 was exposed for a length of 6 feet along the south face with up to 11 inches of vertical face exposure.

Photograph 3. Overall View of Pier 7, Looking Northeast.

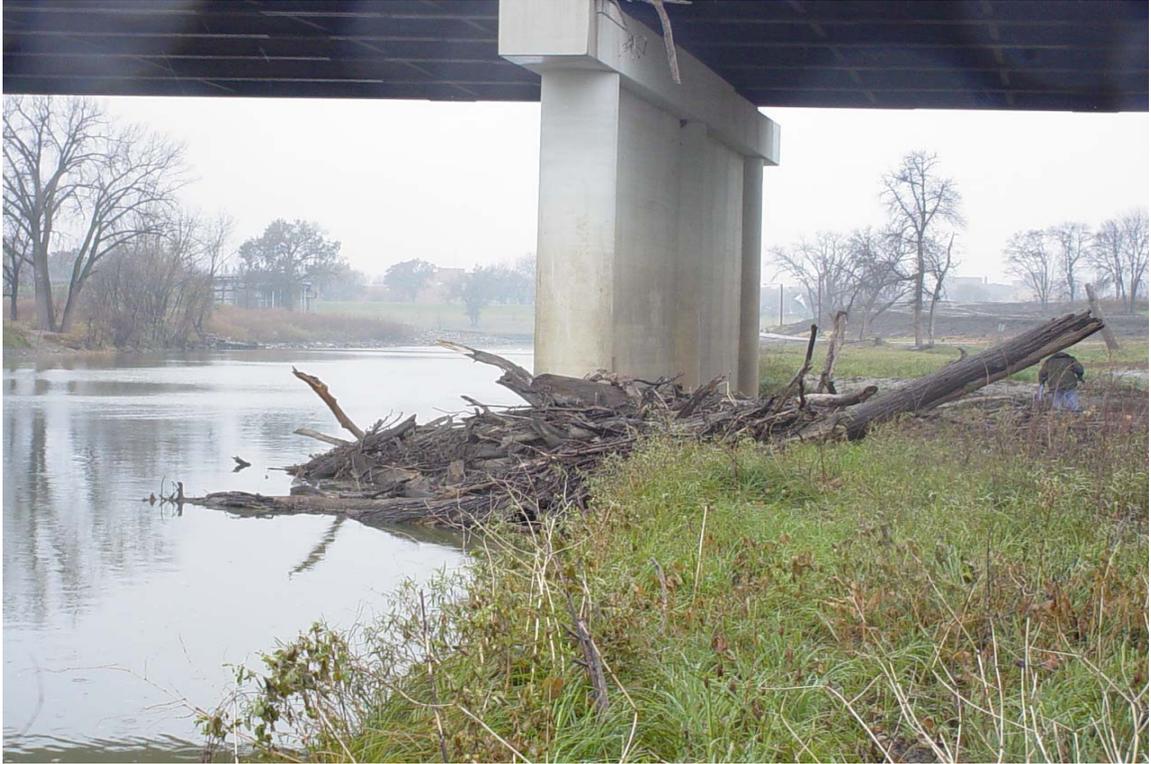
- (D) A heavy accumulation of timber debris, consisting of 1 to 2 feet diameter logs, was observed at the upstream end of Pier 7 and extended from the channel bottom to 6 feet above the waterline. The timber debris extended from the upstream end of Pier 7 to the north shoreline and along the shore to the center column of the pier. There was also light drift at Pier 6 and around the remainder of Pier 7.
- (E) The downstream column of Pier 6 exhibited a local scour depression that measured 2 feet of deep by approximately 3 feet in radius.

Photograph 5. View of Timber Debris at the Upstream Nose of Pier 7, Looking West.

- (A) Remove the heavy accumulation of timber debris at the upstream nose of Pier 7 during routine maintenance.
- (B) Reinspect the submerged substructure units at the normal maximum recommended (NBIS) interval of five (5) years.

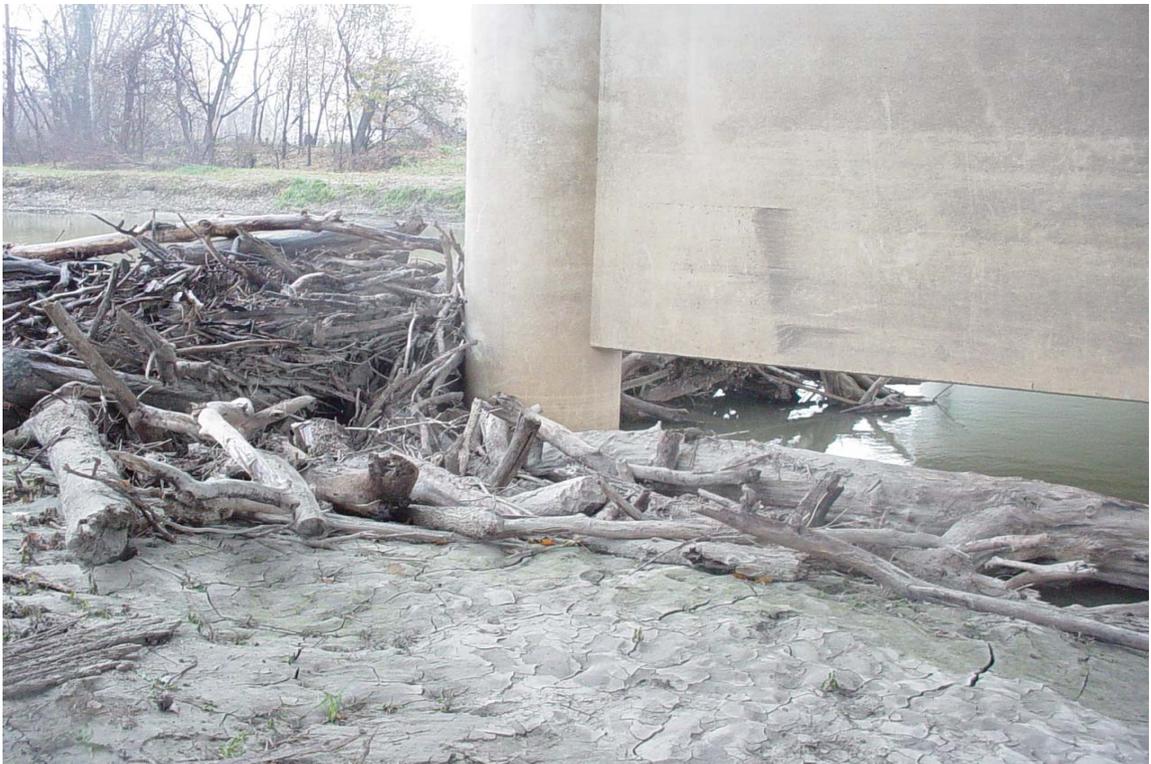
Photograph 6. View of Timber Debris at the Upstream Nose of Pier 7, Looking Southeast.

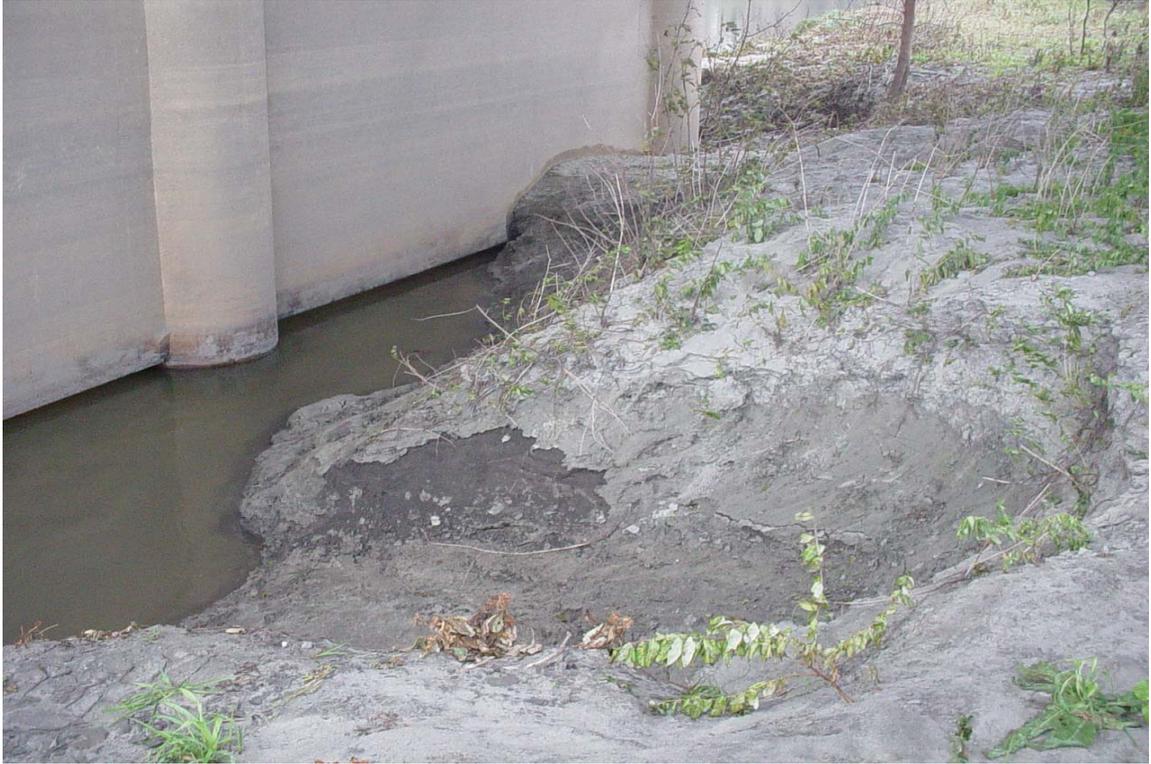
Photograph 7. View of Erosion of the South Bank at Pier 6, Looking Northeast.

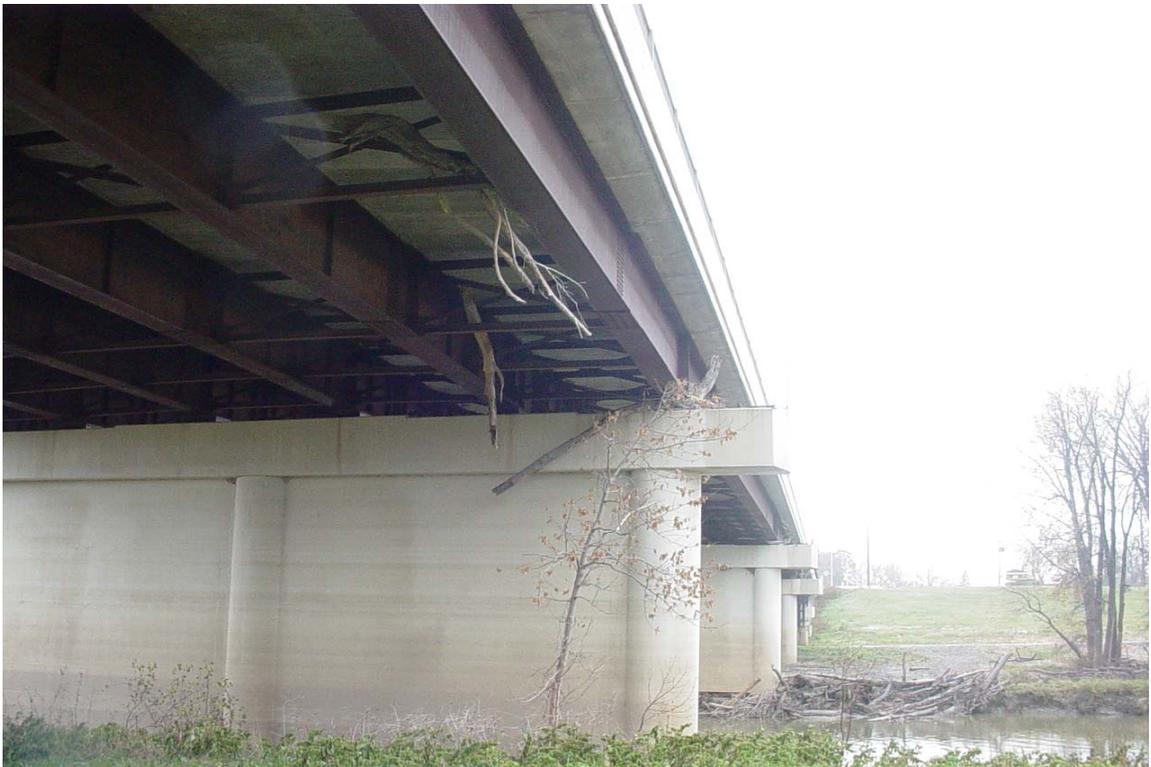
Photograph 8. View of Timber Debris at the Pier Cap of Pier 6, Looking North.
