# UNDERWATER BRIDGE INSPECTION REPORT

STRUCTURE NO. 4992  
CSAH NO. 4  
OVER THE  
CLEARWATER RIVER (DAM)  
DISTRICT 2 - CLEARWATER COUNTY

PREPARED FOR THE  
MINNESOTA DEPARTMENT OF TRANSPORTATION  
BY  
COLLINS ENGINEERS, INC.  
JOB NO. 5221 (CEI 36)

MINNESOTA DEPARTMENT OF TRANSPORTATION  
UNDERWATER BRIDGE INSPECTION

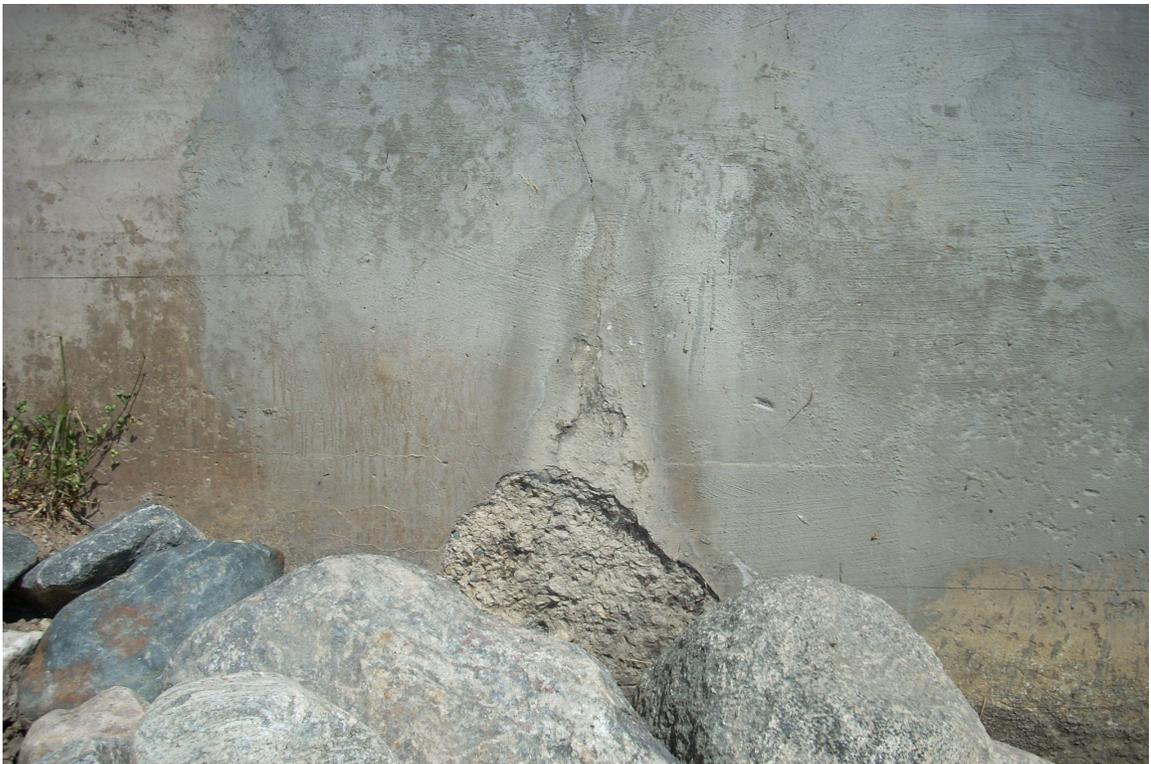
Photograph 8. View of Crack and Spalling (failed patch repair) at center of West Wingwall of the North Abutment, Looking Northeast.

- 5 Random light scaling of below water concrete surfaces with up to 1/8 inch penetration.
- 6 Vertical 1/16 inch wide crack extending from the footing slab up 8 feet through a failing repair patch with a 6 inch diameter spall 2.5 feet above the channel bottom.

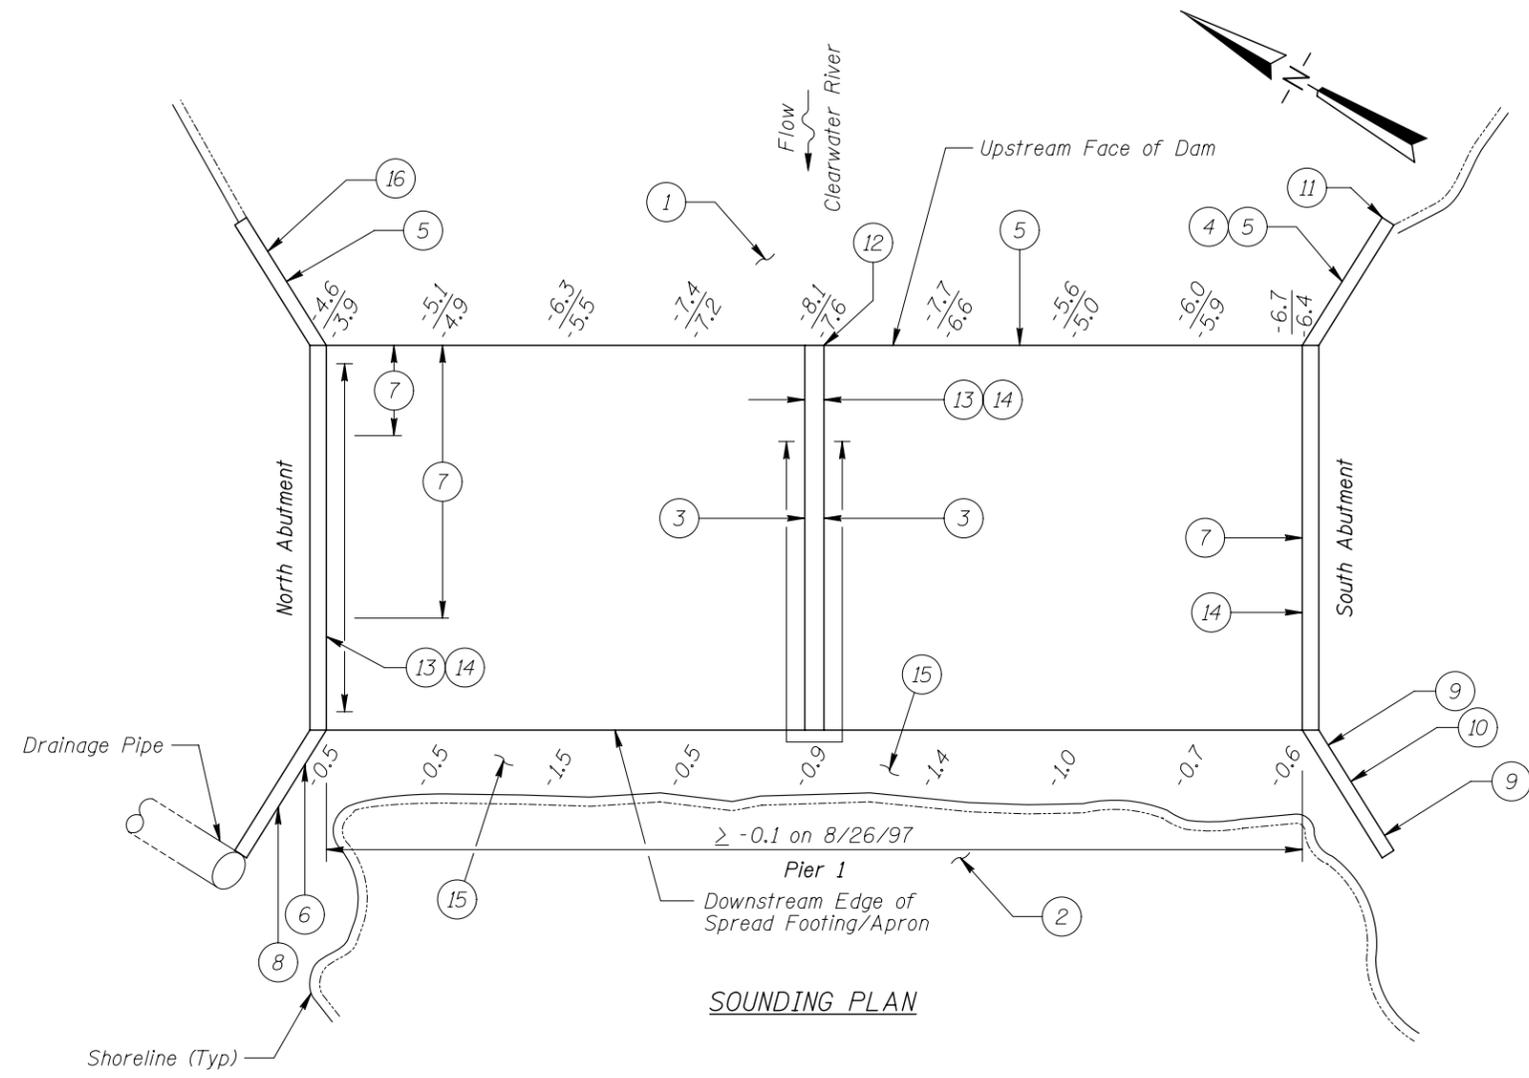
SOUNDING PLAN

- 1 The channel bottom material consisted of sandy gravel with random riprap and up to 2 inches of probe rod penetration.
- 2 The channel bottom material consisted of 6 to 18 inch diameter riprap with no probe rod penetration.

- 3 Three diagonal 1/16 inch wide cracks on both sides of Pier 1 extending from the the bottom of pier cap to the top of concrete pier encasement.
- 4 Spalled, cracked, and unsound concrete area centered at the waterline, 2 feet wide by 2 feet high, with exposed aggregate and up to 2 inches maximum penetration.

- 7 Two vertical 1/16 inch wide cracks extending from 3 to 4 feet above the waterline to the bottom of the wall.
- 8 Vertical 1/16 inch wide crack extending from the top of footing slab up 8 feet through a failing repair patch with 1 foot diameter spall at the footing.

- 9 Vertical 1/16 inch wide crack extending up from the top of footing 8 feet and continuing diagonally to the top of the wingwall.
- 10 Vertical 1/8 inch wide crack extending up from the top of footing 8 feet and continuing diagonally to the top of the wingwall.

- 11 Area of minor section loss 1 1/2 inch by 6 inch with maximum penetration of 6 inches located at the end of the southeast wingwall.
- 12 Corner spall, 6 inches wide by 6 inches high, with 1 inch maximum penetration was observed at the upstream nose of Pier 1 at the waterline.

- 13 In addition to repairs, the North Abutment and Pier 1 have concrete encasements extending from the channel bottom to 4 feet to 5 feet above the waterline. The concrete encasements exhibited minor hairline shrinkage cracking, but were smooth and sound.

- 14 Since the previous inspection, both abutment wingwalls and pier have areas of concrete repair.
- 15 Since the 2002 inspection, riprap has been added to the downstream portion of the bridge.

- 16 Deterioration of skin coat grout facing, with 1/4 inch penetration near waterline.

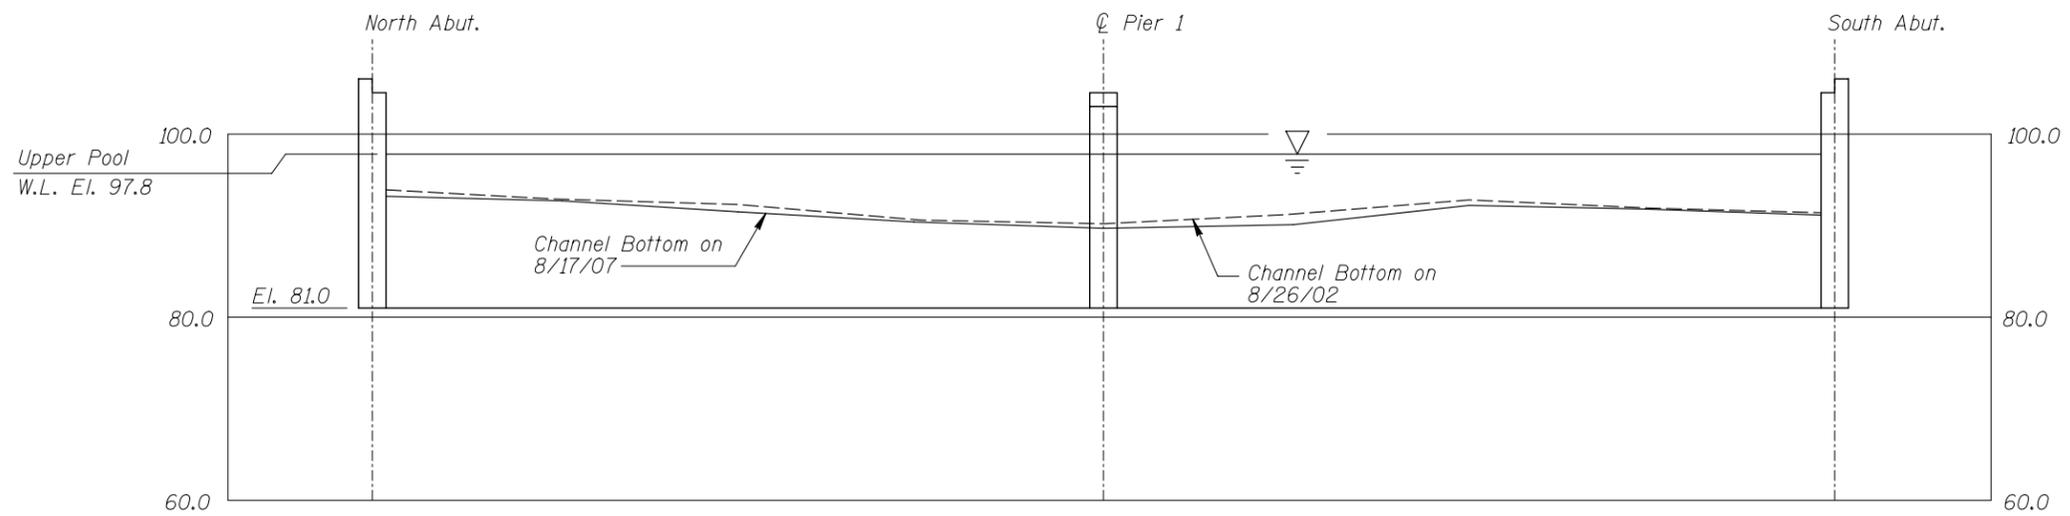
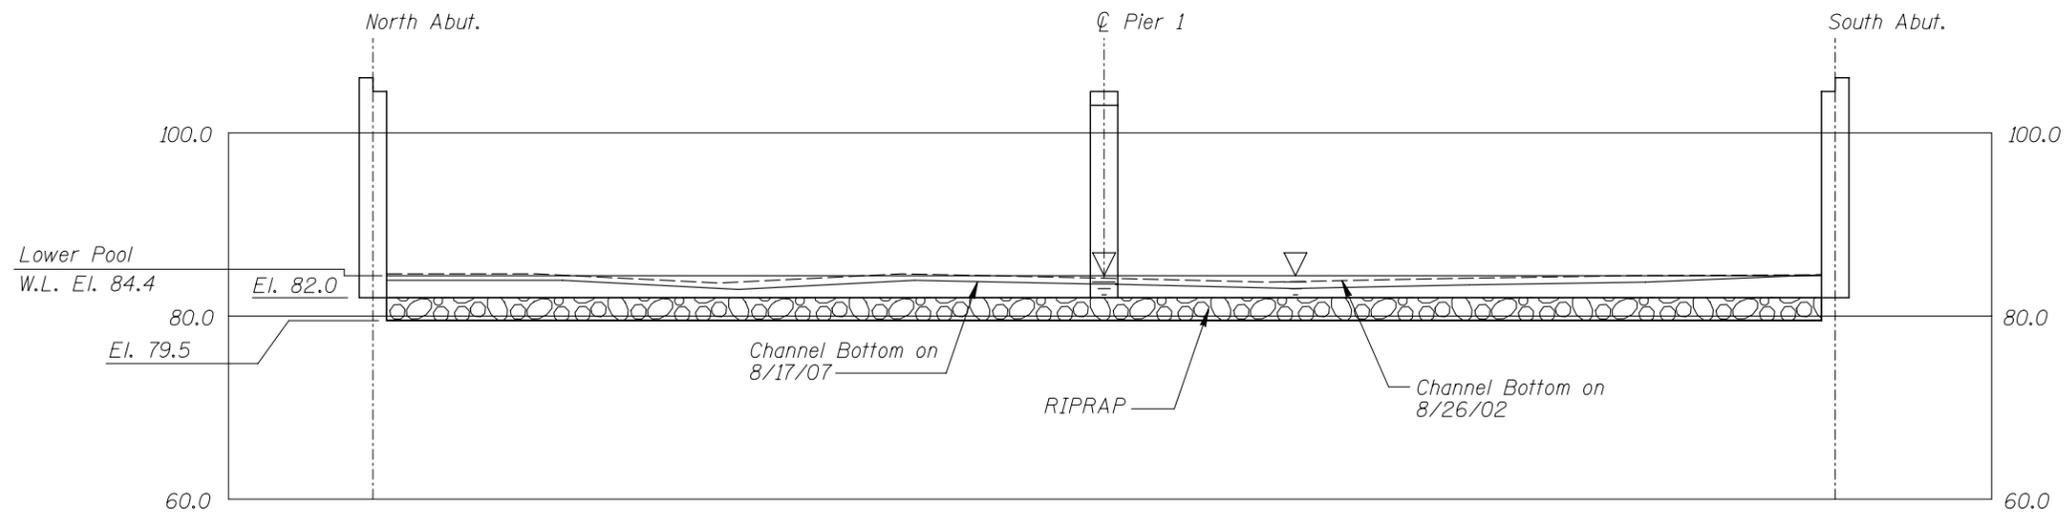
**EAST FASCIA PROFILE**  
Vertical Scale: 1"=20'-0"

**WEST FASCIA PROFILE**  
Vertical Scale: 1"=20'-0"
