UNDERWATER BRIDGE INSPECTION REPORT

STRUCTURE NO. 60506

RED RIVER OF THE NORTH

AUGUST 29, 2012

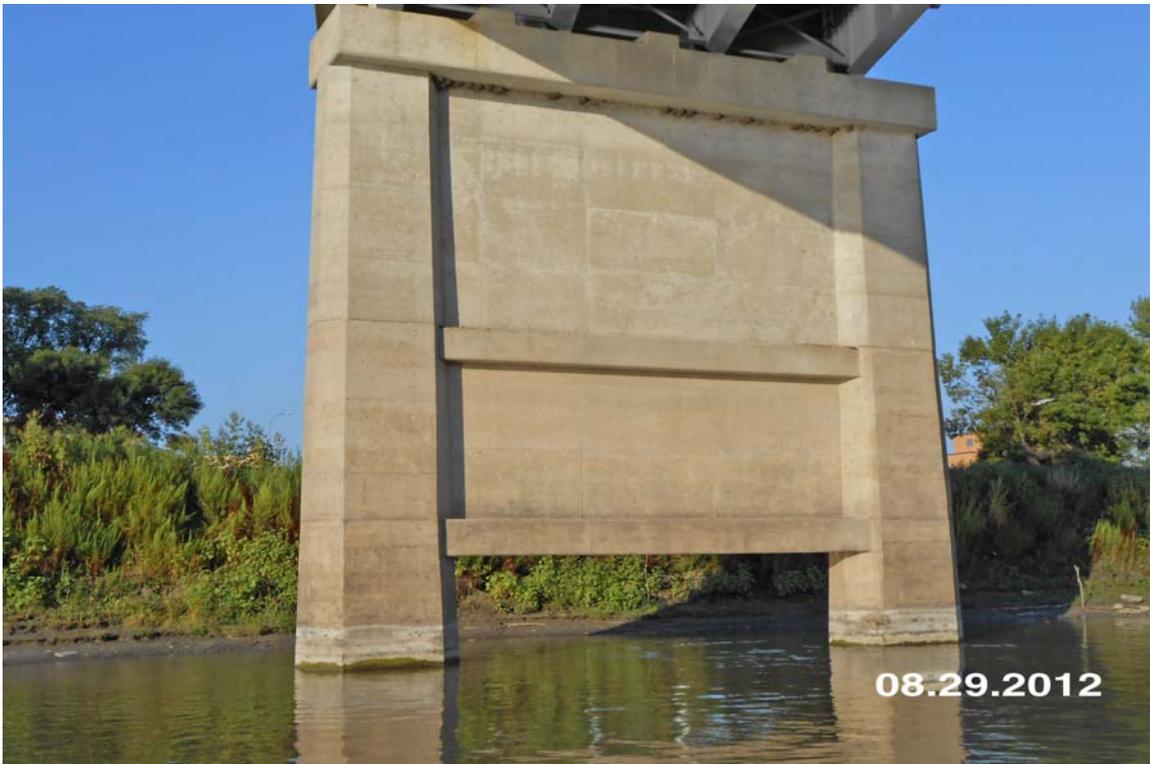
Photograph 2. View of Pier 6, Looking West.

- ③ The channel bottom consisted of sandy silt with up to 1 foot of probe rod penetration.
- ④ A light accumulation of timber debris, consisting of 6 inch diameter branches, was observed at the upstream end of Pier 6 which extended from the channel bottom up 1 foot and 4 feet off the column faces.

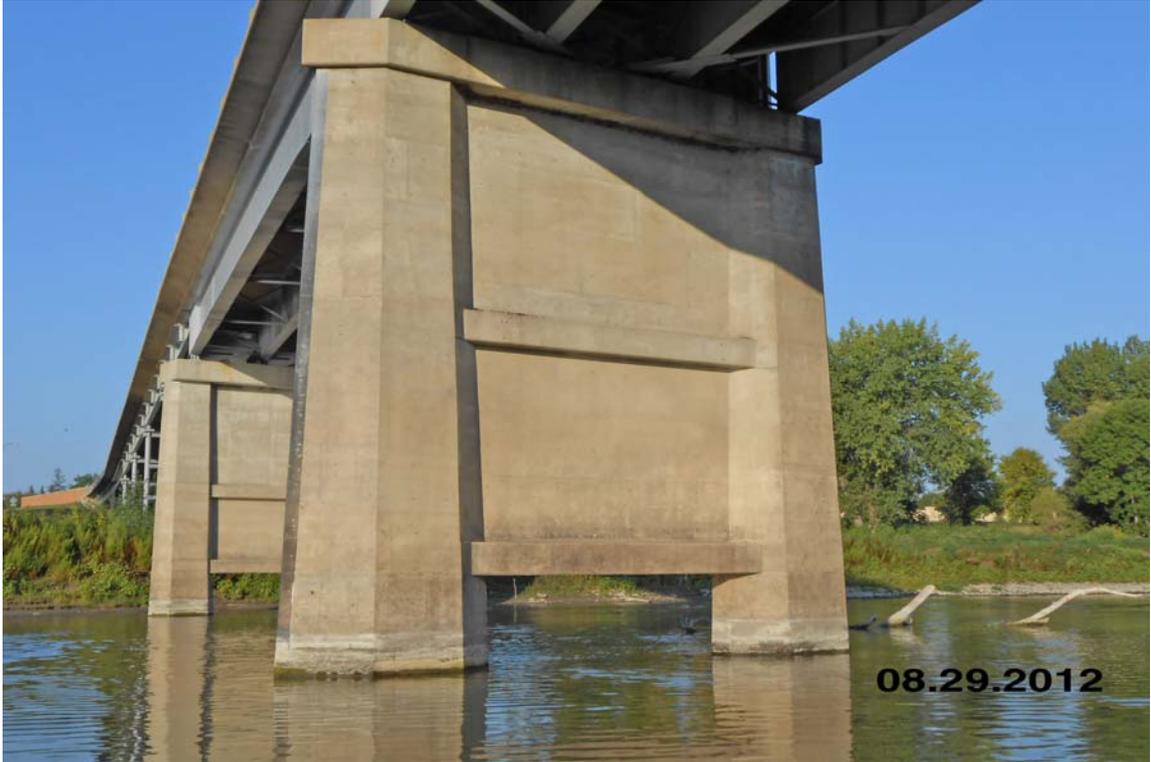
Photograph 3. View of Pier 7, Looking West.

- ⑤ A moderate accumulation of timber debris, consisting of 1 to 2 foot diameter logs, was observed around the entire perimeter of upstream column of Pier 7. The debris extended from channel bottom up 6 feet and approximately 8 feet off the column faces.

- ⑥ Both riverbanks of the channel exhibited moderate erosion.
- ⑦ A moderate accumulation of timber debris consisting of 1 foot diameter and smaller logs and branches was observed around the entire perimeter of downstream column of Pier 7. The debris extended from channel bottom up 4 feet and up to 6 feet off the column faces.

- (A) Monitor the accumulations of timber debris at Pier 7 during future underwater inspections and consider removal if it is found to be increasing.
- (B) Reinspect the submerged substructure units at the normal maximum recommended (NBIS) interval of sixty (60) months.

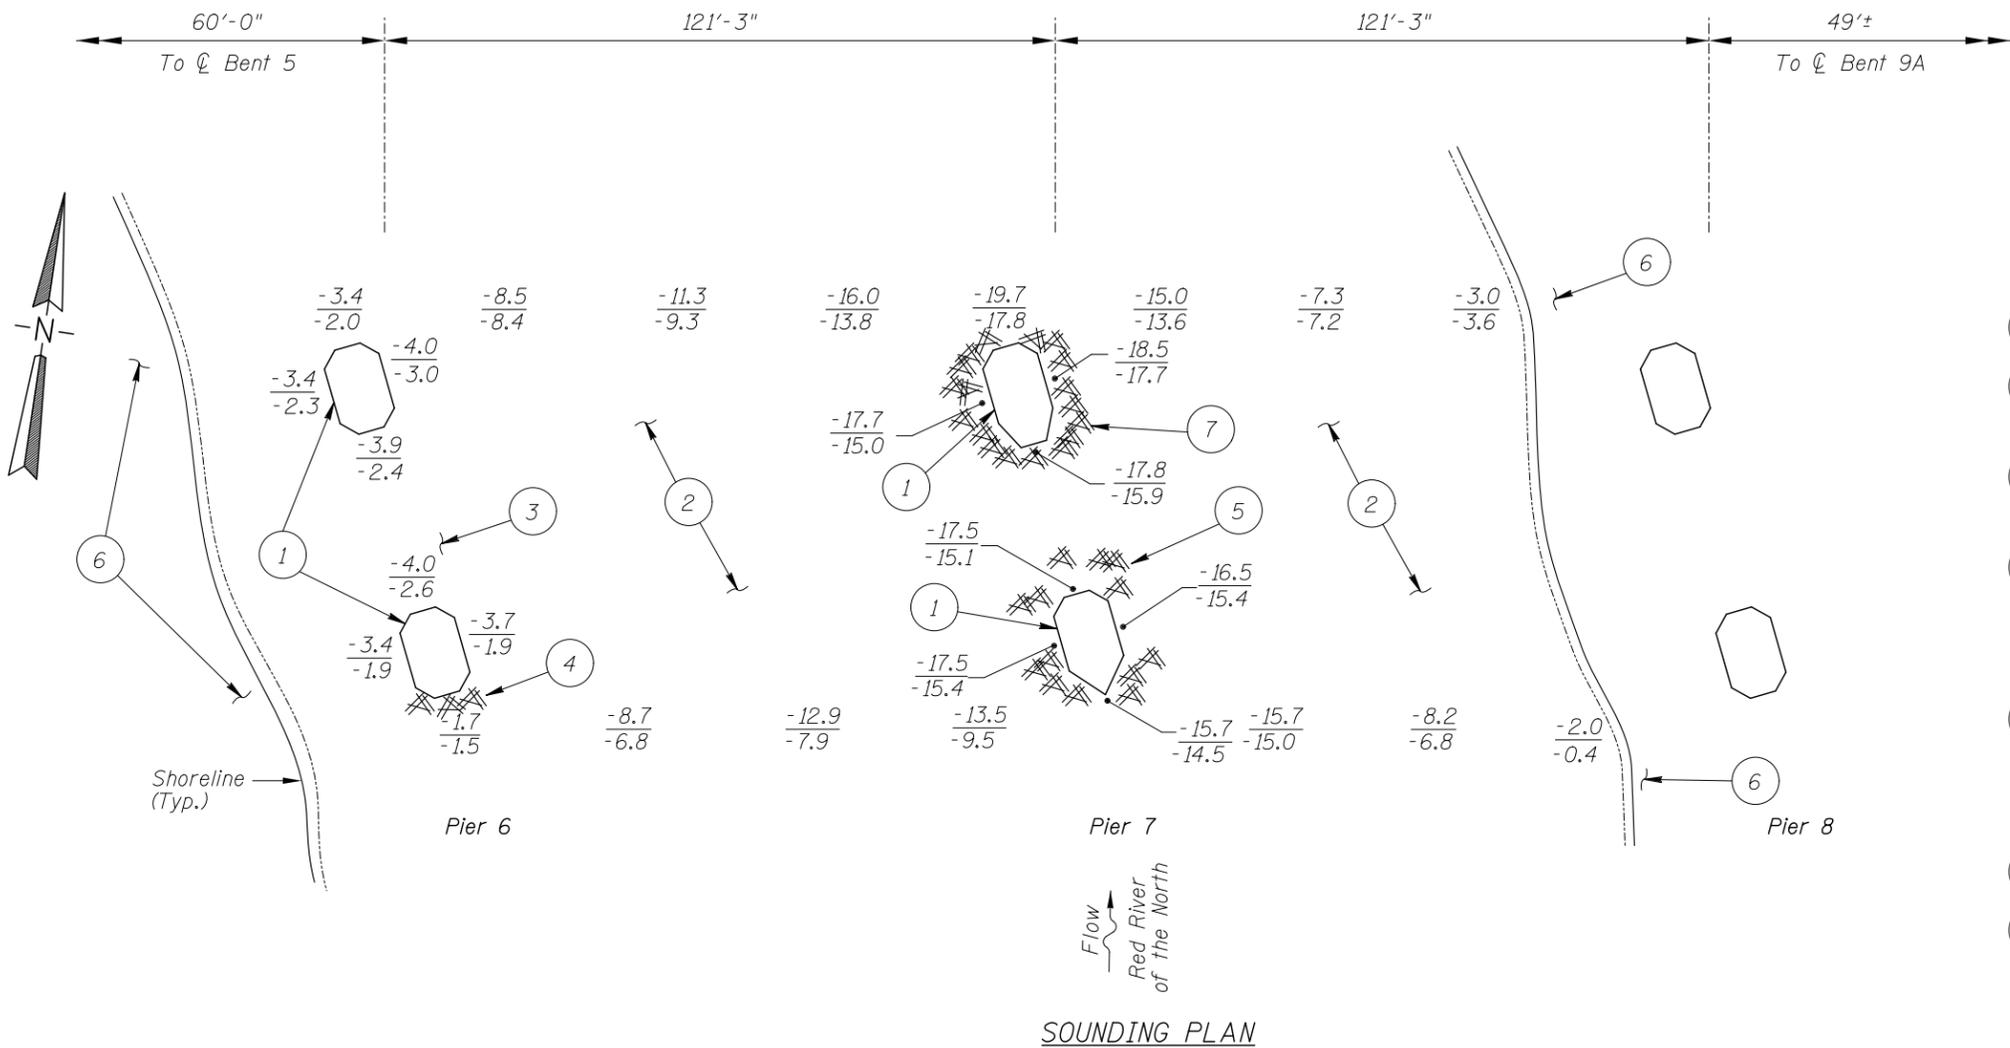
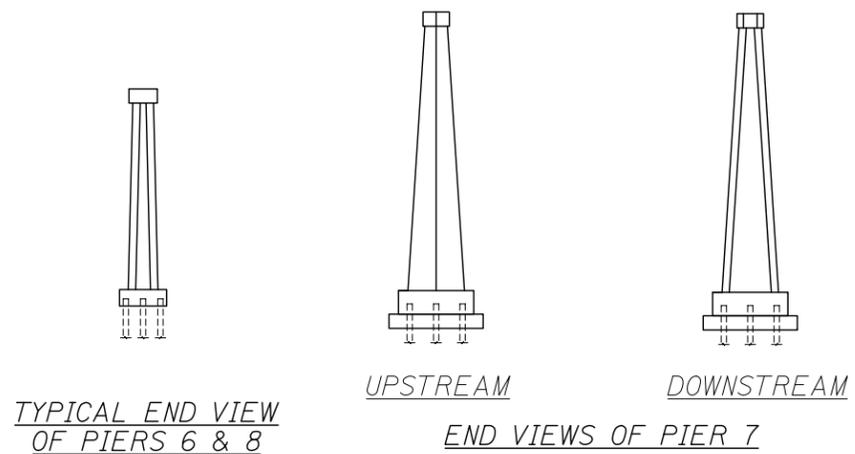
- ① Overall, the concrete of the piers was sound and smooth.
- ② The channel bottom consisted of sandy clay with a probe rod penetration of up to 6 inches.

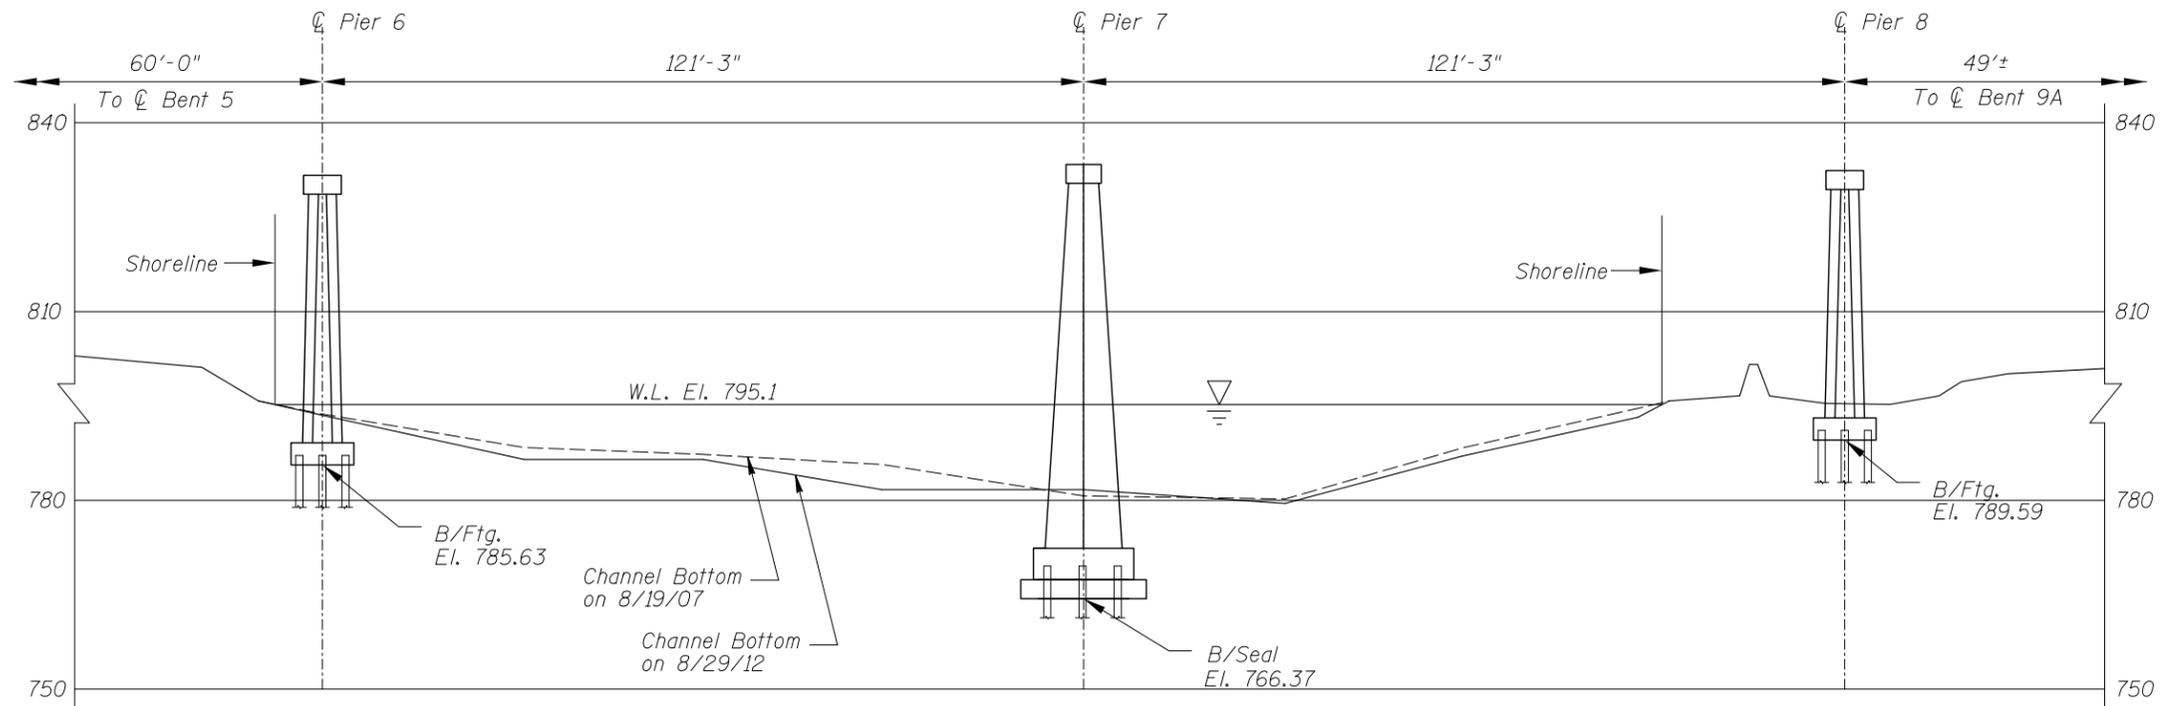
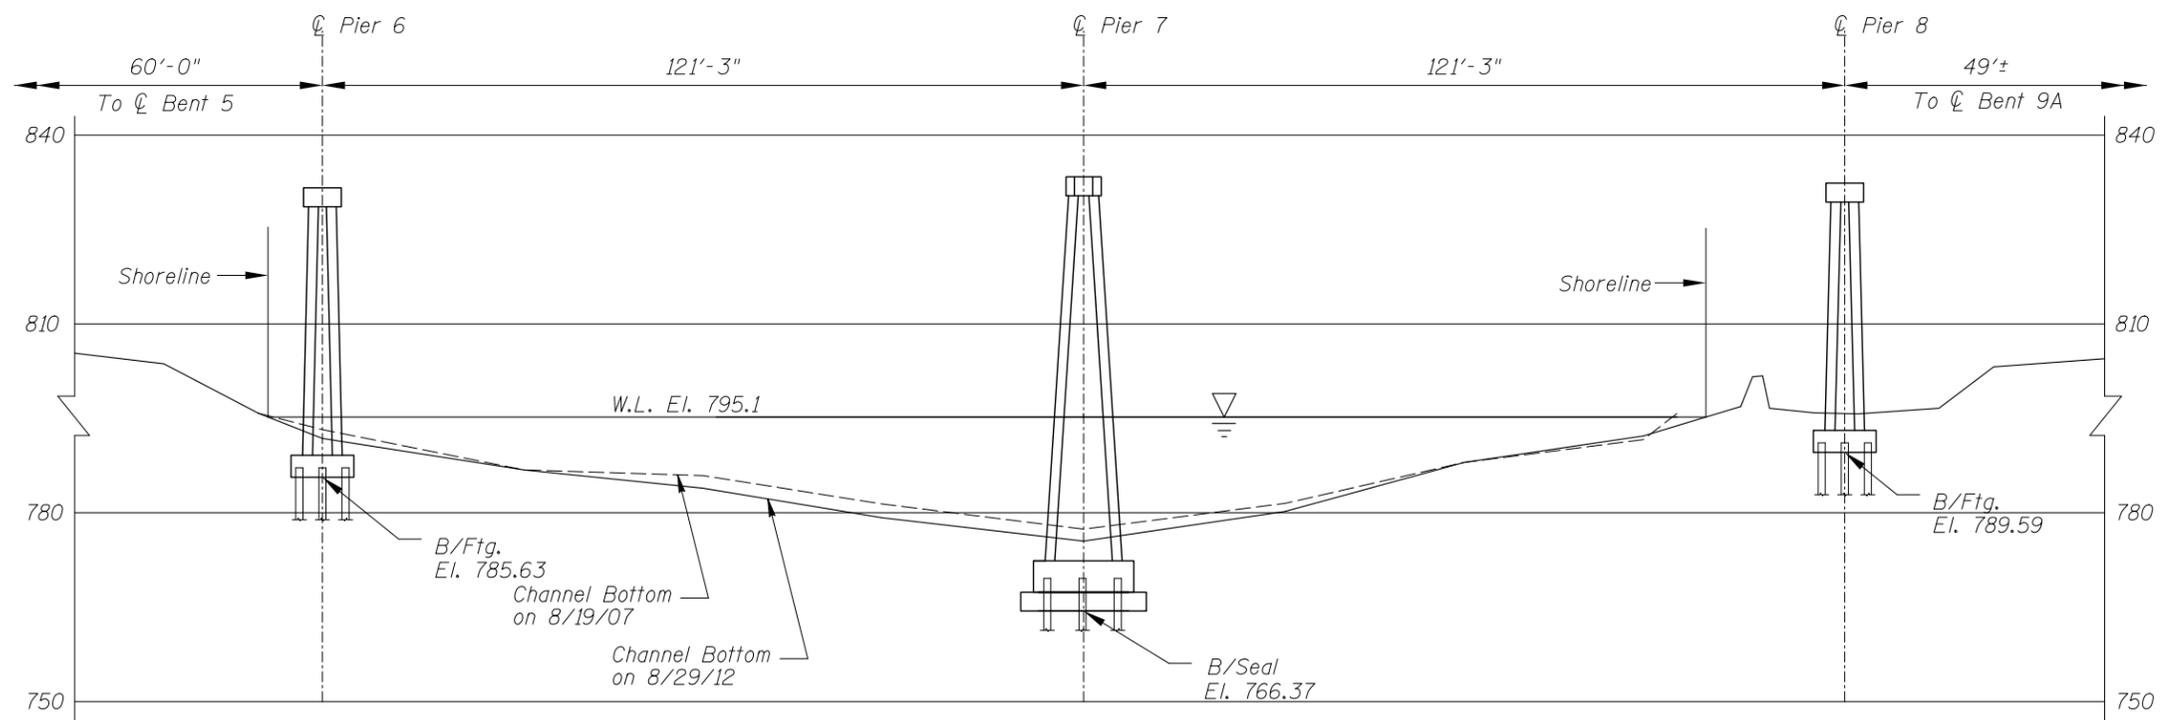
UPSTREAM FASCIA PROFILE

DOWNSTREAM FASCIA PROFILE
