# 2016 UNDERWATER BRIDGE INSPECTION REPORT

## BRIDGE # 4886 CSAH 32 over CLEARWATER RIVER

DISTRICT: District 2      COUNTY: Clearwater      CITY/TOWNSHIP: COPLEY  
STATE: Minnesota

Date of Inspection: 09/25/2016

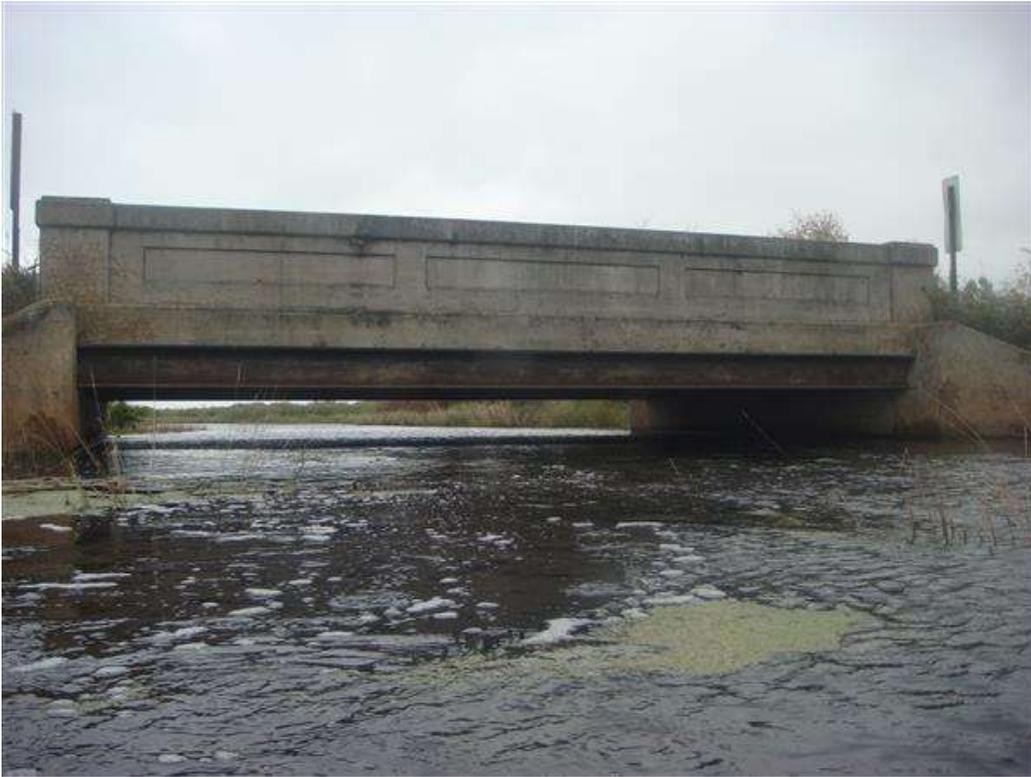
Photo 1 - Overall View of Upstream Fascia, Looking North

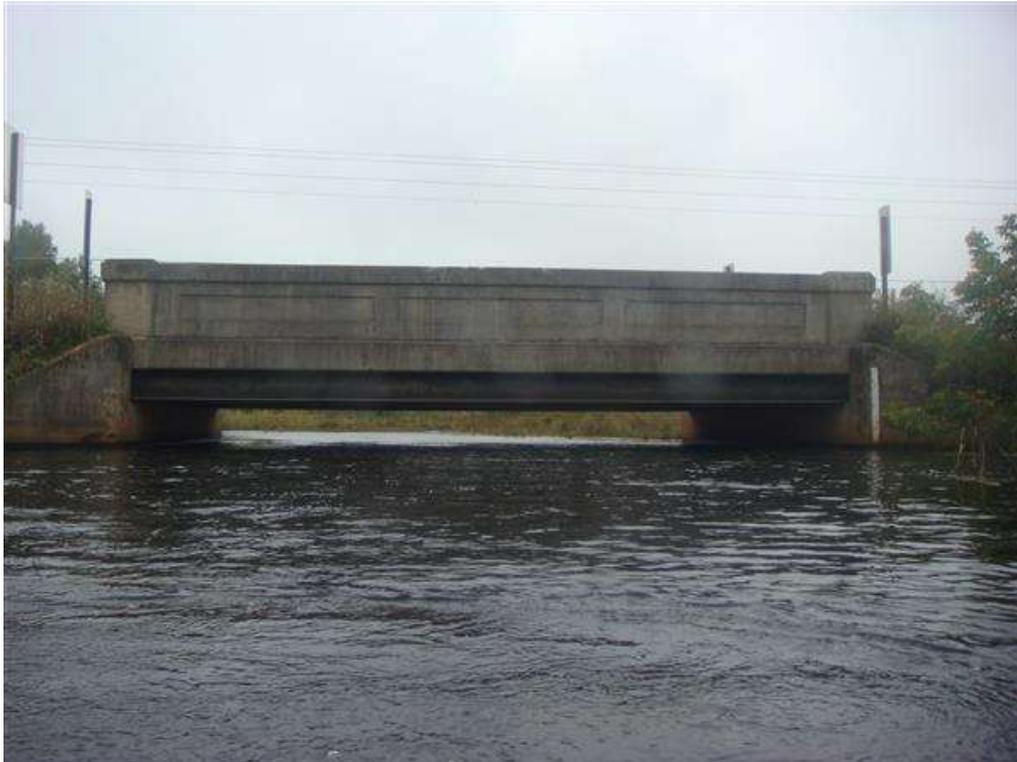
Photo 2 - Overall View of Downstream Fascia, Looking South

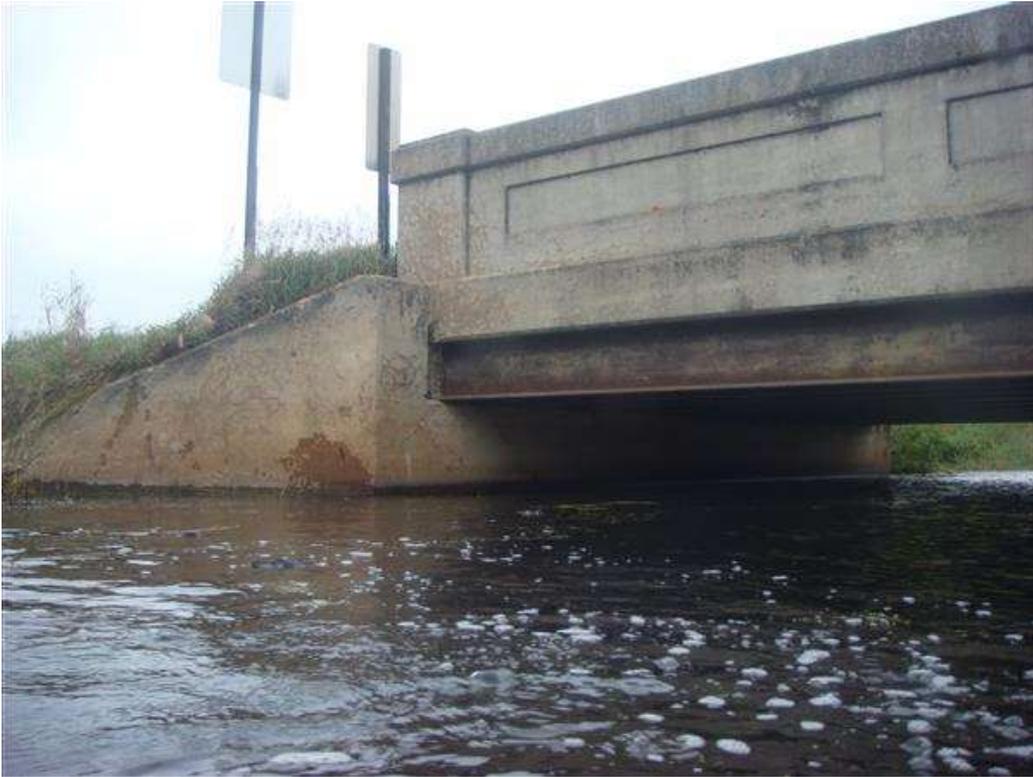
- G. Footing exposure was observed along a 10 foot section at the West Abutment near the midpoint with no vertical face exposure.
- H. An area of scaling up to 2 inches deep was observed from the midpoint of the southwest wingwall to the West Abutment breastwall extending from 6 inches to 18 inches below the waterline.

Photo 3 - View of West Abutment, Looking West

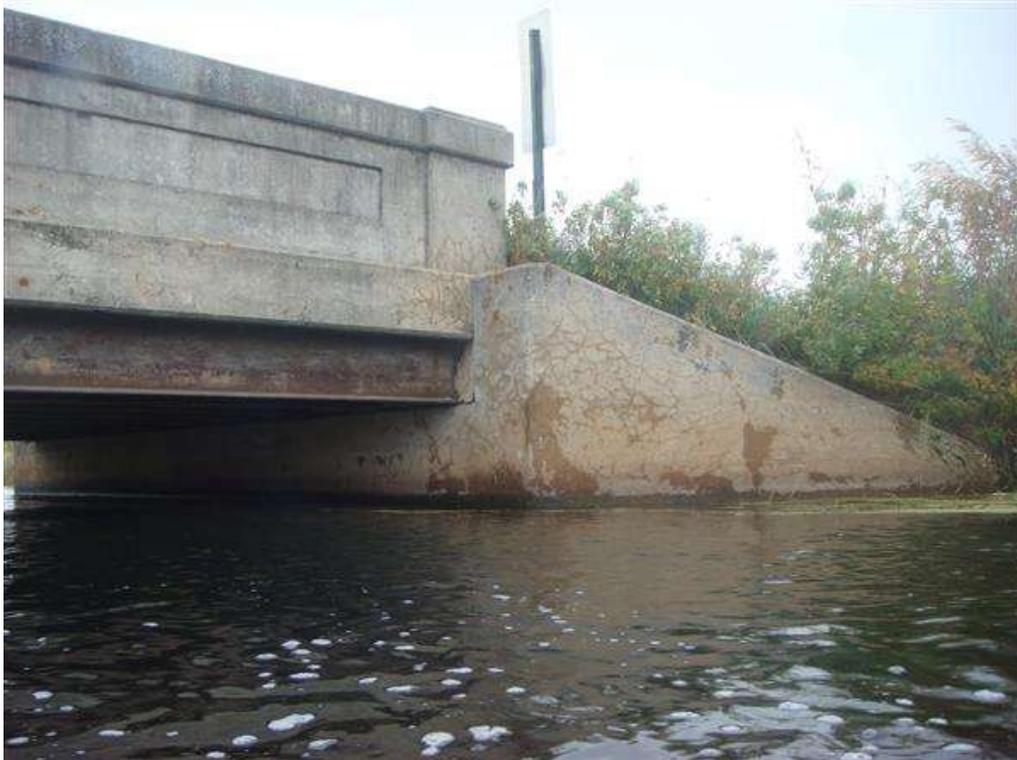
- D. The channel bottom consisted of silty sand allowing 1 foot of probe rod penetration.
- E. Footing exposure was observed along a 15 foot section at the East Abutment near the midpoint with 6 inches of maximum vertical exposure.

Photo 4 - View of East Abutment, Looking East

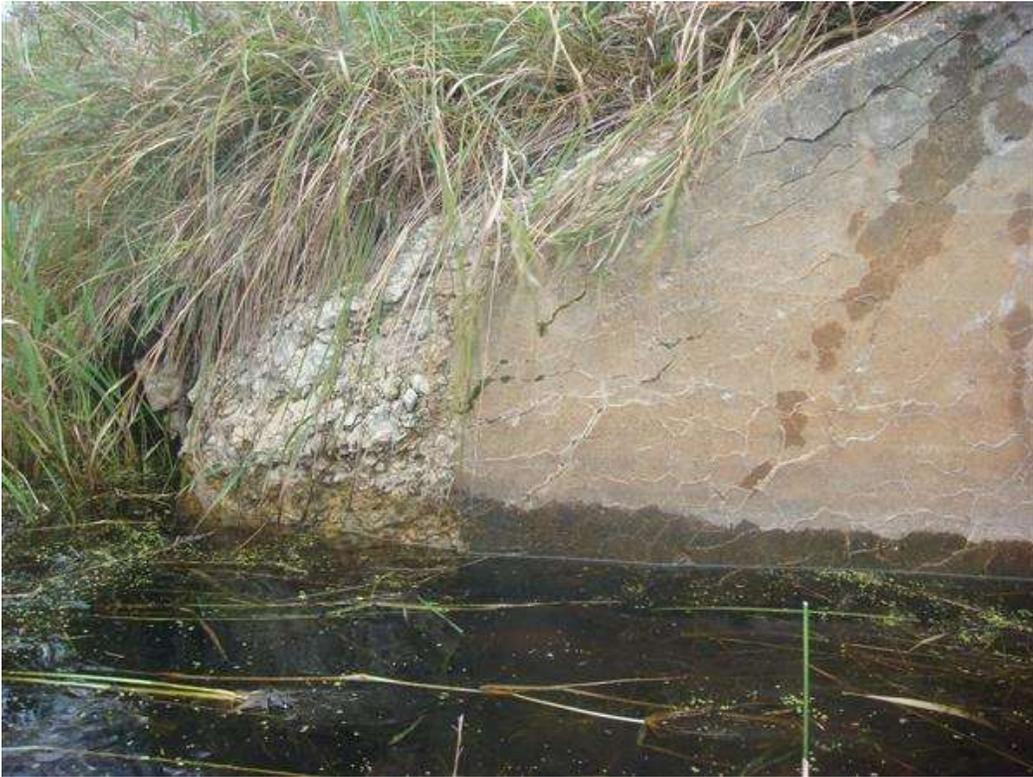
- F. The end of southwest wingwall had a delaminated and/or spalled area approximately 6 inches below the waterline. The area measured 2 foot wide, 2 feet high, with 6 inches of penetration and one exposed reinforcing steel bar.

Photo 5 - View of Deterioration at Southwest Wingwall, Looking Southwest

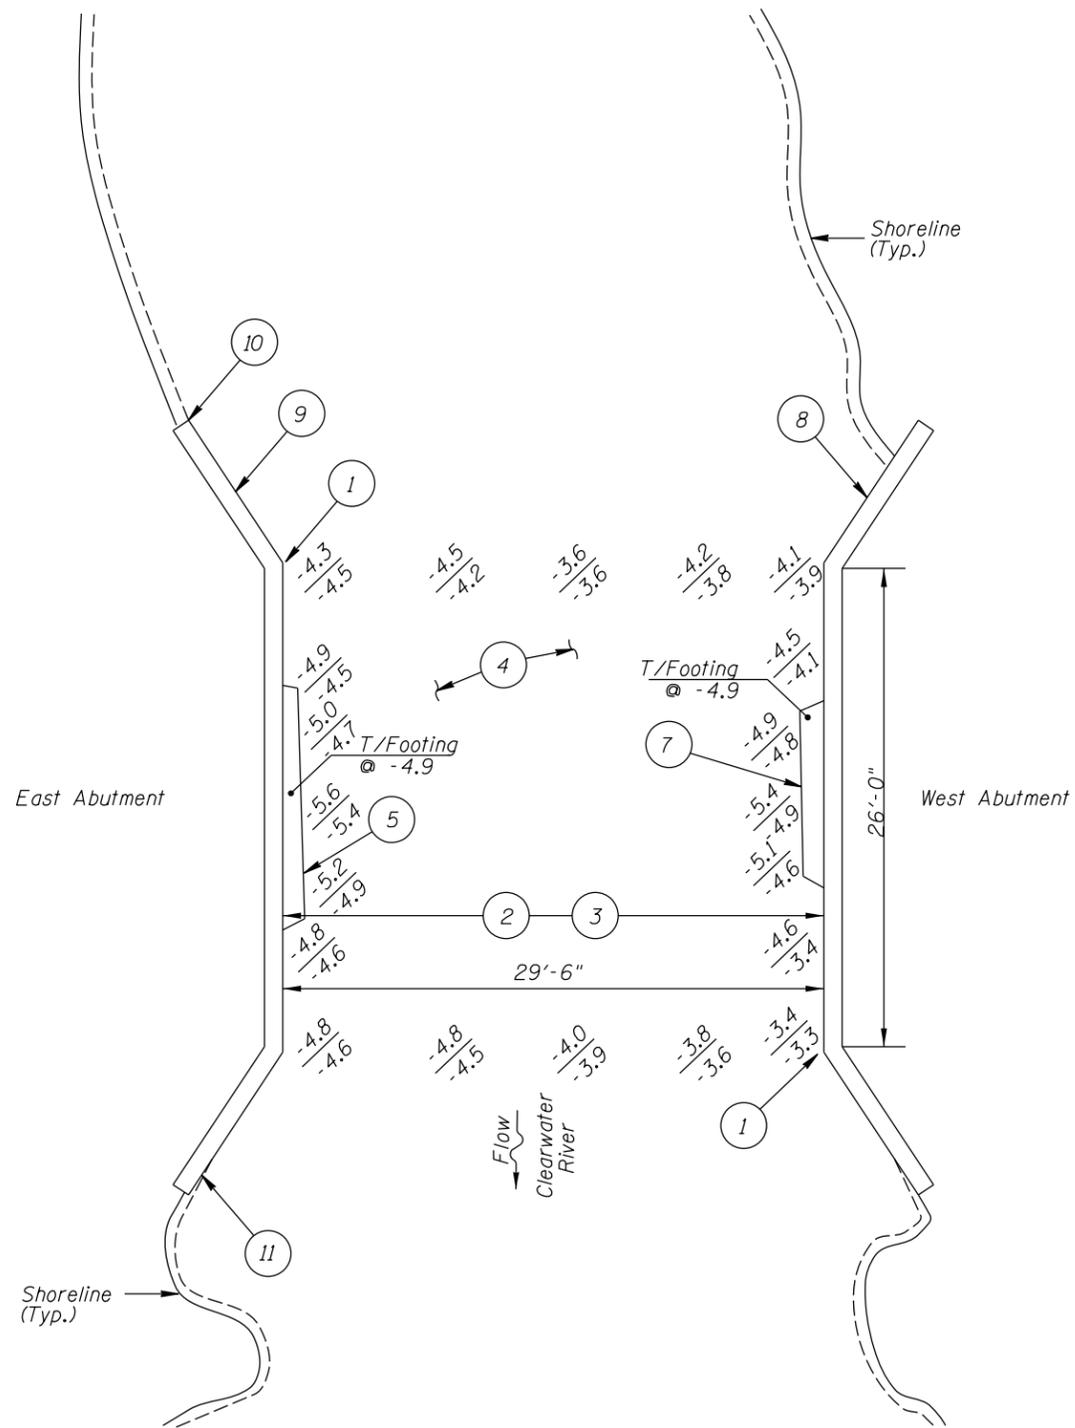
- 1 Loss of section at the joint between the southeast wingwall and East Abutment breastwall, located 4.8 feet below the top of the wingwall measuring 6 inches in diameter with a maximum penetration of 1 inch with no exposed reinforcing steel.

- 2 Random vertical cracks extending from the bridge seat down 4 feet measuring from hairline to 1/16 inches wide located approximately every 5 feet along both abutment faces.

- 3 Above and below the waterline the concrete was typically smooth and sound with areas of hairline map cracking on the wingwalls and on the abutment breastwall faces. Random areas of minor scaling were noted on the northeast wingwall.

- 4 The channel bottom consisted of silty sand allowing 1 foot of probe rod penetration.
- 5 Footing exposure was observed along a 15 foot section at the East Abutment near the midpoint with 6 inches of maximum vertical exposure.

- 6 The end of southwest wingwall had a delaminated and/or spalled area approximately 6 inches below the waterline. The area measured 2 foot wide, 2 feet high, with 6 inches of penetration and one exposed reinforcing steel bar.

- 7 Footing exposure was observed along a 10 foot section at the West Abutment near the midpoint with no vertical face exposure.
- 8 An area of scaling up to 2 inches deep was observed from the midpoint of the southwest wingwall to the West Abutment breastwall extending from 6 inches to 18 inches below the waterline.

- 9 An area of scaling, 1 foot high by 2 feet wide and up to 2 inches deep, was observed beginning on the southeast wingwall and extending to the East Abutment breastwall.

- 10 The end of the southeast wingwall exhibited an area of scaling at the waterline. The area measured 1 foot wide by 1 foot high and approximately 2 inches deep.

- 11 A 1/16 inch wide vertical crack was observed 6 inches from the edge of the northeast wingwall and extending from the top of the wingwall to the channel bottom.

- (A) Reinspect the submerged substructure units at the normal maximum recommended (NBIS) interval of sixty (60) months.
