2016 UNDERWATER BRIDGE INSPECTION REPORT

BRIDGE # 57502 CSAH 24 over RED LAKE RIVER

UNDERWATER INSPECTION

REPORT SUMMARY

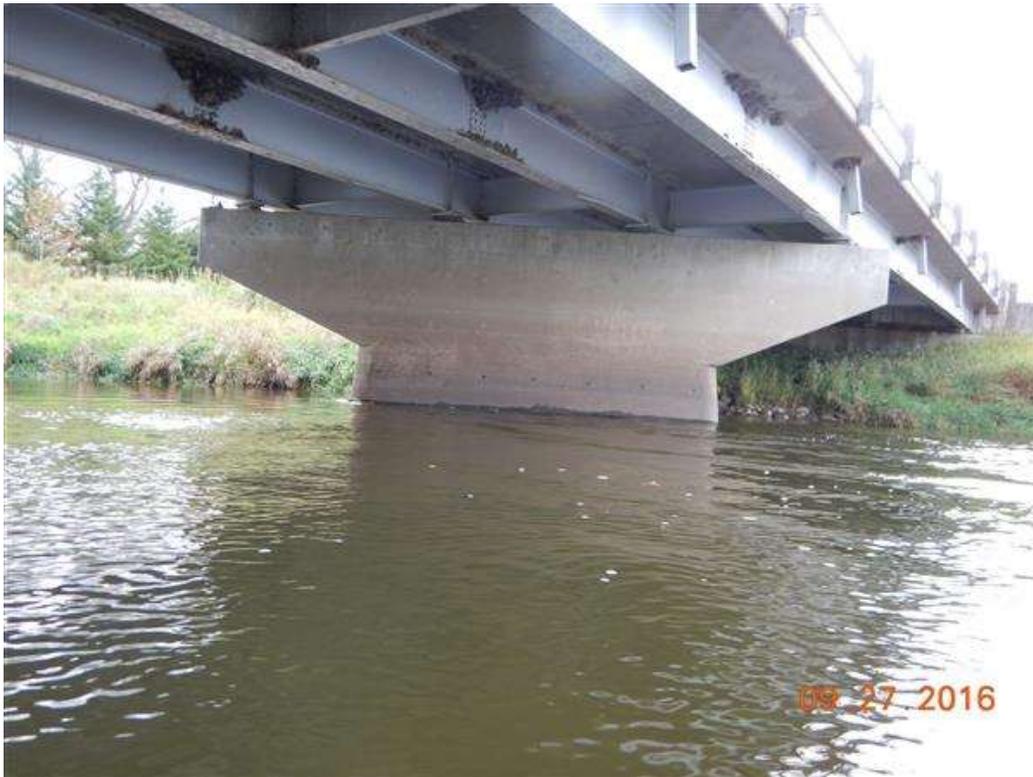
Photo 5 - Pier 1 North Face

- (A) The concrete was smooth and sound with random minor areas of poor consolidation with up to ¼ inch penetration on the faces of Piers 1 and 2.
- (B) Minor scaling was observed from the channel bottom to 2 feet above the waterline (bottom of hammerhead pier cap) with up to ¼ inch maximum penetration on the upstream noses of Piers 1 and 2.
- (C) The channel bottom material around Pier 1 consisted of sand with 3 inches of maximum probe rod penetration; and around Pier 2, the bottom consisted of silty sand with 12 inches of maximum probe rod penetration

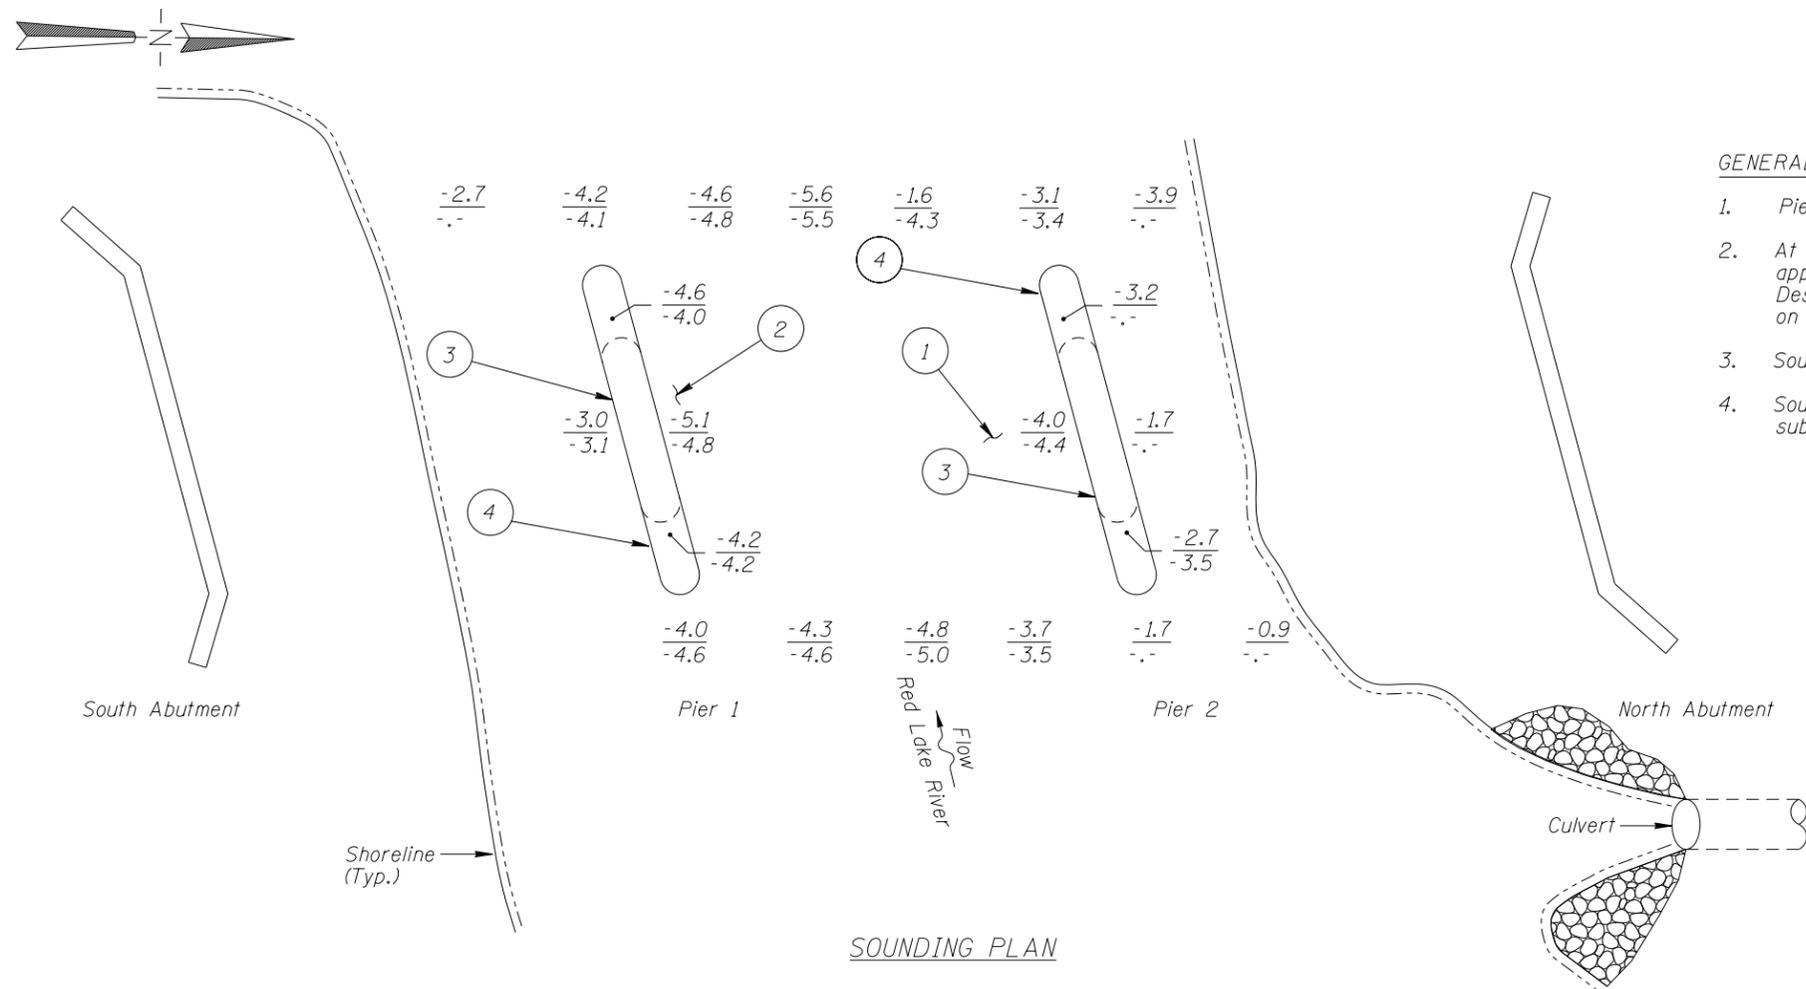
INSPECTION AND SOUNDING PLAN

- 1 The channel bottom material around Pier 2 consisted of silty sand with up to 12 inches maximum probe rod penetration.
- 2 The channel bottom material around Pier 1 consisted of sand with 3 inches of maximum probe rod penetration.
- 3 The concrete was typically smooth and sound with random minor areas of poor consolidation with up to 1/4 inch penetration on the faces of Piers 1 and 2.
- 4 Minor scaling was observed from the channel bottom to 2 feet above the waterline (bottom of hammerhead pier cap) with up to 1/4 inch maximum penetration on the upstream noses of Piers 1 and 2.
