2016 UNDERWATER BRIDGE INSPECTION REPORT

BRIDGE # 57517 CR 63 over THIEF RIVER

DISTRICT: District 2 COUNTY: Pennington CITY/TOWNSHIP: NORTH
STATE: Minnesota

Date of Inspection: 09/28/2016
Equipment Used:

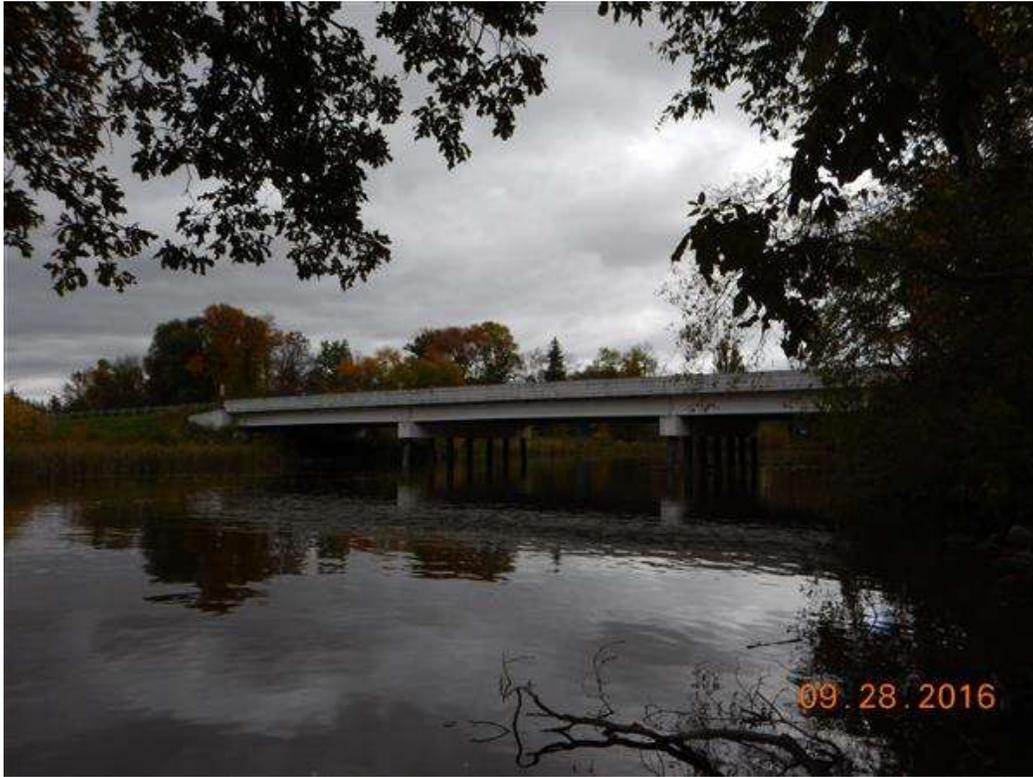
Photo 1 - Upstream Profile

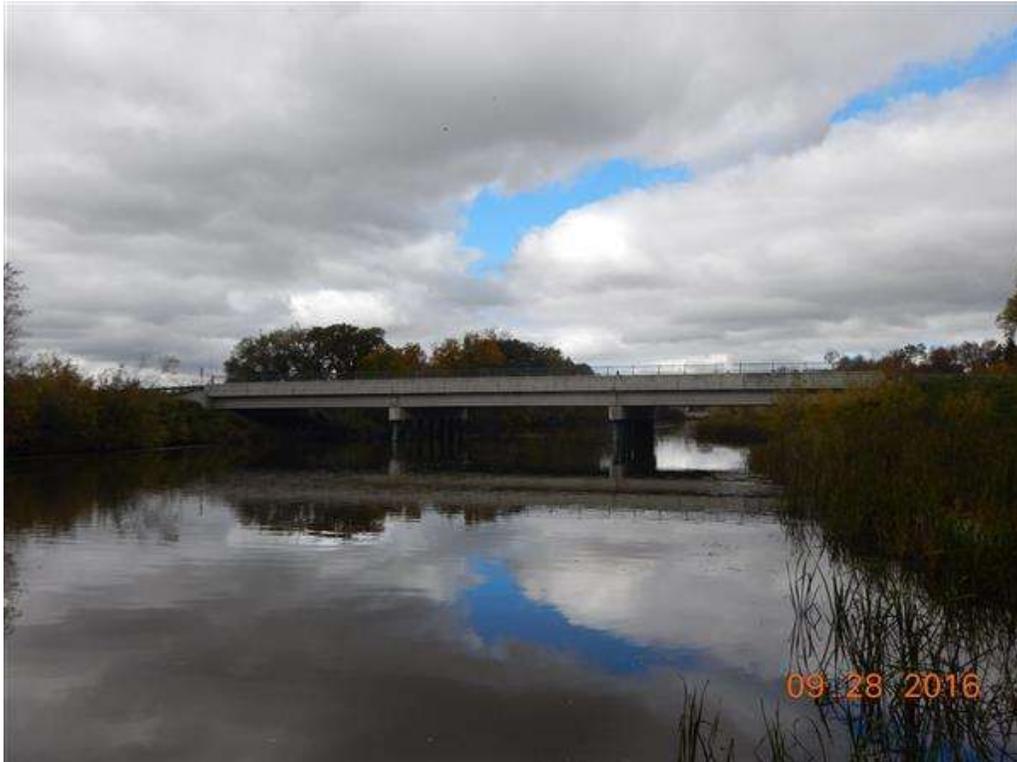
Photo 2 - Downstream Profile

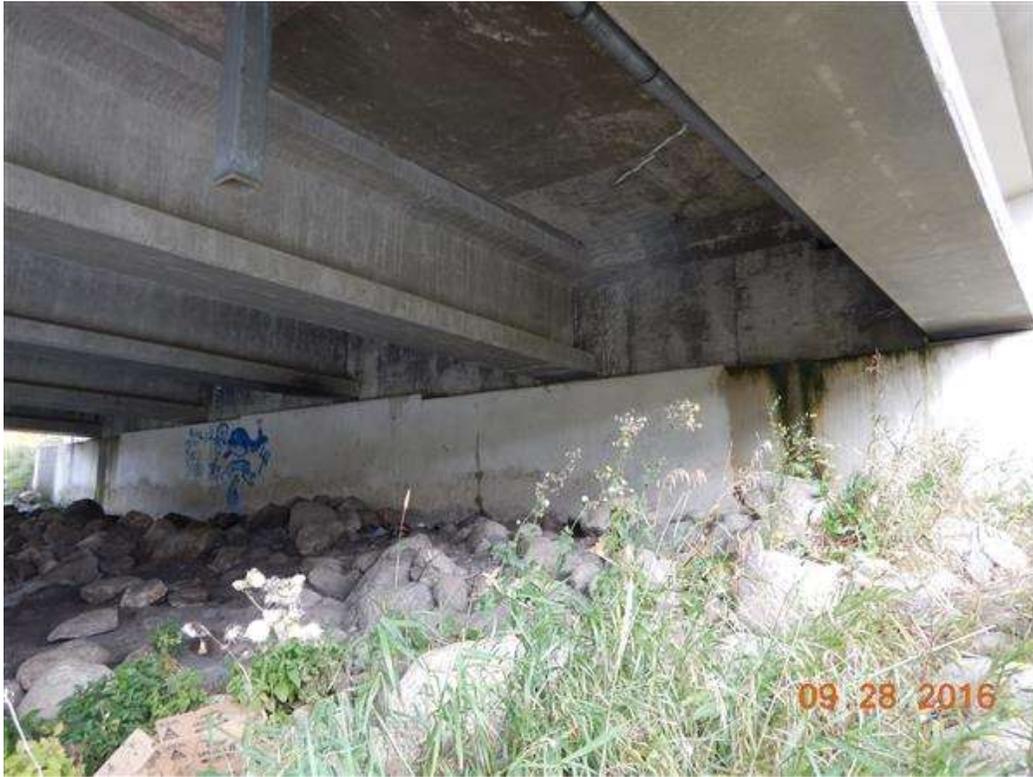
Photo 3 - North Abutment

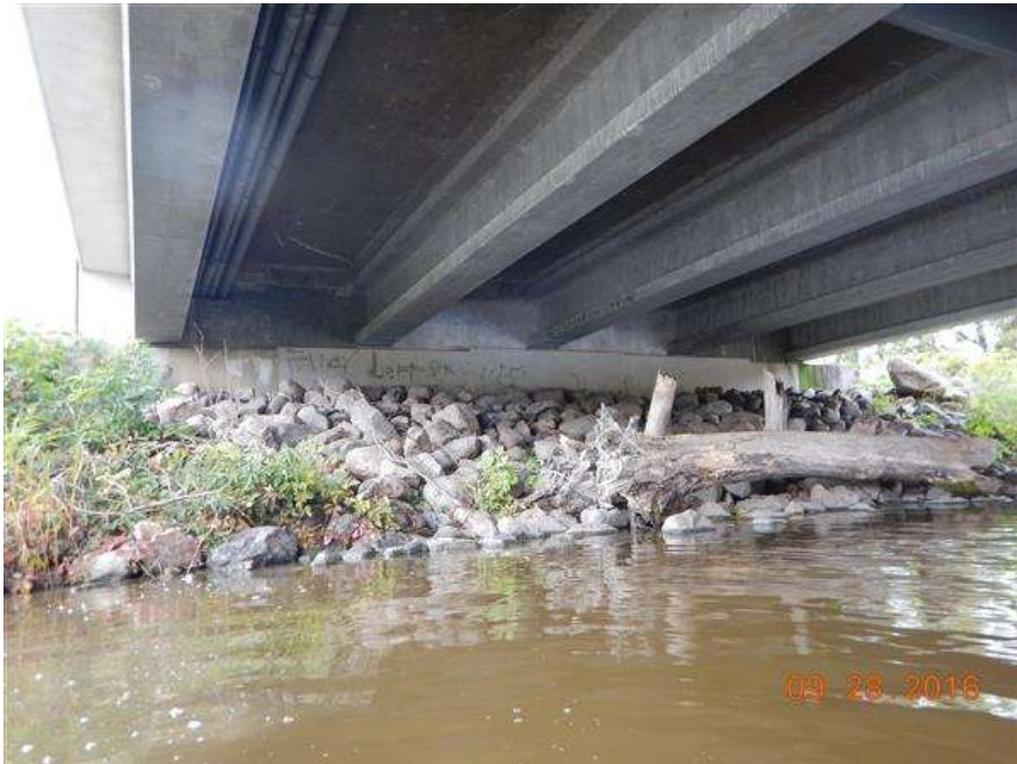
Photo 4 - South Abutment

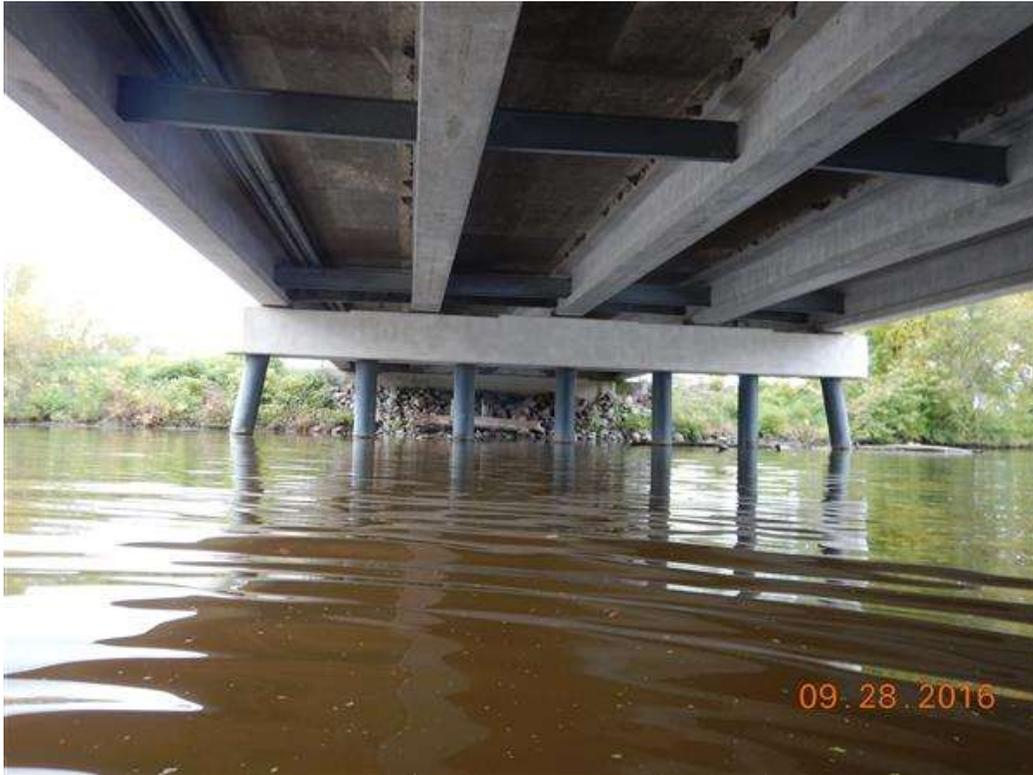
(C) A moderate accumulation of timber debris consisting of 1 foot diameter and smaller branches was observed along both sides and in between piles 1 to 3 at Pier 1.

Photo 5 - Pier 1 North Face

(A) Monitor the timber debris, and if found to be increasing in the future, removal operations may become warranted.

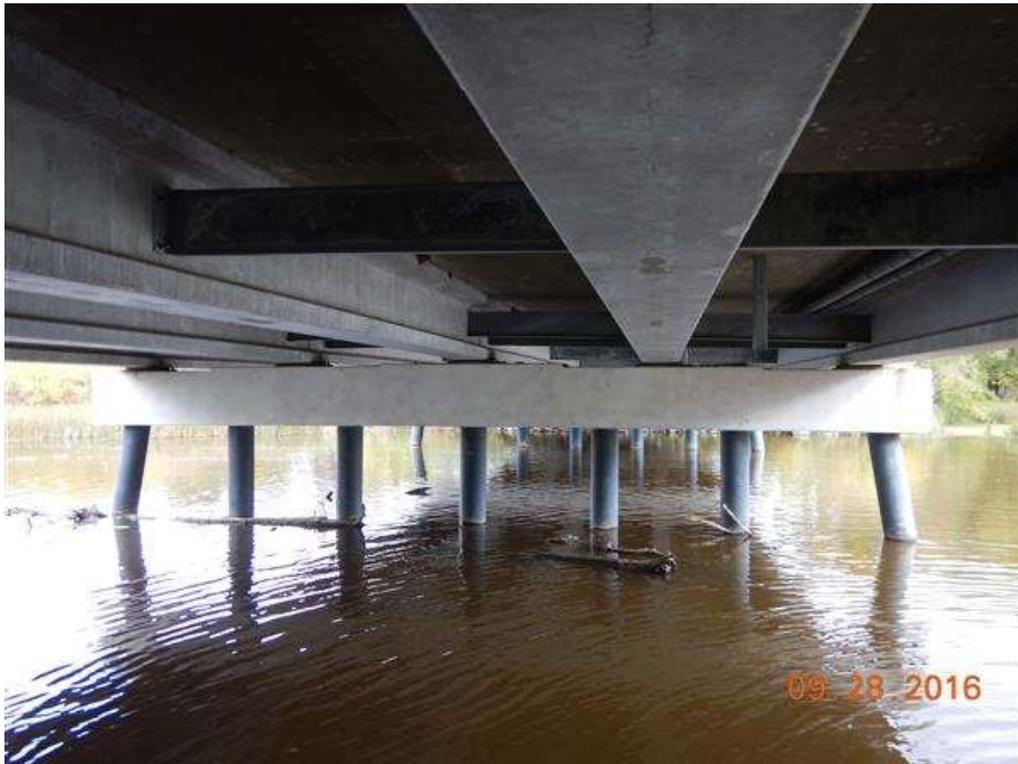
Photo 6 - Pier 1 South Face

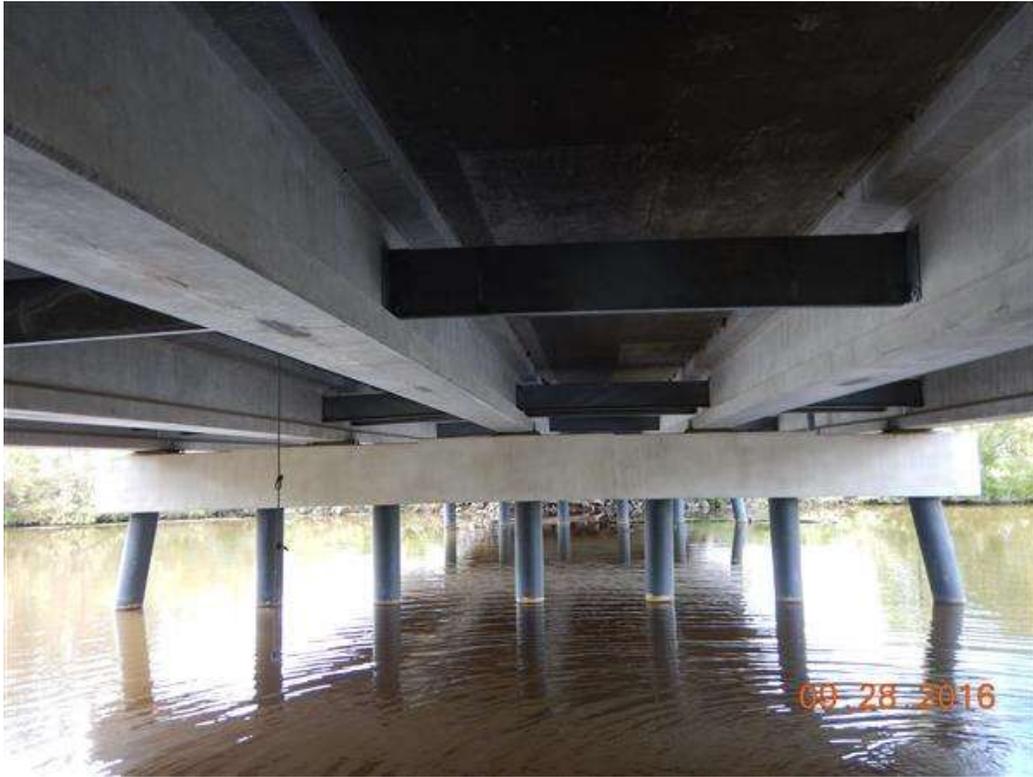
Photo 7 - Pier 2 North Face

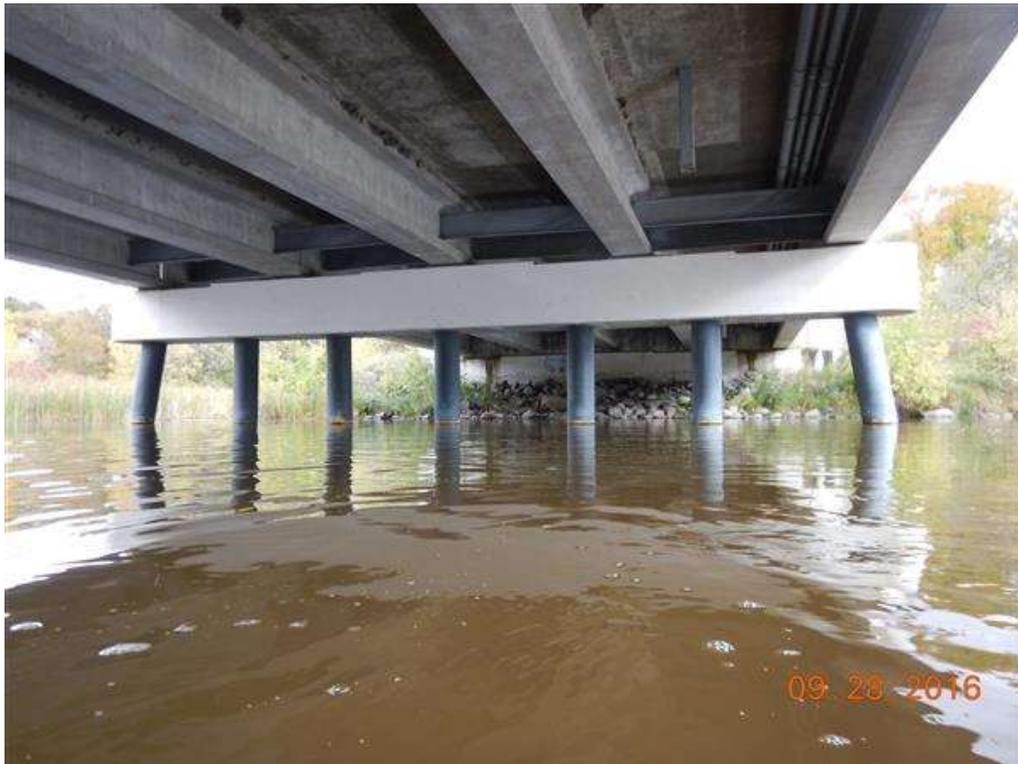
Photo 8 - Pier 2 South Face

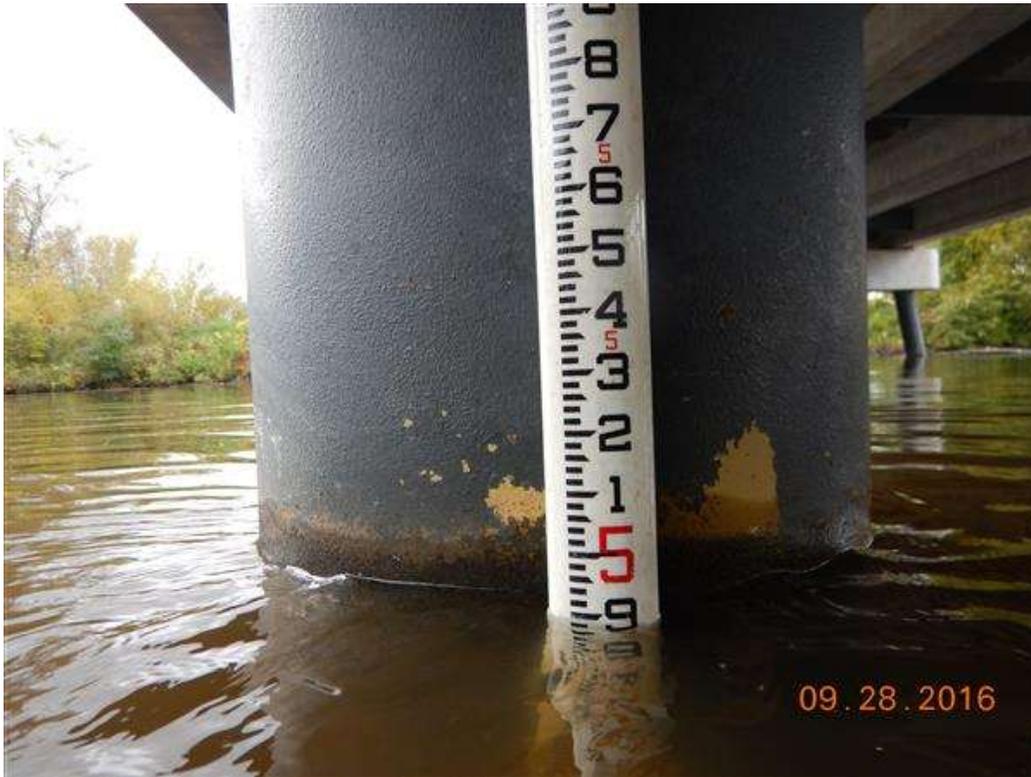
(A) The 20 inch diameter steel pile encasements of both piers from the top of pile down 6 feet were coated. The coating has minor random areas of coating loss on less than one percent of total surface area. In areas of coating loss, the exposed steel exhibited minor corrosion with no appreciable section loss.

Photo 9 - Typical Condition at Waterline

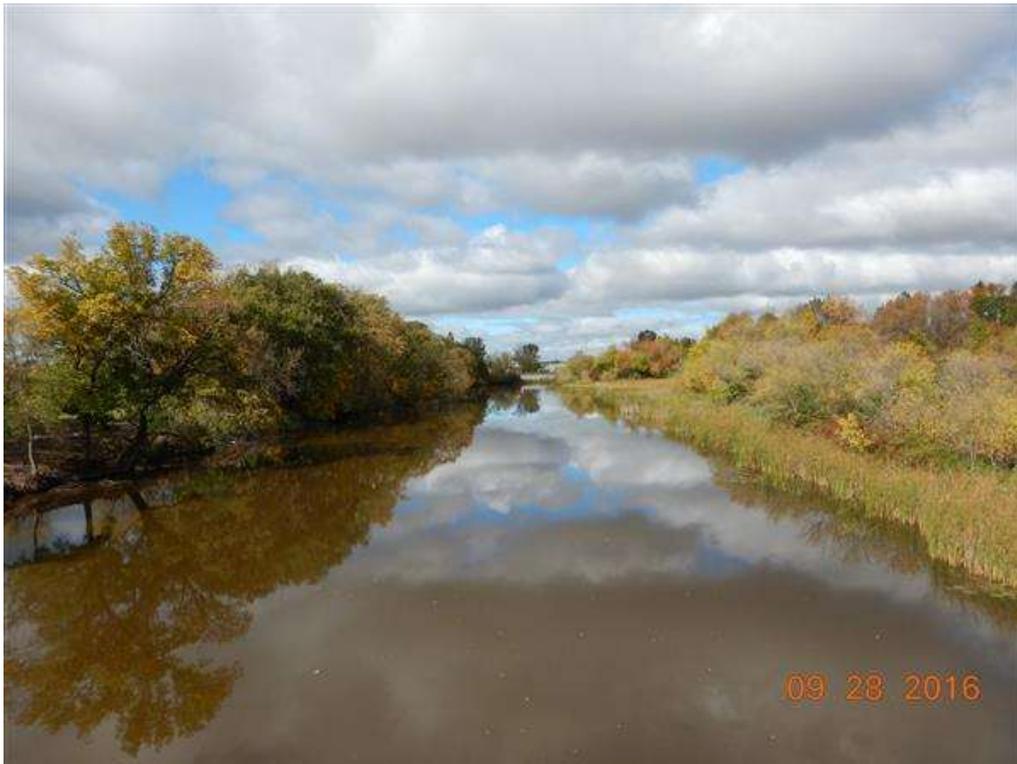
Photo 10 - Upstream Channel

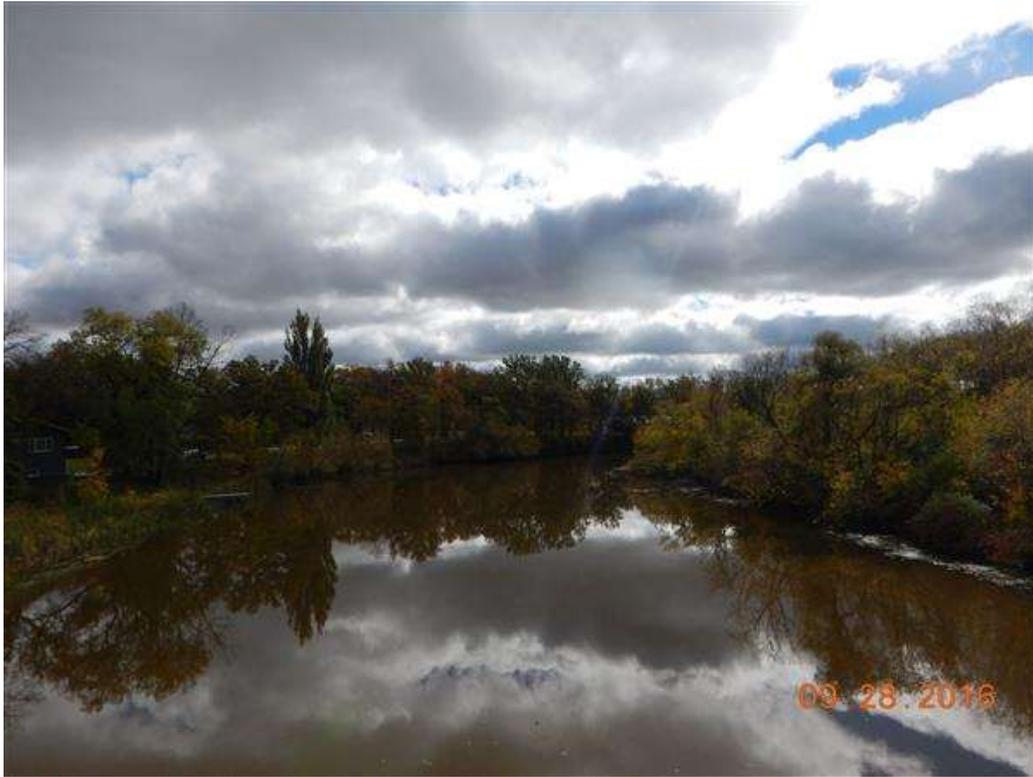
Photo 11 - Downstream Channel
