2016 UNDERWATER BRIDGE INSPECTION REPORT

BRIDGE # 7097 CSAH 7 over RED RIVER OF THE NORTH

DISTRICT: District 2 COUNTY: Polk CITY/TOWNSHIP: VINELAND

Date of Inspection: 10/19/2016

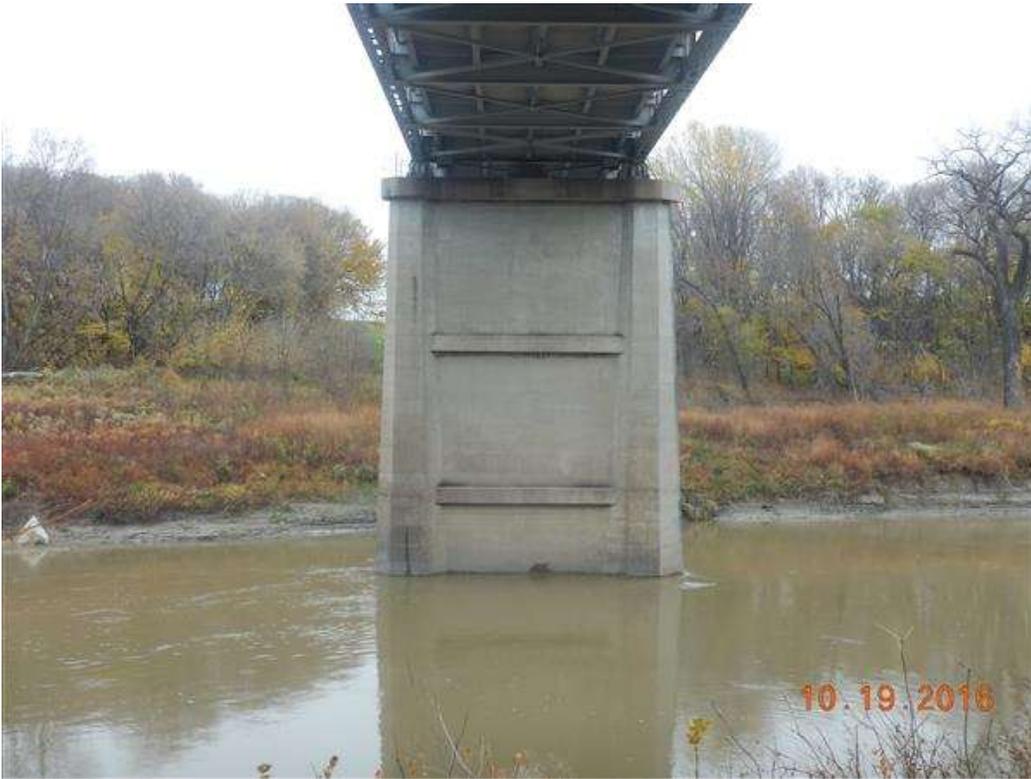
Photo 5 - West Face of Pier

(B) Vertical crack up to 1/8 inch wide was located on east and west faces of Pier 2 extending from the strut to the channel bottom at midpoint of the pier.

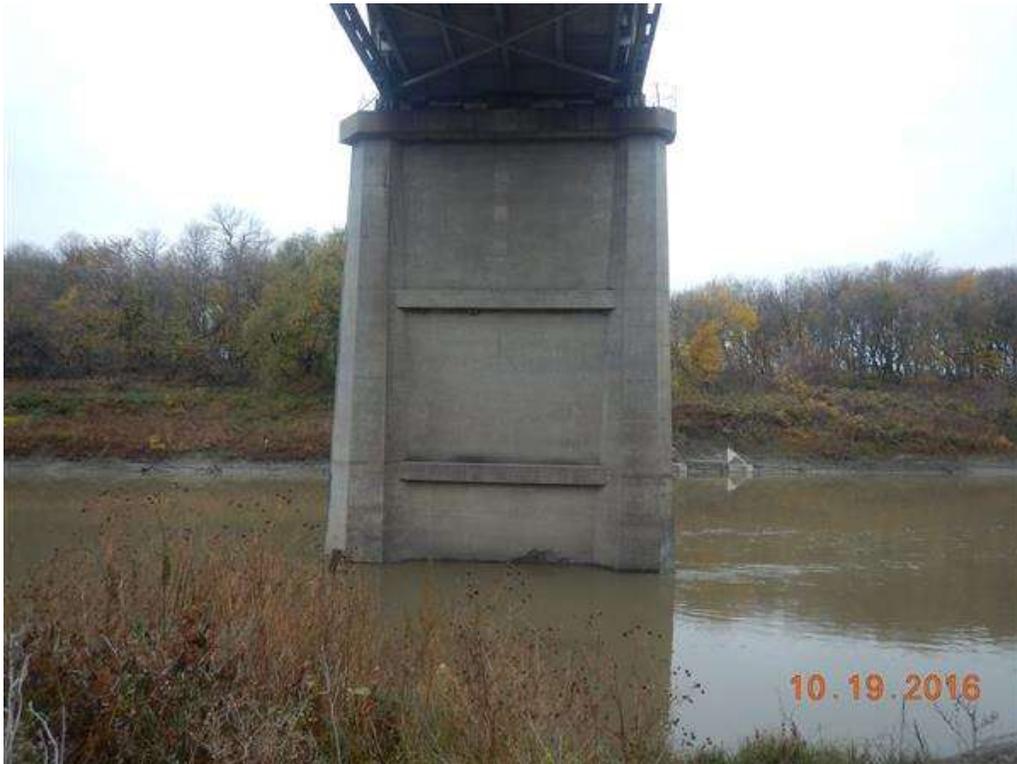
Photo 6 - East Face of Pier

(A) Moderate to heavy timber debris consisting of logs and branches 2 feet diameter and smaller was observed at the south (upstream) end and along the entire east face of Pier 2. The debris extended from the channel bottom to just below the waterline, 6 feet off the east face and 4 feet off the upstream nose towards the west.

(A) Monitor the timber debris, and if found to be increasing in the future, removal operations may become warranted.

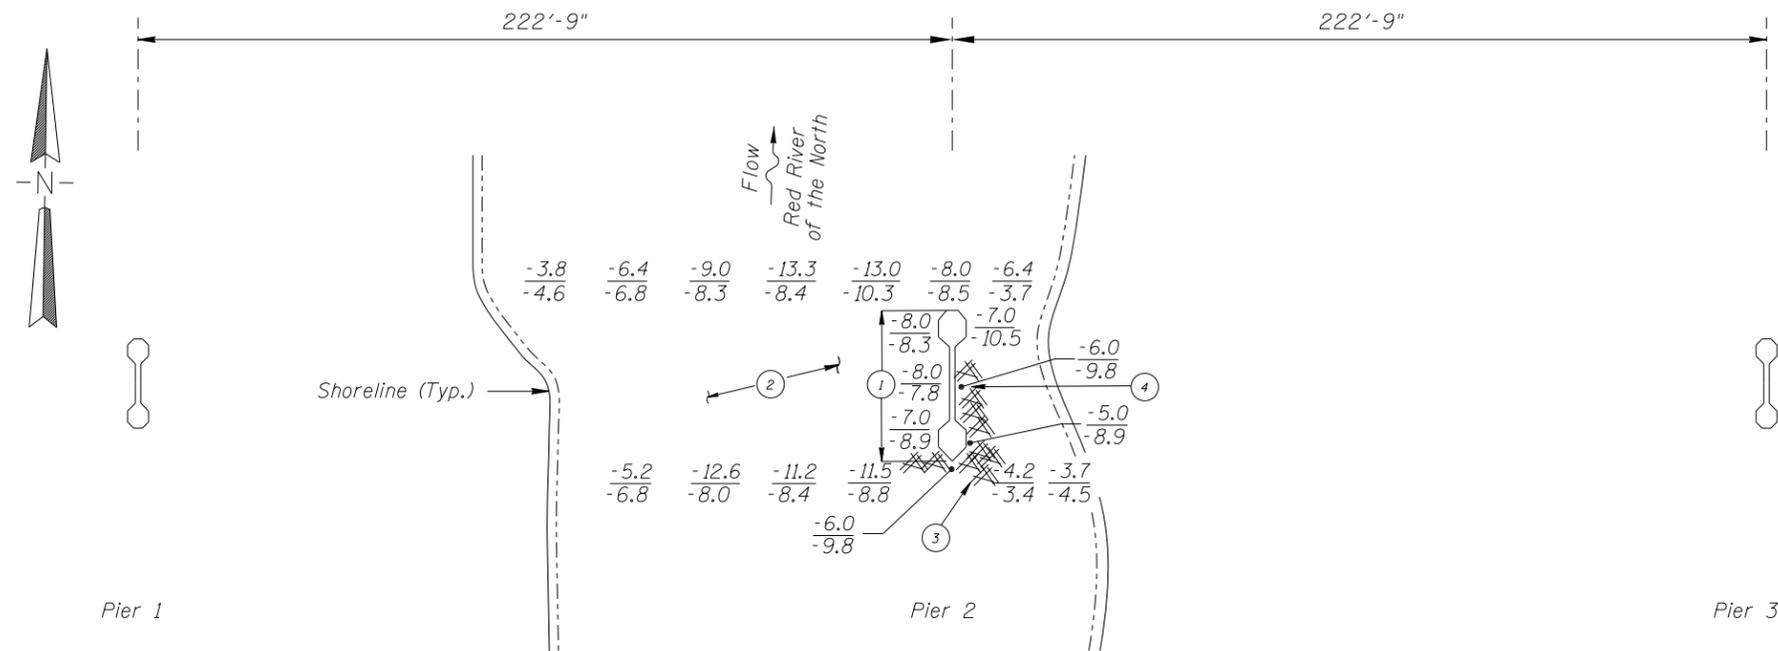
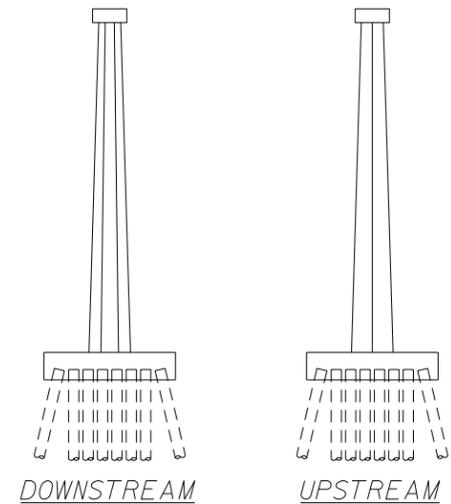
INSPECTION AND SOUNDING PLAN

- ① Overall, concrete was smooth and sound with no significant defects.
- ② The channel bottom consisted of soft silt with 2 feet of maximum probe rod penetration.
- ③ Moderate to heavy timber debris consisting of logs and branches 2 feet in diameter and smaller was observed at south end and east face of Pier 2. The debris extended from channel bottom to just below the waterline, 6 feet off the east face and 4 feet off the upstream nose.
- ④ Vertical crack 1/8 inch wide extending from strut to channel bottom was located at midpoint of pier on east and west faces of Pier 1.
