2016 UNDERWATER BRIDGE INSPECTION REPORT

BRIDGE # 89595 CSAH 42 over SAND HILL RIVER

Date of Inspection: 09/26/2016

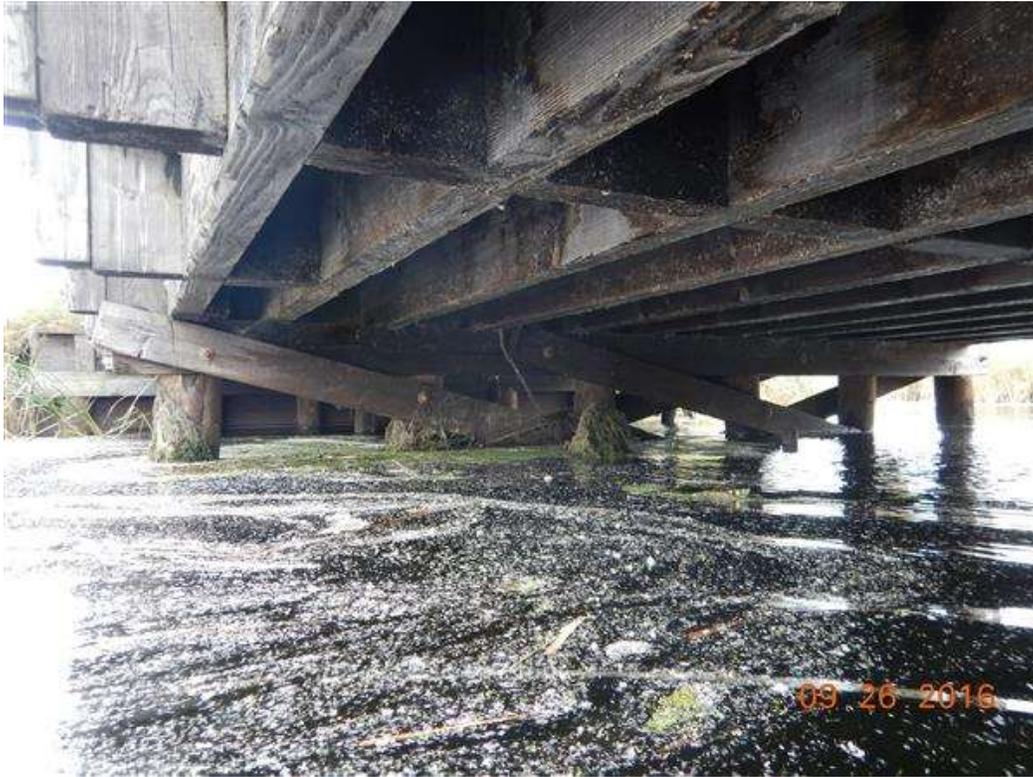
Photo 3 - Pier 1 North Side

- (A) Channel Bottom was typically sand.
- (B) The timber piles have minor splits and checks at both abutments and pier.
- (C) There is minor local scour around Pier 1.

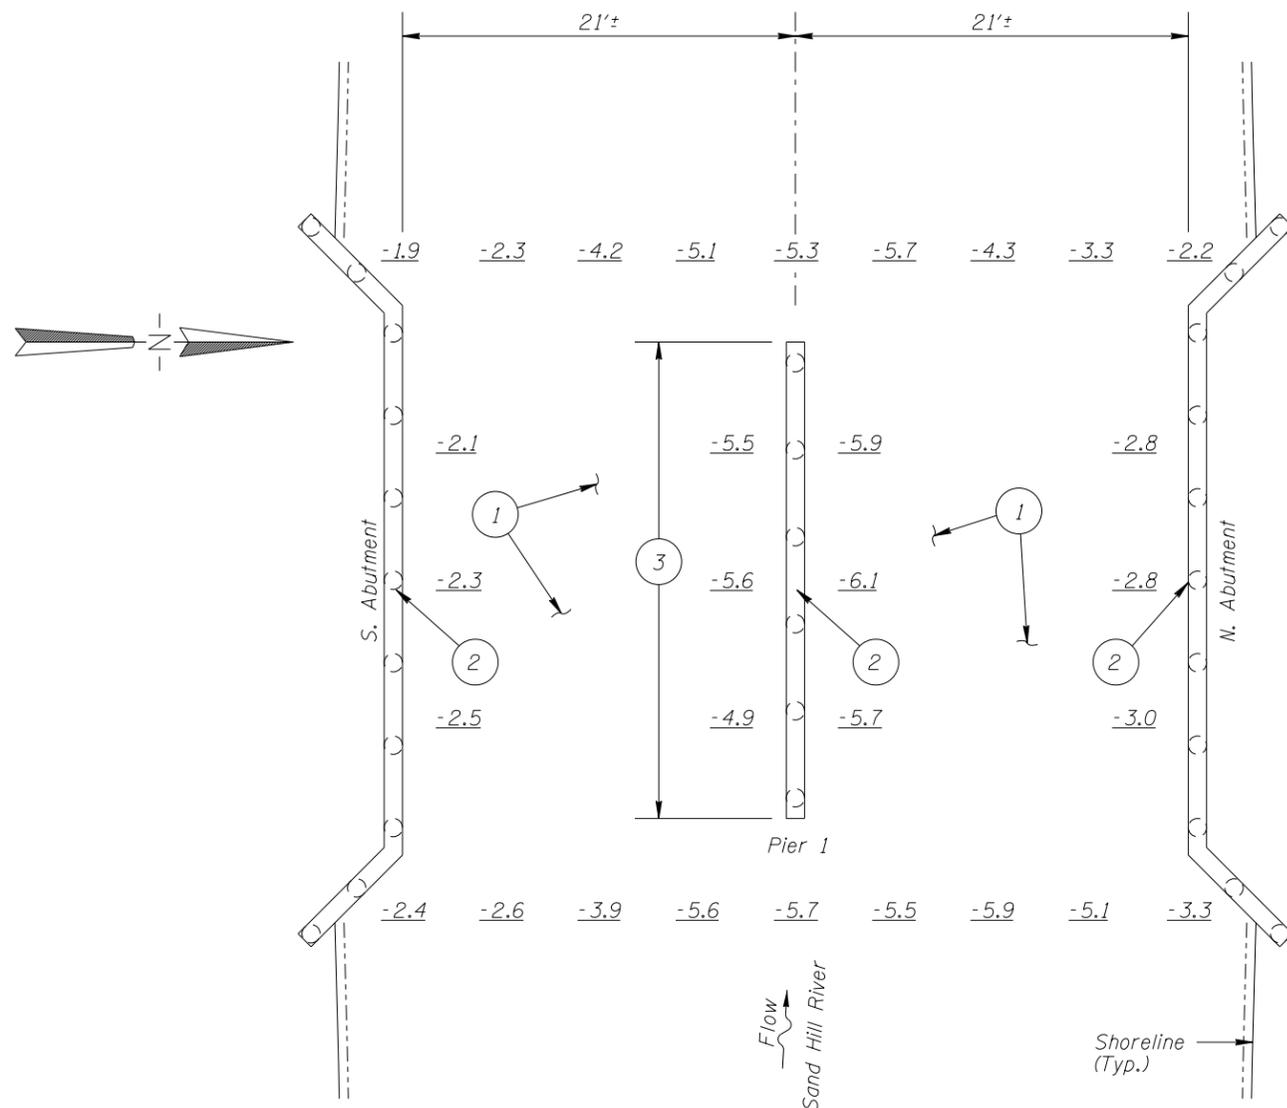
INSPECTION AND SOUNDING PLAN

- 1 The channel bottom typically consisted of sand.
- 2 The timber piles have minor splits and checks throughout.
- 3 There is minor local scour around Pier 1 extending away from the pier 4 feet at the downstream half of the south side and the entire length of the north side up to 1.2 feet deep.
