UNDERWATER BRIDGE INSPECTION REPORT

STRUCTURE NO. 18506

RABBIT LAKE

MINNESOTA DEPARTMENT OF TRANSPORTATION
UNDERWATER BRIDGE INSPECTION

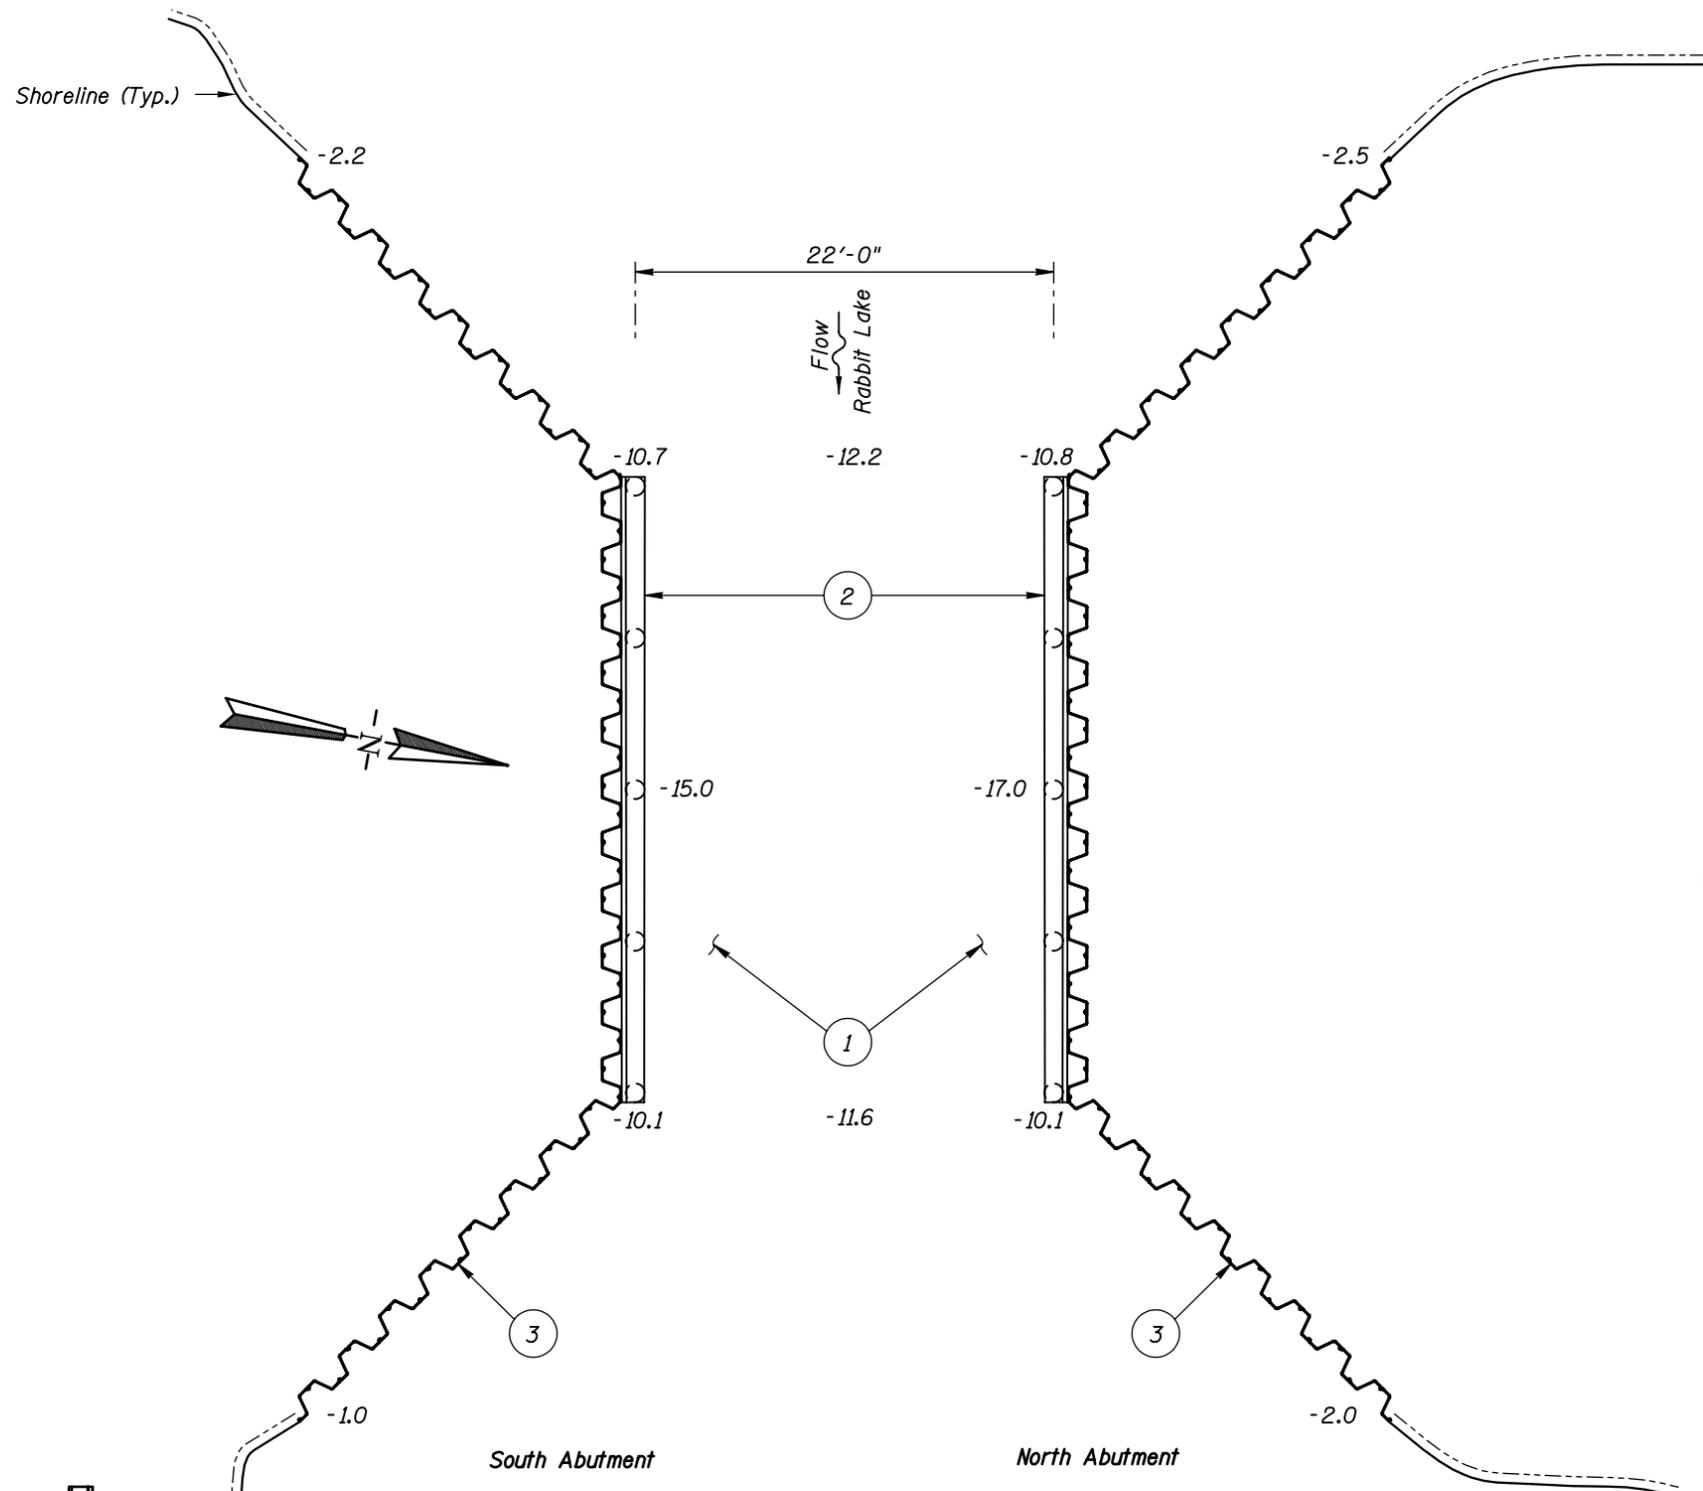
- ① Channel bottom consisted of silty sand with 2 to 4 inches of probe rod penetration.
- ② Very minor checking with width generally less than 1/8 inch on all timber members.
- ③ Light aquatic growth on the steel sheeting below the waterline.

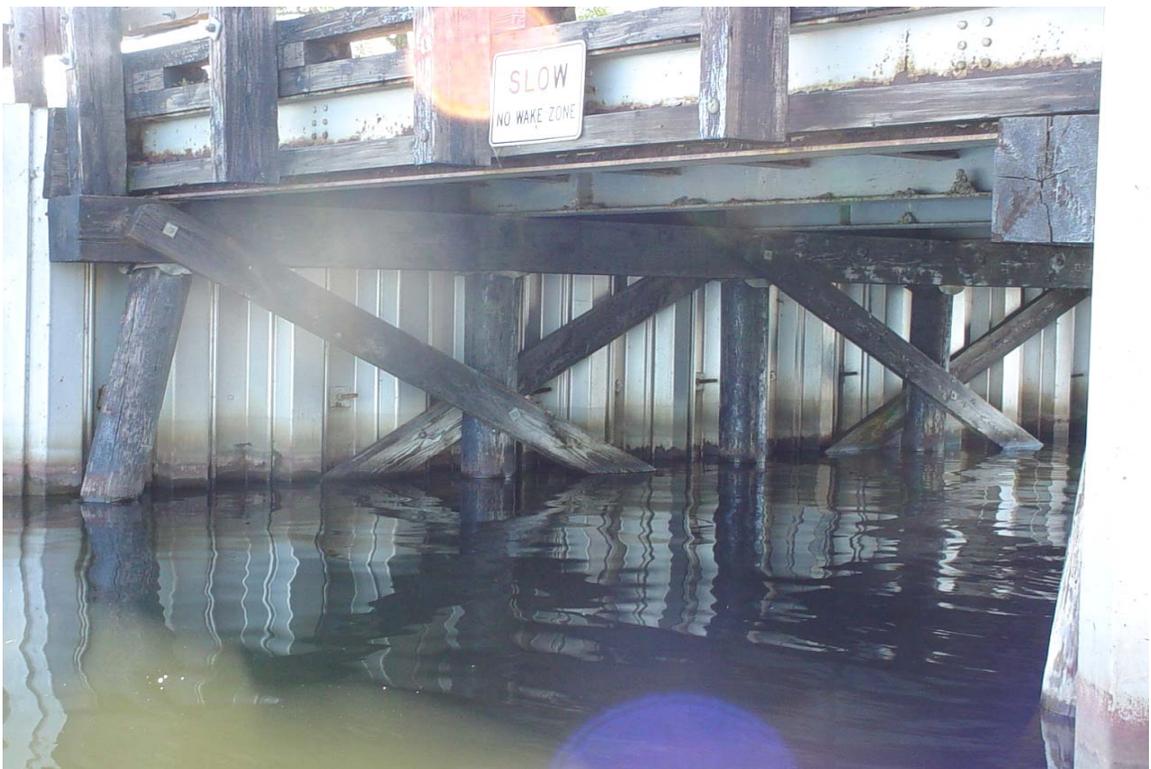
Photograph 2. View of South Abutment, Looking Southwest.

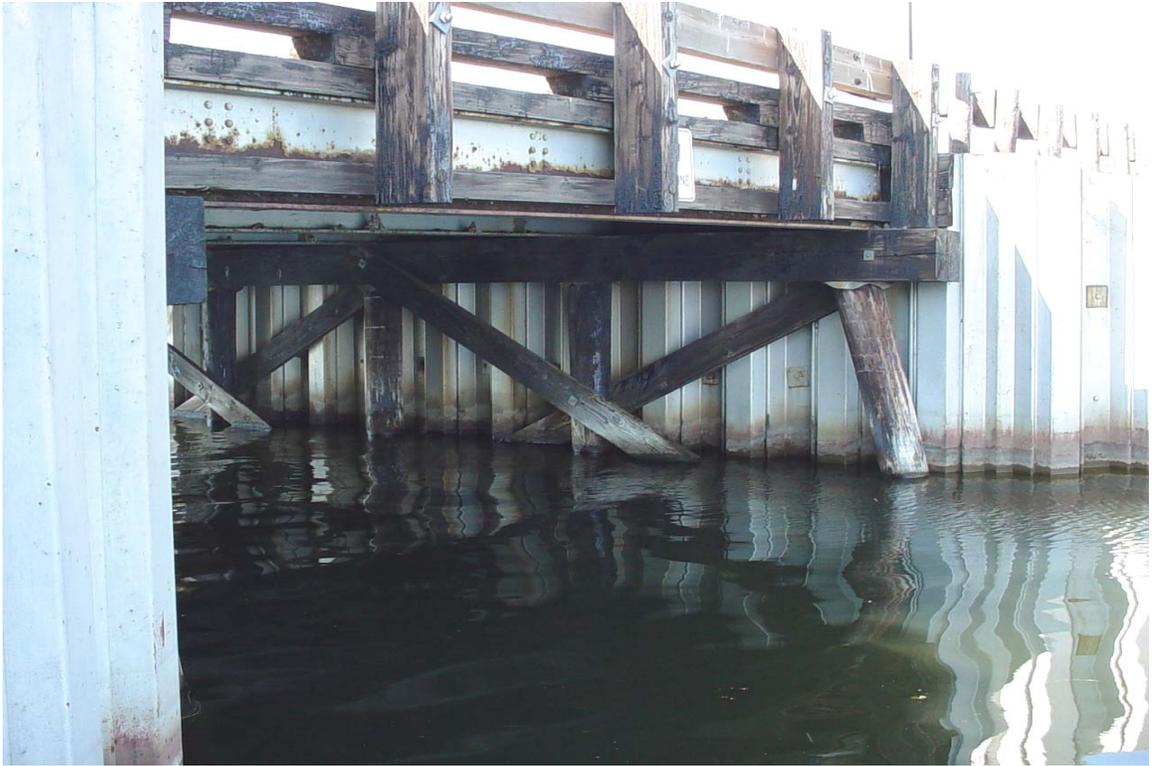
Photograph 3. View of North Abutment, Looking Northeast.
