UNDERWATER BRIDGE INSPECTION REPORT

STRUCTURE NO. 49520  
CSAH NO. 1  
OVER THE  
CROW WING RIVER  
DISTRICT 3 - MORRISON COUNTY

PREPARED FOR THE  
MINNESOTA DEPARTMENT OF TRANSPORTATION  
BY  
COLLINS ENGINEERS, INC.  
JOB NO. 3512 (CEI 65)

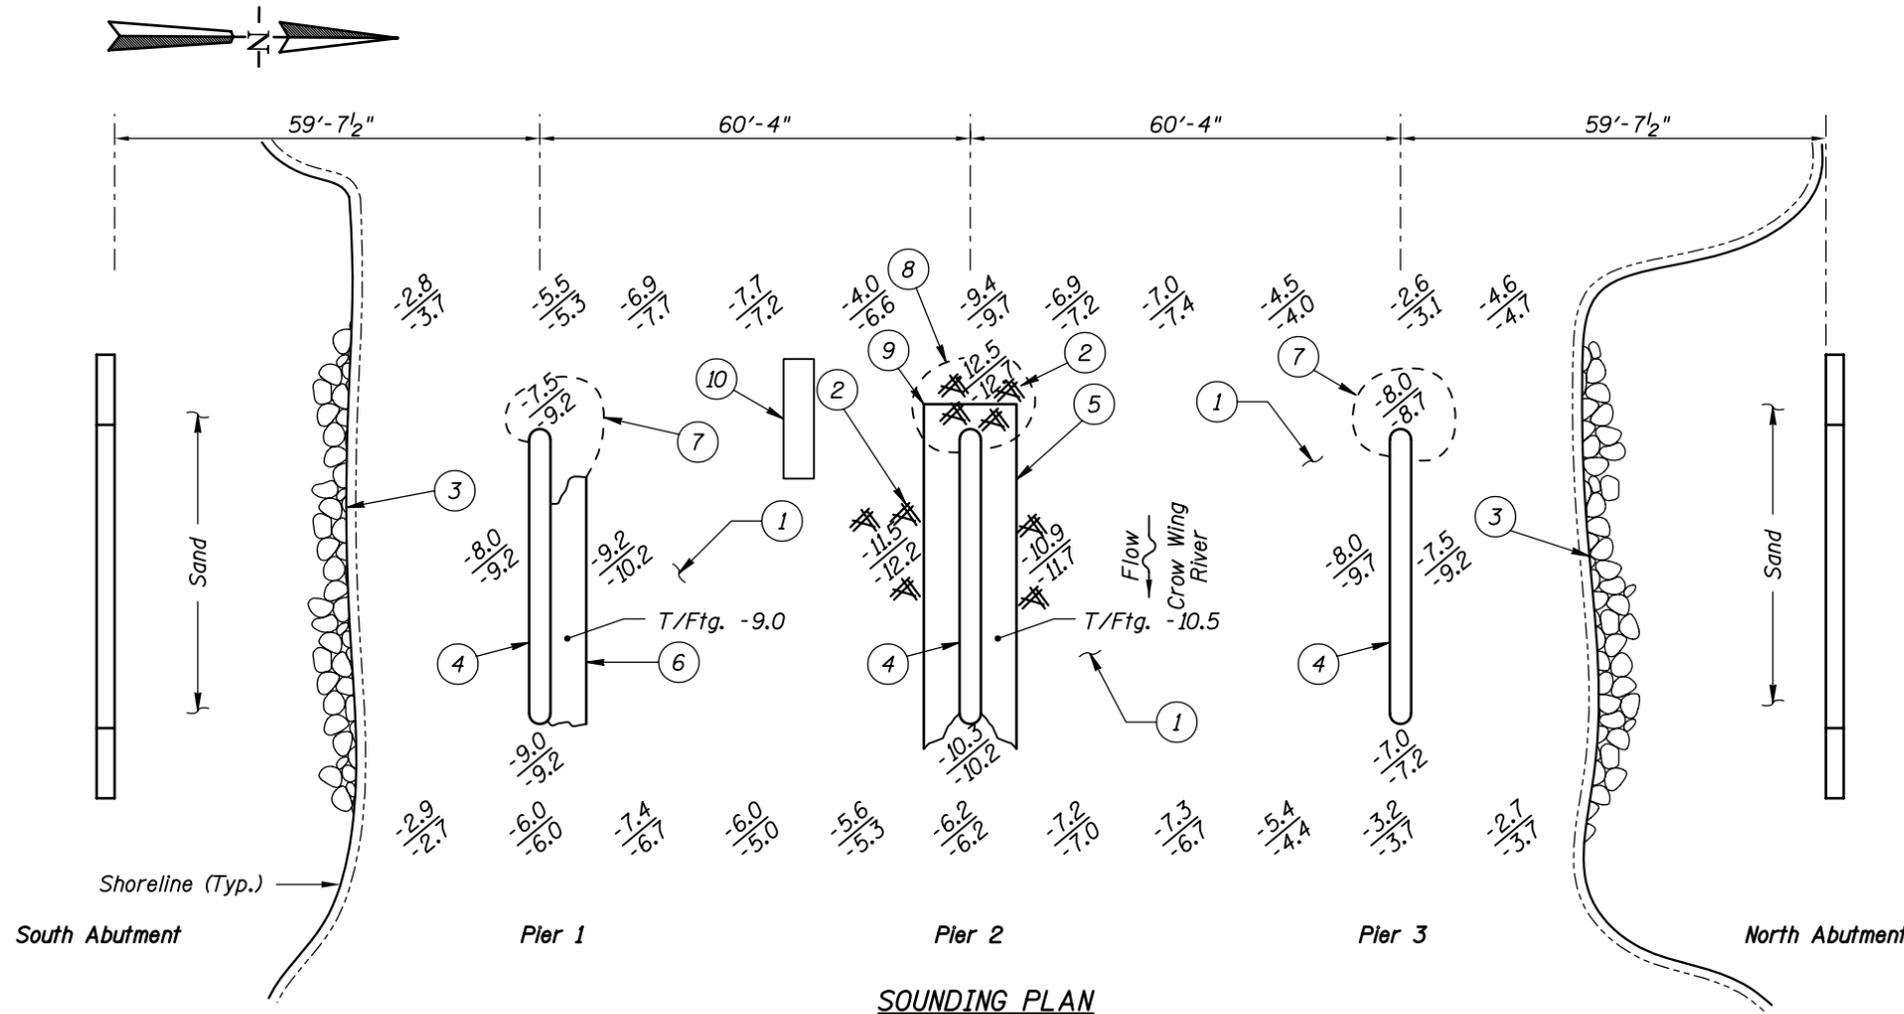
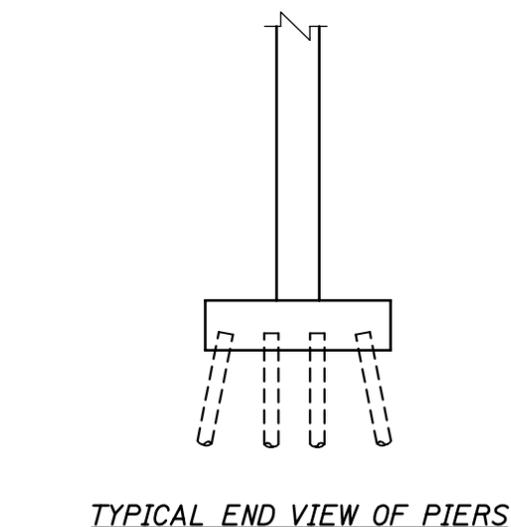
- ① The channel bottom consisted of firm sandy gravel, 6-inch cobbles, and occasional 1- to 2-foot-diameter riprap with a maximum probe rod penetration of 2 inches.

- ② A heavy accumulation of 2-foot-diameter and smaller timber debris was observed at the upstream end and along both faces of Pier 2.
- ③ The embankments consisted of sandy slopes with a 4-foot band of 1- to 2-foot-diameter riprap along the shoreline.

- ④ The concrete was generally in good condition with random areas of poor consolidation and up to 1/2 inch of penetration.
- ⑤ The footing was exposed around Pier 2 with up to 2 feet of vertical exposure at the upstream end of the pier.

- ⑥ The footing was exposed along the north side of Pier 1 with up to 2 inches of vertical exposure.
- ⑦ A 5-foot-radius, 3-foot-deep scour pocket was observed at the upstream end of Piers 1 and 3.

- ⑧ A 3-foot-radius, 1.5-foot-deep scour pocket was observed at the upstream end of Pier 2.
- ⑨ The southwest corner of the exposed footing exhibited a 1-foot-diameter area of section loss with up to 1/2 of inch of penetration.

- ⑩ A concrete pier from the previous bridge was encountered 2.5 feet below the waterline.

- (A) Monitor the timber debris at Pier 2, and if found to be increasing in the future, removal operations may become warranted.

- (B) Reinspect the submerged substructure units at the normal maximum recommended (NBIS) interval of five (5) years, and continue to monitor extent of footing exposure at all piers.

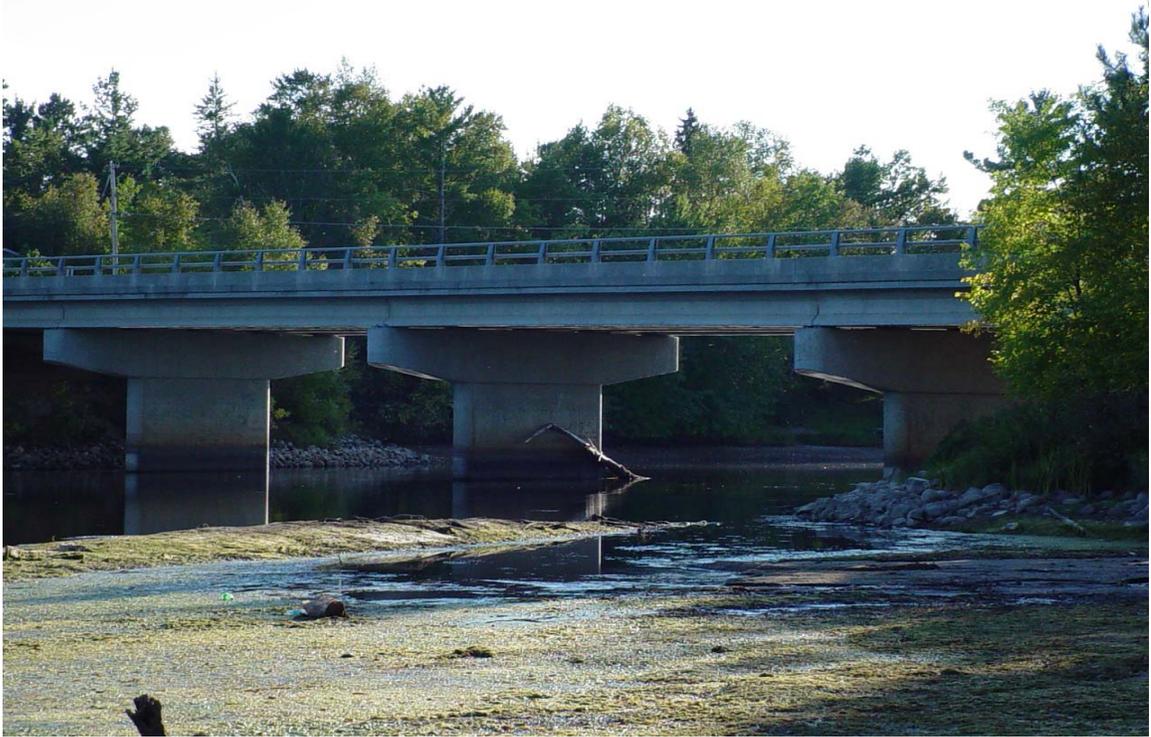
Photograph 1. Overall View of the Structure, Looking Southwest.

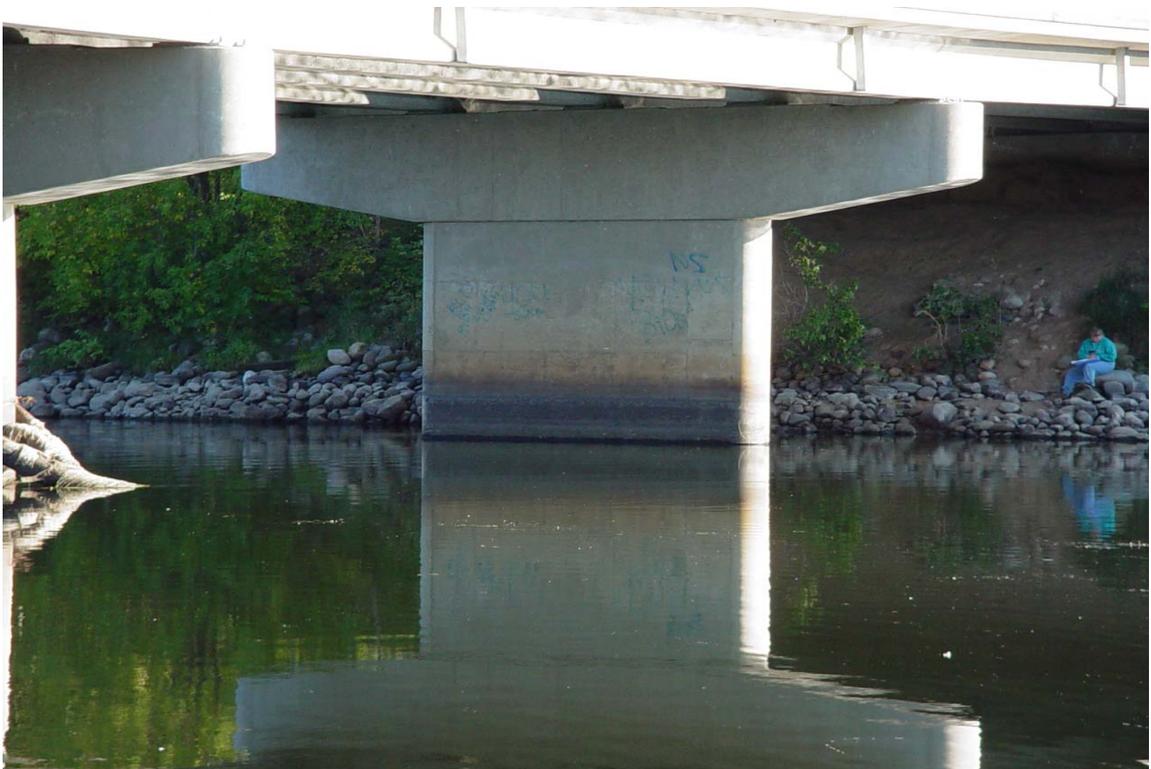
Photograph 2. View of Pier 1, Looking Southeast.

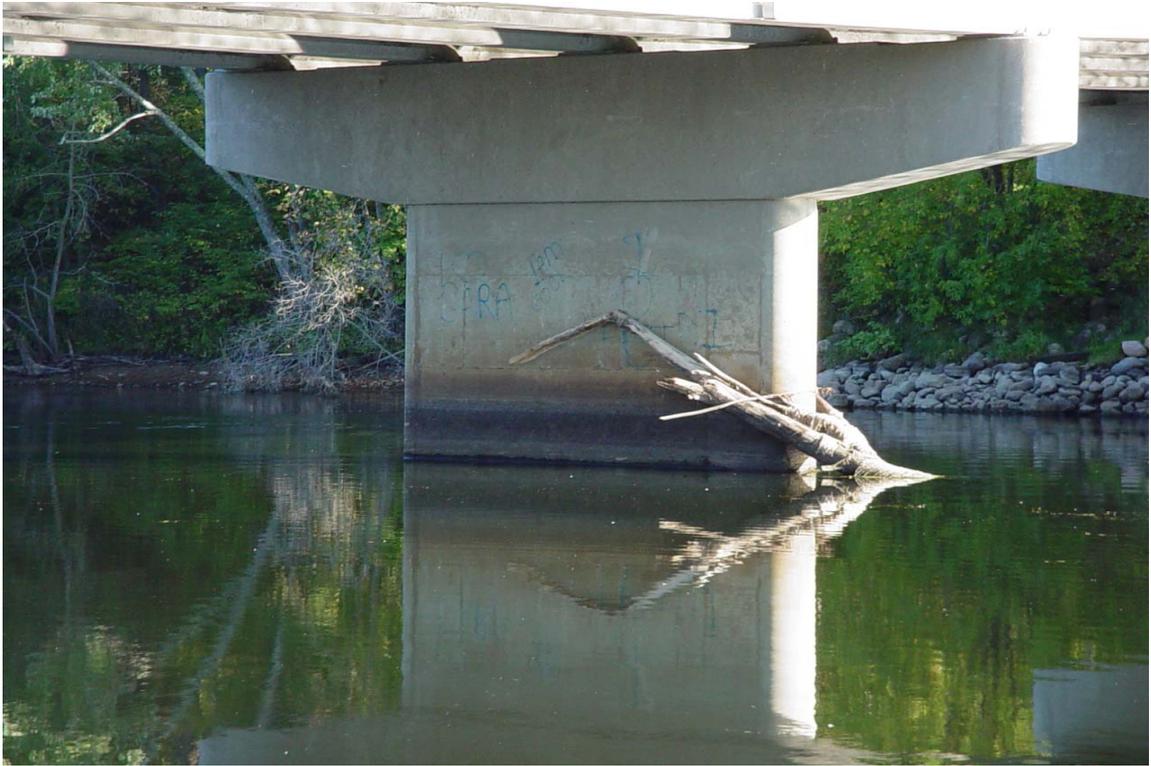
Photograph 3. View of Pier 2, Looking Southeast.

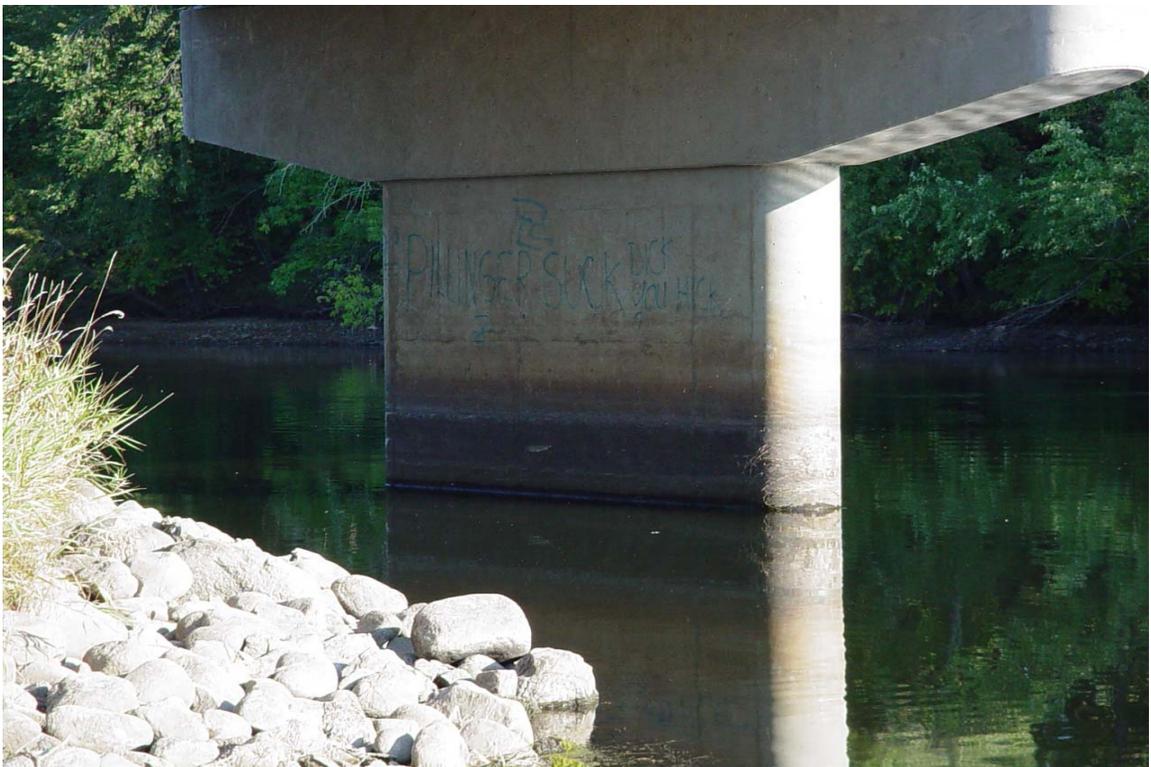
Photograph 4. View of Pier 3, Looking Southeast.
