UNDERWATER BRIDGE INSPECTION REPORT

STRUCTURE NO. L6492

TWP 129

COUNTY DITCH #11

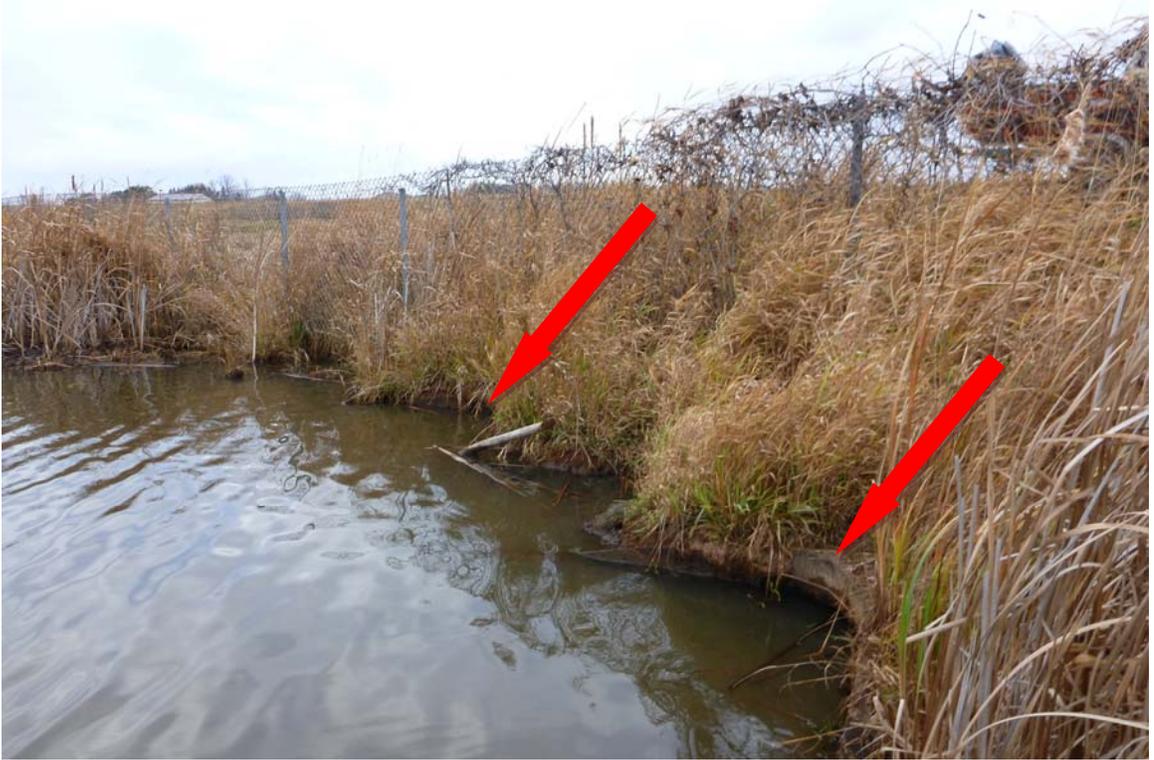
Photograph 1. Overall View of the West Opening, Looking North.

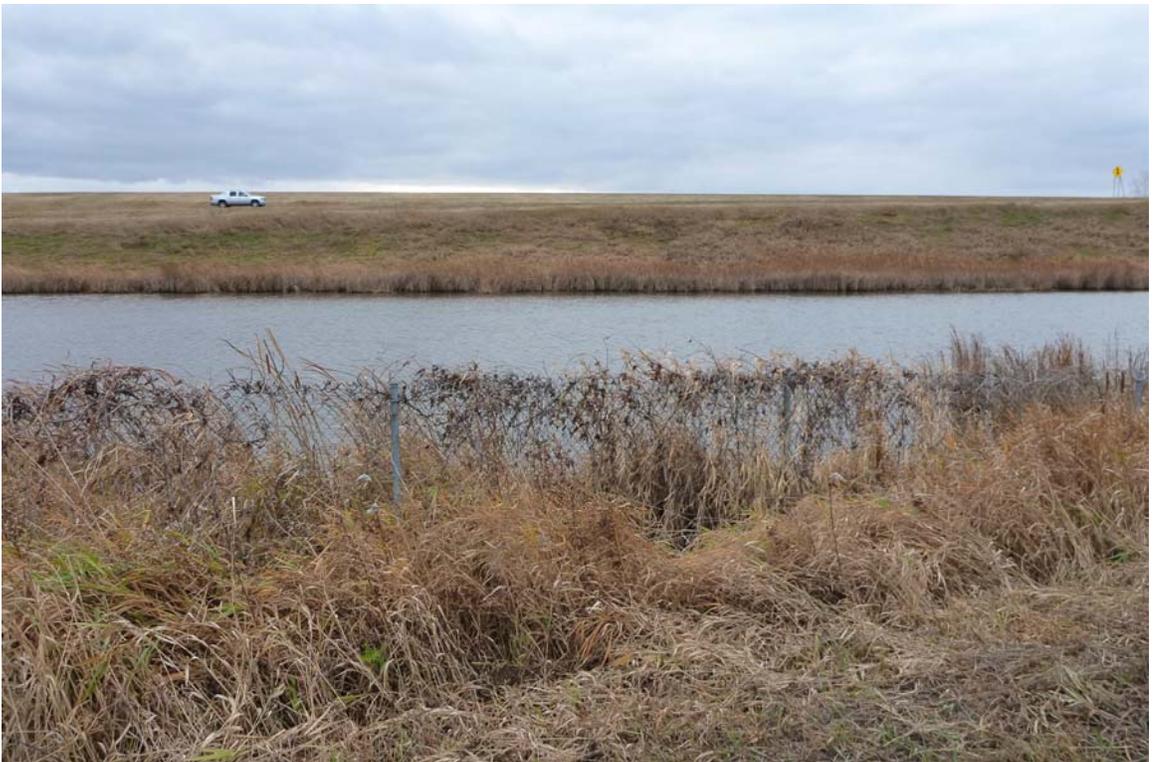
Photograph 2. View of West Channel, Looking West.

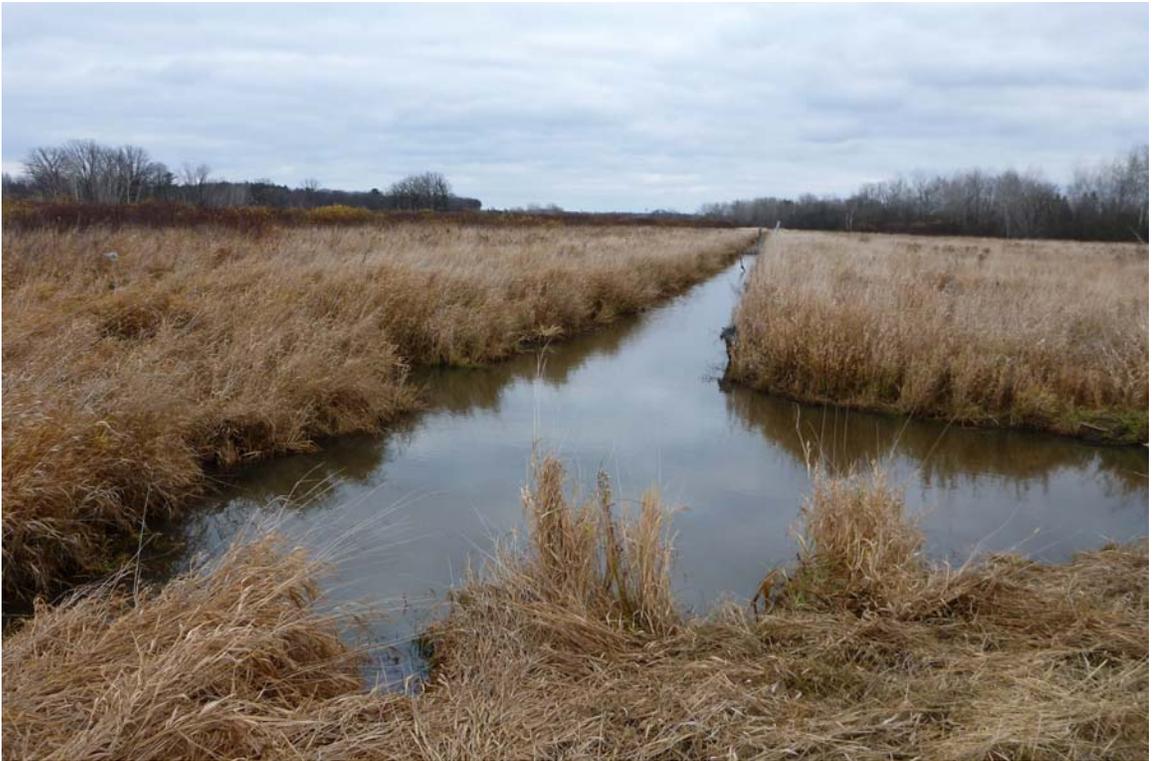
Photograph 3. View of East Channel, Looking East.

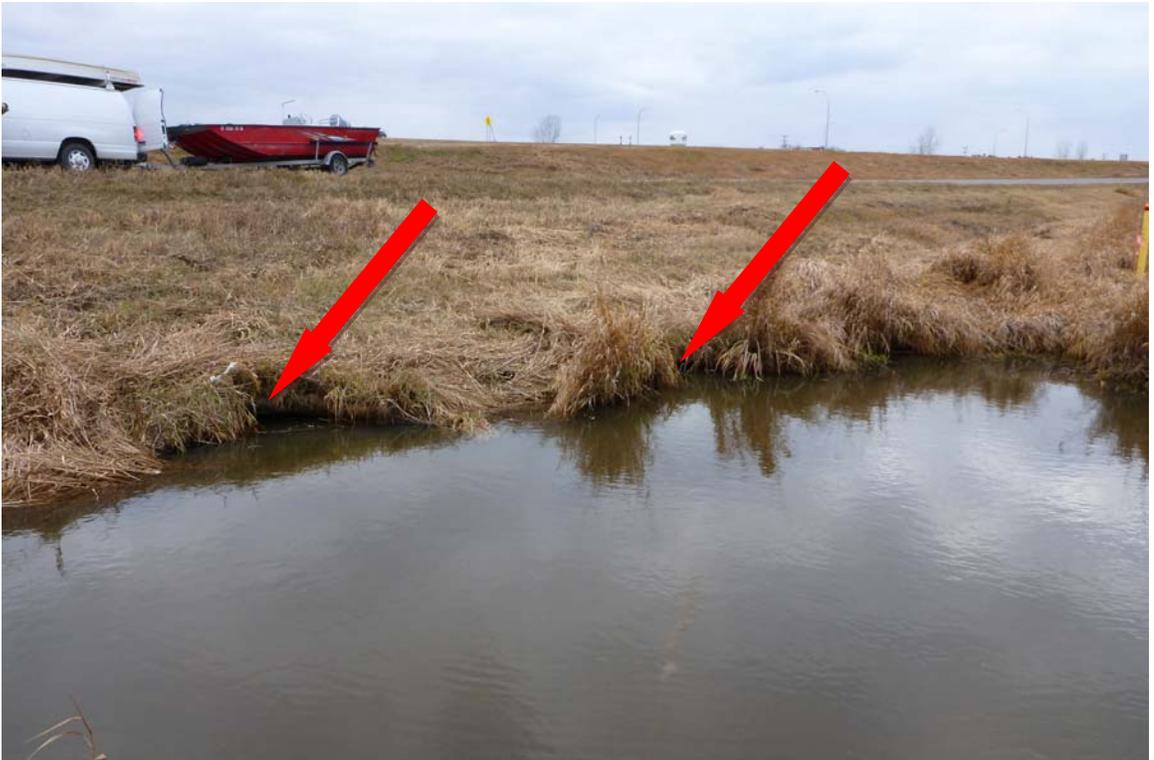
Photograph 4. Overall View of the East Opening, Looking Northwest.

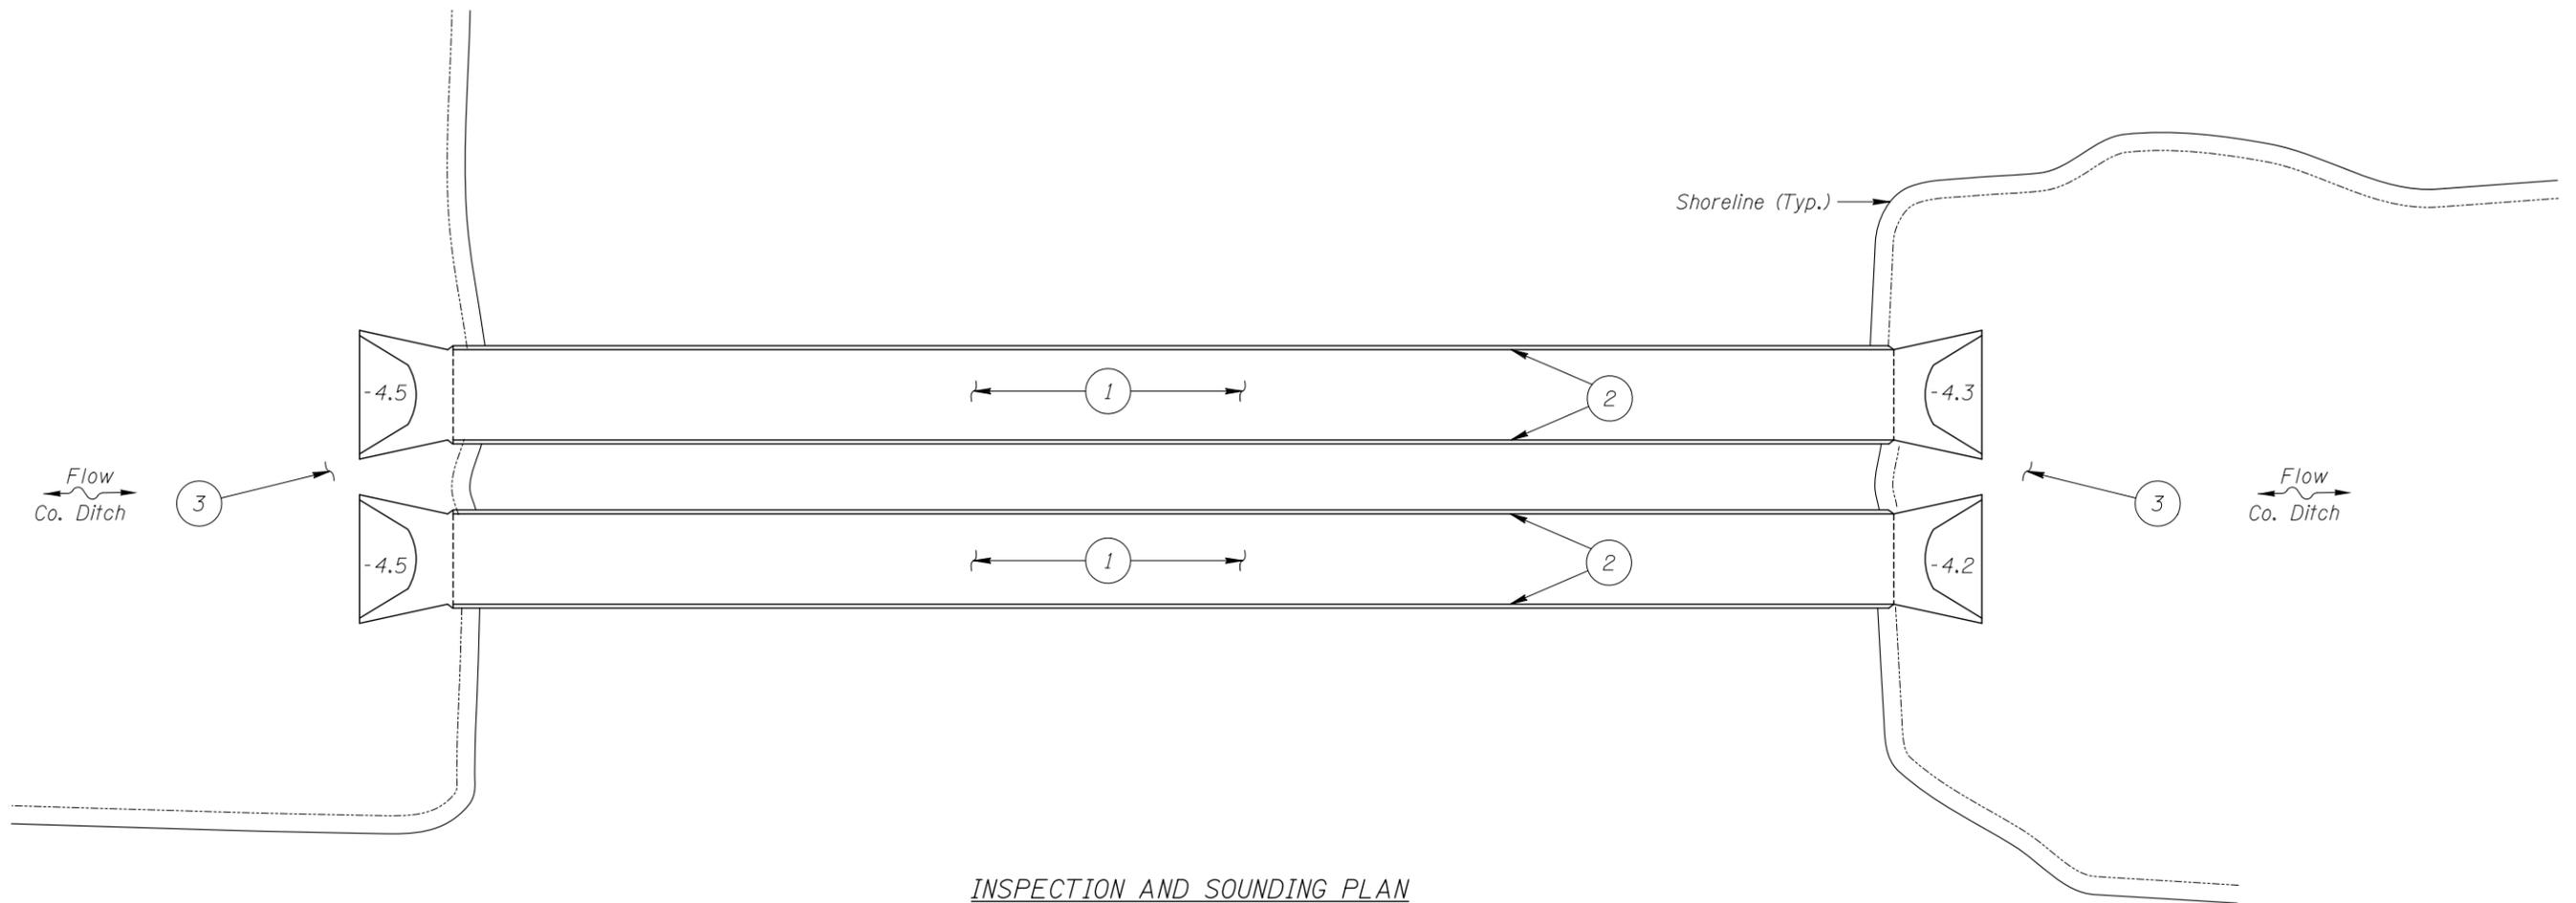
INSPECTION AND SOUNDING PLAN

- ① The floor of the culverts was typically covered with a 2 to 6 inch layer of silt.
- ② The concrete of both culverts was sound with no defects of structural significance observed.
- ③ The channel bottom at the upstream and downstream openings was soft organic silt with up to 1.5 feet of probe rod penetration.
