**2016 UNDERWATER
BRIDGE INSPECTION REPORT**

**BRIDGE # 01506
CSAH 1 over MISSISSIPPI RIVER**

Date of Inspection: 06/08/2016

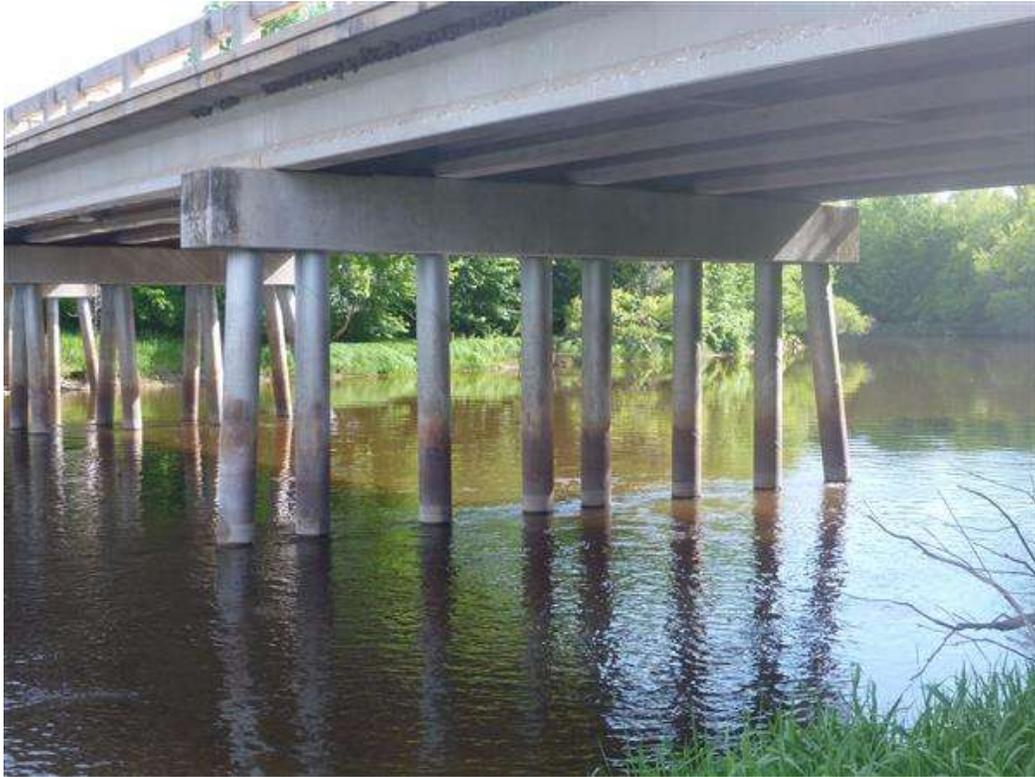
(A) The channel bottom material around Pier 2 consisted of silty sand allowing 6 to 8 inches of probe rod penetration.

(C) The steel pipe piles exhibited 100 percent coating failure with light to moderate corrosion and minor rust nodules with up to 1/8 inch deep pitting (1/16 inch typical) over 50 percent of the surface area from the waterline to 8 feet above, and on 100% of the surface area below water.

(E) A moderate accumulation of timber debris consisting of 1 foot diameter and smaller logs and branches was observed along the entire length of Pier 2 at the channel bottom.

Photo 3 - Overall View of Pier 2, Looking Northeast.

(A) Monitor timber debris accumulations around the piles at Piers 2 and 3 during future inspections, and if found to be progressing, removal may become warranted, to eliminate excessive lateral loads on piers and the potential for scour.

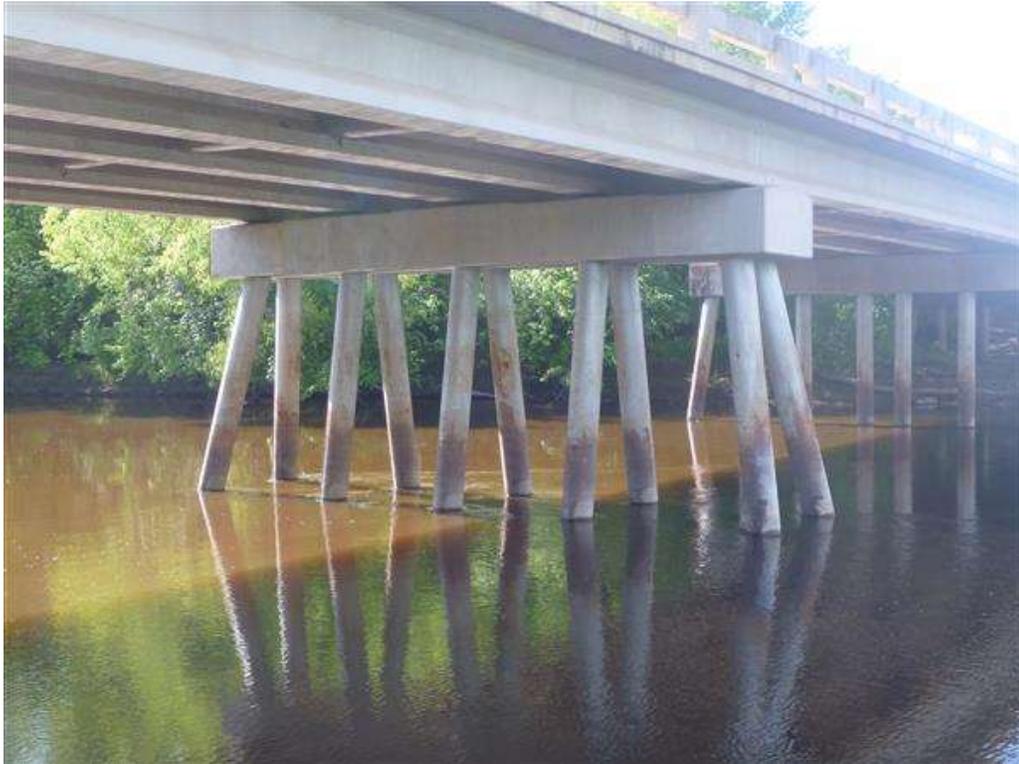
(B) The channel bottom material around Pier 3 consisted of soft silt allowing up to 8 inches of probe rod penetration.

(D) The steel pipe piles at Pier 3 exhibited 1/16 inch thick rust delaminations due to corrosion from the waterline to the channel bottom.

(F) A moderate accumulation of timber debris consisting of 1 foot diameter and smaller logs and branches was observed extending from the channel bottom to 5 feet below the waterline at the upstream end extending to the upstream quarter points of Pier 3.

Photo 4 - Overall View of Pier 3, Looking Southeast.

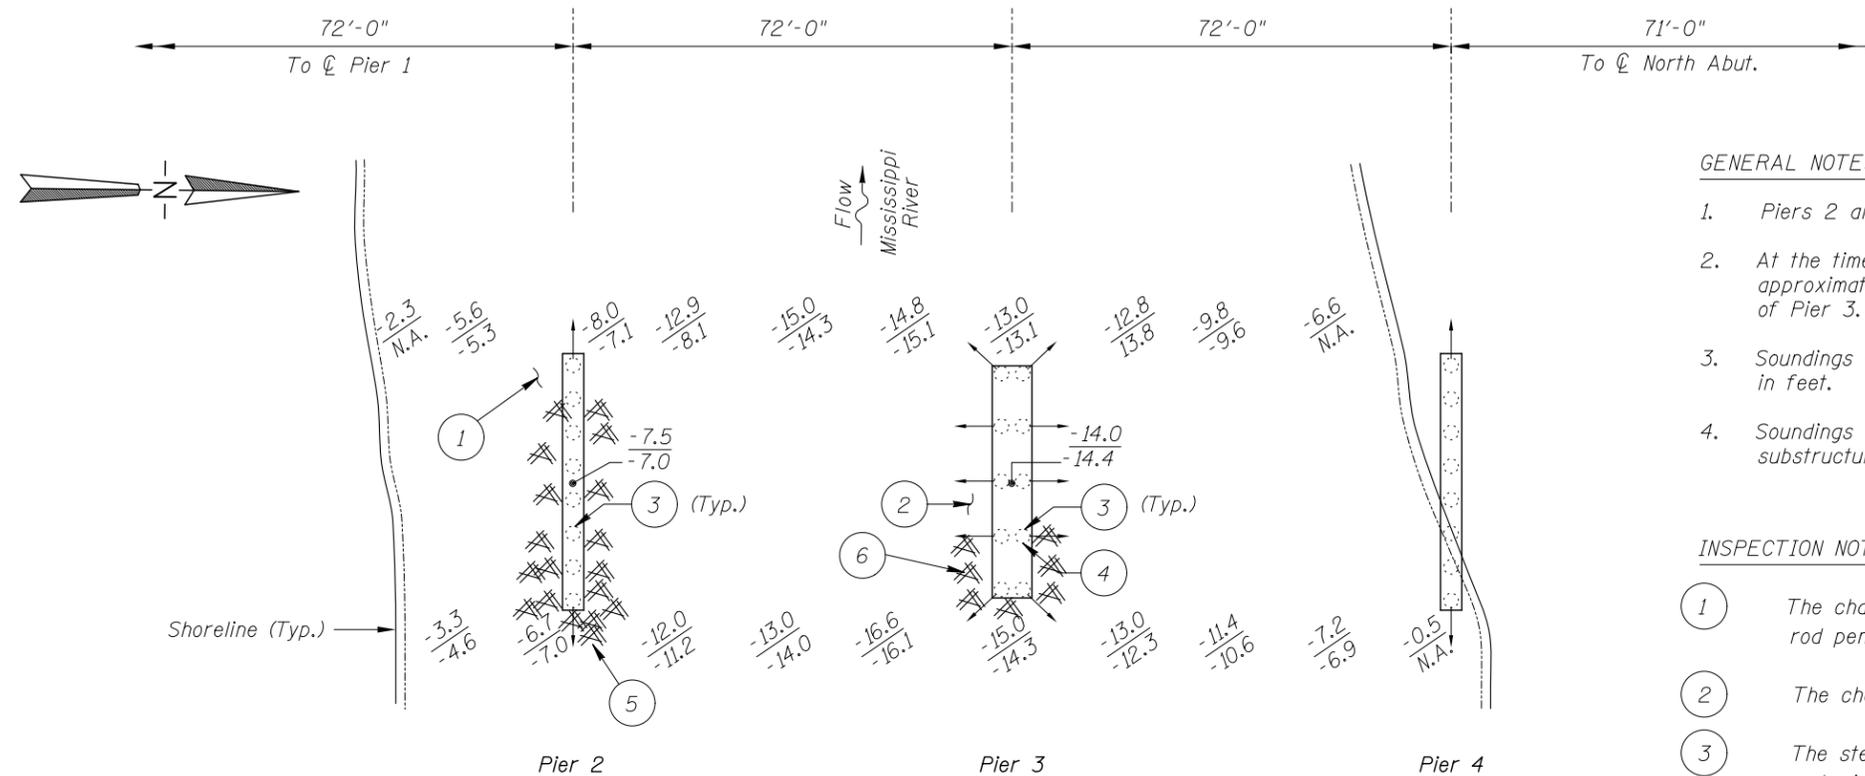
SOUNDING PLAN

- 1 The channel bottom material consisted of silty sand with 6 to 8 inches of probe rod penetration.
- 2 The channel bottom material consisted of soft silt with up to 8 inches of probe rod penetration.

- 3 The steel pipe piles exhibited 100 percent coating failure with light to moderate corrosion and minor rust nodules with up to 1/8 inch deep pitting (1/16 inch typical) over 50 percent of the surface area from waterline to 8 feet above waterline, and on 100 percent of the surface area below water.

- 4 The steel pipe piles at Pier 3 exhibited 1/16 inch thick rust delaminations due to corrosion from the waterline to the channel bottom.
- 5 A moderate accumulation of timber debris consisting of 1 foot diameter and smaller logs and branches was observed along the entire length of Pier 2 at the channel bottom.

- 6 A moderate accumulation of timber debris consisting of 1 foot diameter and smaller logs and branches was observed extending from the channel bottom to 5 feet below the waterline at the upstream end extending to the upstream quarter points of Pier 3.
